# Woodbarn Farm

(/A404//13.10//) SMIS Structure Key: 18761

**Principal Inspection**

**20 January 2014**

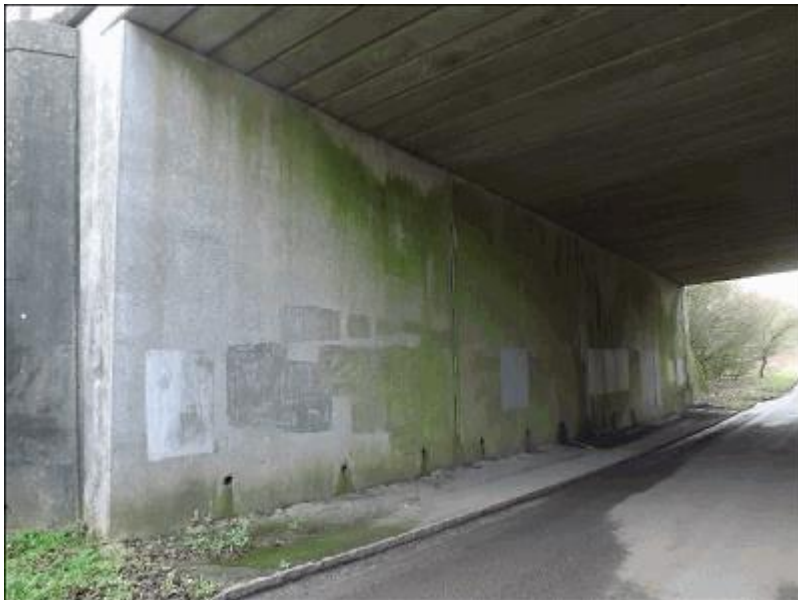
04 - South Abutment 20.1.14

Structure found to be in generally fair condition due to active water penetration through to the south abutment, areas of major cracking across the carriageway surfacing and exposed reinforcement to the parapet edge beams.

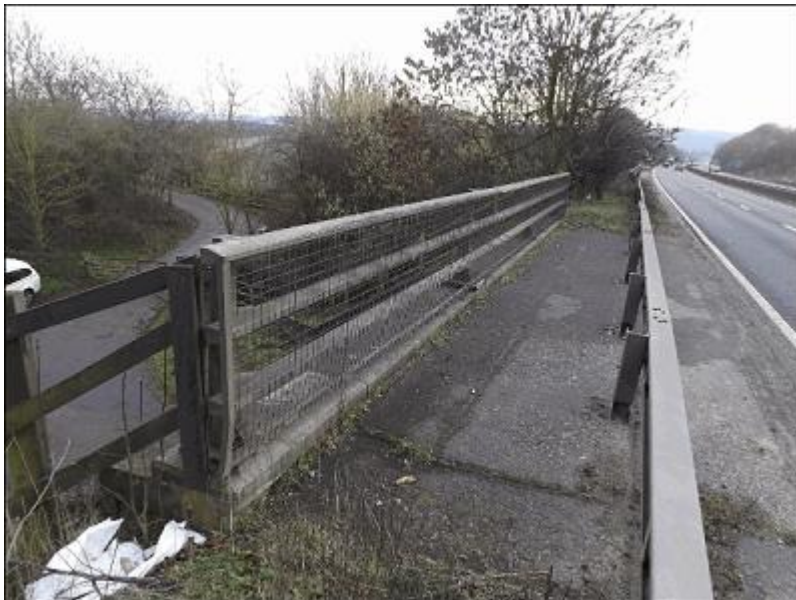
14 - East Parapet 20.1.14

<b>Components</b>	Centre Deck - West Parapet Plinth, Centre Deck - East Parapet Plinth
<b>Defect Type</b>	ER - Exposed reinforcement
<b>Extent</b>	SC - Defect present in 5% to not more than 20% of area or length of element
<b>Severity</b>	D3 - Moderate: Defect is probably causing damage to element or structure, or is likely to do so in the near future
<b>Priority</b>	Medium
<b>Comments</b>	Exposed reinforcement to east and west parapet edge beams due to low cover
