BRE Global Client Report

BS 8414-1:2015 + A1:2017 Test referred to as DCLG test 7.

Prepared for: DCLG
Date: 18th August 2017 (Issue 1.0)
12th September 2017 (Issue 2.1)
Report Number: B137611-1037 (DCLG test 7) Issue: 2.1

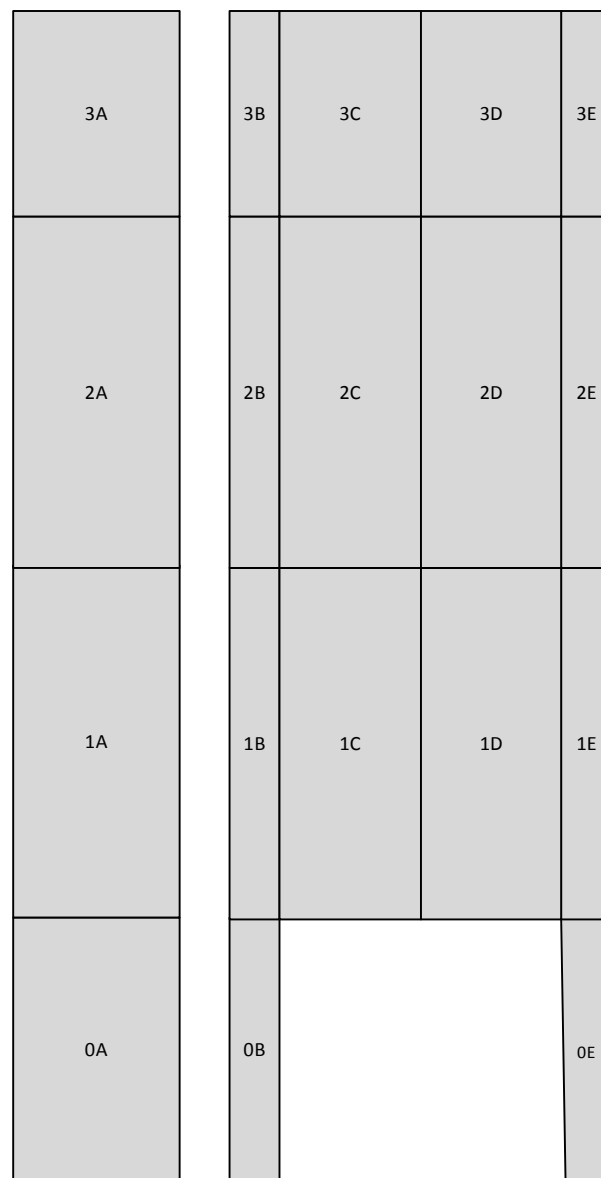
Figure 1. Layout of panels and labelling system used for reporting purposes. Not to scale.

2:18	0:23	Flame tips reach the horizontal junction between panels 1C and 2C.
2:49	0:54	Distortion of panels 1C and 1D observed.
3:03	1:08	Detachment of the surface coating from panels 1C and 1D.

On the main wall, the damage to the ACM panels was (See *Figures 22 to 28* and with reference to *Figure 1*):

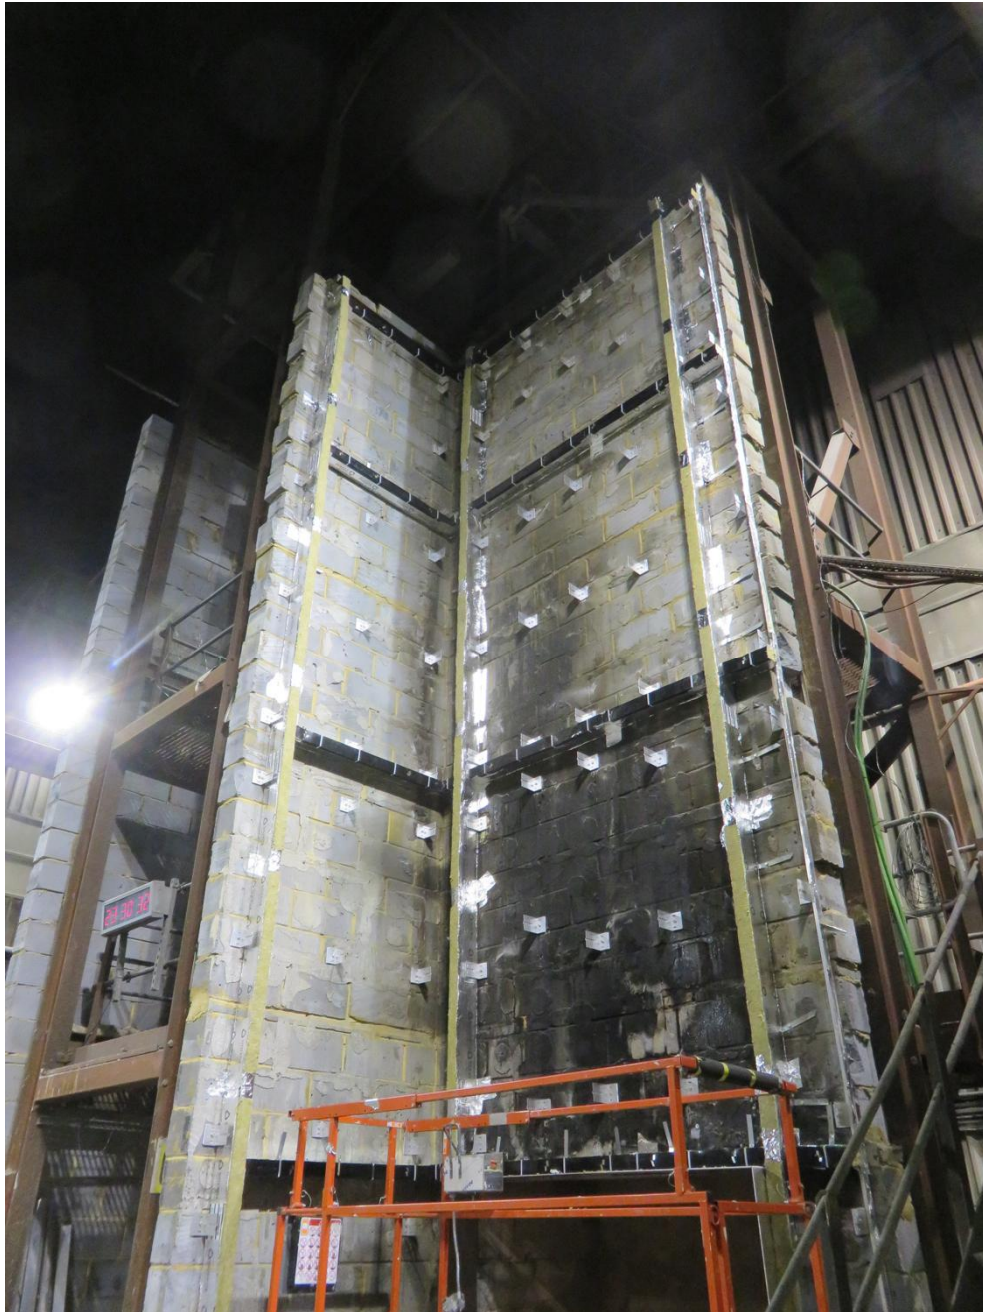
Figure 3. Location of 'L' brackets (partially visible) vertical and horizontal cavity barriers.

On the wing wall, one 75mm-wide×160mm-deep stone wool vertical cavity barrier, with 10mm compression, was fixed in position at the edge of the system, approximately 1350mm from the external face of the main wall – see *Figure 3*. Once installed in position the stone wool vertical cavity barriers were compressed by the ACM panels to fully close the 50mm ventilated cavity.

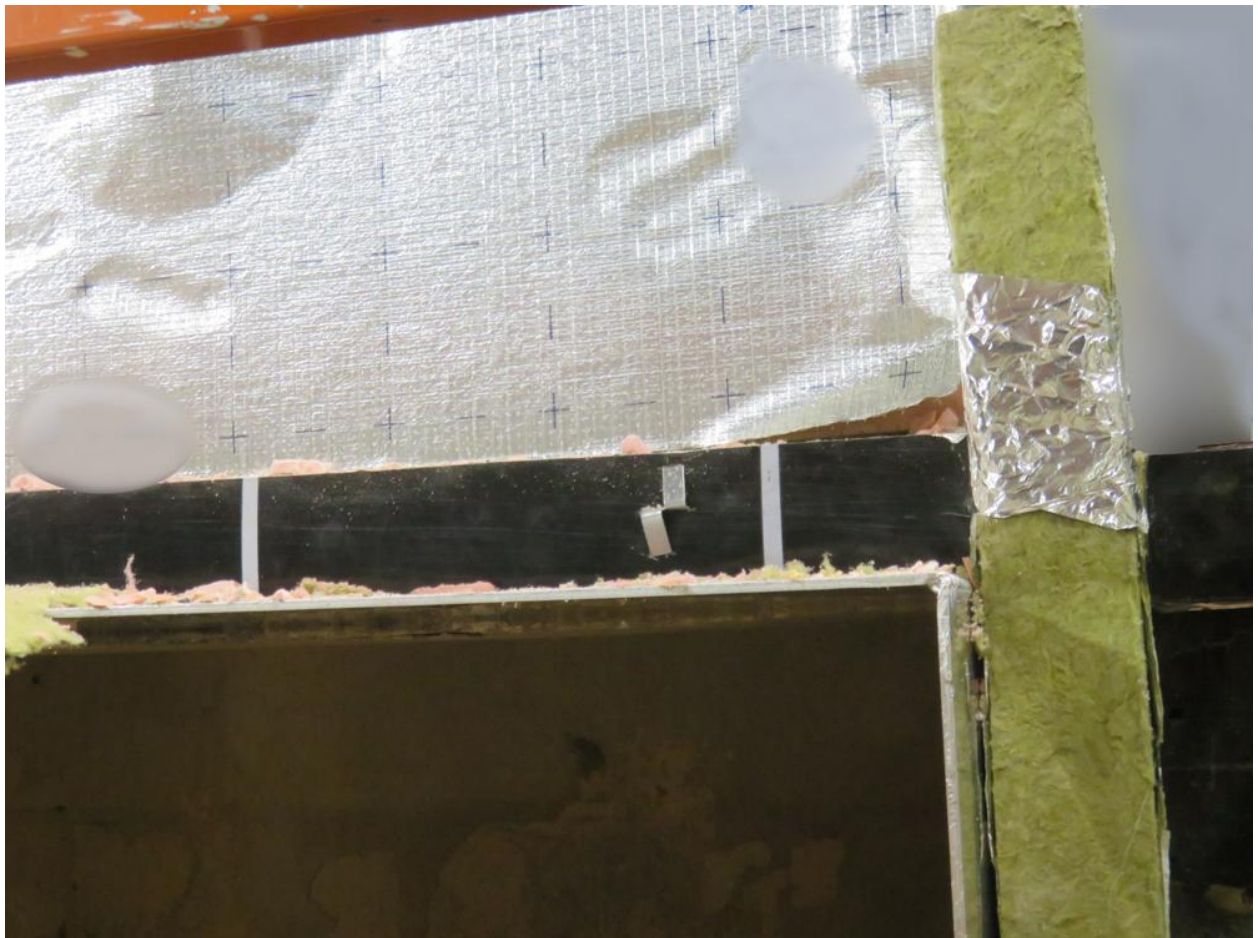
Figure 4. Horizontal intumescent cavity barriers fitted between vertical cavity barriers.

The system included vertical and horizontal cavity barriers – see *Figure 4*. On the main face, two 75mm-wide×160mm-deep stone wool vertical cavity barriers, with 10mm compression, were fixed in position with a clear distance of 1950mm between them. The vertical cavity barriers were skewered to $\frac{3}{4}$ -depth on steel brackets fixed into the masonry wall with one 70mm-long× ϕ 4mm anchor. Two steel brackets were used for each length of 1200mm of stone wool cavity barrier. The vertical cavity barriers were trimmed to fit – see *Figure 6*.

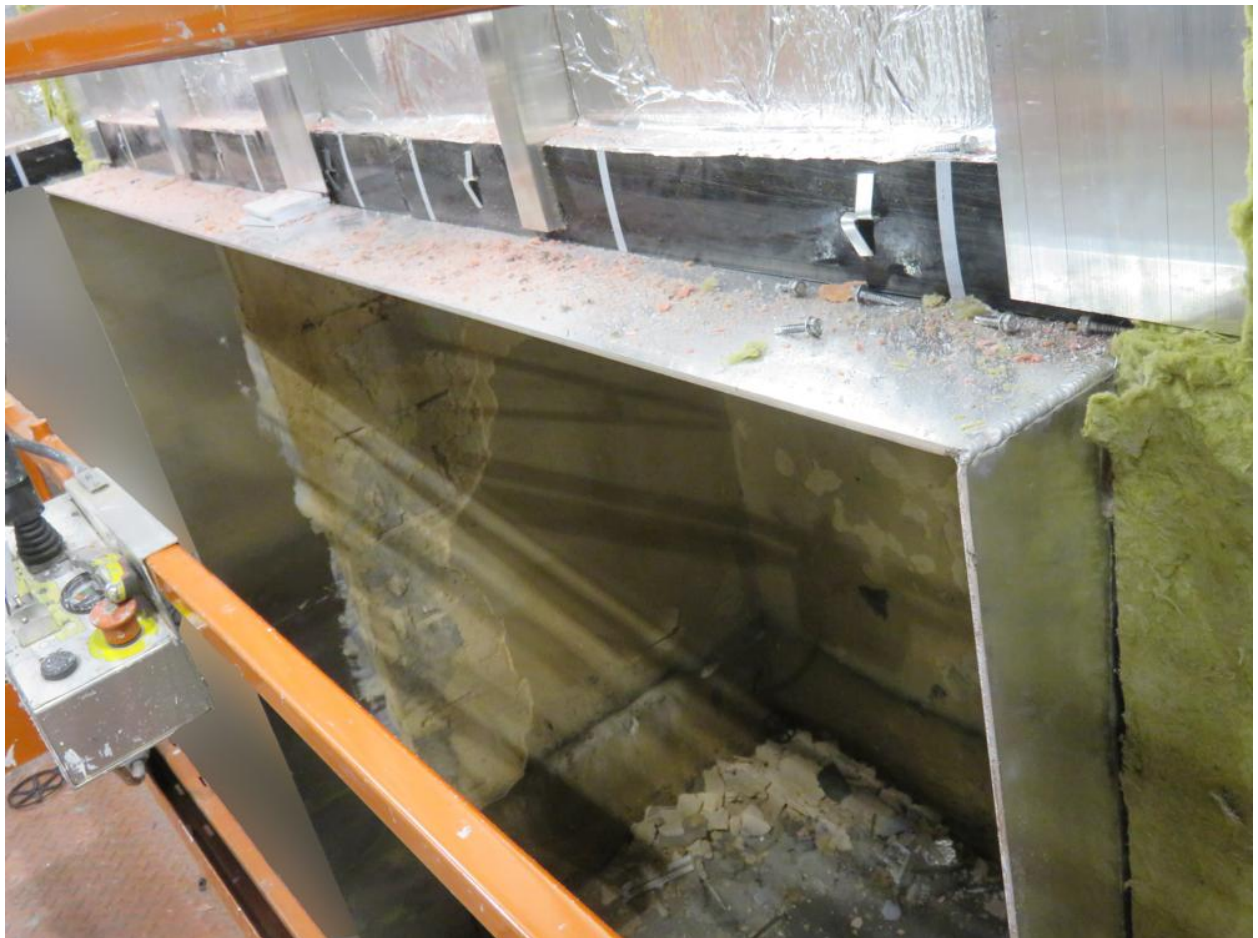
Figure 5. Horizontal intumescent cavity barriers fixed through the entire depth on face turned steel brackets, fitted above window pod.

A pre-fabricated, welded window pod constructed from 5mm-thick aluminum was fixed onto the edge of the combustion chamber opening with eight (two on top, three on both vertical edges) 90mm-long× ϕ 8mm stainless steel screw anchor and plastic plugs – see *Figure 5*.

The horizontal cavity barriers were fixed through the entire depth on face turned steel brackets –see *Figure 5*. Two steel brackets were used per length of 1200mm of stone wool cavity barrier, each fixed into the masonry wall with one 70mm-long× ϕ 4mm anchor, positioned above the cavity barrier. The horizontal intumescent cavity barriers were installed with a maximum gap of 25mm to the back face of the panel in accordance with the manufacturer's recommendation.

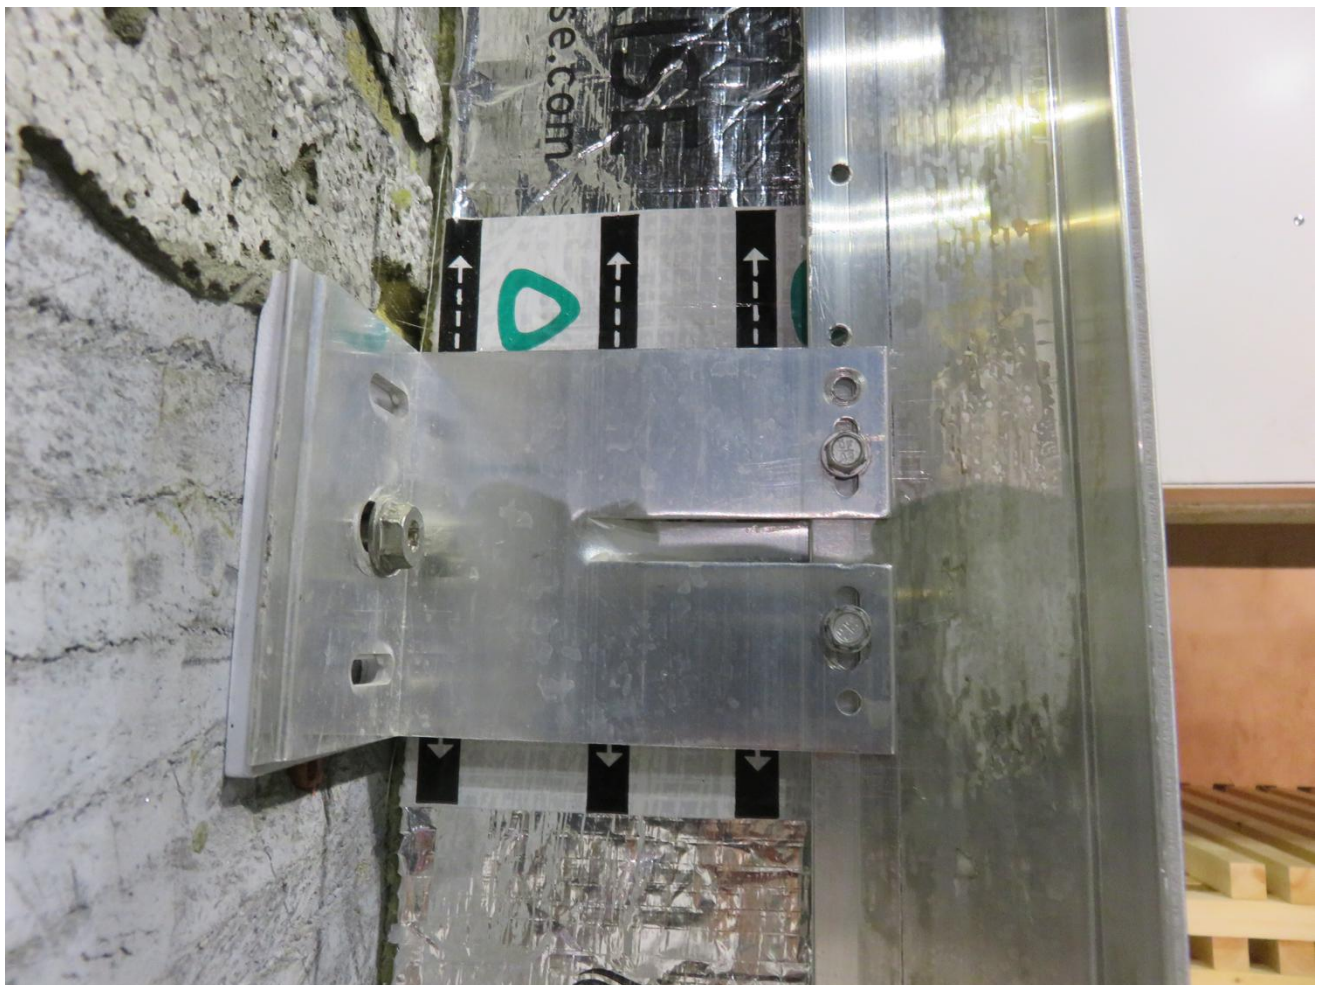
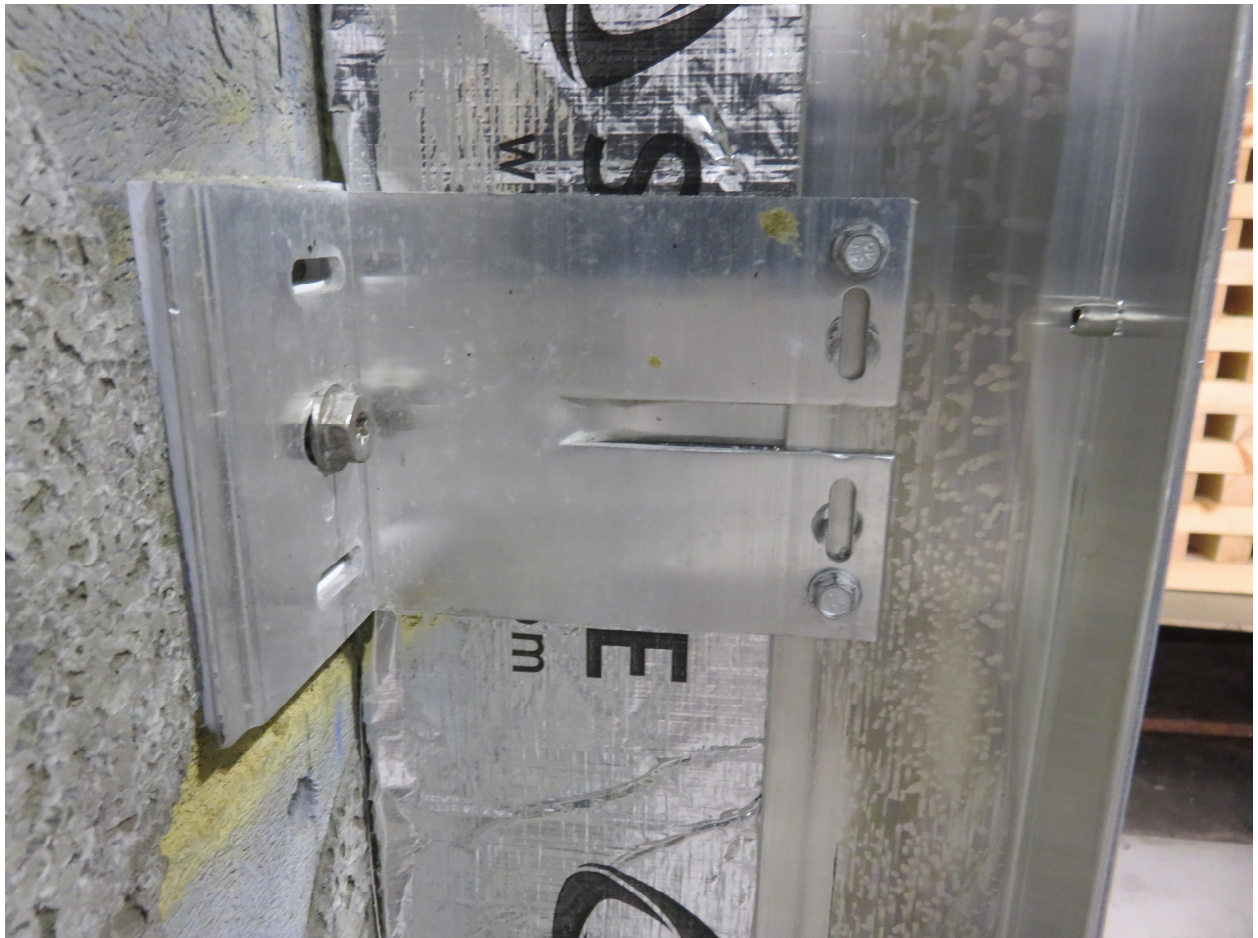
Figure 8. Example of aluminium rail fixed to 'L' bracket through movement holes.

Onto the masonry support structure the 90mm-high × 64mm-wide × 113mm-deep × 4mm-thick aluminium 'L'-shaped brackets were fixed in position on low density polyethylene isolation pads (5mm-thick), with a single 90mm-long × ϕ 8mm stainless steel screw anchor and plastic plug – see *Figures 8&9*. On the main face the horizontal spacing between the brackets varied between 340mm and 500mm – *Figure 3*. On the wing wall the horizontal spacing between the brackets was 645mm as specified in the manufacturer's details. The vertical spacing between the brackets was 960mm and where horizontal cavity barriers were present a spacing of 410mm was used - see *Figure 3&4*.

After the insulation was fixed in position, the 120mm-wide×60mm-deep×2mm-thick aluminium 'T'-section and 40mm-wide×60mm-deep×2mm-thick 'L'-section framing were installed at horizontal spacings of 480mm – see *Figure 10*. The horizontal spacing between successive sections of aluminium 'T'-section or 'L'-section framing was 970mm. The aluminium vertical rails, with a typical length of 2300mm, were positioned 10mm inside the thermal insulation with each rail fixed to the brackets with 2×4.8×16mm self-drilling, self-tapping, stainless steel screws. The aluminium rails were installed with a 30mm gap at the floor levels to allow for structural movement – see *Figure 6*. Three brackets supported each section of rail: the middle bracket was fixed while the top and bottom brackets were connected with movement holes – see *Figures 8&9*.

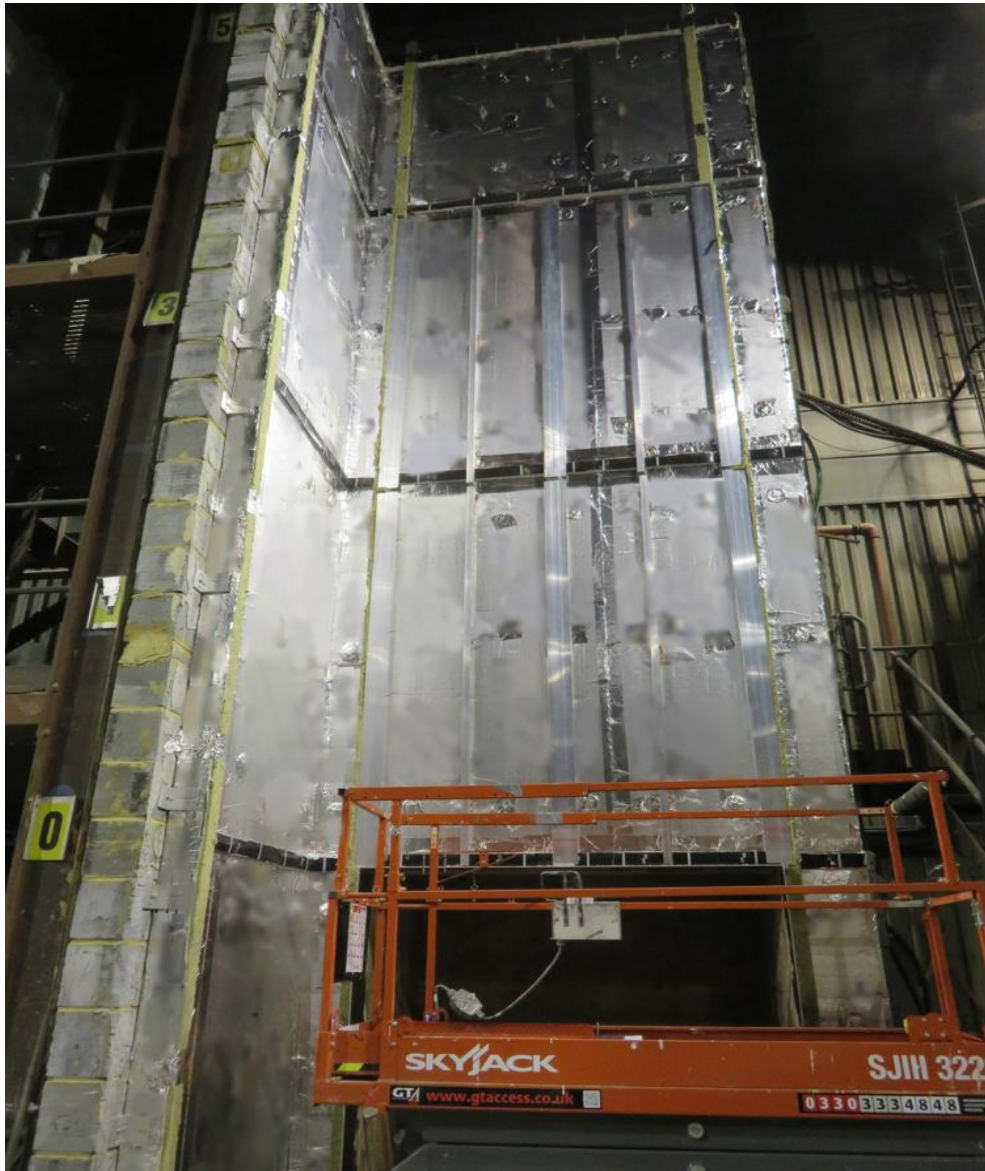
Figure 10. Completed installation of railing substructure visible on main wall.

The 100mm-thick foil-faced phenolic insulation panels (supplied in 2400mm×1200mm panels and cut to fit) were installed in position through the substructure bracket fixing systems and fixed to the support structure (masonry wall) with five 125mm-long× ϕ 8mm plastic anchors and four 140mm-long× ϕ 8mm stainless steel anchors per full size panel – see *Figure 7*. The insulation panels were installed with the long edge orientated vertically. All the gaps between the insulation panels and at the intersection with the cavity barriers or aluminium brackets were sealed with aluminium tape as recommended by the manufacturer – see *Figure 10*.

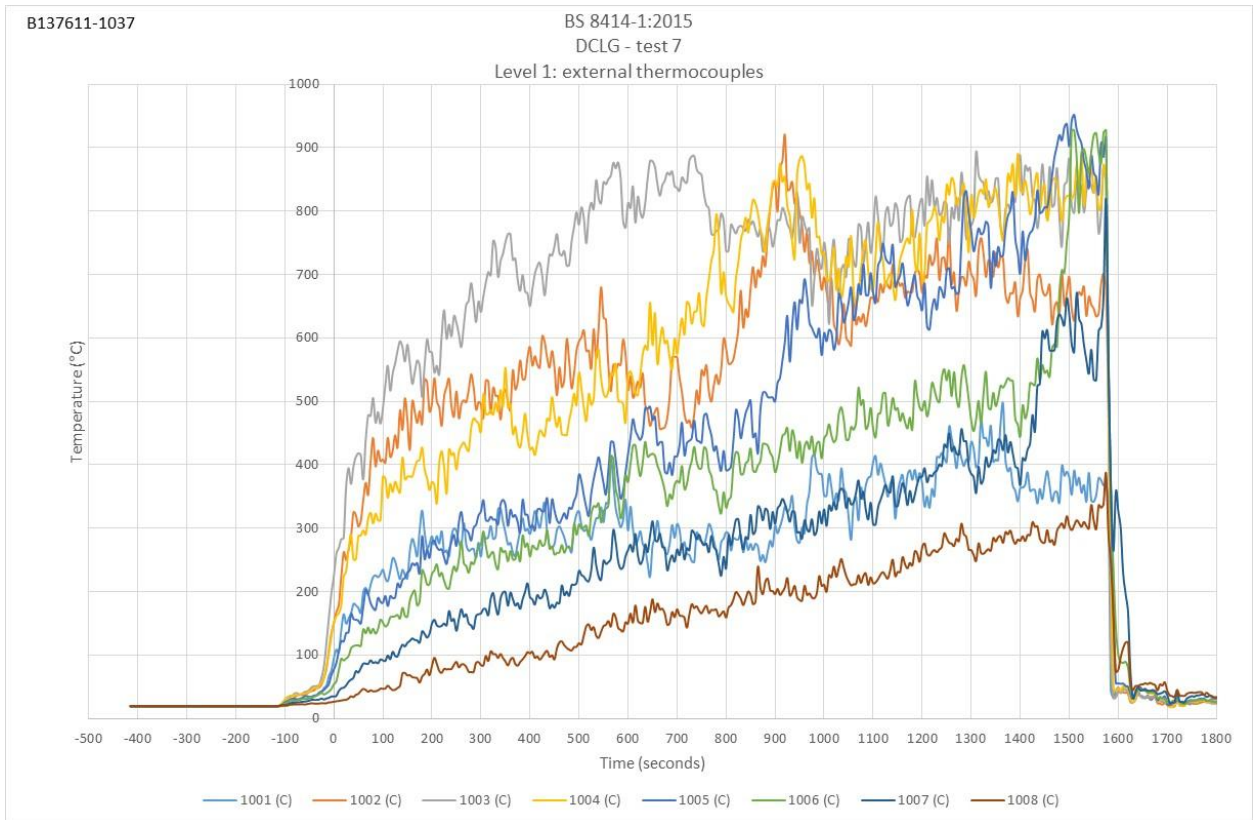
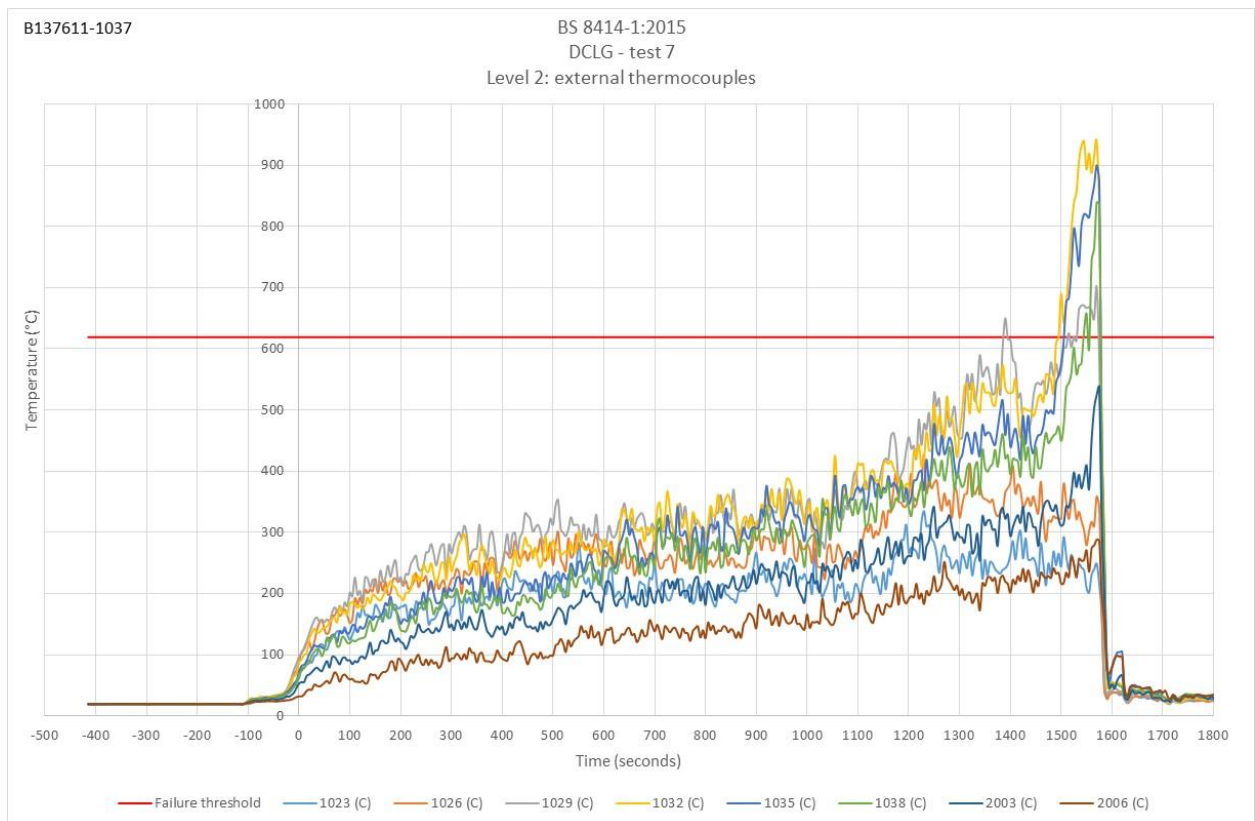
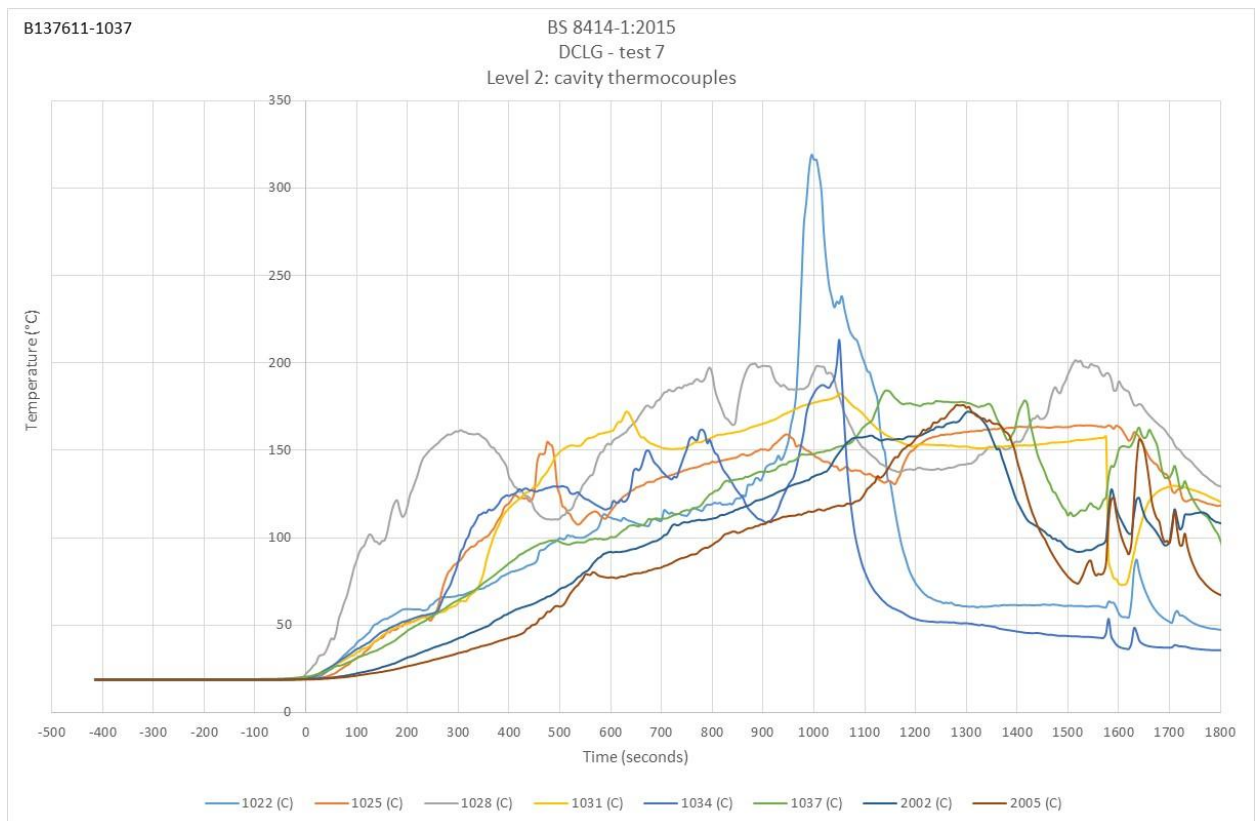
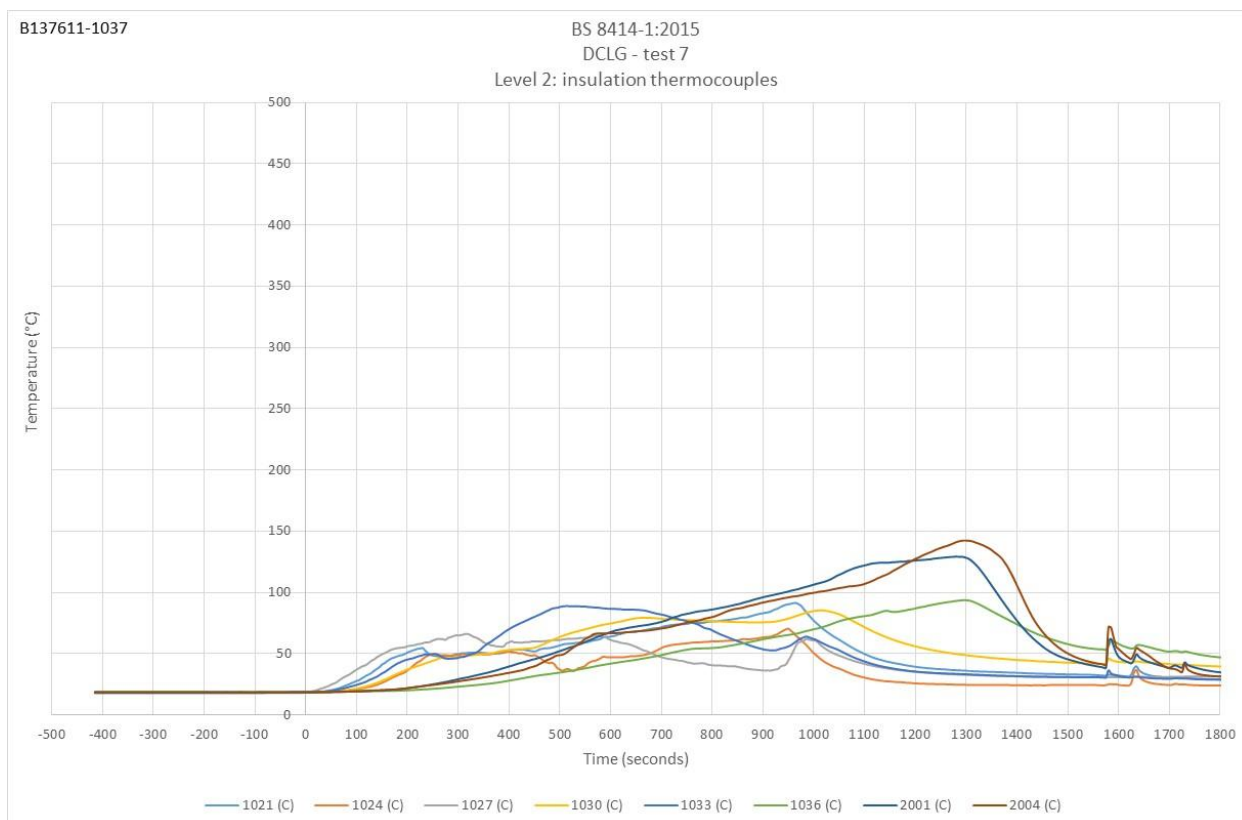
Figures 18-21 provide the temperature profiles recorded. Figure 12 shows the system before the test.
