ACCIDENT

Aircraft Type and Registration:	Cessna 402C, N603AB
No & Type of Engines:	2 Continental TSIO-520-VB piston engines
Year of Manufacture:	1997 (Serial no: 402C0603)
Date & Time (UTC):	11 February 2017 at 2004 hrs
Location:	Virgin Gorda Airport, British Virgin Islands (BVI)
Type of Flight:	Commercial Air Transport (Passenger)
Persons on Board:	Crew - 1 Passengers - 8
Injuries:	Crew - None Passengers - None
Nature of Damage:	Extensive damage to the landing gear and aircraft structure
Commander's Licence:	Commercial pilot's licence (FAA)
Commander's Age:	29 years
Commander's Flying Experience:	5,458 hours (of which 809 were on type) Last 90 days - 225 hours Last 28 days - 80 hours
Information Source:	AAIB Field Investigation

Synopsis

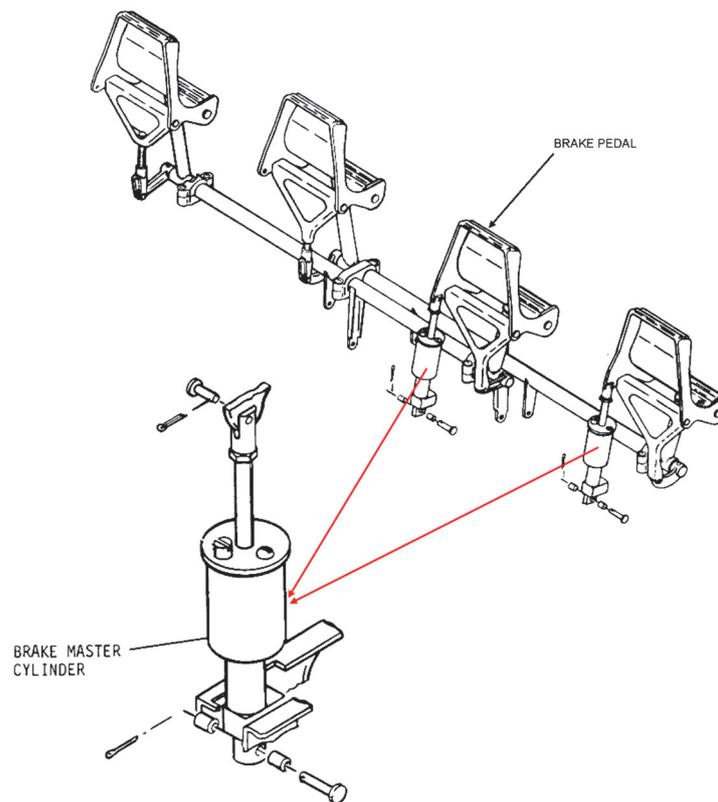
Figure 1

There are two hydraulic master cylinders, one for each brake, connected to the pilot’s rudder pedals. The master cylinders have integral oil reservoirs and depressing the top of a rudder pedal causes the corresponding piston rod to push the piston into the cylinder, thereby pressurising the brakes (Figure 1).

Schematic of the brake master cylinder installation

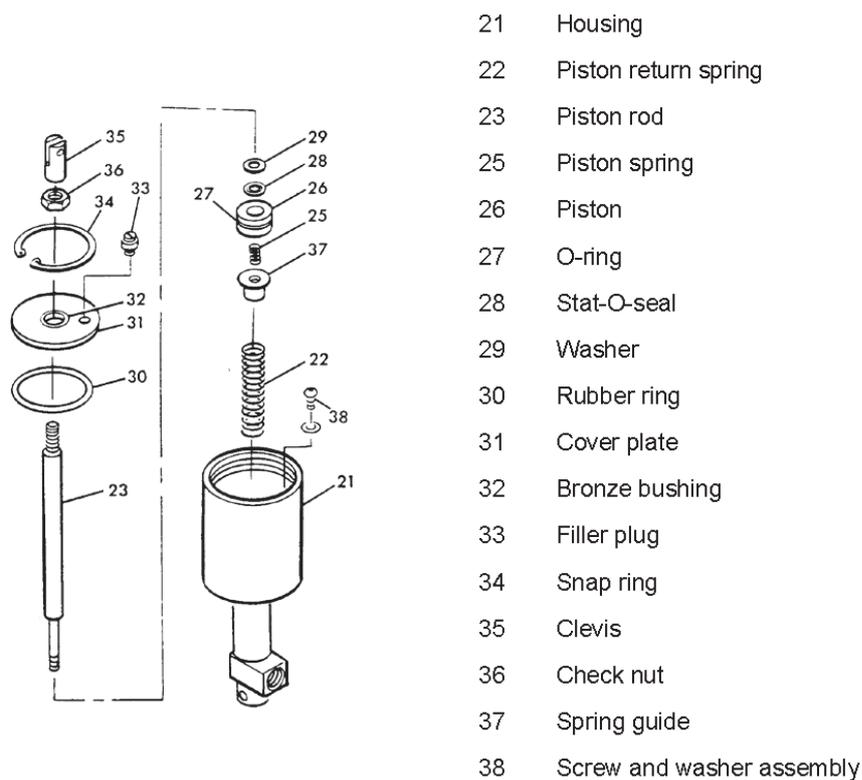
Damage on the identification plate obscured most of the details but the unit was manufactured by Cleveland in August 1994. Figure 3 is a schematic depicting the internal construction of a Cleveland master cylinder.

Schematic of the Cleveland brake master cylinder

The filler plug was missing and the cover plate could be rotated using finger pressure. When the snap ring and cover plate were removed, it was apparent that the rubber ring was missing.
