SERIOUS INCIDENT

Aircraft Type and Registration:	Let L-410 UVP-E, OK-LAZ	
No & Type of Engines:	2 Walter M601E turboprop engines	
Year of Manufacture:	1990 (Serial no: 902504)	
Date & Time (UTC):	23 February 2017 at 0927 hrs	
Location:	Isle of Man (Ronaldsway) Airport	
Type of Flight:	Commercial Air Transport (Passenger)	
Persons on Board:	Crew - 2	Passengers - 3
Injuries:	Crew - None	Passengers - None
Nature of Damage:	None	
Commander's Licence:	Airline Transport Pilot's Licence	
Commander's Age:	51 years	
Commander's Flying Experience:	7,800 hours (of which 2,200 were on type) Last 90 days - 120 hours Last 28 days - 40 hours	
Information Source:	AAIB Field Investigation

Synopsis

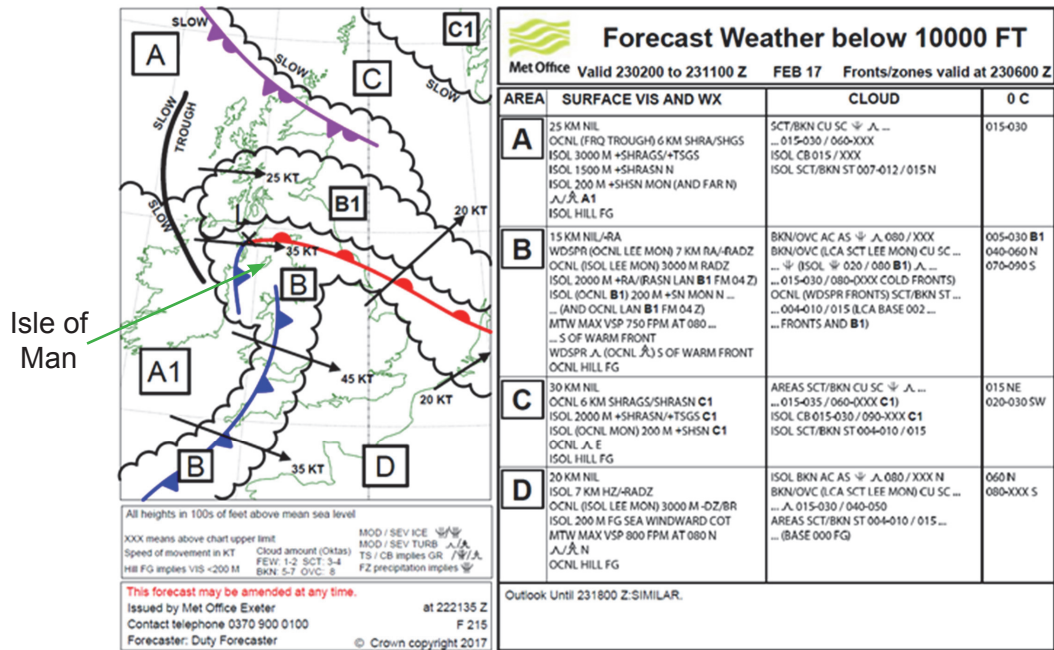
Figure 2

At 0600 hrs on the morning of 23 February 2017 a deep low pressure system, named 'Storm Doris' by the UK Met Office, was centred in the vicinity of Northern Ireland and the Isle of Man. The associated 0600 hrs chart for forecast weather below 10,000 ft (Figure 2), shows a cold front approaching the Isle of Man and a slow moving trough following behind. The centre of the low pressure system was expected to track across Northern Ireland, the Irish Sea and Northern England. The chart indicates that widespread moderate turbulence and occasional severe turbulence was forecast to the south of the warm front and therefore in the vicinity of the Isle of Man. Behind the frontal system, isolated cumulonimbus clouds were forecast and there is mention of associated heavy thunderstorms with small hail or snow pellets.

Met Office F215 Chart Valid between 0200 and 1100 hrs UTC on 23 February 2017
