ACCIDENT

Aircraft Type and Registration:	Kolb FireFly, G-CEPN	
No & Type of Engines:	1 Fuji Robin 330 piston engine	
Year of Manufacture:	2007 (Serial no: FF05.4.00048)	
Date & Time (UTC):	20 June 2017 at 0920 hrs	
Location:	Near Newell Lane, Luffenhall, Hertfordshire	
Type of Flight:	Private	
Persons on Board:	Crew - 1	Passengers - None
Injuries:	Crew - 1 (Fatal)	Passengers - N/A
Nature of Damage:	Aircraft destroyed	
Commander's Licence:	Private Pilot's Licence	
Commander's Age:	71 years	
Commander's Flying Experience:	5,215 hours (of which 342 were on type) Last 90 days - 0 hours Last 28 days - 0 hours	
Information Source:	AAIB Field Investigation

Synopsis

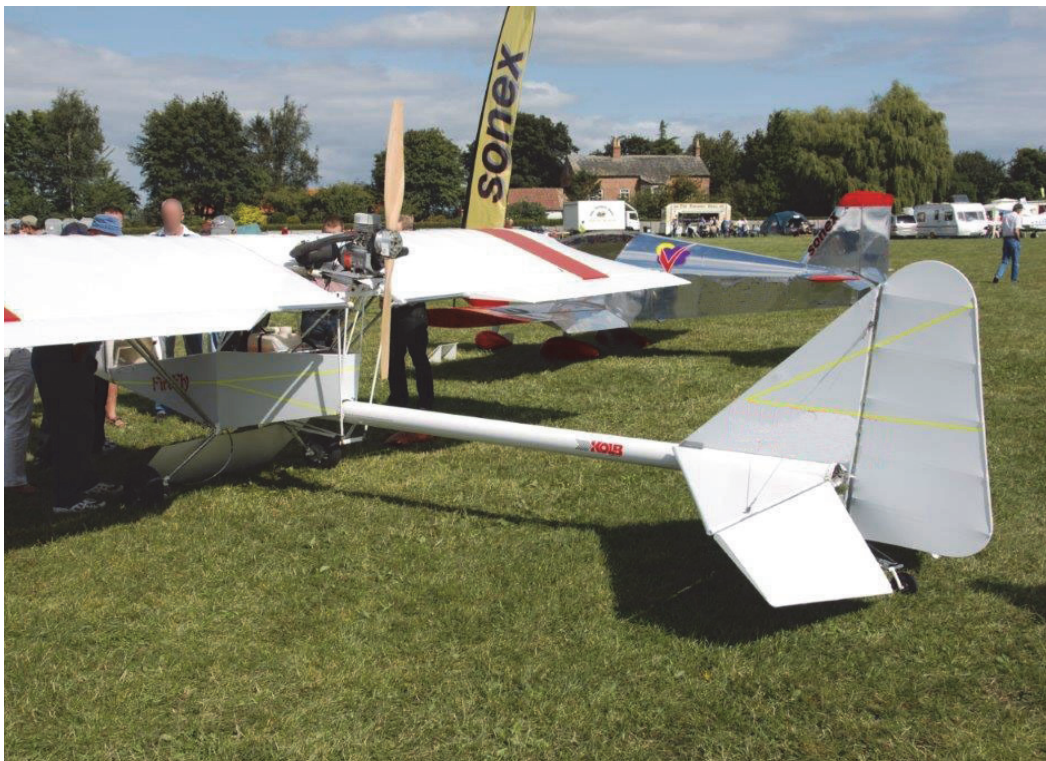
Figure 1
Kolb FireFly

The Kolb FireFly is a high-wing 'unregulated' ultralight/microlight aircraft. The aircraft is an American design with an open cockpit and was intended for amateur construction. The forward fuselage is mainly constructed of steel tubing, which is mated to an aluminium tail boom. The structure of the wings, horizontal stabiliser and tail fin are of aluminium tubing, covered with fabric. The wings are quick-folding for ease of storage and transportation. The FireFly is fitted with a single engine mounted between the wings which powers a pusher propeller through a belt-driven reduction gear system. The aircraft design was intended to meet the limited requirements of the 'FAR Part 103' federal regulations in the USA for 'Ultralight Aircraft', which would mean the aircraft would not need to be registered and the pilot would not require a licence.
