AAIB Bulletin: 3/2018	G-CKLR	EW/C2017/04/01
ACCIDENT		
Aircraft Type and Registration:	SZD-55-1, G-CKLR	
No & Type of Engines:	None	
Year of Manufacture:	1993 (Serial no: 551193056)	
Date & Time (UTC):	8 April 2017 at 1045 hrs	
Location:	Currock Hill Airfield, Northumbria	
Type of Flight:	Private	
Persons on Board:	Crew - 1	Passengers - None
Injuries:	Crew - 1 (Fatal)	Passengers - N/A
Nature of Damage:	Extensive	
Commander's Licence:	Private Pilot's Licence	
Commander's Age:	62	
Commander's Flying Experience:	18,800 hours (of which 39 were on type) Last 90 days - 1 hour Last 28 days - 0 hours	
Information Source:	AAIB Field Investigation

Synopsis

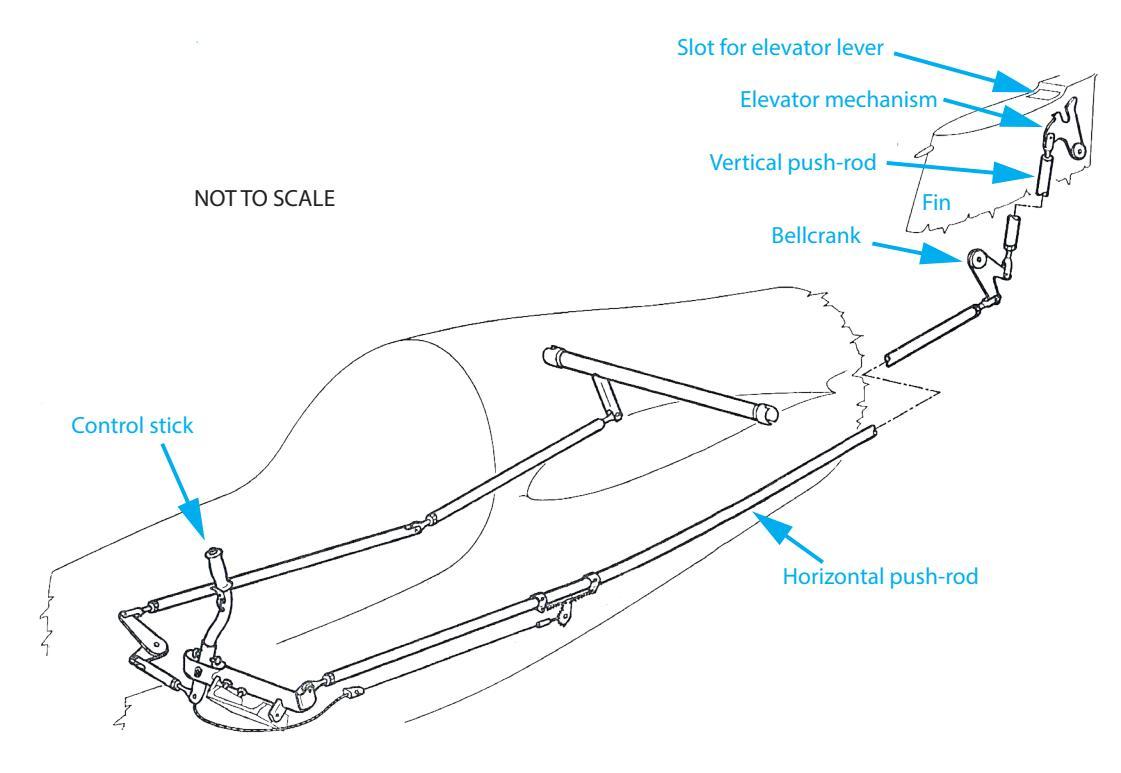
Figure 3 SZD-55-1 elevator control system

The elevator control system on the SZD-55-1 (Figure 3) is comprises a horizontal push-rod which runs from the control stick quadrant, throughout the length of the fuselage to the base of the tail fin, where it is connected via a bellcrank to another push-rod, which runs vertically up through the fin. At the top of the vertical push-rod, a pivoting guide mechanism, known as the elevator mechanism, couples with the elevator control hinge (elevator lever), when the tailplane is attached to the fin. A roller on the end of the elevator lever facilitates alignment by ensuring the lever engages in the U-shaped channel of the mechanism. Figure 4 shows a detailed view of the elevator lever and elevator mechanism.

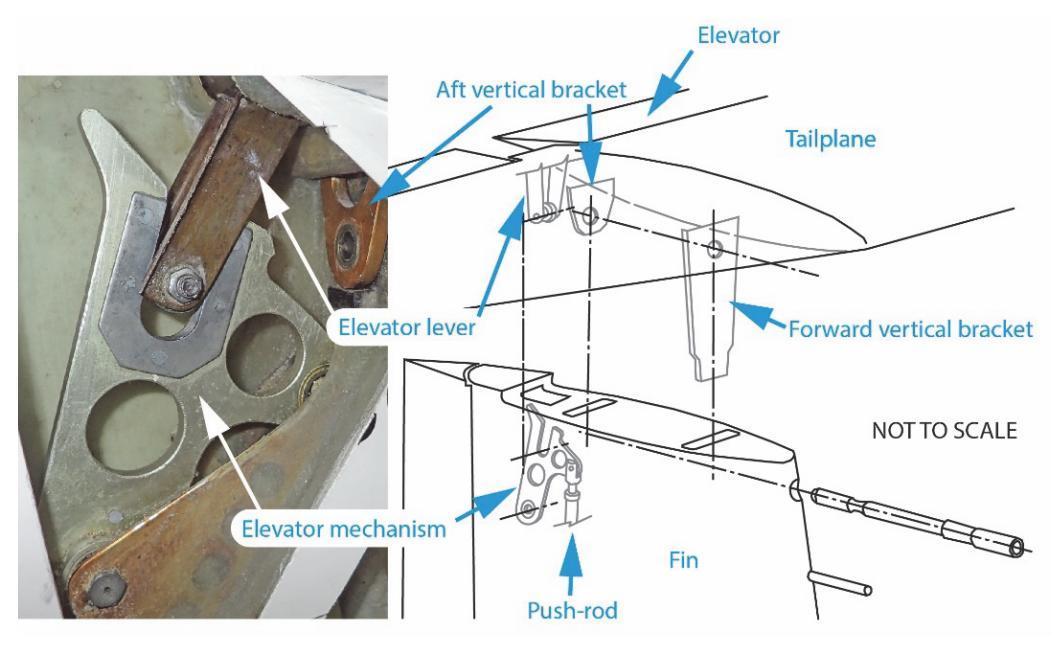
Figure 4

Normal connection of elevator lever and elevator mechanism on SZD-55-1

The geometry of the tail fin and the dimensions of the slots on the upper surface of the tail fin are intended to ensure correct alignment of the structural and flight control connections, and to prevent improper connection of the elevator lever.

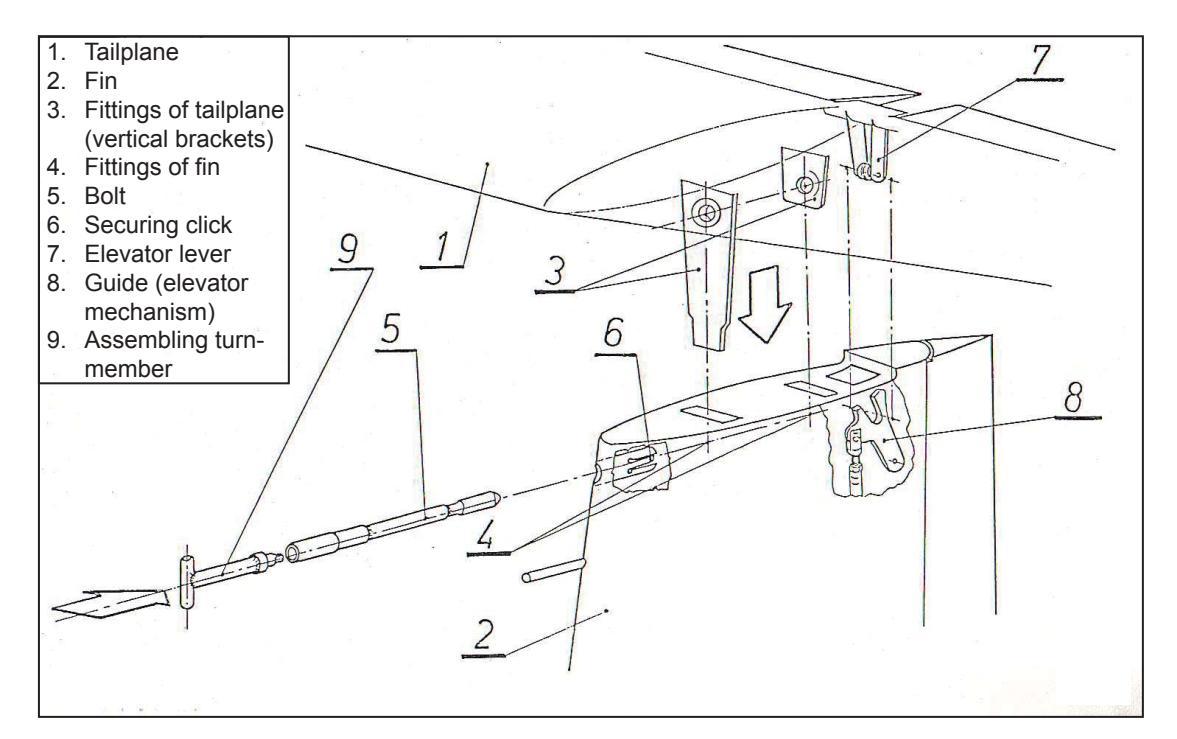
Figure 5

- Put the [control] stick in the neutral position using the trimming device.
- Fit the tailplane (1) on the fin. Move the stick, if necessary, to insert the lever (7) into the guide (8).
- Connect the tailplane (3) and fin (4) fittings by means of bolt (5) with the assembling turn-member (9) screwed in
- Screw-off the assembling turn-member and check at the final phase of screwing-off (2 threads) the efficient securing [of] the bolt against shifting out.
-
- Hold the elevator and ailerons and check the operation of the control systems under the loading.
-'

Amended extract from SZD-55-1 Flight Manual showing tailplane and elevator rigging
