Rail Accident Investigation Branch

Rail Accident Report

**Trailer runaway near Hope, Derbyshire
28 May 2017**

Report 03/2018
February 2018

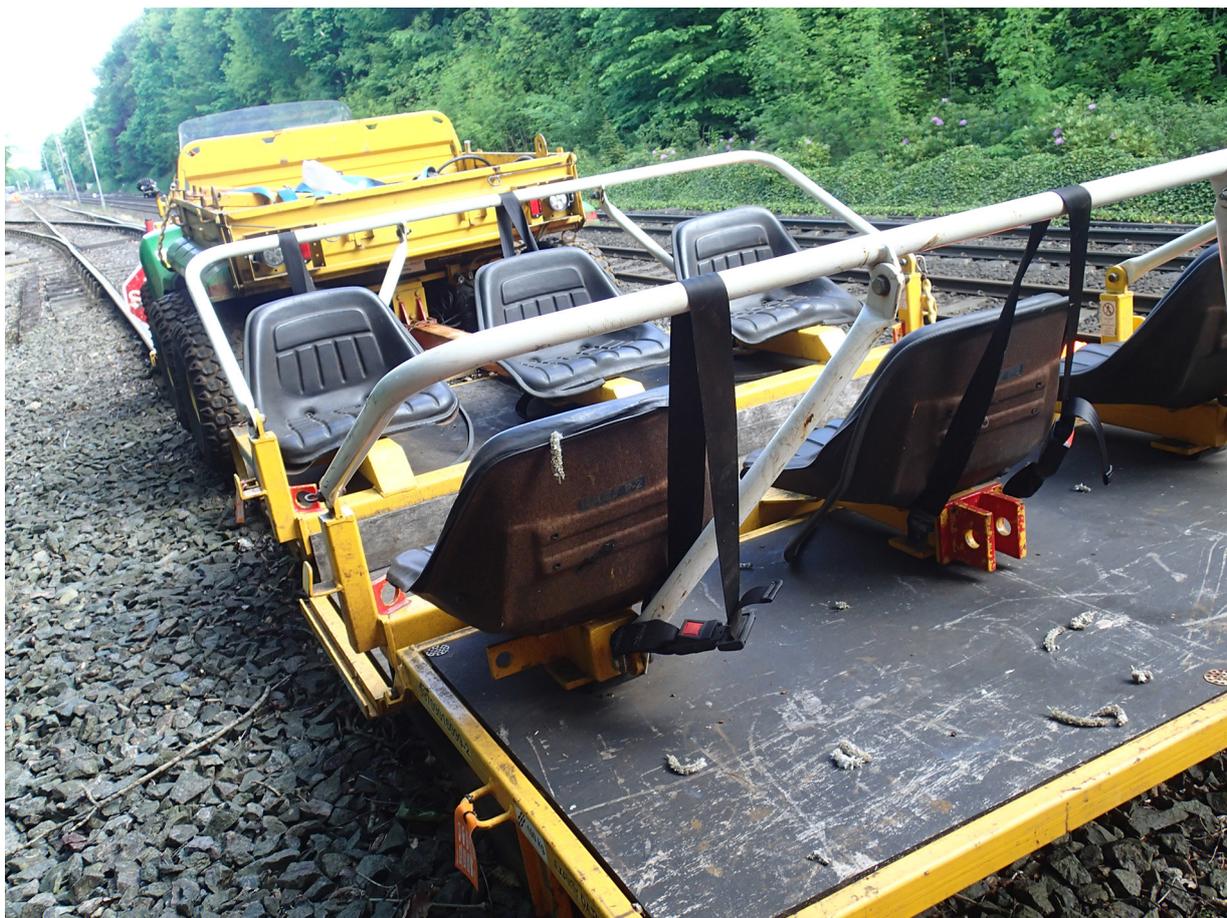
Figure 3: Personnel carrier trailer

- 15 The trailer that ran away was a Permaquip Personnel Carrier (figure 3). This is a four-wheeled trailer designed to carry six seated persons. Two of the four rail wheels, on one side of the trailer, are braked. These brakes are spring applied and are released by hydraulic oil pressure applied by a hose connection from the vehicle being used to tow the trailer. There is also a manual release for each of the braked wheels (figure 4), which is operated by attaching and pulling a handle at each end of the trailer.

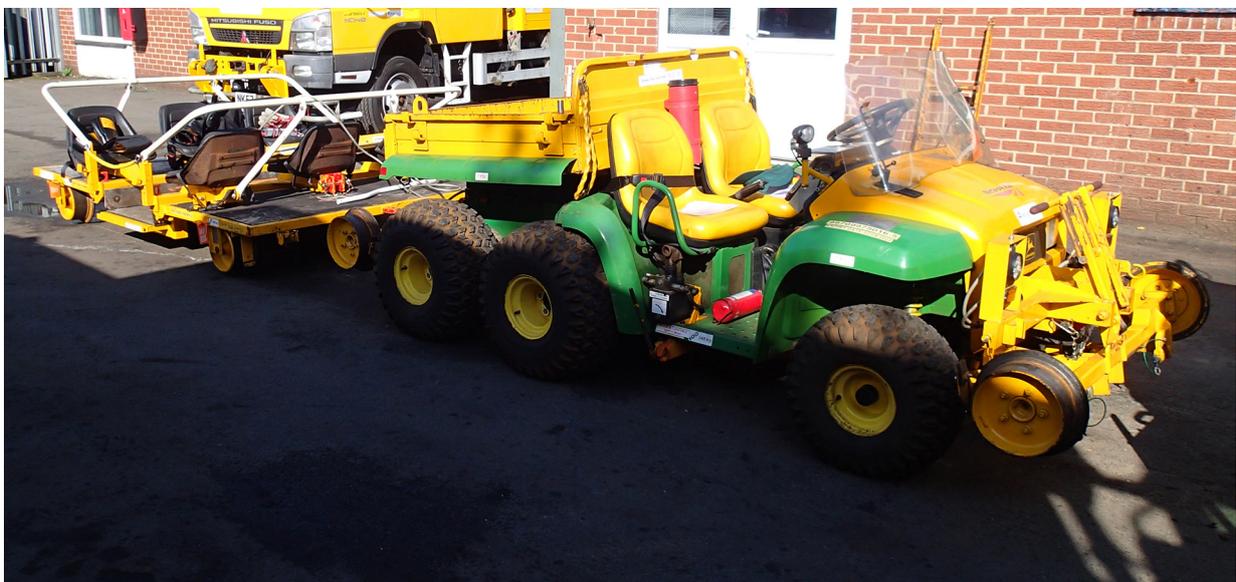
Figure 5: Gator with personnel carrier trailer

- 16 The tractor unit was a Permaquip Gator 6x4 (figure 5). This was a six-wheeled all-terrain vehicle that had been converted for use on the UK rail network by Permaquip. When on the track, the rail wheels are lowered to provide guidance. The rear four road wheels remain in contact with the rail and provide traction and braking. The front two road wheels are lifted clear of the rail, and the rail wheels take the weight.

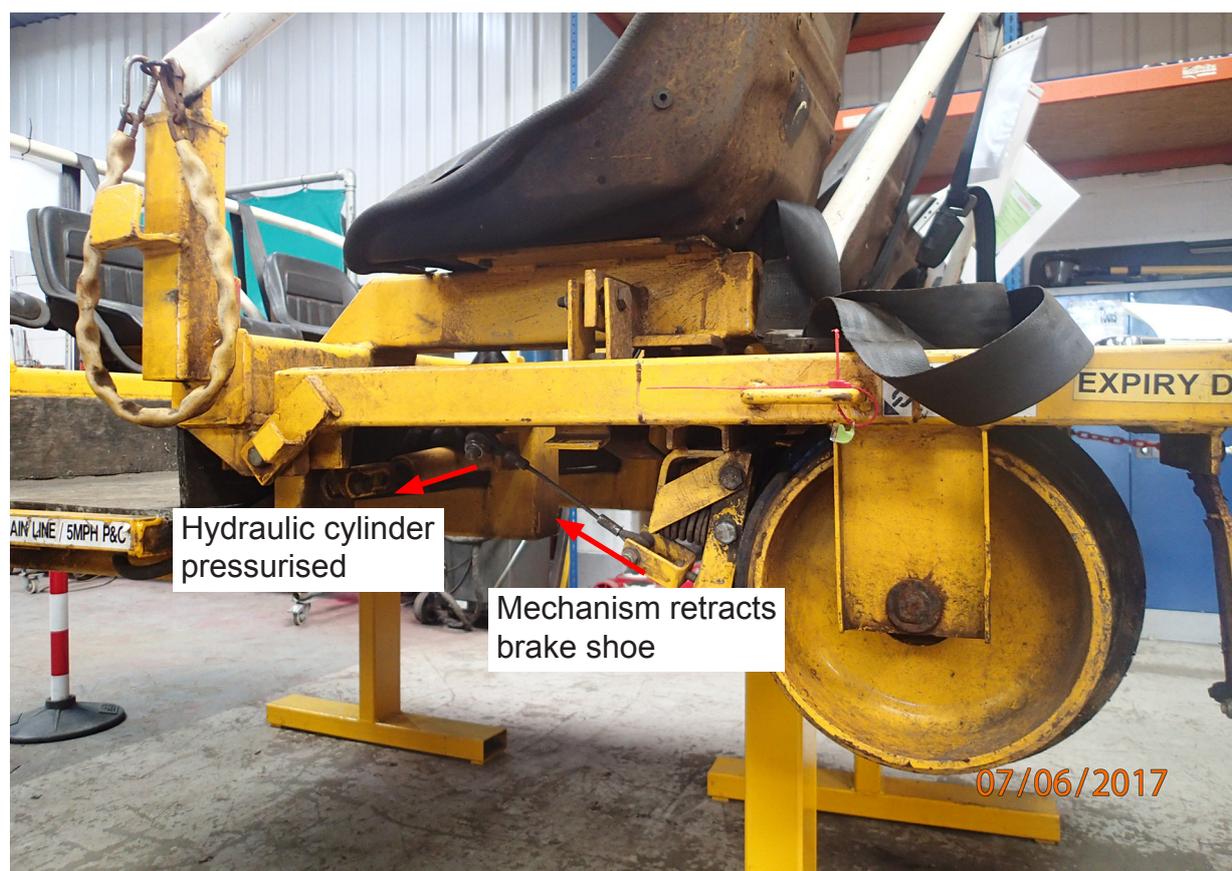
Figure 6: Trailer brakes

- 40 When the personnel carrier trailer is coupled to the gator, the braking on the trailer is spring applied and hydraulically released. A hydraulic pump on the gator pressurises oil in a sealed system, which is used to operate brake cylinders on the trailer which compress the springs, retracting the brake shoes and releasing the brakes (figure 6). This system is binary, in that the system is either fully pressurised, to release the brakes on the trailer, or depressurised, in which case the brakes are spring applied. RAIB testing was unable to identify a condition where partial braking could be present.

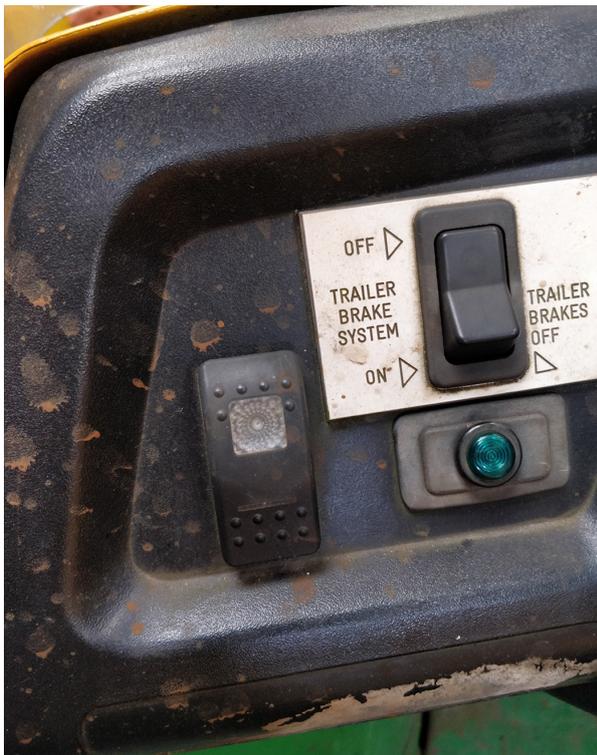
Figure 7: Hydraulic brake system control and indication

- 41 The hydraulic pump is switched on by the operator, using a switch on the gator's dashboard. When service pressure is reached (normally in a second or two) a pressure switch stops the pump, a light is lit on the dashboard, labelled 'trailer brakes off', and the trailer brakes are fully released (figure 7).

- 44 If the trailer's hose is not connected, the hydraulic system on the gator can still be switched on and pressurised because the valve in the coupling remains closed. The pressurised indication lamp on the dashboard is also illuminated (figure 7). The hydraulic system also acts to release and recharge pressure as the gator brakes are applied and released. However, in this situation the pressure is not transmitted to the trailer and therefore it has no effect on the trailer brakes.

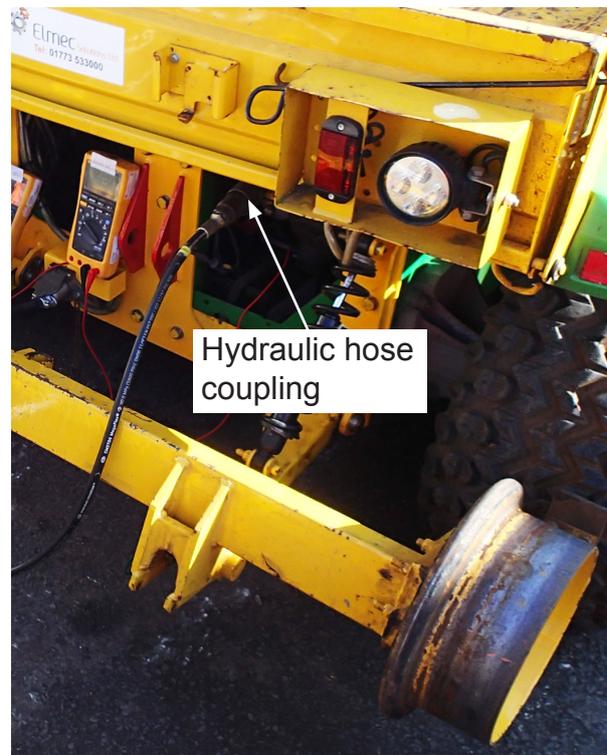
Figure 8: Hydraulic hose coupling

- 43 A hose connects the hydraulic system on the gator to the brake release cylinders on the trailer. The hose is permanently coupled to the trailer and attaches to the gator using a sealed bayonet coupling (figure 8). This coupling snaps into place and requires a locking collar to be manually retracted to allow it to be released. The hydraulic connection between the gator and the trailer is not made until the coupling is snapped into place. When this is done, the coupling is secured and a valve in the coupling is opened to allow pressure to be transmitted.

- 64 **The hydraulic hose between the gator and the trailer was not correctly connected at the time that the towbar coupling pin fell out.**
- 65 When the trailer came to a stop at Earles Sidings, the bayonet fitting at the end of the trailer's hydraulic brake hose was not connected to the gator. The fixed coupling at the trailer end of the hose had snapped and the hose was found on the track close to where the trailer came to a stop. The outer surfaces of the hydraulic hose bayonet coupling were covered in scratches and marks consistent with it having been dragged along the track, although it is possible that some of these were present prior to the incident (figure 13).

- 69 The RAIB also considered the possibility that the hose was connected to the gator prior to the runaway and that the bayonet coupling parted as the trailer started to run away. However, the hose is designed so that the fixed coupling at the trailer forms a weak link and will break in the event of excessive force being applied along the hose. The RAIB was unable to replicate any condition where the coupling was connected allowing hydraulic pressure to reach the trailer, yet able to be disconnected by pulling on the hose.

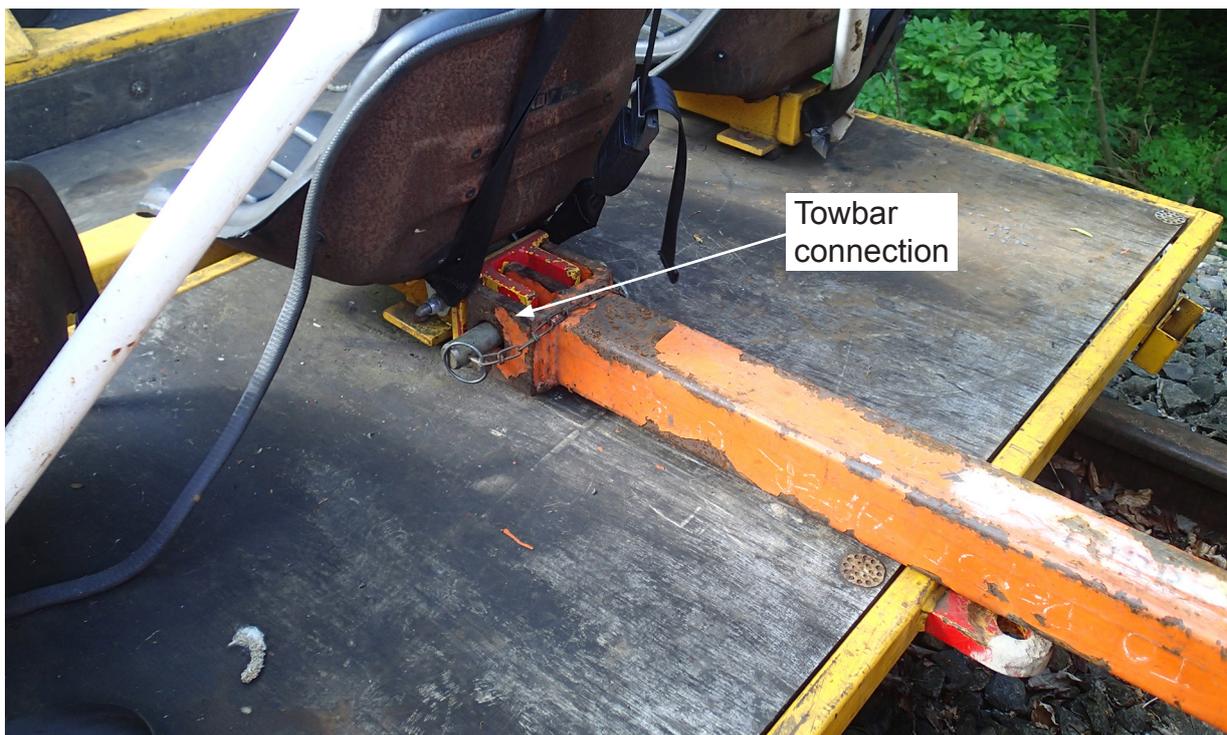
Figure 10: Towbar connected to trailer

- 57 The coupling pin at the trailer end of the towbar had fallen out.**
- 58 The towbar consists of a horizontal steel bar which is connected between coupling points on the gator and on the trailer. Each end of the towbar has three vertical fins, which interleave with two vertical fins that are mounted on the vehicle's coupling point (figure 10). A towbar pin is inserted horizontally through holes in the five vertical fins, securing the towbar to the vehicle (figure 11).

- 61 After the runaway, the towbar pin was found on the rear deck of the trailer, adjacent to the coupling. The linch pin was attached to it by a chain but was not inserted in the hole in the towbar pin. This is consistent with the towbar pin having vibrated its way out.
