Baseline Survey Report for 11 Low-Volume Sealed Roads in Kenya

Final Report

By: Across Africa Consultants Ltd.

Prepared for Kenya Materials Testing and Research Department (MTRD)

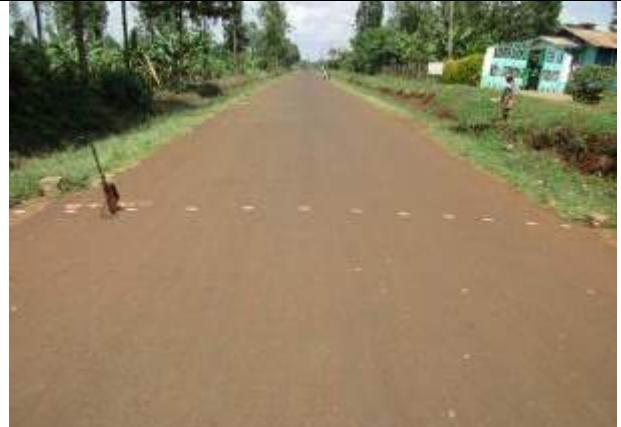
Fig No	Location (Km)	Defect assessment and description	Photos illustrating the pavement distress & defect
Fig 1	Km 0+000 – 0+020 main carriage way	-No visible defect on the surface

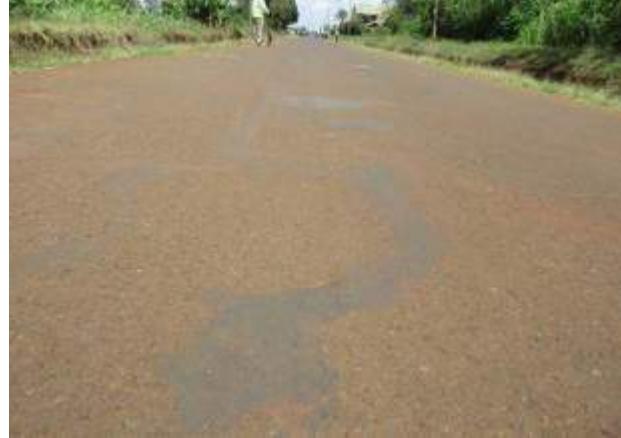
Fig3	Km 0+050 main carriage way at the centerline	-Crack sealing done on the main carriage way at the centerline

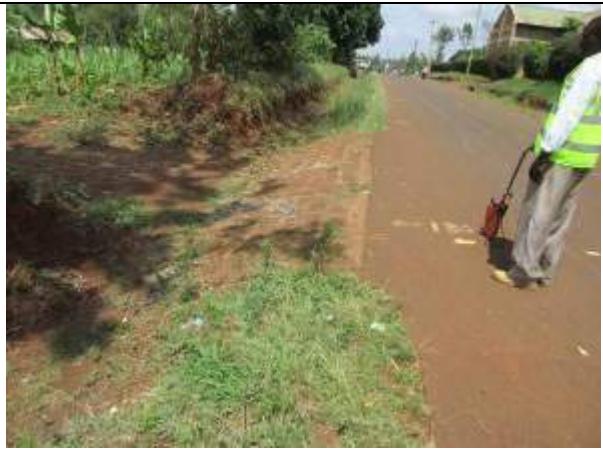
Fig 5	Km 0+100 – 0+130 main carriage way at the centerline	-Crack sealing on carriage way -Vegetation on the encroaching the road edge

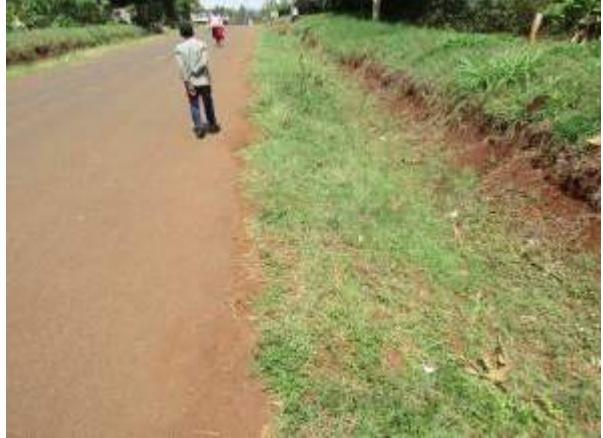
Fig6	Km 0+120 – 0+130 LHS	-Vegetation on side slope hindering free flow of water to the side drain

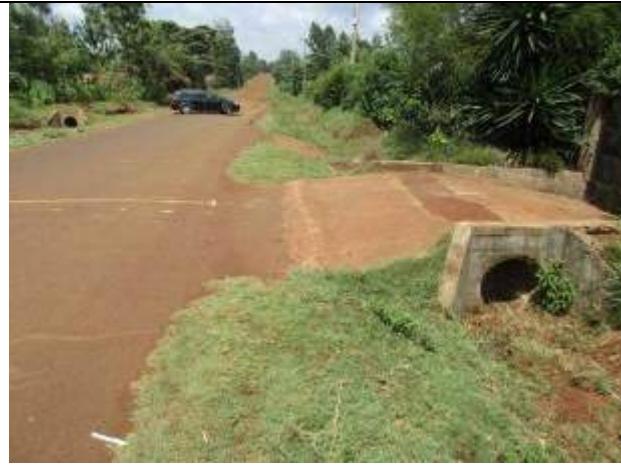
Fig10	Km 0+300 – 0+350 main carriage	-Vegetated side slope extending towards the edge and may result into moistening pavement hence premature failure

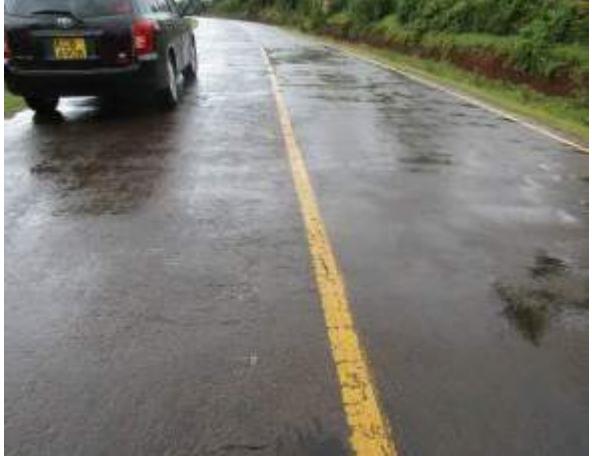
Fig 2	Km 0+008–0+018 LHS carriage way	-Alligator cracks and surface irregularity on the carriage way

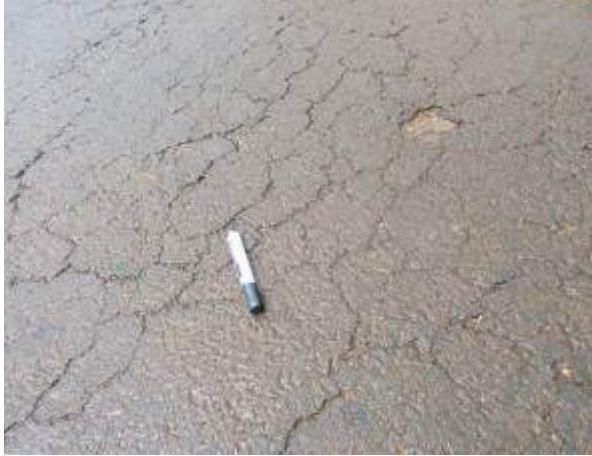
Fig 4	Km 0+025 main carriageway	-Extensive alligator cracking on the carriage way

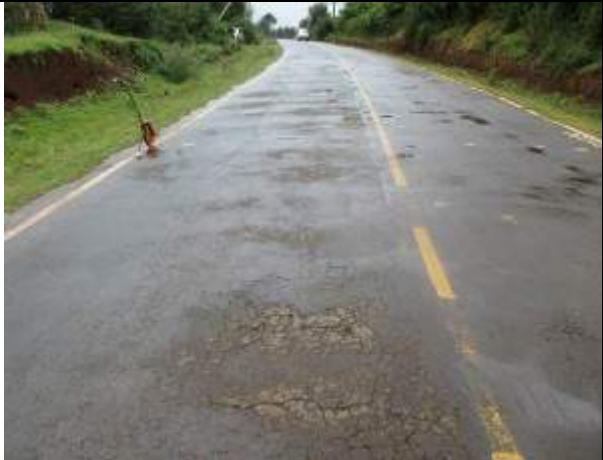
Fig6	Km 0+030 – 0+042 LHS inner wheel path	-Alligator cracks on the inner wheel path

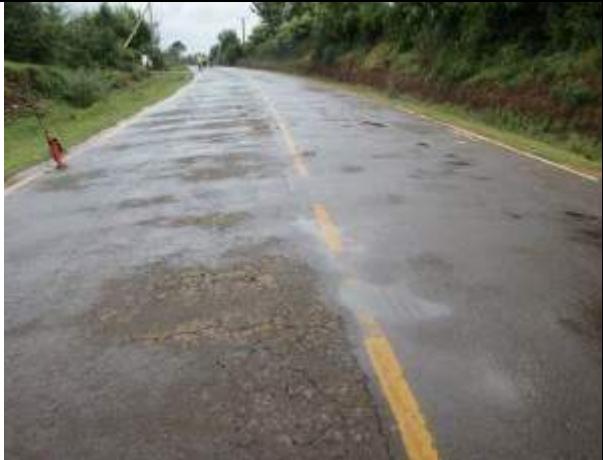
Fig 7	Km 0+043 – 0+060 LHS main carriage way	-Alligator cracking and deforming on the inner wheel path

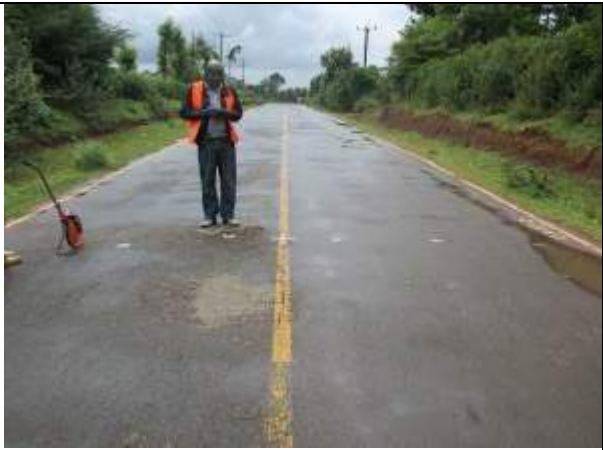
Fig 8	Km 0+100 -0+120	Ponding on the potholes especially on the wheel paths caused by road poor levels

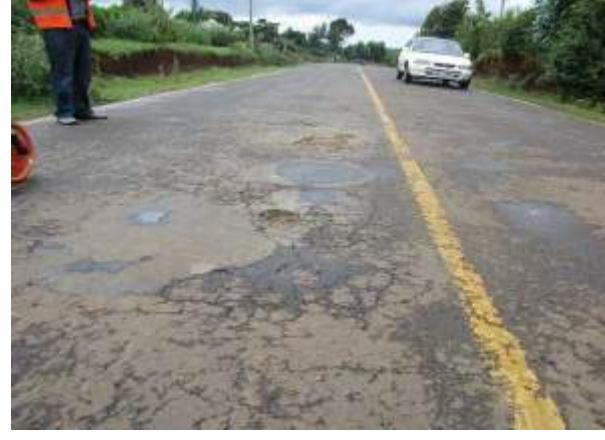
Fig 11	Km 0+200 – 0+305 LHS carriage way	-Extensive alligator cracks and potholes on the carriage way especially on the LHS lane

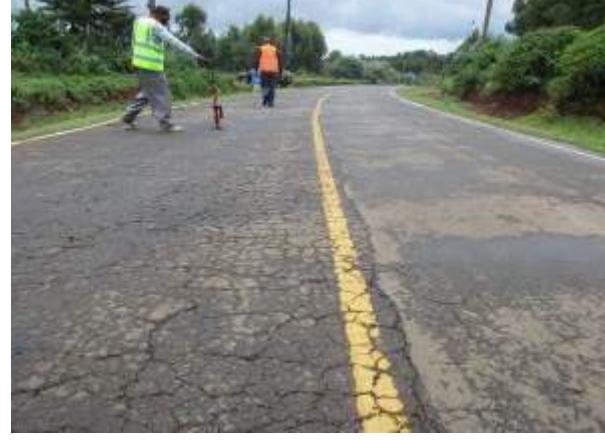
Fig 12	Km 0+223-0+305 LHS carriage way	-Extensive alligator cracks on the carriage way especially on the LHS lane

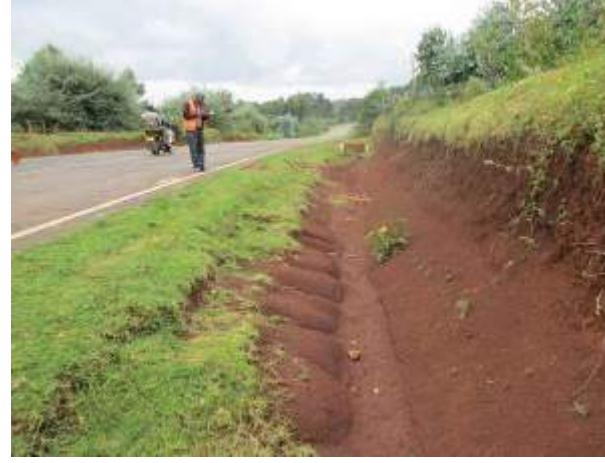
Fig 15	Km 0+356 -0+380 LHS	-Gully erosion on the side and side slope drain approx. 30m long

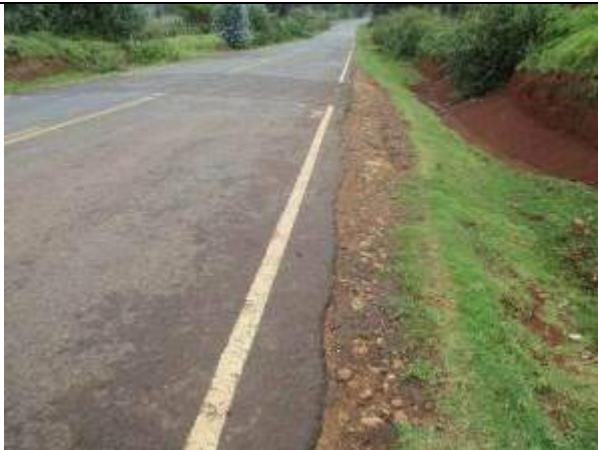
Fig 17	Km 0+380 – 0+420 RHS	-Eroded side slope approximately and edge 20m long

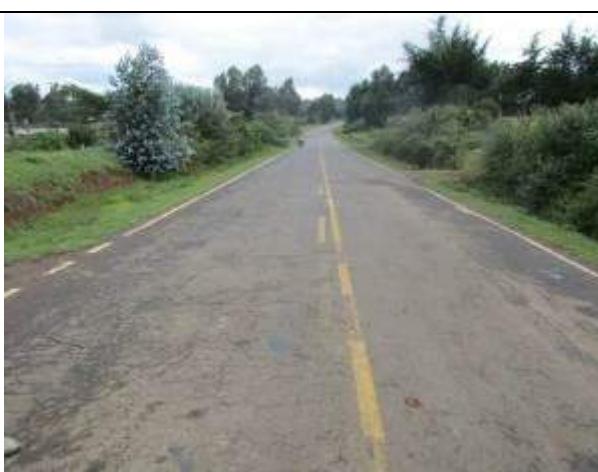
A photograph showing a paved road with a yellow center line. The right shoulder has been eroded, leaving a steep, exposed bank of earth and grass along the edge.
Fig 18	Km 0+400 – 0+420 main carriage way	-Alligator cracks all over the carriage way -Vegetation on the side slope hindering free flow of water along drain

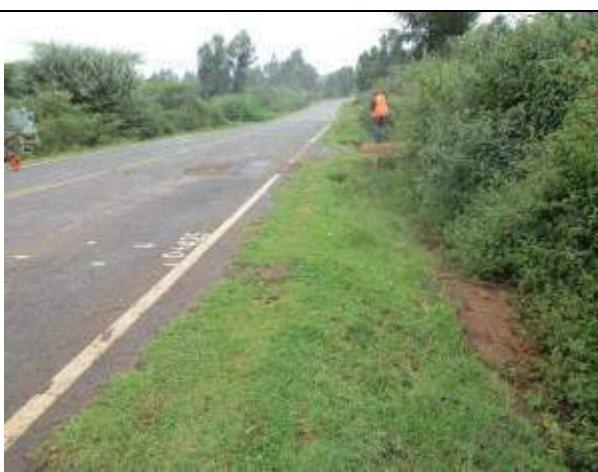
A photograph of a paved road with a yellow center line. The surface shows extensive alligator cracking. The sides of the road are bordered by green vegetation.
Fig 19	Km 0+420 -0+440 LHS	-Alligator cracks and Longitudinal depression on the outer wheel path approx. 1.3m by 22m long -Heavy vegetation on the side drain

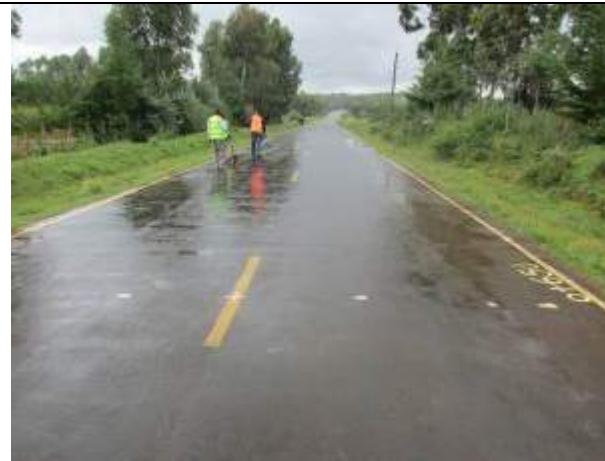
Fig 18	Km 0+640 – 0+680 main carriage way	<ul style="list-style-type: none"> -Surface bumpy and irregular -Edge deformation and subsidence on the outer wheel path covering about 20m long and 7m width with a depth 30mm

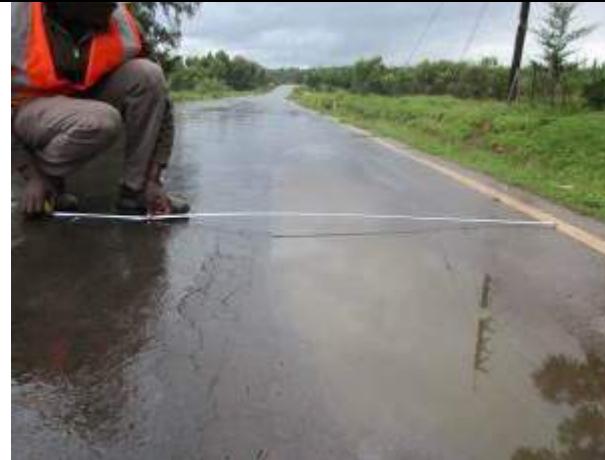
Fig 19	Km 0+717 – 0+737 RHS lane	<ul style="list-style-type: none"> -Longitudinal depression and alligator on the outer wheel path approx. 1.3m by 22m long -Vegetation encroaching towards the RHS edge

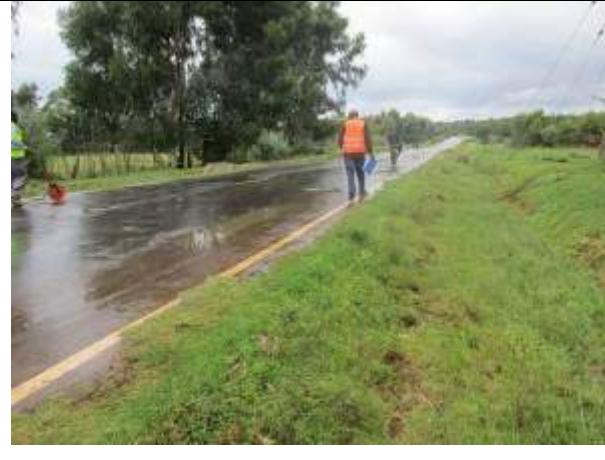
Fig 20	Km 0+750- 0+800 RHS carriage way	<ul style="list-style-type: none"> -Depression and ponding on the carriage way 20m long -Grass encroaching from the side drain ,side slope, shoulders and extending towards the edge - Surface bumpy and irregular

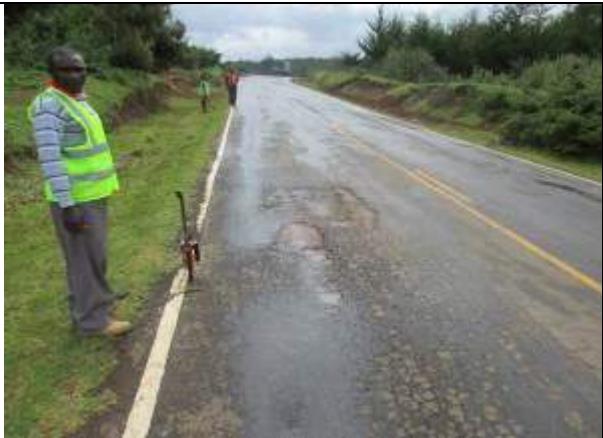
Fig 21	Km 0+896 -0+920 LHS main carriage way both sides of the outer wheel path	-Deformation and depression leading extensive loss of surfacing material

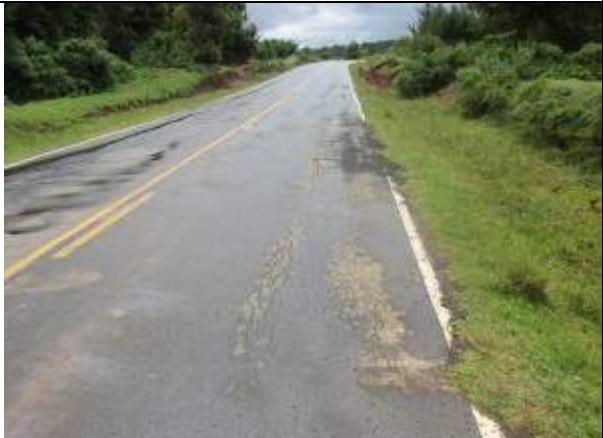
Fig 22	Km 0+896 -0+920 RHS main carriage way both sides of the outer wheel path	-Longitudinal depression and deformation on the RHS carriage way covering 30m long and 1.3m width caused by poor drainage system

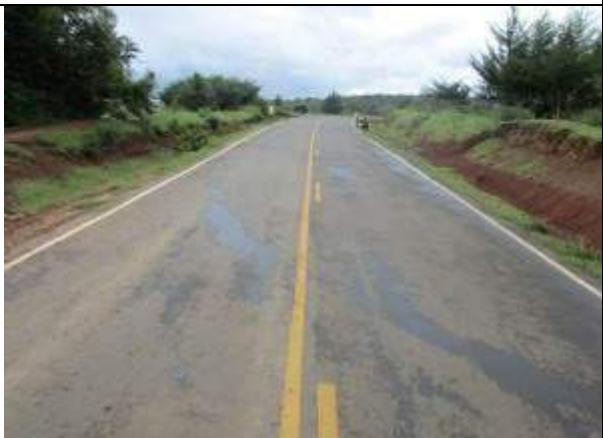
Fig 23	Km 0+900 – 1+000	-Alligator cracks all over the carriage way and Gully erosion on the side drain and side slope especially on the RHS

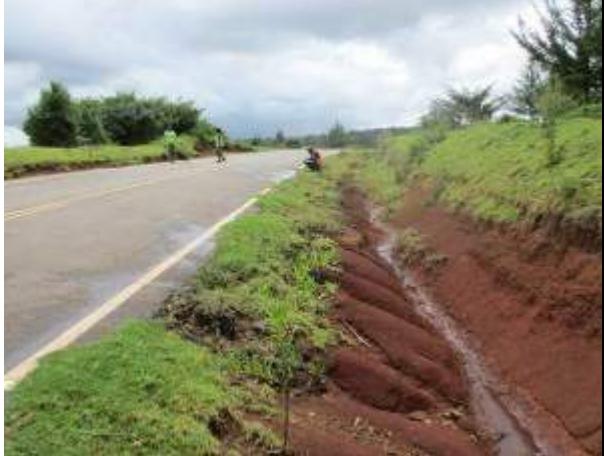
Fig 20	Km 0+950 – 1+000	<ul style="list-style-type: none">-Gully erosion on the side drain and side slope-Alligator cracks all over the carriage way

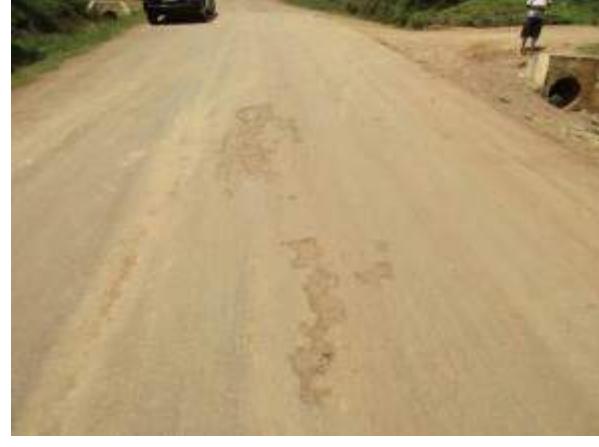
Fig No	Location (Km)	Defect assessment and description	Photos illustrating the pavement distress & defect
Fig 1	Km 0+000 – 0+011 main carriage way	Alligator cracks and localized loose of pavement materials covering an area 1m by 5m long(A-5m ²) at the centerline

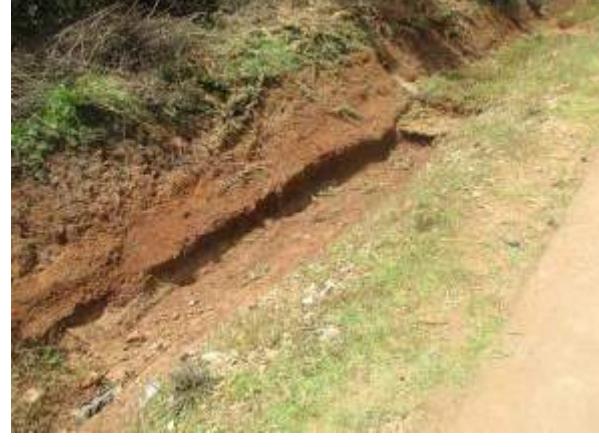
Fig 3	K 0+120 LHS	-Erosion gullies on the side drain

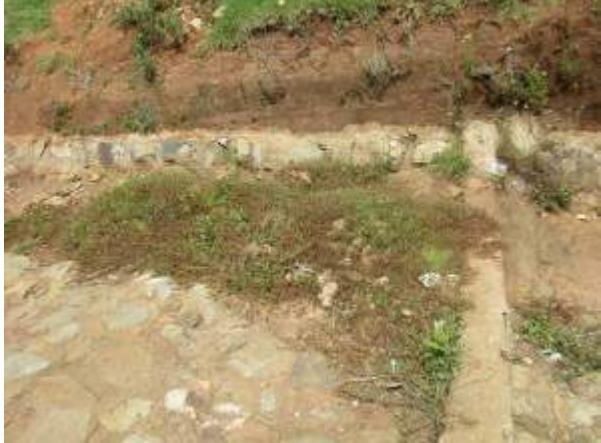
Fig 4	Km 0+030 – 0+045	-Silted and vegetated stone pitching on the side drain and scour checks

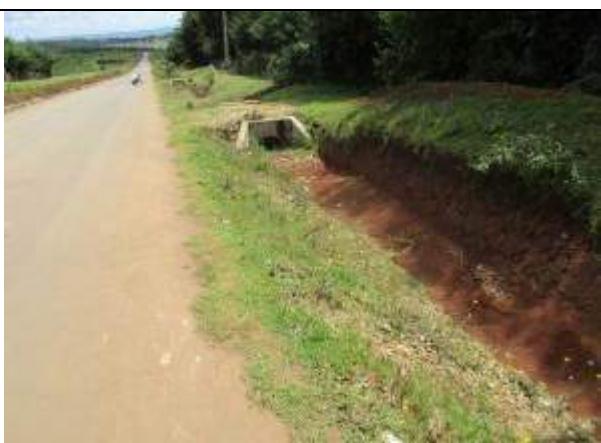
Fig 5	Km 0+085-0+130 RHS	-Moistening of the edge due to grass growing on the side slope and extending to towards the edge

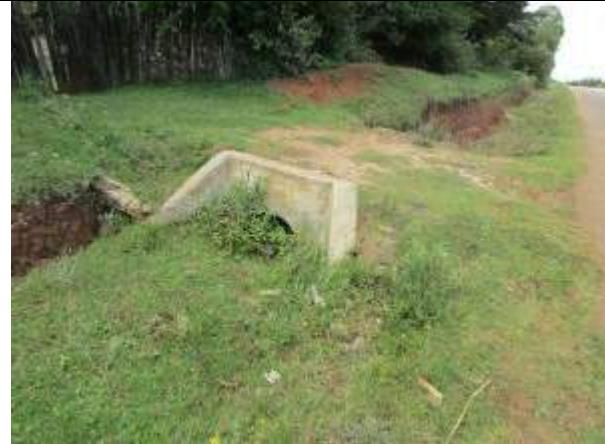
Fig 7	Km 0+140 LHS	-Blocked side drain and silted access culvert

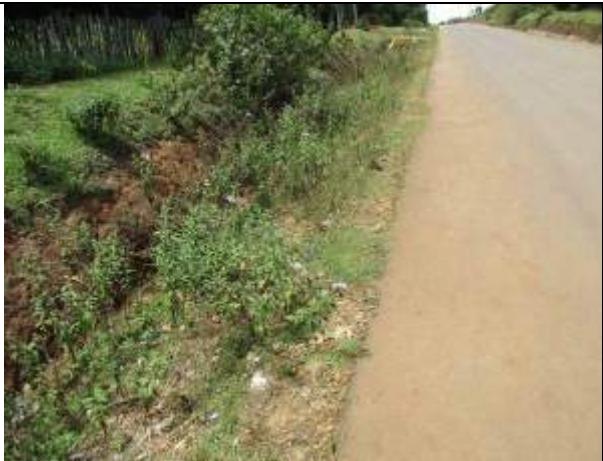
Fig10	Km 0+250-0+270LHS	-Vegetation on the side drain on the LHS lane

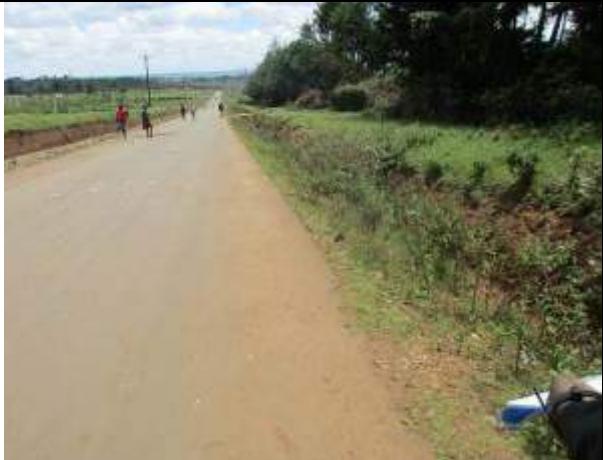
Fig 11	Km 0+277 main carriage way	-Slight bleeding visible on the surface indicating too much bitumen in the mix approximately 6m long and 2.0 m width (Approx. area 12m ²)

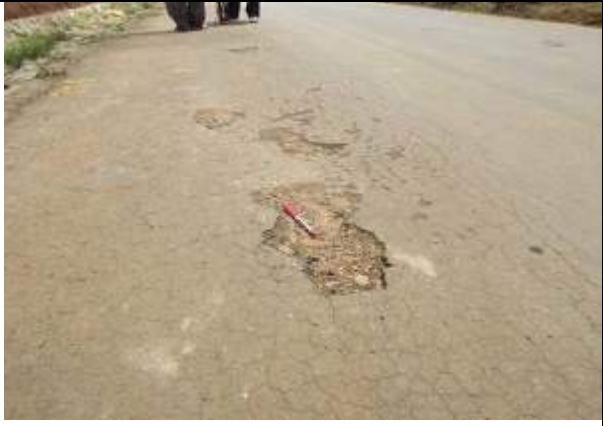
Fig 11	Km 0+296-0+310 LHS outer wheel path	- Extensive alligator cracks on the surface, pothole and localized loss of asphalt concrete layer of about 11m long *1.5 m width at especially at the LHS lane

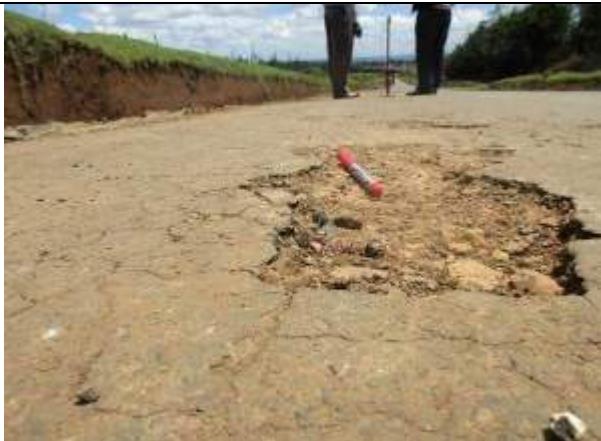
Fig 12	Km 0+296-0+310 LHS outer wheel path	A close view of Alligator cracks on the surface, pothole and localized loss of asphalt concrete layer of about 11m long *1.5 m width at especially at the LHS lane

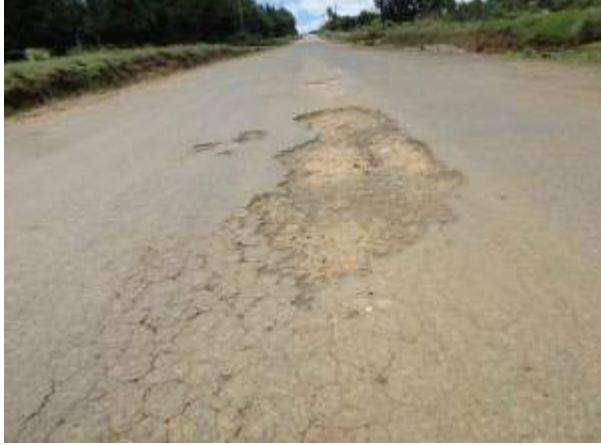
Fig 14	Km 0+340 -0+350 Centerline	-Extensive alligator cracks on the surface, pothole and localized loss of asphalt layer of about 11m long *2 m width at especially at the centerline

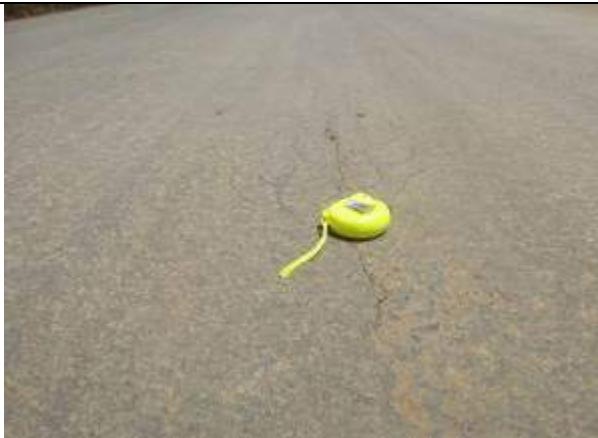
Fig 15	Km 0+335 main carriage way at the centerline	-Alligator cracks on the surface

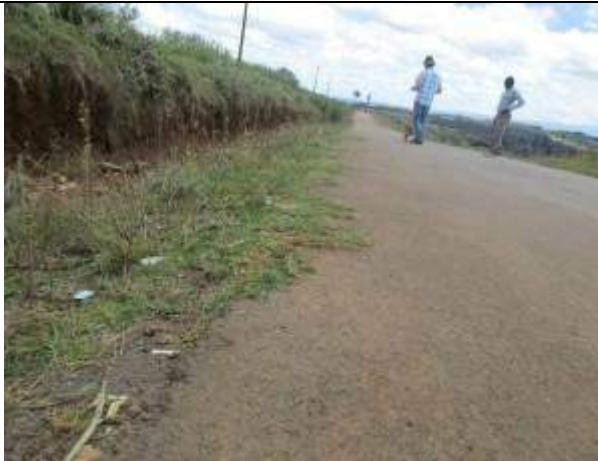
Fig 17	Km 0+550 -0+600 RHS	-Grass encroaching the road edge moistening and softening the pavement that would eventually lead to premature pavement deformation and failure

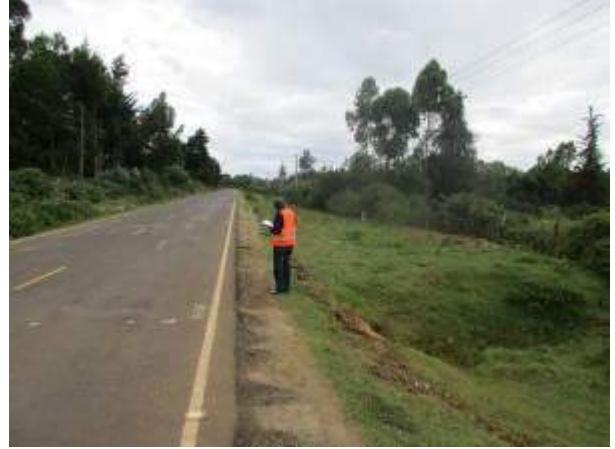
Fig 7	Km 0+145 -0+180 RHS and main carriage way	-Alligator cracks scattered all over the carriage way -Eroded side slope -Spot bleeding on the main carriageway

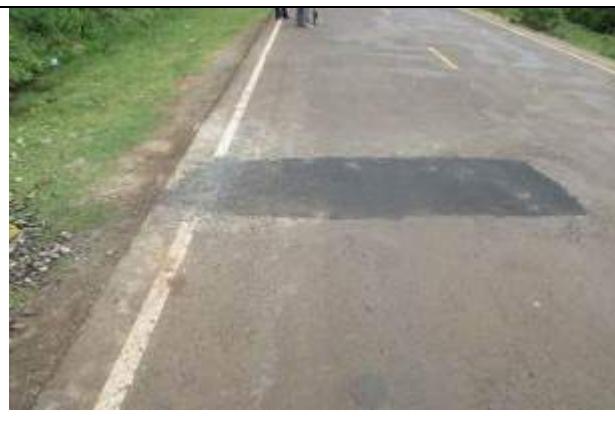
Fig 8	Km 0+234– 0+250 LHS	-Alligator cracks scattered all over the carriage way covering 16m long

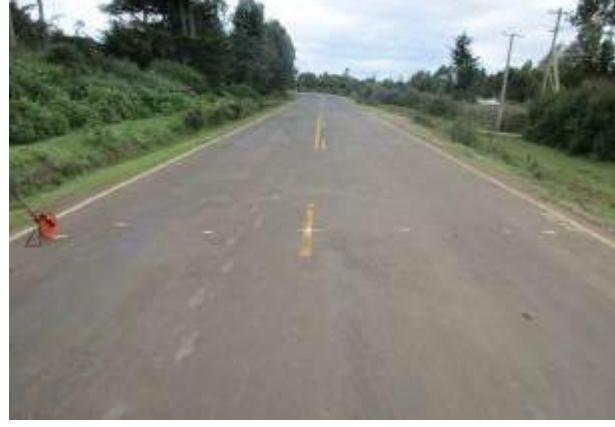
Fig 9	Km 0+300 – 0+350 main carriage way	-Alligator cracks scattered all over the carriage way covering 100m long and 3m width -Bleeding on the LHS main carriage way

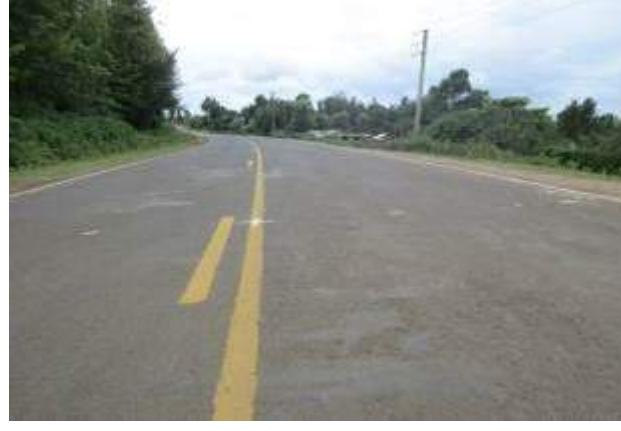
Fig 12	Km 0+473-0+500	<ul style="list-style-type: none"> -Alligator cracks all over the carriage way covering 30m long and 3m width

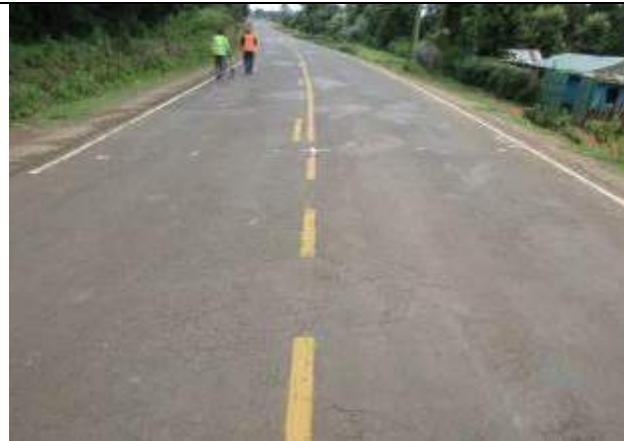
Fig 13	Km 0+500 -0+600	-Alligator cracks all over the carriage way covering 100m long and 4m width especially on the centerline

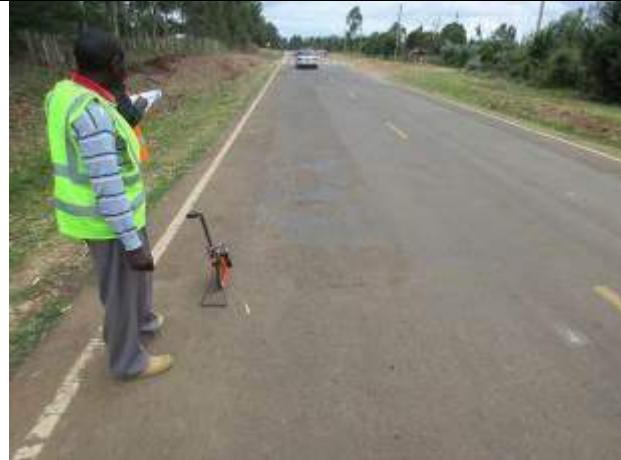
Fig 16	Km 0+816-0+821 LHS	Alligator cracks on the LHS carriage way , area -(7m*2m) 14m ²

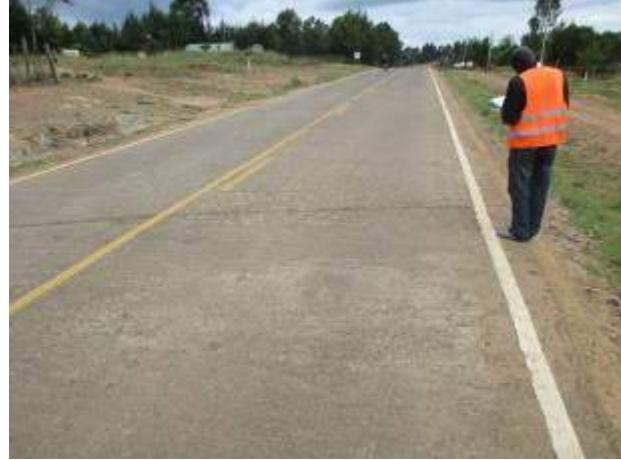
A view of a two-lane asphalt road. The left side shows a grassy verge and some trees. The right side of the road appears to have some surface damage or depression. The road has a solid yellow center line and white dashed lines on the edges.
Fig 18	Km 0+937 RHS	-No visible defect on the main carriage way -Loss of surface texture and aggregates (3.0*5)15m ² long

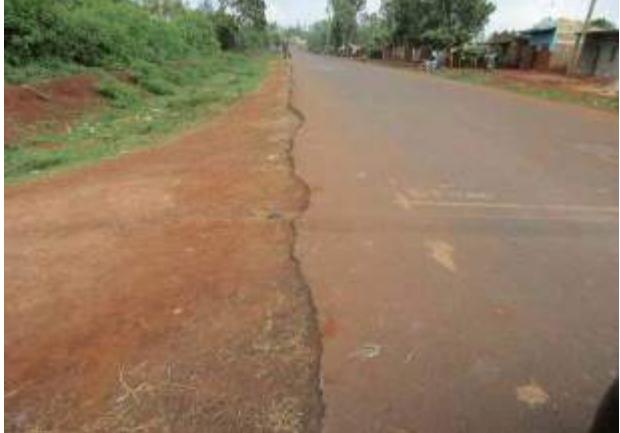
Fig No	Location (Km)	Defect assessment and description	Photos illustrating the pavement distress & defect
Fig 1	Km 0+000-0+040 LHS	Eroded side slope and edge of approximately 50 m long

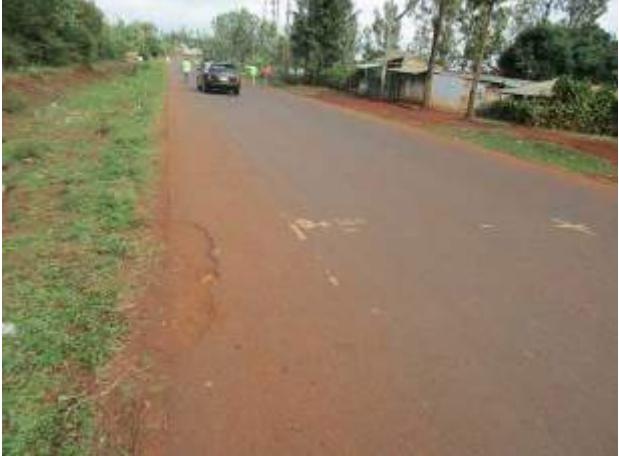
Fig 2	Km 0+100LHS	-Eroded edge and shoulders of about 15cm by 500cm

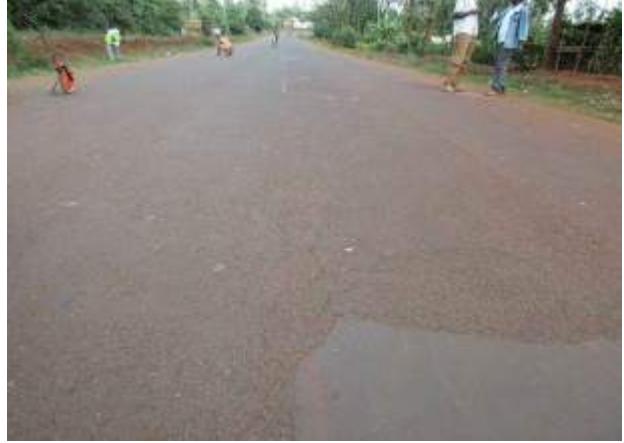
Fig 3	Km 0+120 RHS	-Alligator cracks ,bleeding and sticky -Patchwork and alligator cracks on the inner and outer wheel path

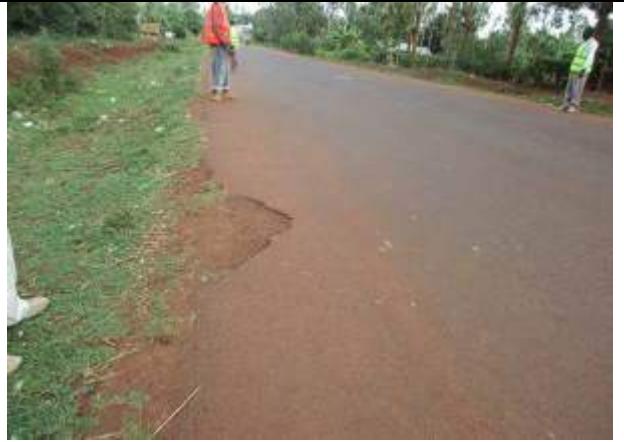
Fig 4	Km 0+140LHS	-Damaged shoulders towards LHS carriage covering an area of $0.3m \times 0.4m M^2$

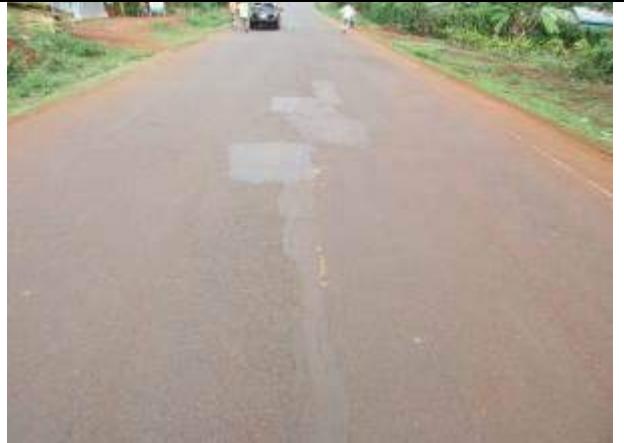
Fig 5	Km 0+150 – 0+175 main carriage way	-Extensive alligator cracks and crack sealing on the centerline of the carriage way

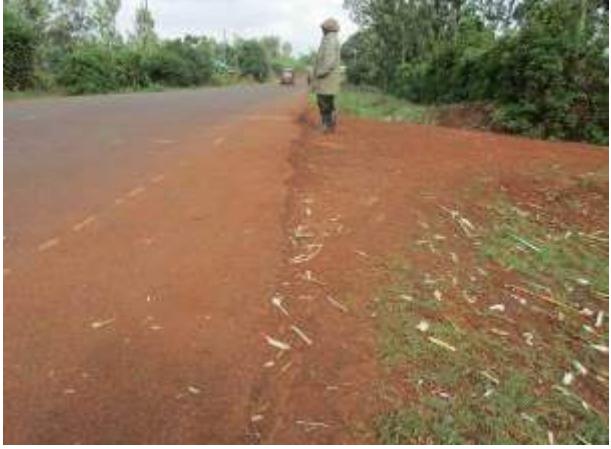
Fig 6	Km 0+190-0+203 LHS	-Eroded shoulders and side slope approximately 13m long caused by motorists turn at the junction

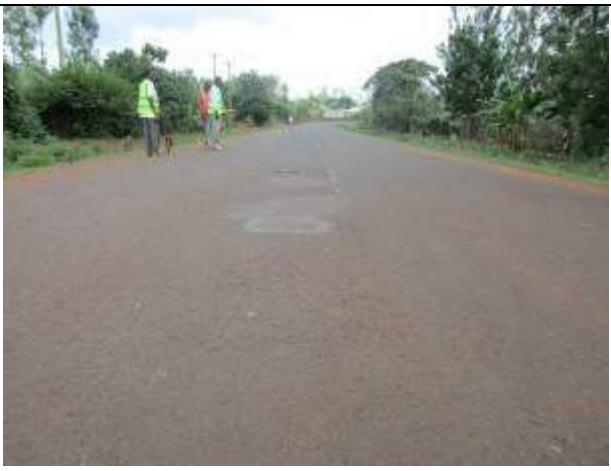
Fig 7	Km 0+226 main carriage way	-Alligator cracks and potholes at the centerline approximate area of $3\text{cm} \times 4\text{cm}(12\text{cm}^2)$ -Area of section affected 12m long and 2.5m width

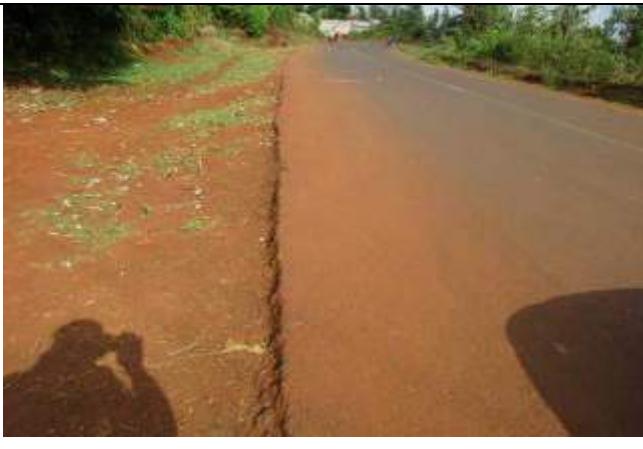
Fig 8	Km 0+300LHS	-Eroded side slope and road edge 10m long -No proper drainage system

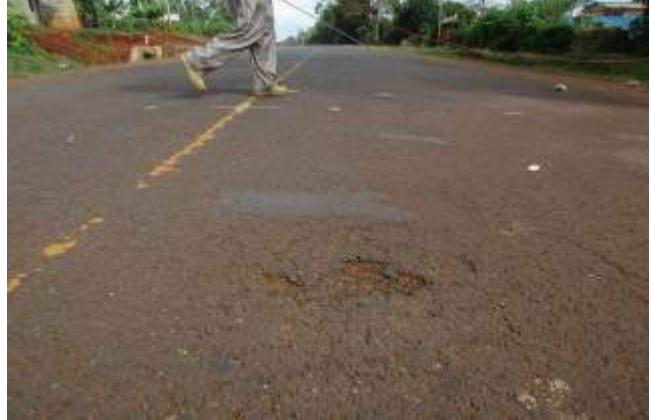
Fig 12	Km 0+540 RHS on inner wheel path	-Alligator cracks and pothole on the inner wheel path

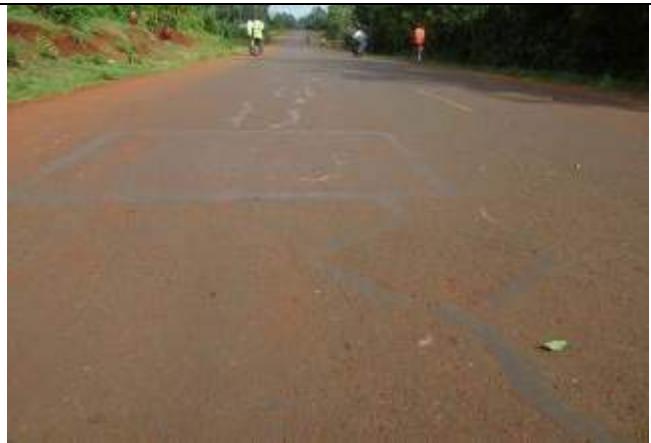
Fig 13	Km 0+550 – 0+570	-Extensive alligator cracks and crack sealing done on the surface 10m long and 2.5m width

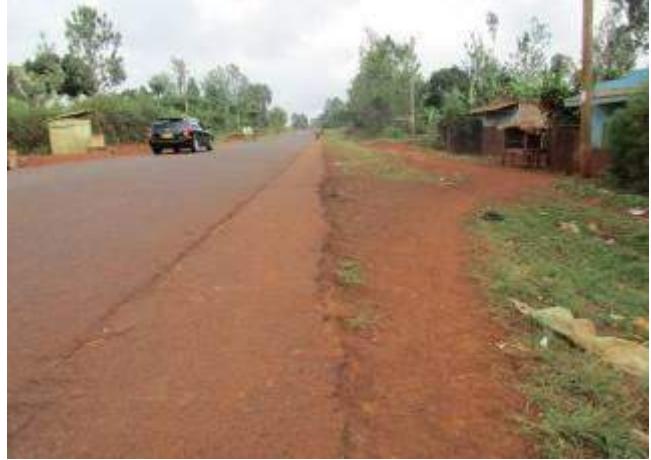
Fig 14	Km 0+820 – 0+850 main carriage and RHS	-Alligator cracks on the LHS carriage way -Erosion on the side slope and shoulders

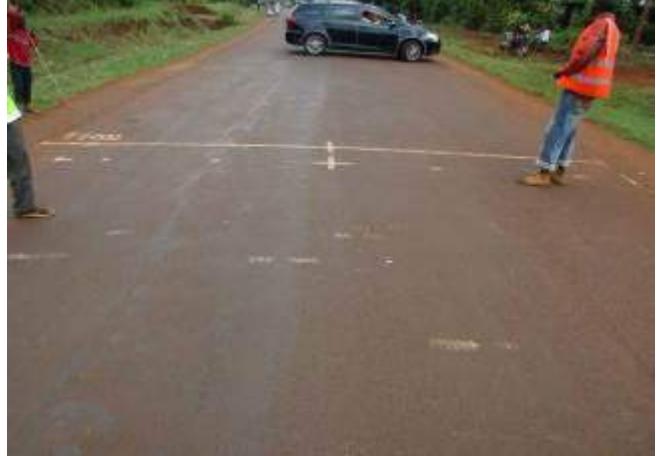
Fig 18	Km 0+980 – 1+000	-Alligator cracks and slight bleeding on the surface

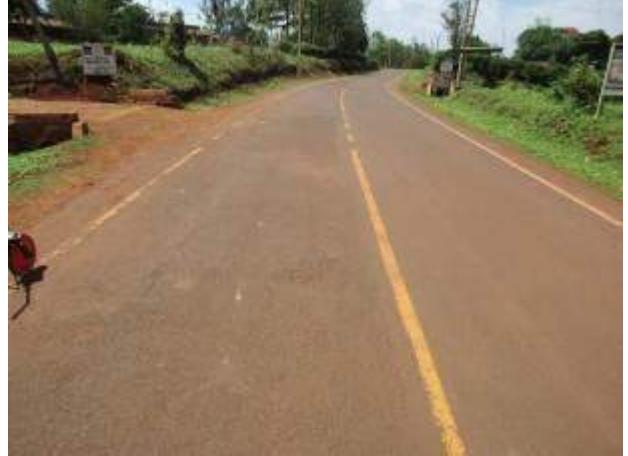
Fig 4	Km 0+340 – 0+356LHS carriage way	-Stripping on the LHS lane covering 12m long and 3m width – Could have been contributed to a coarser mix -Noticeable inconsistency in the mix

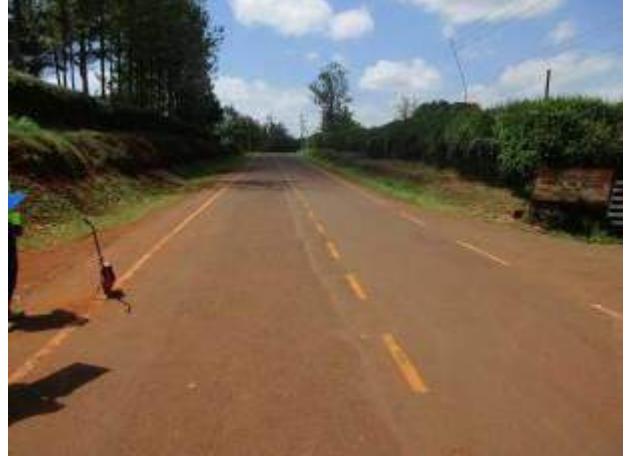
Fig 5	Km 0+360-0+380 main carriage way	-Noticeable inconsistency in the mix

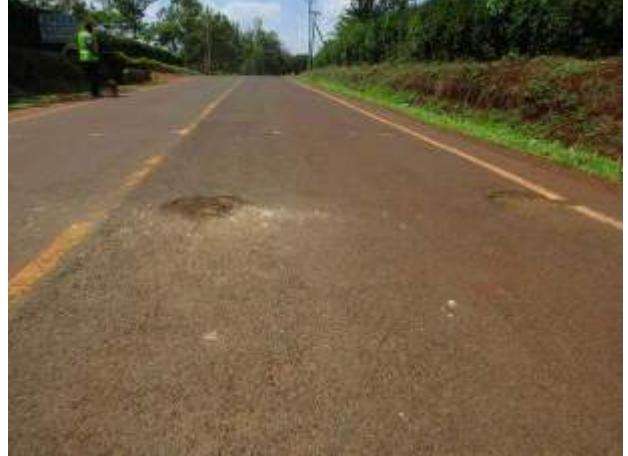
Fig 6	Km 0+400 -0+420 RHS lane	<ul style="list-style-type: none"> -2No Potholes on the RHS carriage way approximate area of - 0.5m*0.5m (Area -0.25m²)and 0.3m*0.5m(Area 0.15m²) respectively on both outer and inner wheel path -The mix used appears too coarse

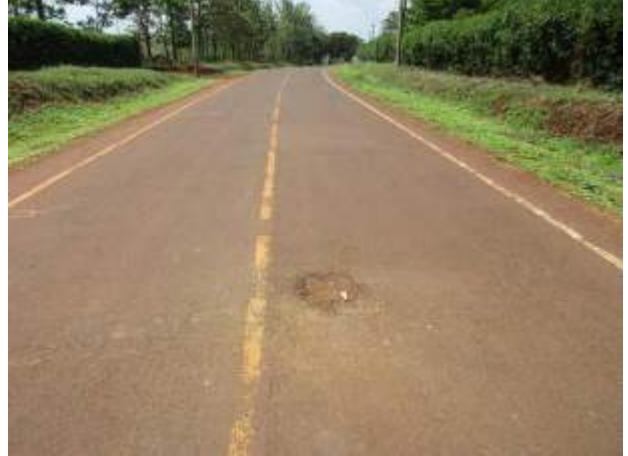
Fig 7	Km 0+479 RHS	1No Pothole at the inner wheel path covering 0.6m by 0.5m with a depth of 65mm

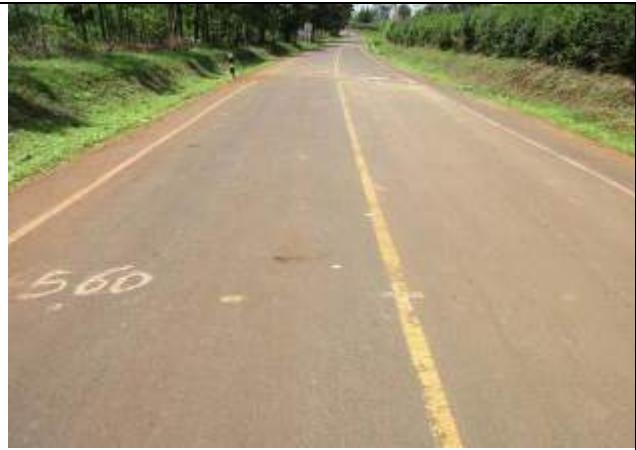
Fig 8	Km 0+560 LHS	-Pothole developing on the LHS carriage way at inner wheel path

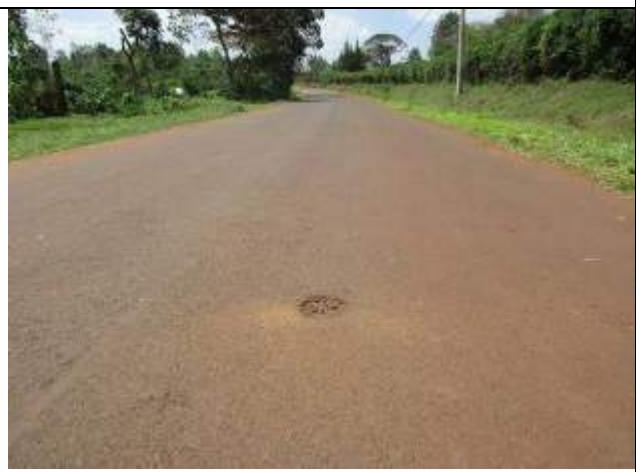
Fig 9	Km 0+693RHS	-Pothole developing on the RHS carriage way at inner wheel path

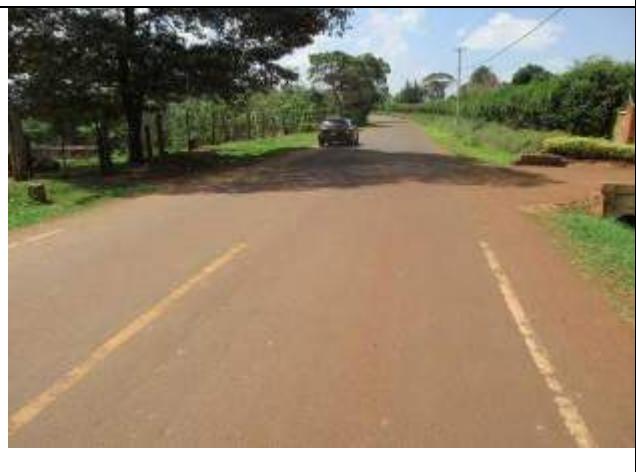
Fig 10	Km 0+600 main carriage way	-No road marking starting from 0+600 main carriage way

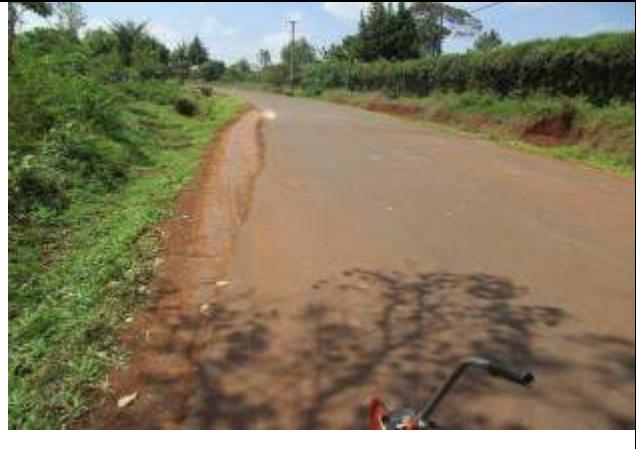
Fig 12	Km0+778-0+800 both sides	-Erosion on side slope and shoulders and edge braking caused by traffic dodging the bump

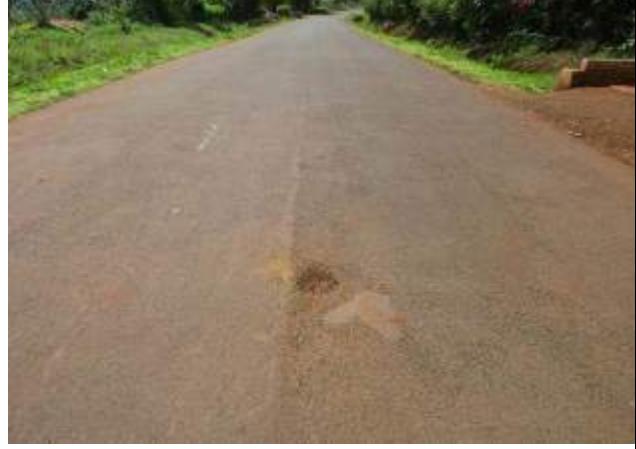
Fig 13	Km 0+885 at the Centerline	-Pothole developing at centerline

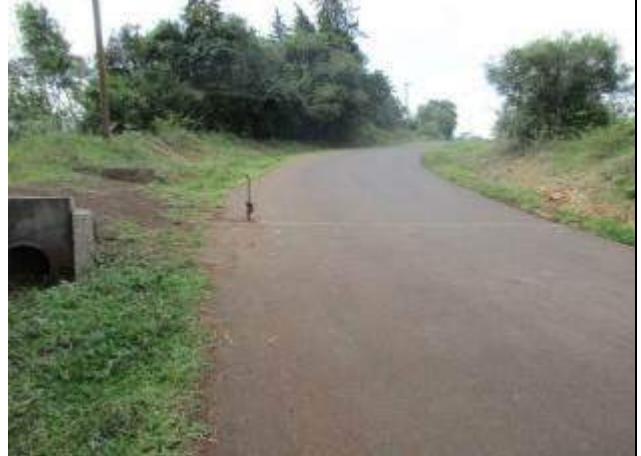
Fig 17	Km 0+970 – 1+000 main carriage way	-Swallow side drain - Vegetation on shoulders hindering free flow of water to side drain

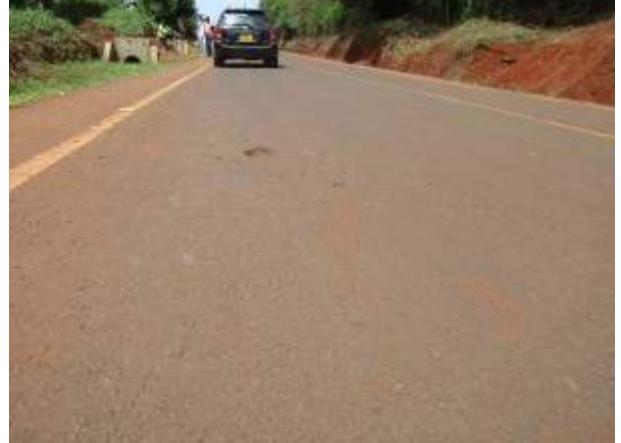
Fig 5	Km 0+177LHS	-Potholes and alligator cracks on the outer wheel path

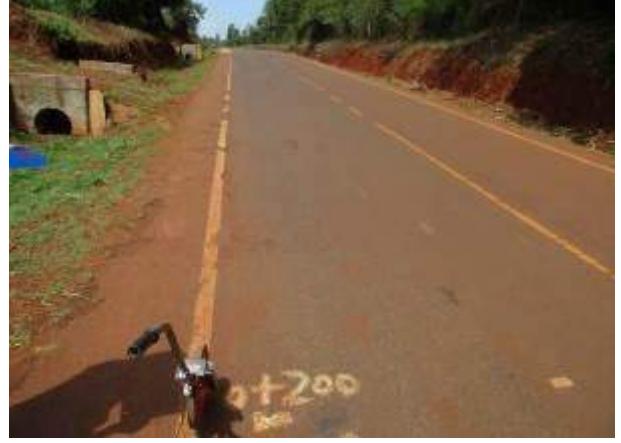
Fig 6	Km 0+200 – 0+230 LHS	-Localized disintegration of ac layer leading to the potholes on the LHS carriage way on the shoulders and outer wheel path -Silted side drain and access culvert

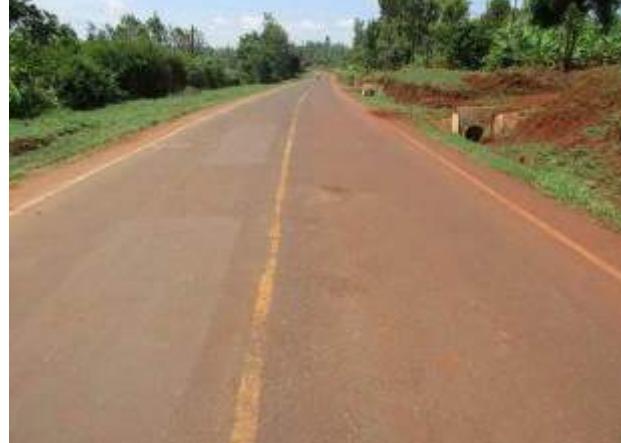
Fig 7	Km 0+455RHS	-Potholes on the RHS lane on the inner wheel a path covering 100mm by 50mm -Surface appears rough and course

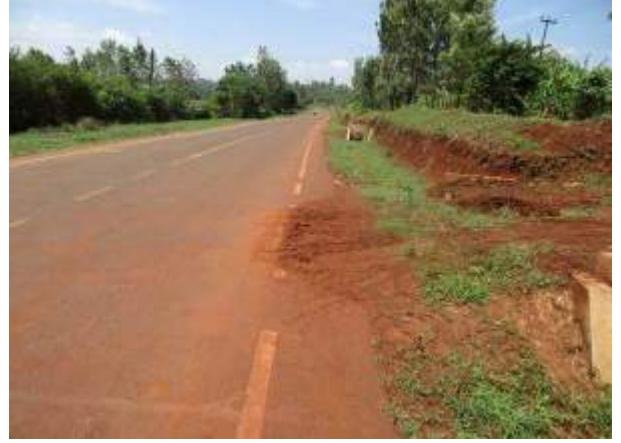
Fig 8	Km 0+660-0+665LHS	-Silted shoulders and edge extending to main carriage way -Soaking of the shoulders and edge with erosion deposits from a poorly placed access culvert

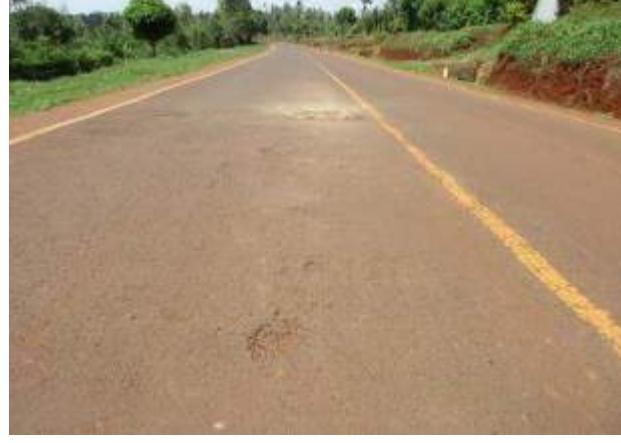
Fig 9	Km 0+716 -0+750 LHS lane	-Disintegration and alligator cracks of asphalt layer leading raveling ,potholes ,stripping and crack sealing done on the carriage way Km 0+716-0+750

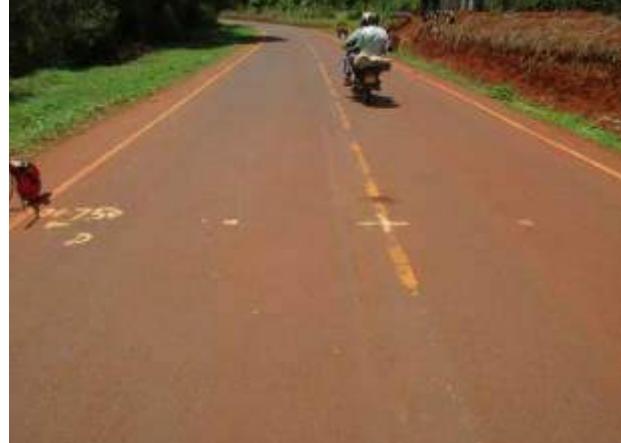
Fig 10	Km 0+752Centerline	-Pothole at the centerline covering 0.3m by 0.2m and a depth of 30mm

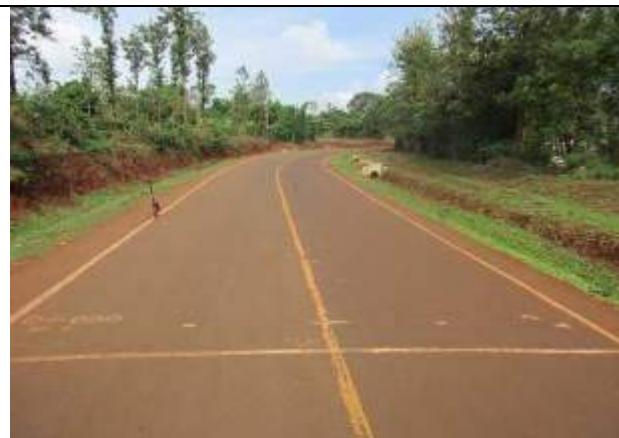
Fig No	Location (Km)	Defect assessment and description	Photos illustrating the pavement distress & defect
Fig 1	Km 0+000 – 0+100 main carriage way	No visible defect on the carriage way

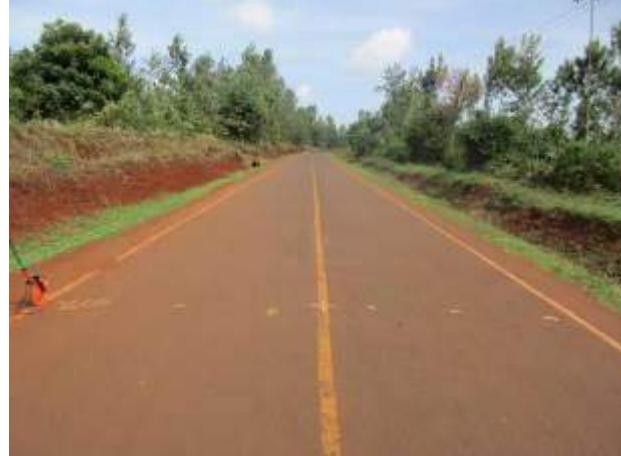
Fig 2	Km 0+150 – 0+250 main carriage way	No visible defect on the carriage way

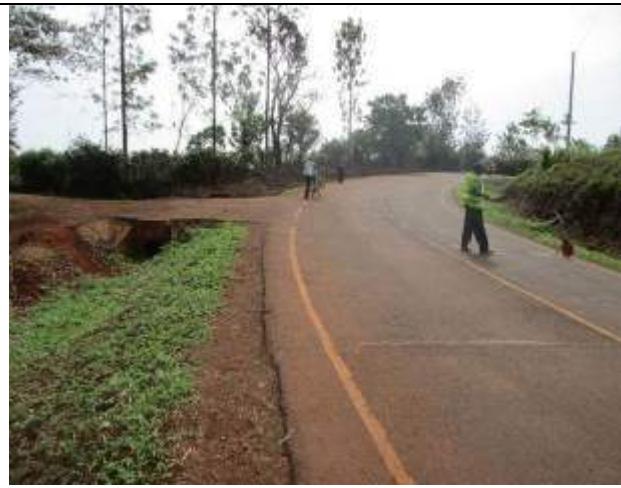
Fig 3	Km 0+600 – 0+650 main carriage way	Slight stripping on the carriage way
