Baseline Survey Report for 11 Low-Volume Sealed Roads in Kenya

Final Report

By: Across Africa Consultants Ltd.

Prepared for Kenya Materials Testing and Research Department (MTRD)

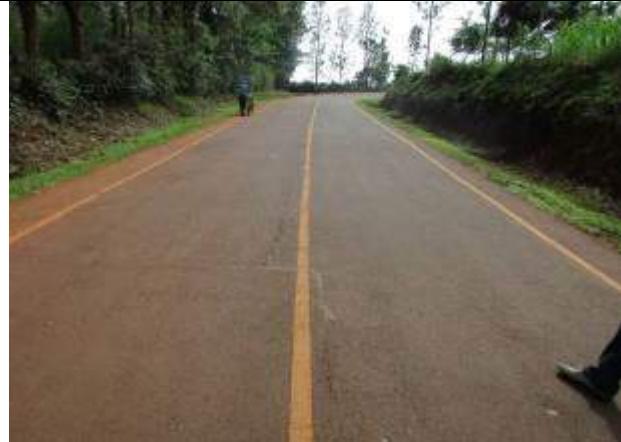
Fig 4	Km 0+720 – 0+740 Main carriage way	-Poor longitudinal joint visible at the centerline

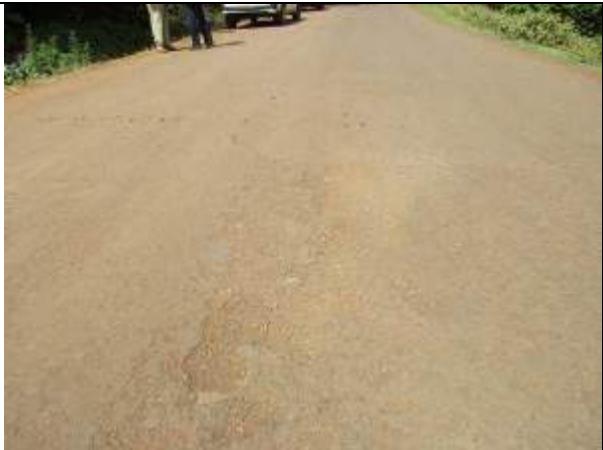
Fig 1	Km 0+028 – 0+030 at the centerline	<ul style="list-style-type: none"> -Localized loss of the asphalt concrete layer -Pothole covering an area of about (1.2m*1.0 m)1.2m²

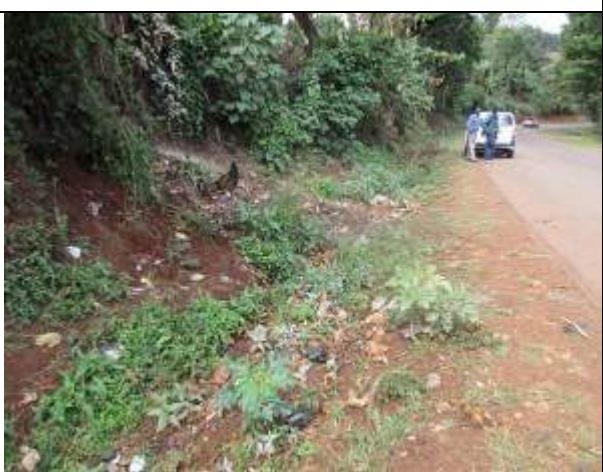
Fig 2	Km 0+015- 0+057LHS drain	<ul style="list-style-type: none"> -Blocked and silted with waste debris

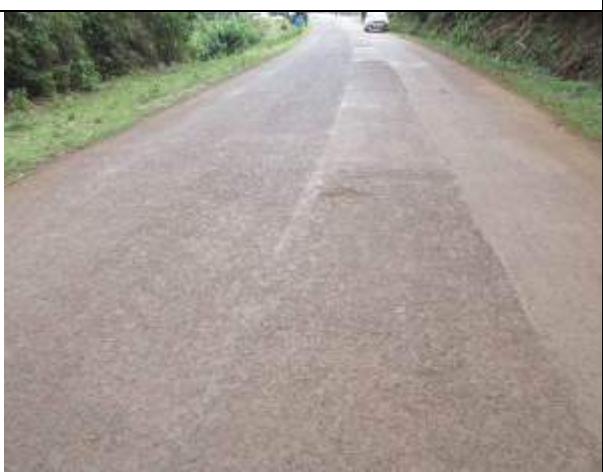
Fig 3	Km 0+057 – 0+100	<ul style="list-style-type: none"> -Inconsistency of the mix causing potholes and stripping on the LHS carriage way -Pothole and area of about (0.1m*0.3m)m2

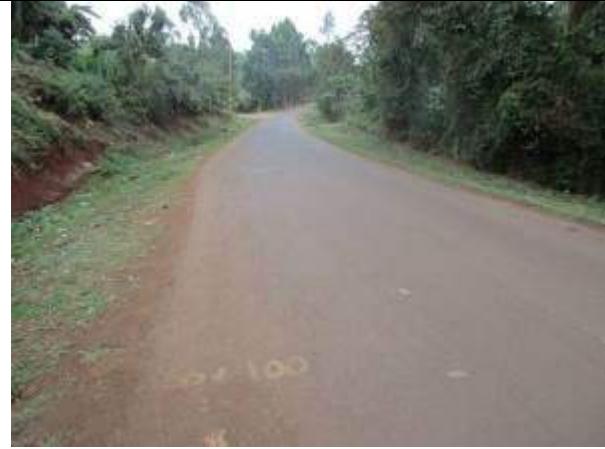
Fig 4	Km 0+100 – 0+177	-No visible defect on the carriage way

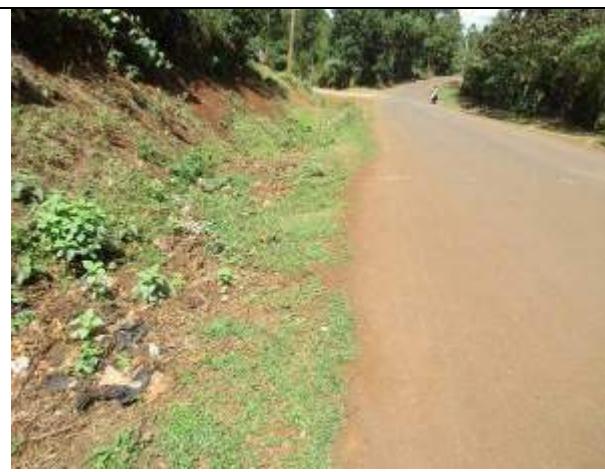
Fig 5	Km 0+058 – 0+150LHS drain	-Blocked and silted on the LHS drain

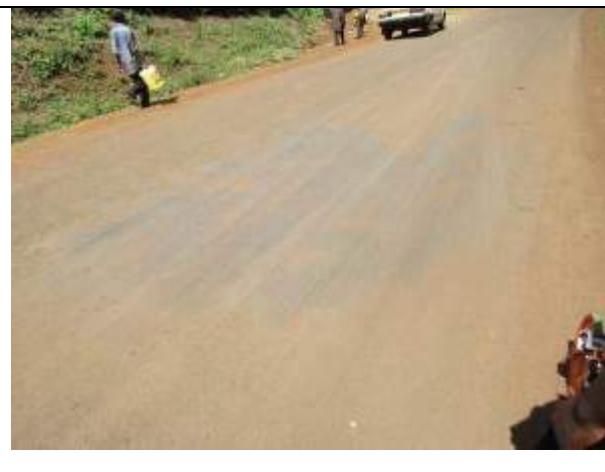
Fig 6	Km 0+177 RHS	-Slight bleeding on the surface inner wheel path and extending to the centerline

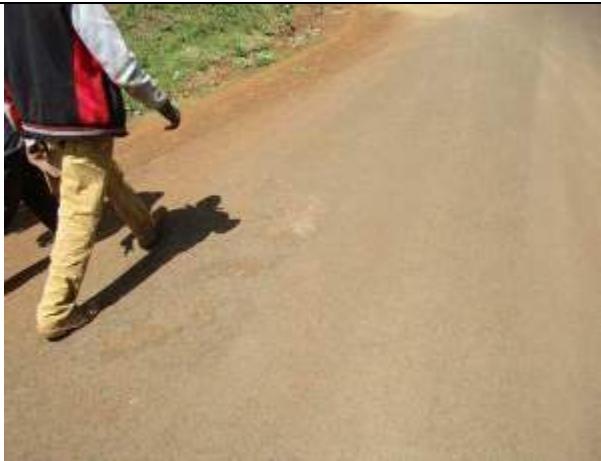
Fig 7	Km 0+180 RHS	<ul style="list-style-type: none"> -Localized loss of the asphalt concrete layer -Pothole covering an area of about $(1.2\text{m} \times 1.0\text{ m})1.2\text{m}^2$ -Potholes developing on the carriage way -the surface texture looks very coarse

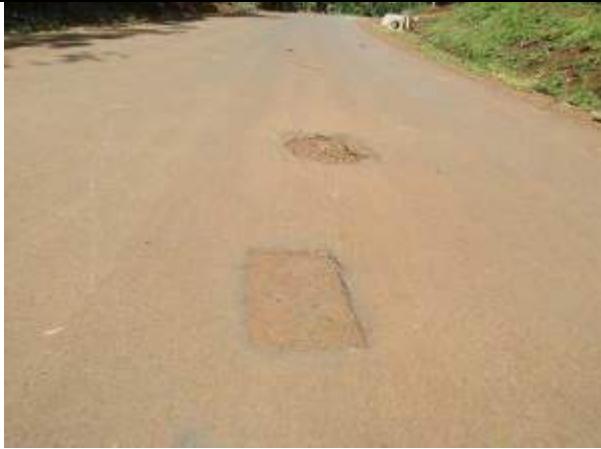
Fig 8	Km 0+235RHS lane	<ul style="list-style-type: none"> -2no -Potholes on outer wheel path -approximate area of about A($1.6\text{m} \times 0.5\text{m}$) and a depth 60mm

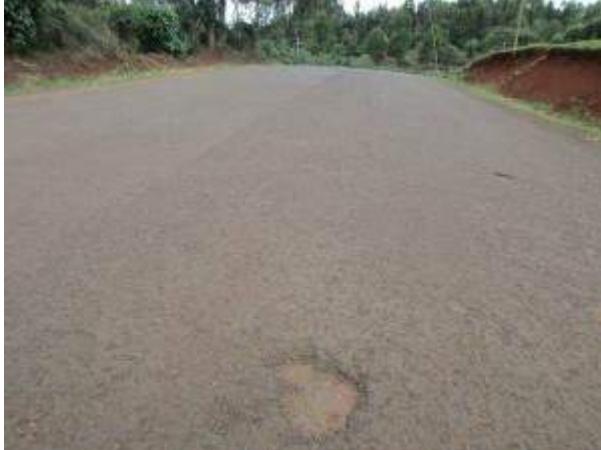
Fig 9	Km 0+306 Inner wheel path	<ul style="list-style-type: none"> -Pothole on inner wheel path -area of about A($0.3\text{m} \times 0.3\text{m}$) and a depth 50mm - Potholes developing on the carriage way -the surface texture looks very coarse

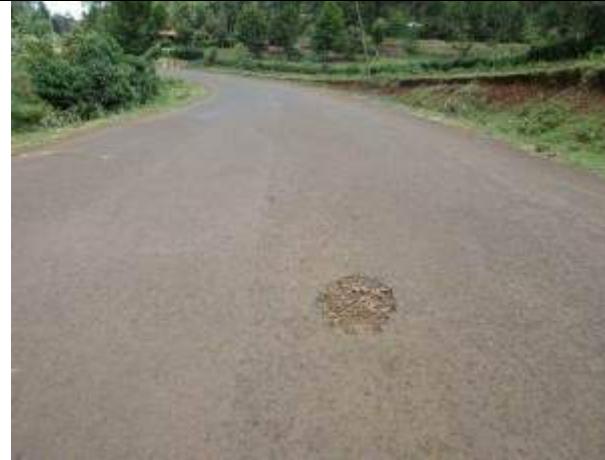
Fig 10	Km 0+322	-Potholes developing on the carriage way -the surface texture looks very coarse

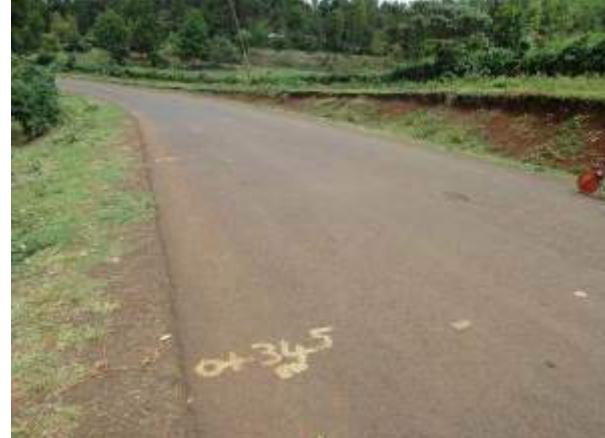
Fig 11	Km 0+357 RHS	-Pothole on the outer wheel path

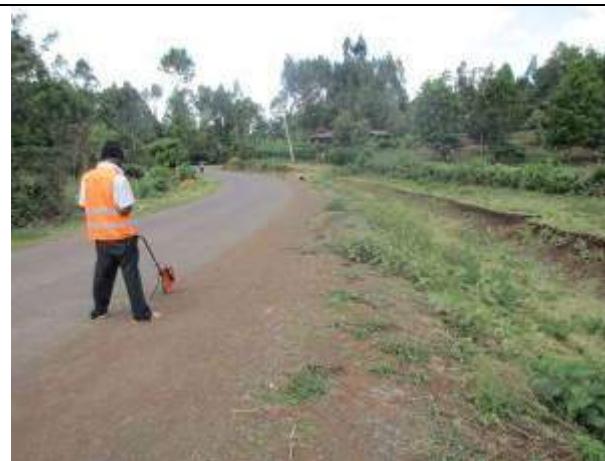
Fig 12	Km 0+375 – 0+400 RHS lane	-Erosion deposits on shoulders hindering free flow of water to side drain km 0+375 - 0+400

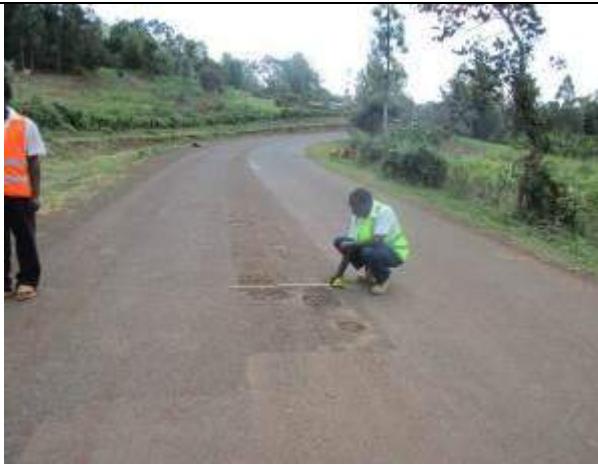
Fig 13	Km 0+400 – 0+455 RHS	-3No potholes on carriage way coving (1.0m*1.5m)m2 -Ravelling and extensive loss of surface texture leading to the development of potholes on the surface

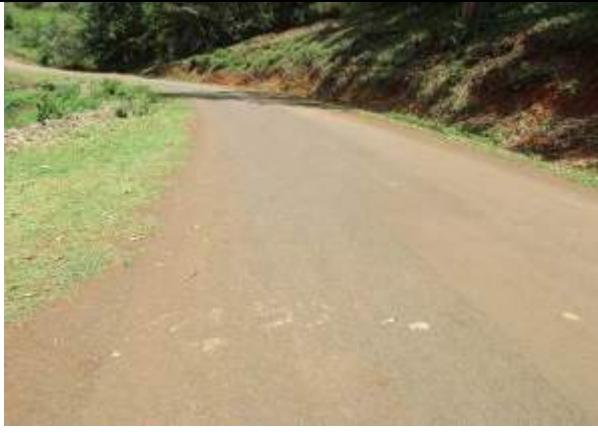
Fig 14	Km 0+520 – 0+540 LHS main carriage way	-The surface texture looks very coarse

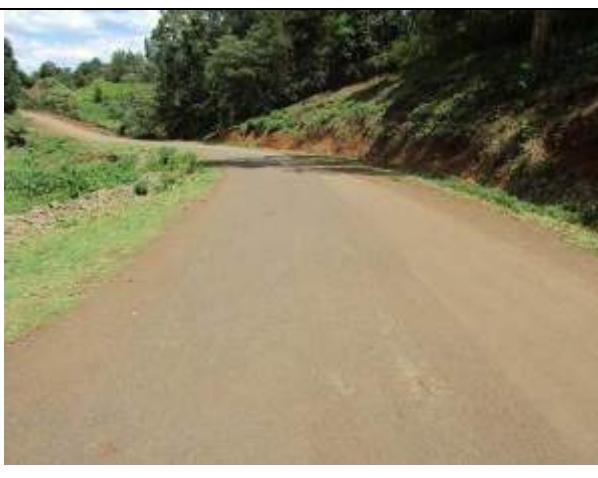
Fig 15	Km 0+530 – 0+550 main carriage way	-The surface texture looks very coarse especially on LHS lane -No side drain on the LHS

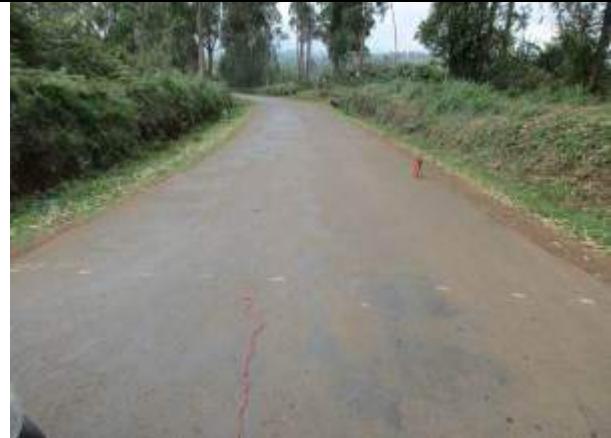
Fig No	Location (Km)	Defect assessment and description	Photos illustrating the pavement distress & defect
Fig 1	Km 0+000 – 0+050 centerline	-Bleeding on the main carriage way at the centerline

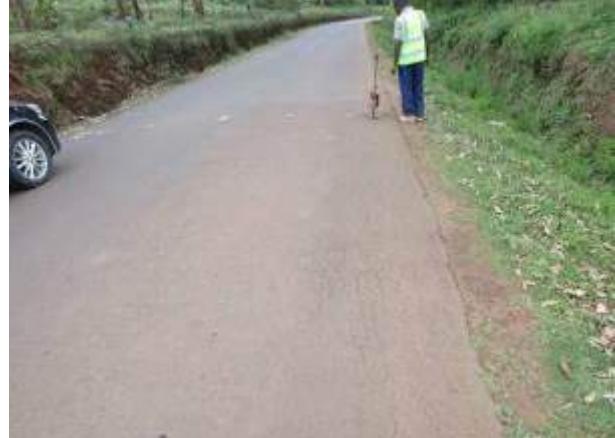
Fig 4	Km 0+094 – 0+100 RHS	-Extensive alligator cracks on the outer wheel path -Deformation and depression on the outer wheel path of about -Area - 4m by 6m (24m^2)

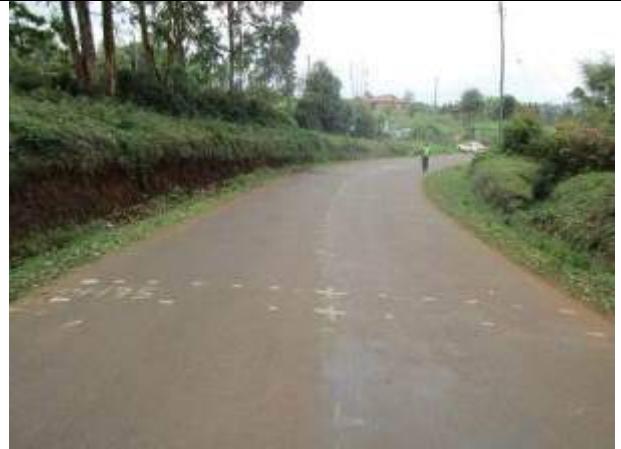
Fig 5	Km 0+060 – 0+175 RHS main carriage way	-Bleeding on the inner wheel path on the RHS lane

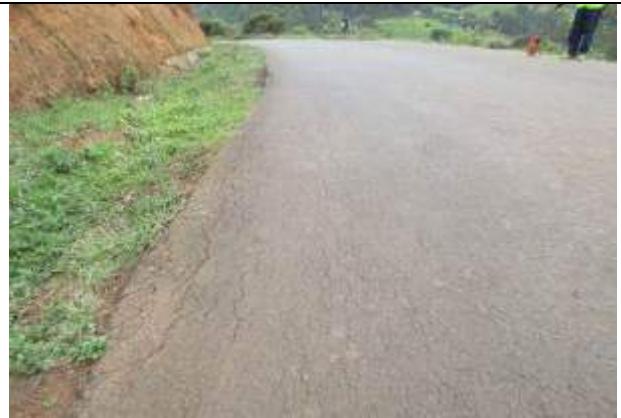
Fig 8	Km 0+030 - 0+320LHS	<ul style="list-style-type: none"> -Extensive alligator cracks on the outer wheel path causing deformation and alligator cracks at the edge -Silted side drain hindering free flow of water along the drain and enhancing accumulation of deposits

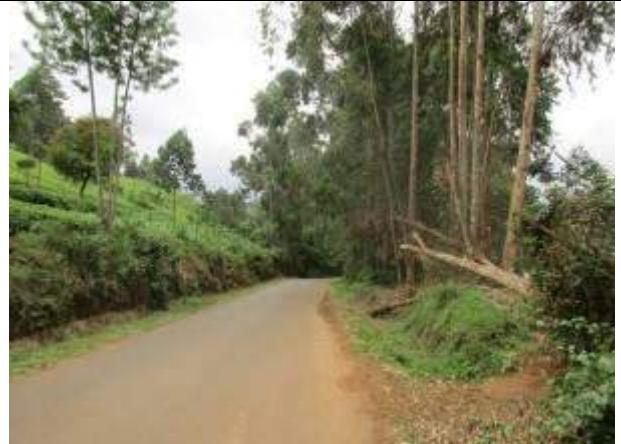
Fig 11	Km 0+533 – 0+600 both sides	-Blocked and silted with waste debris side drain

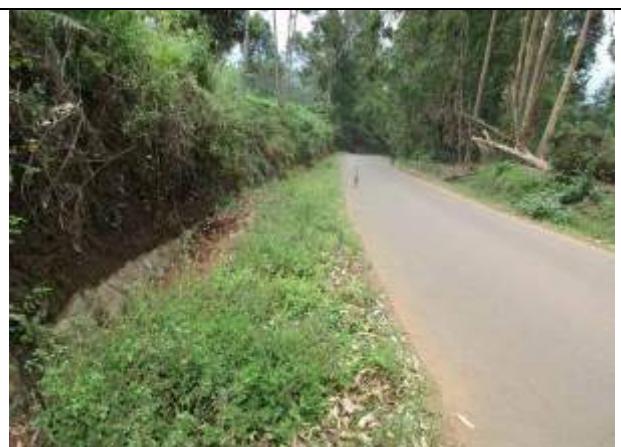
Fig 12	0+601 – 0+613 LHS	-Silted side drain and Vegetated side slope allowing the accumulation of erosion deposits on shoulders and edge

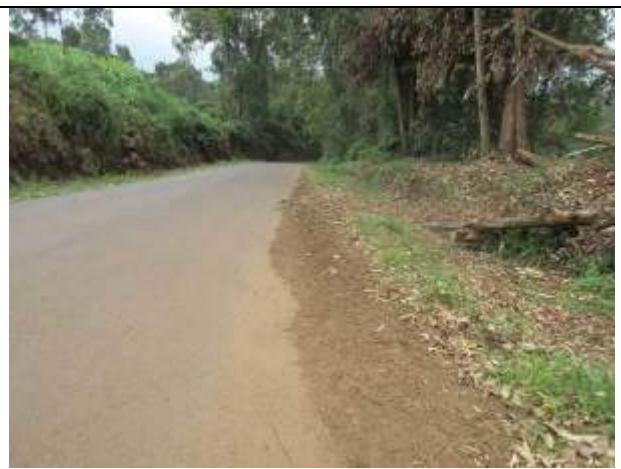
Fig 13	Km 0+590- 0+650LHS	-Silted side drain forcing water to overflow across the carriage way -Silted edge

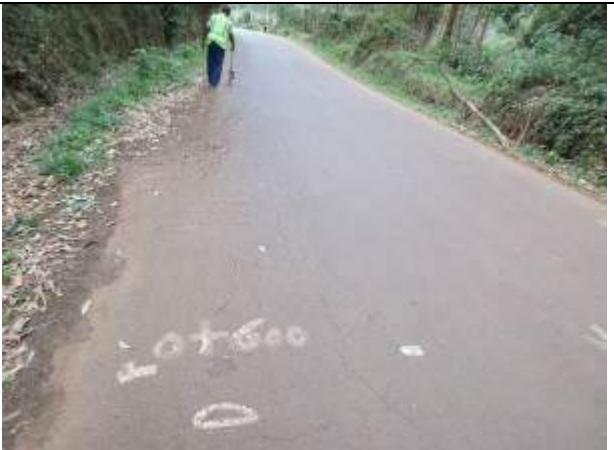
Fig 14	Km 0+590- 0+650LHS	-Edge subsidence ,deformation , alligator cracks and outer wheel path failure -Blocked with erosion deposits

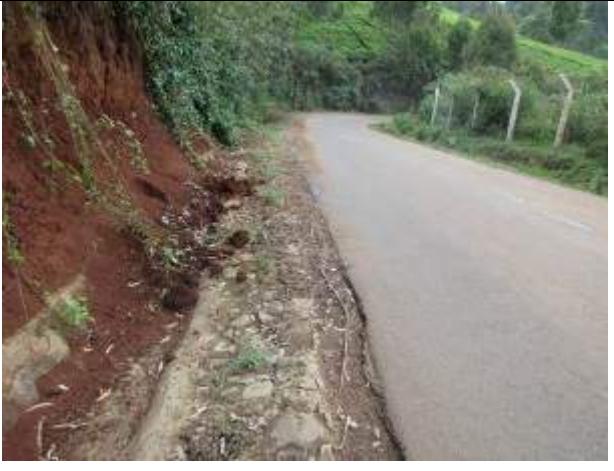
Fig 15	Km 0+730 – 0+750 LHS	-Collapsing side slope causing blockage on the side drain

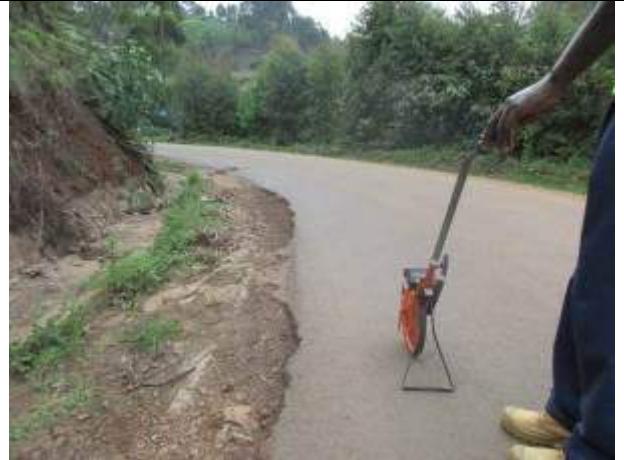
Fig 17	Km 0+850 – 0+900 LHS	-Eroded side slope and edge braking -Collapsing side slope

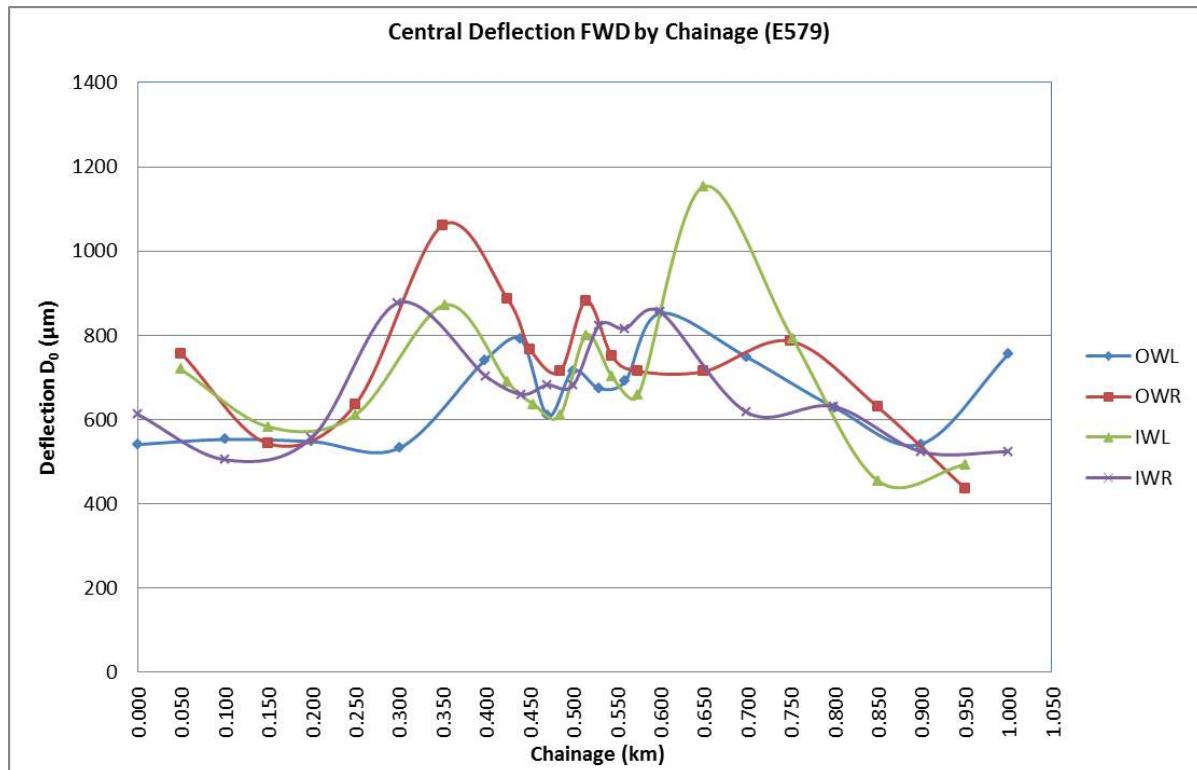
Figure 13-2: Central deflection by chainage (E579)

All the deflection outputs from the FWD for all the sensors (D_0 up to D_6) for all the test locations are presented in the Appendix section of the report. Figure 13-2 shows the central deflection of each wheel path along the road. The values are highly variable.

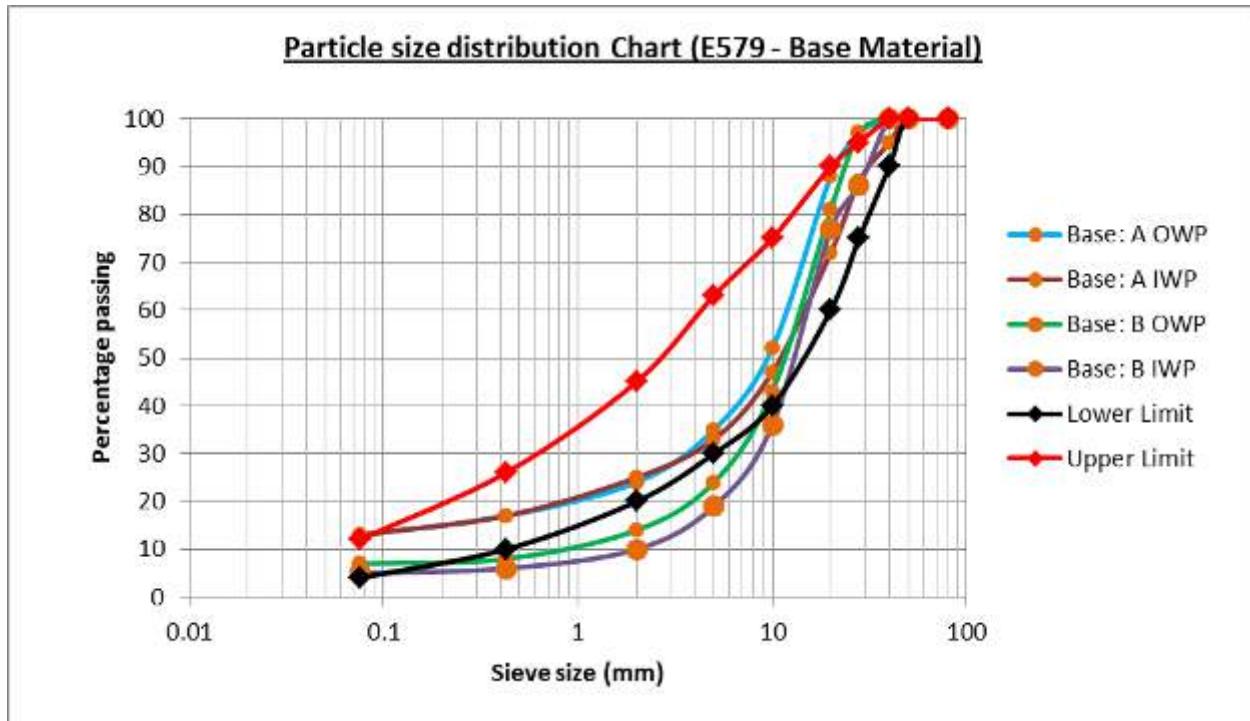
Figure 13-5: Particle size distribution for base material (E579)

The plots in Figure 13-5, Figure 13-6, and Figure 13-7 below show the particle size distribution for each layer. The base materials mostly lie outside the specification envelope.
