AIRCRAFT ACCIDENT REPORT 1/2018

Report on the accident to Sikorsky S-92A, G-WNSR West Franklin wellhead platform, North Sea on 28 December 2016

Air Accidents Investigation Branch

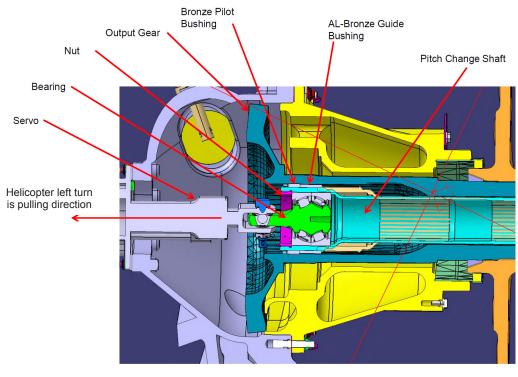
Figure 4 TGB cross-section

The investigation determined that the TRPCS bearing had degraded and failed. As a consequence, the tail rotor pitch change servo was damaged resulting in uncommanded and uncontrolled inputs being made to the tail rotor (TR). The manner in which the servo was damaged had not been previously identified.

The TRPCS bearing location within a TGB cross-section is shown in green in Figure 4.

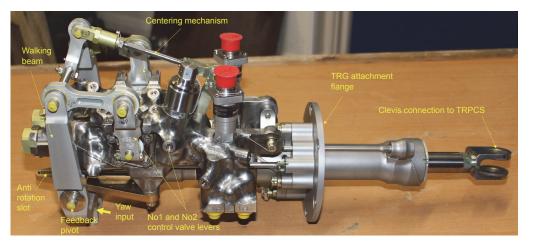
Figure 5 TR servo walking beam and valve linkages

The TR servo consists of two pistons on the same shaft, each piston being powered independently by the No 1 and No 2 hydraulic systems. Inputs from the yaw control system act on a 'walking beam' which is mounted on a pivot on the outer end of the servo piston shaft. The walking beam is y-shaped and connected to two servo valves, one for each hydraulic system, which are operated simultaneously on movement of the walking beam. Yaw inputs cause the walking beam to pivot and, in turn, this movement opens the servo valves to allow hydraulic pressure to the servo pistons. The servo moves inwards or outwards, depending on the yaw direction required, and carries with it the walking beam pivot. On cessation of the input from the yaw system the pivot location effectively transfers to the control rod connection, leaving the piston shaft to continue to move until the servo valves are recentralised by the walking beam. Figure 5 shows the TR servo and walking beam assembly. The range of movement of the servo is approximately 3.5 inches (89 mm). The servo piston assembly is prevented from rotating by means of a tab which engages with an anti-rotation slot on the outer casing of the servo.

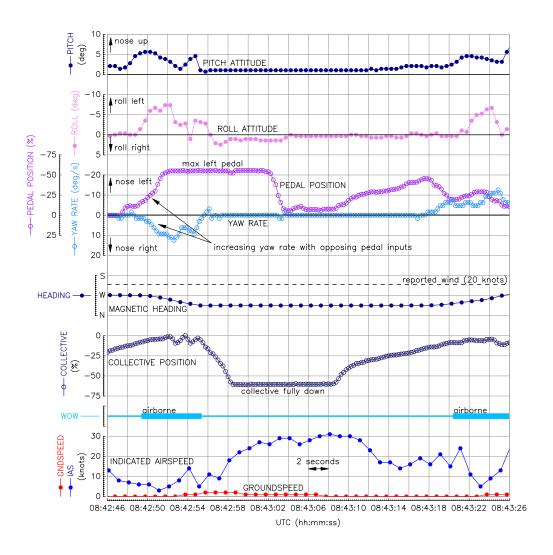
Figure 6 is a plot of the salient flight data parameters for the Elgin yaw event and lift off for the transit to West Franklin, starting with the helicopter on the helideck. In summary, the data indicates the following:

UTC (hh:mm:ss)	Event
08:42:47	Left pedal input made (helicopter on helideck – heading 270°).
08:42:49	Helicopter lifts off, rolls left and yaws right.
08:42:52	Full left pedal input, helicopter yawing 10°/s to the right.
08:42:53	Peak yaw rate of 12.5°/s recorded.
08:42:55	Collective reduced (then helicopter back on helideck – heading now 315° having yawed right 45°).
08:43:08.5	Collective lever starts to raise.
08:43:18	Helicopter lifts to hover and starts to yaw left.
08:43:20.5	Helicopter departs (for transit to West Franklin).

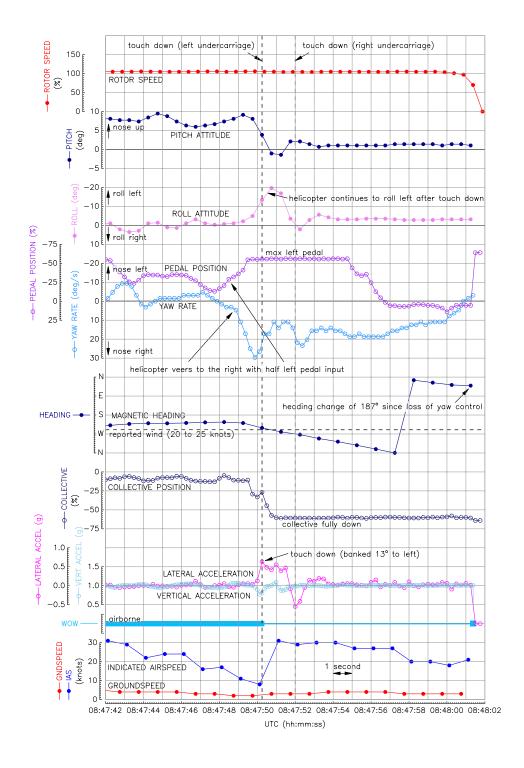
Figure 7 Recorded flight data for the West Franklin landing

Figure 7 is a plot of the salient flight data parameters for the landing on the West Franklin platform starting with the helicopter manoeuvring over the helideck just prior to touchdown. Note that the flight recorder does not record data associated with the use or status of the landing gear wheel brakes. In summary, the data indicates the following:

08:47:50.2	Helicopter touches down (on left landing gear) rolled 13° to left – maximum left roll of 20° recorded less than half a second later.
08:47:52	Helicopter touches down on right landing gear - yaw rate about 20°/s with max left pedal inputs still being made.

08:47:55	Left pedal inputs reduce.
08:47:57	Pedals are nominally zero - right yaw rate reduces.
08:47:58	Rotor speed starts to reduce.
08:48:01.5	End of recorded data – helicopter final heading of 041° having rotated through 187° since loss of yaw control.

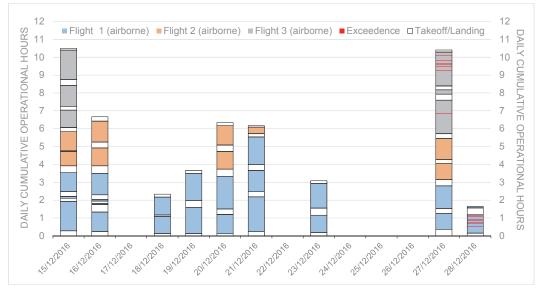
Figure 13 shows a graphical representation of the flight schedule for G-WNSR for the two weeks leading up to the accident. During this period, G-WNSR flew on nine of these days, two of which contained two flights with a daily total operational time of over 10 hours. The timing of the exceedences concerning these flights is indicated.

G-WNSR operating history for previous two weeks

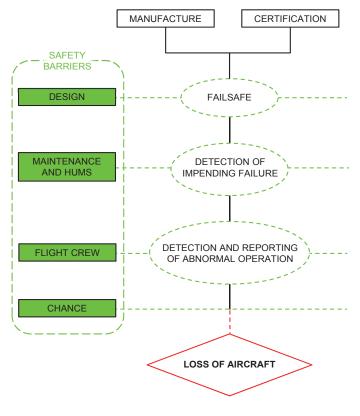
Figure 24 Schematic representation of the applicable safety barriers

To provide assurance of safe flight a series of safety barriers are in place which are designed to prevent the catastrophic loss of an aircraft. On this occasion most of the barriers were breached and it was fortuitous that the final component failure occurred when the helicopter was in the landing phase above the helideck, in a position from which, despite the loss of control, the commander could immediately lower the collective and land. Figure 24 is a schematic representation of the applicable safety barriers.
