# AIRCRAFT ACCIDENT REPORT 1/2018

Report on the accident to  
**Sikorsky S-92A, G-WNSR**  
West Franklin wellhead platform, North Sea  
on 28 December 2016

**Air Accidents Investigation Branch**

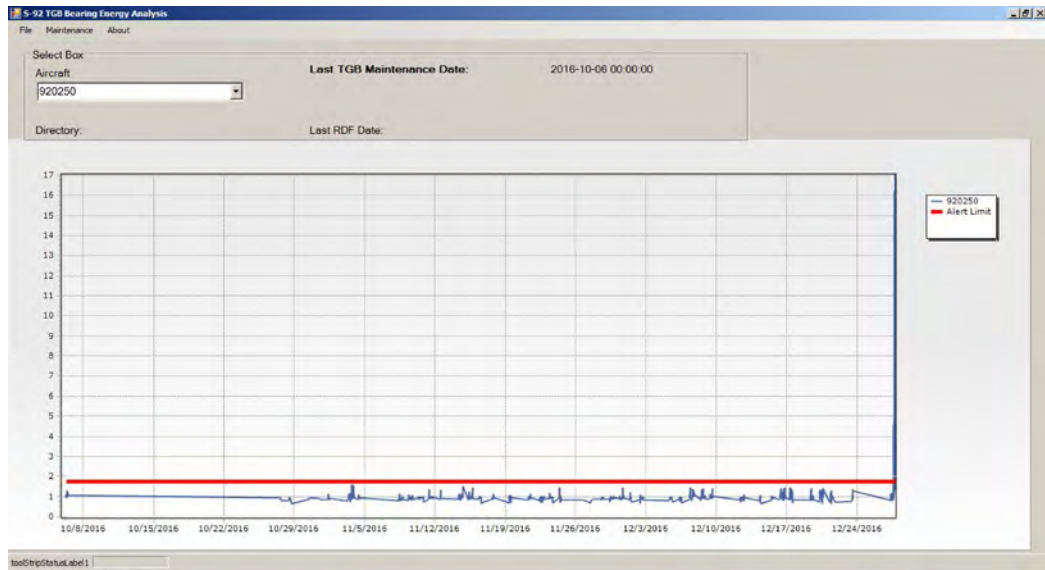
**Figure 9**

Figure 9 shows the time-history chart as presented to Engineers A and B, when they visually inspected the TGB bearing energy CI ratio (this figure has been recreated, using the original data, for the purposes of this accident report). Note that the x-axis automatically scales to show the complete time-history since last TGB maintenance date, which for G-WNSR was 6 October 2016, and the y-axis automatically scales from zero to the full range of CI ratio values.

However, had either of the licensed engineers successfully zoomed in on the day's flight, the exceedences would have been clearly visible (see Figure 10 for a recreated zoomed-in version of the original data) with the highest and final exceedence being just over 17 compared to the alert limit threshold of 1.75.

Recreated TGB bearing energy CI ratio time-history chart

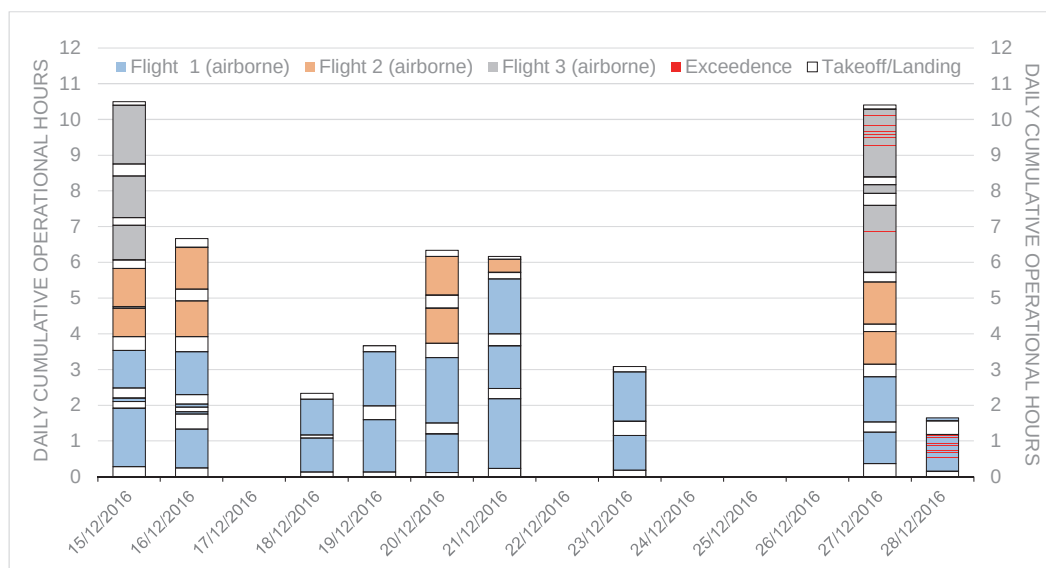
**Figure 13**

Figure 13 shows a graphical representation of the flight schedule for G-WNSR for the two weeks leading up to the accident. During this period, G-WNSR flew on nine of these days, two of which contained two flights with a daily total operational time of over 10 hours. The timing of the exceedences concerning these flights is indicated.

G-WNSR operating history for previous two weeks

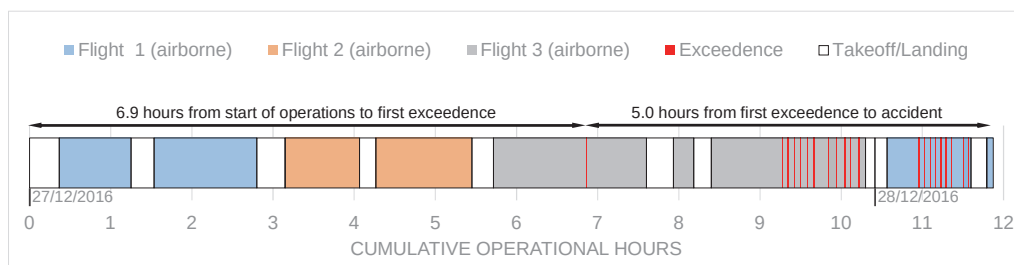
**Figure 14**

Figure 14 combines the operating histories for the last two days to form a timeline beginning with the start of operations on 27 December 2016, with the first exceedence highlighted at 6.9 operational hours and the accident 5 operational hours (about 4 flying hours) later.

G-WNSR operating history for the two days prior to the accident

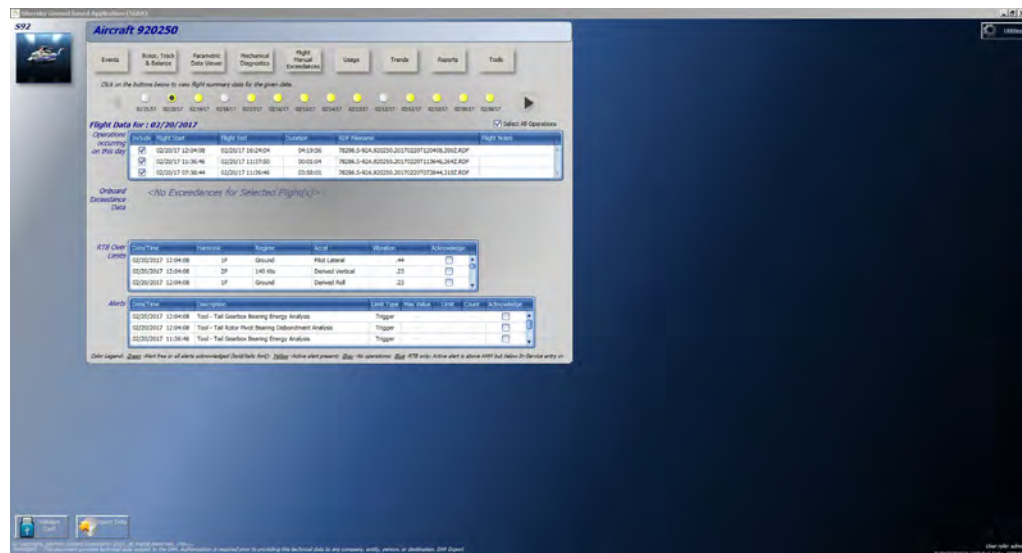
Figure 16

One key difference is that the first page (Figure 16) automatically presented to the user gives a summary of all CI exceedences and alerts to be actioned in accordance with the AMM, including those which previously, using the IMD GS software, required manual interrogation.

SGBA initial page highlighting exceedences and alerts

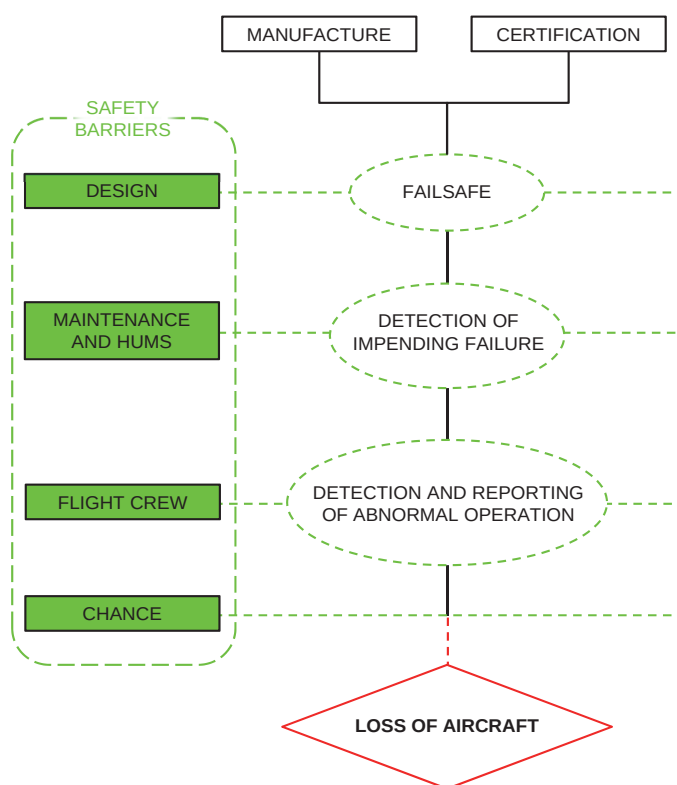
**Figure 24**

To provide assurance of safe flight a series of safety barriers are in place which are designed to prevent the catastrophic loss of an aircraft. On this occasion most of the barriers were breached and it was fortuitous that the final component failure occurred when the helicopter was in the landing phase above the helideck, in a position from which, despite the loss of control, the commander could immediately lower the collective and land. Figure 24 is a schematic representation of the applicable safety barriers.

Schematic representation of the applicable safety barriers

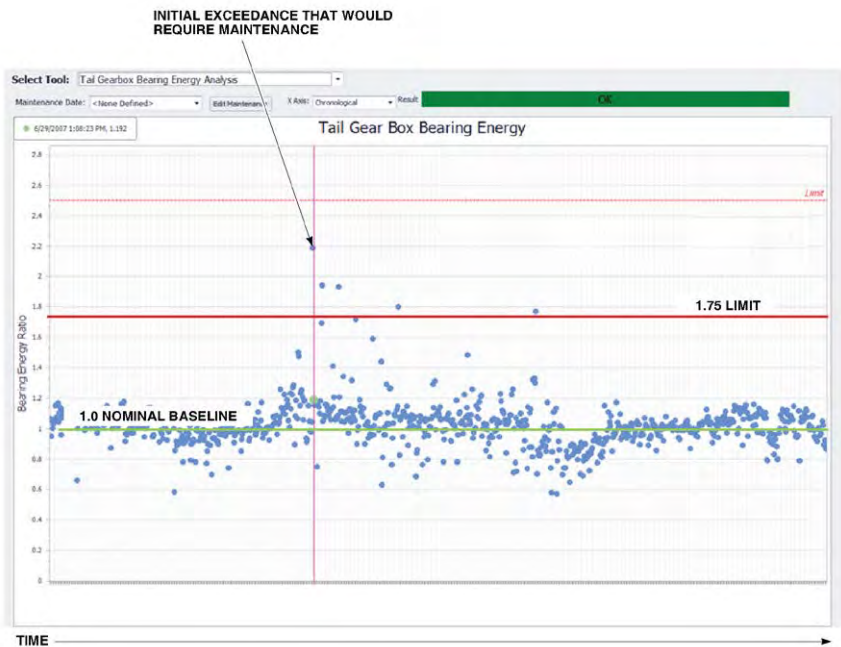
EXAMPLE OF RECORDED EXCEEDANCE OF TRPCS THAT REQUIRES MAINTENANCE  
**WARNING: A CI RATIO GREATER THAN 1.75 WILL NOT AUTOMATICALLY DISPLAY AS AN ALERT.**  
NOTE: The 1.75 limit may be manually defined as a threshold.  
FIGURE 1

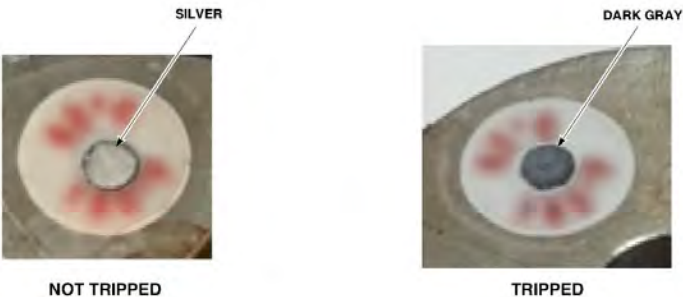
TEMPERATURE DOTS  
FIGURE 3

NOTE: The 180°F temperature dot is pre-tripped to provide a visual comparison of when a dot is tripped. (Refer to Figure 3 for an example).

- (1) Visually inspect temperature indicator plug (92358-06134-041) to verify that three (3) indicator dots are not tripped. If any of the three (3) temperature dots are found tripped, contact Sikorsky Aircraft Customer Service Engineering at 1-800-WINGED-S or Email: [wcs\\_cust\\_service\\_eng.gr-sik@lmco.com](mailto:wcs_cust_service_eng.gr-sik@lmco.com).
- (2) Thread temperature indicator plug (92358-06134-041) onto installation rod assembly (92700-10391-042) until threads bottom on installation rod shoulder. (Refer to Figure 4).
