AAIB Bulletin

4/2018

Published 13 April 2018

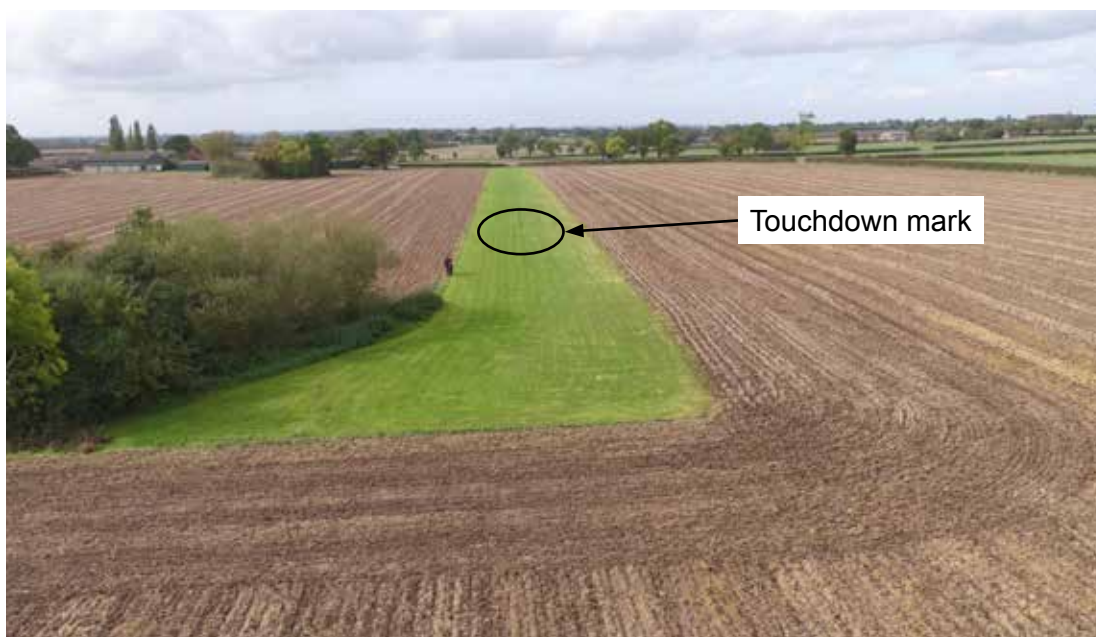
Figure 3

The runway was examined and it was in good condition with short grass and a reasonably firm surface. A touchdown mark from the single mainwheel was found close to the centre line of the runway approximately 73 m from the start of the runway (Figure 3). It indicated the aircraft had made a firm touchdown after which it became airborne again. Although there were more ground markings approaching the hedge, the subsequent touchdown point could not be identified.

View in direction of landing (from AAIB UAS)

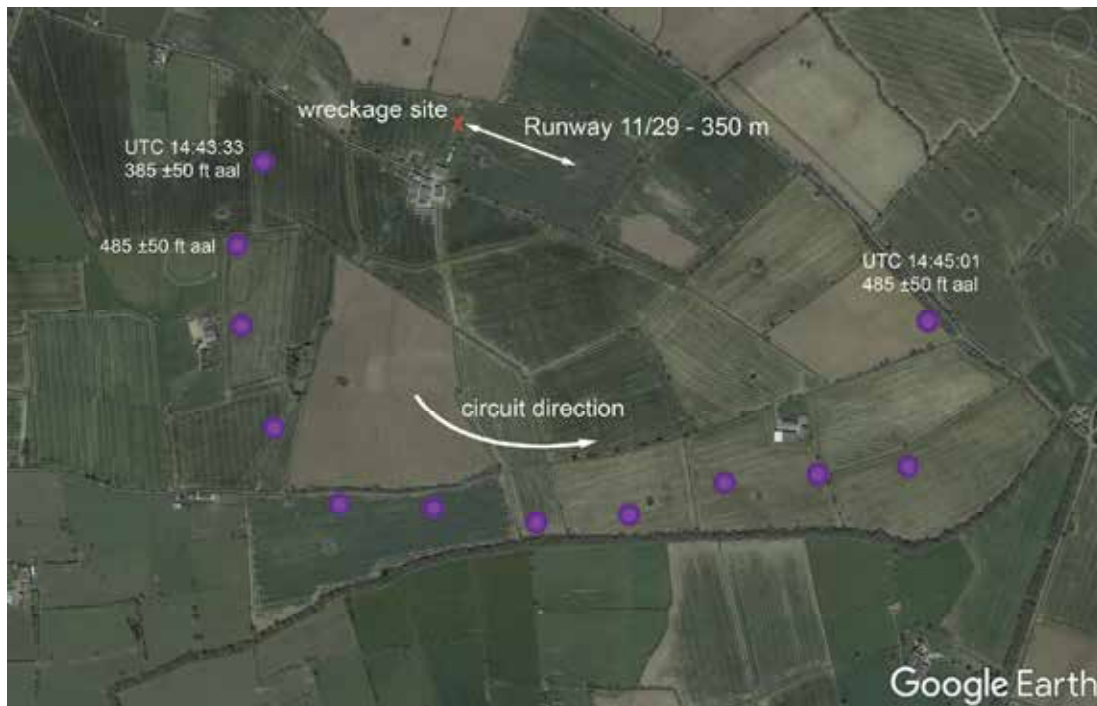
Figure 4

None of the aircraft's avionics survived the post-accident fire and no aircraft recorded data was recovered; however, a limited amount of radar data was recorded that tracked the aircraft in a left-hand circuit for Runway 29. Transponder Mode C altitude information, corrected to the QNH of 1017 hPa and the runway elevation of 380 ft, indicated that the circuit was flown at a height of 485 ± 50 ft aal (Figure 4).

Circuit ground track from radar data

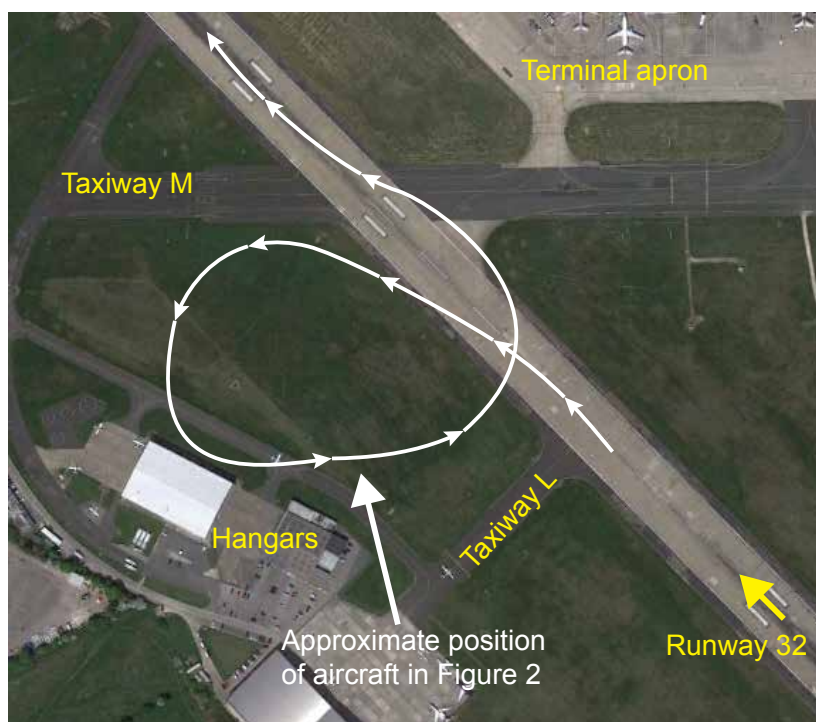
Figure 1

The takeoff and the low-level manoeuvres were recorded by several CCTV cameras and by a witness with a mobile phone. The recordings confirmed that when the aircraft approached the edge of the runway, south of Taxiway M (Figure 1), it rotated abruptly and rolled into a left turn but the pitch attitude then reduced and it made a short, shallow climb until it reached a height estimated to be no greater than 100 ft agl. At one point the aircraft appeared to start rolling out of the turn onto a south-westerly track, which might have taken it clear of the hangar area, but the angle of bank then increased suddenly.

Aerial view of Leeds Bradford Airport (© 2018 Google, Image © 2018 DigitalGlobe)

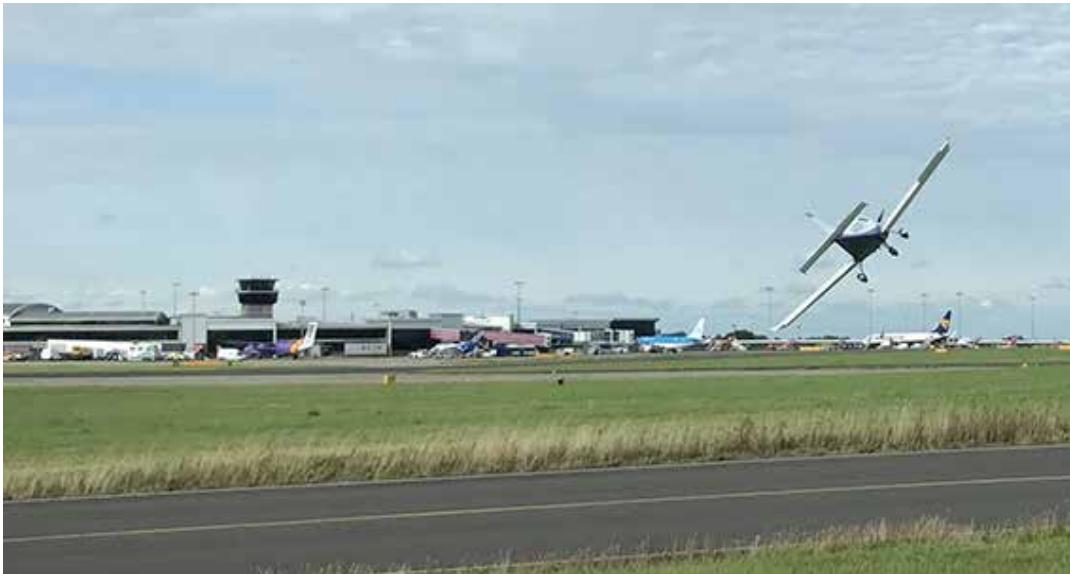
Figure 2

The aircraft continued turning, while flying at approximately the same height as the roof of the tallest hangar. It appeared to remain over the area between the hangars and the runway, with its angle of bank estimated to reach 60°. Then, as the aircraft turned back towards the runway, it descended below the level of the hangar roofs and the angle of bank began to reduce (Figure 2) but the left wingtip almost touched the grass while still in a left turn towards the runway, with an estimated angle of bank of 40°. However, the aircraft then started climbing again and it rolled out of the turn in the vicinity of the runway while climbing towards the north-west.

G-DTFT with a bank angle exceeding 40°, shortly before the wingtip almost touched the grass
(Photograph courtesy of Mr D Firman)

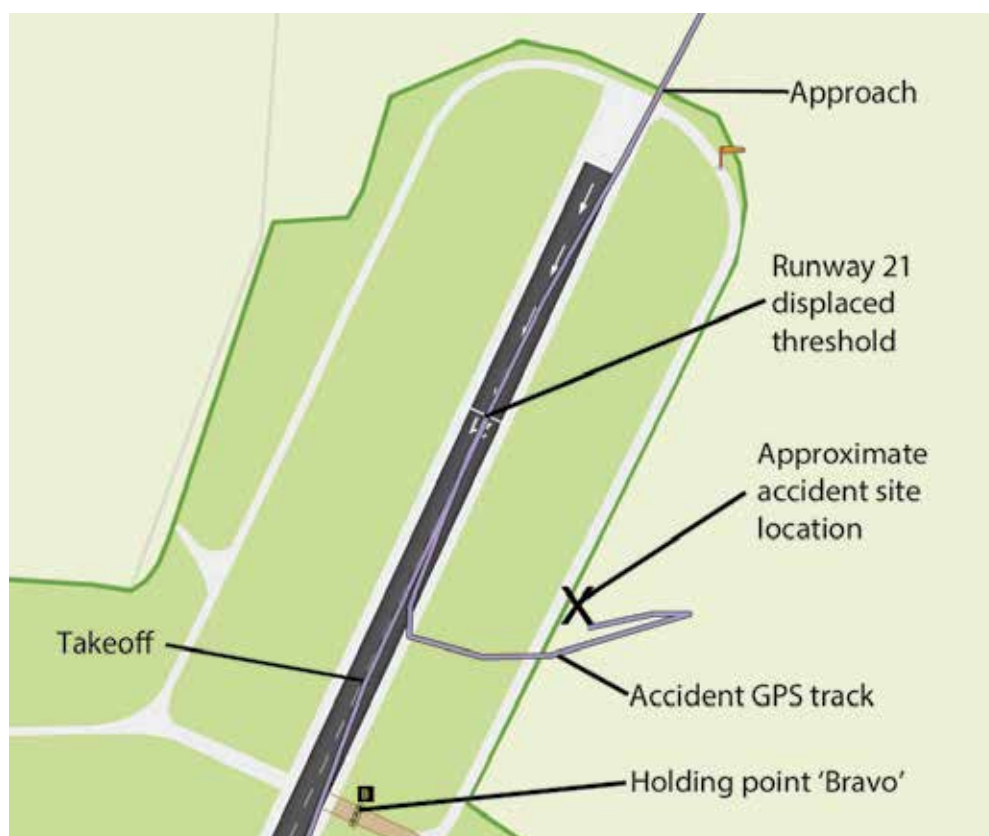
Figure 1

The aircraft struck the ground and came to rest close to the final recorded GPS point from the pilot's SkyDemon track log, to the left side of the runway (Figure 1). The pilot was seriously injured and transported to hospital by air ambulance.

Recorded GPS ground track from SkyDemon log showing the takeoff and the final accident track (underlying image ©SkyDemon)

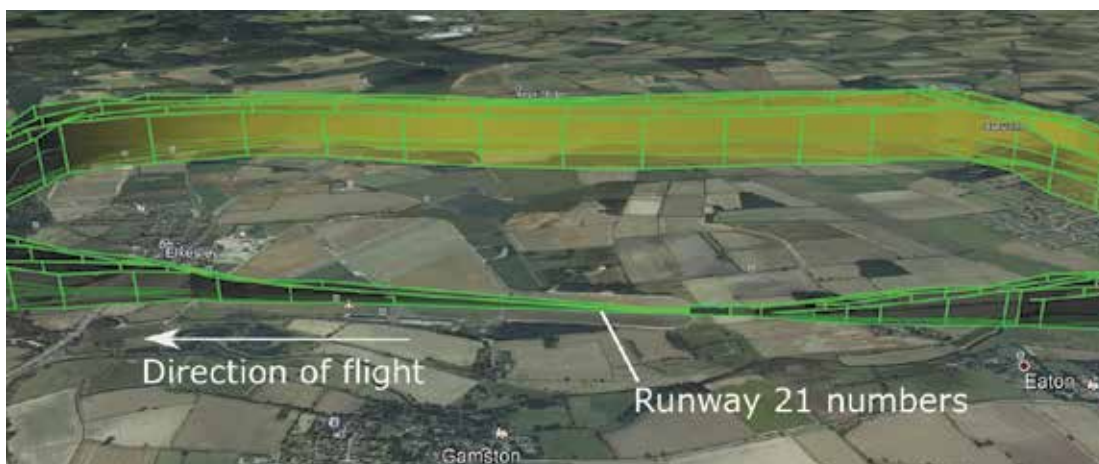
Figure 3

There was no recorded GPS data for the dual flight on 13 May 2017, but the radar data was obtained. This data revealed that five circuits were carried out to Runway 21 and the approach and climb-out profiles were almost identical for the first four, with the last one ending in a full-stop landing. The lowest recorded altitudes on each of the first four approaches was 47 ± 50 ft (corrected for QNH) and the runway elevation was between 72 and 87 ft. This data indicated that the first four were probably normal touch-and-go landings but it is possible that at least one was actually a very low go-around, from almost touchdown height, although a higher and earlier initial rate of climb would be expected from a go-around than a touch-and-go.

Radar data from G-BHNA's flight on the day before the accident, 13 May 2017
