Rail Accident Investigation Branch

Rail Accident Report

Explosion inside an underframe equipment case at Guildford 7 July 2017

Report 05/2018
March 2018

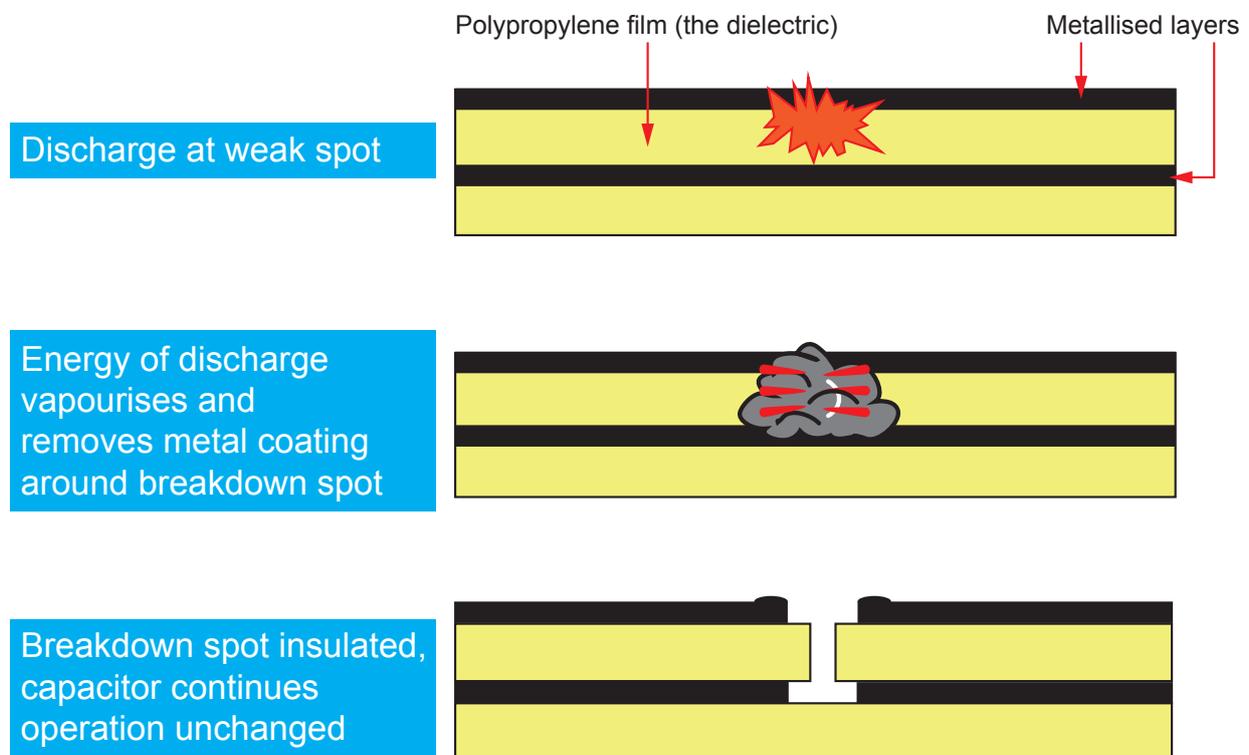
Figure 6: The process of self-healing within a film-type capacitor

- 51 A property of film-type capacitors is their ability to 'self-heal'. Self-healing occurs on a microscopic level at minor irregularities in the polypropylene film. Such irregularities can result in a small electrical discharge between the metallised layers at weak spots in the polypropylene film. This discharge vaporises and removes the metallic coating around the weak spot, which electrically isolates the irregularity. The self-healing process is depicted in figure 6. It continues through the lifespan of a capacitor. As this occurs on a microscopic level, the resulting loss of capacitance is negligible, even after a typical 30-year life span for a film-type capacitor.

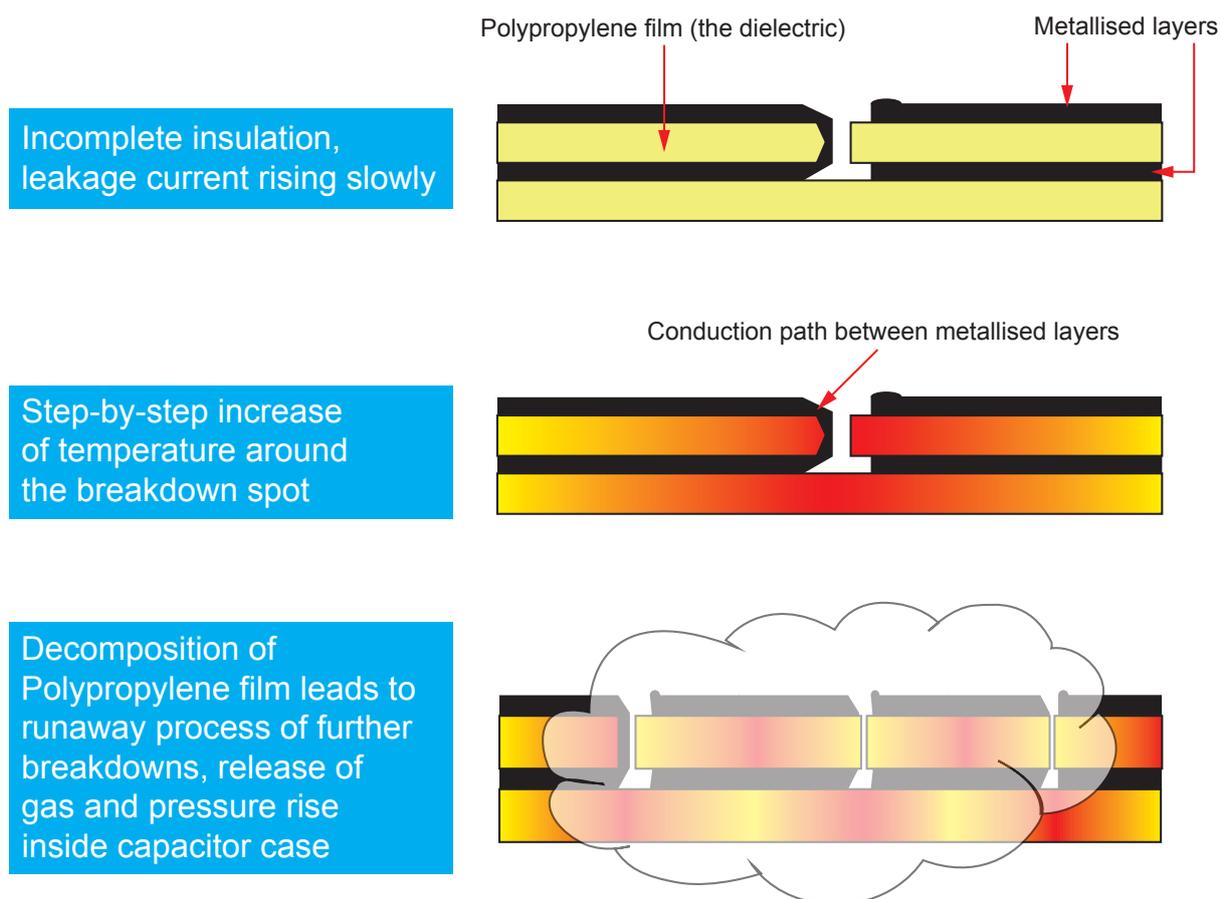
Figure 7: Drawing illustrating failure of self-healing

- 52 However, in some circumstances, it is also possible for the self-healing process to fail. This can occur if the polypropylene film is damaged or distorted. Such damage can lead to direct electric discharge at the site of an irregularity. Increased conduction of leakage current between the metallised layers then occurs, and this leads to localised heating as shown in figure 7.
- 53 The localised heating will then further degrade the polypropylene film in the vicinity, resulting in further discharges and damage to the film. This process can create a runaway process of damage and heating to the capacitor winding. Ultimately this heating can lead to *pyrolysis* of the polypropylene film.
