ACCIDENT

Aircraft Type and Registration:	Silence Twister, G-JINX
No & Type of Engines:	1 Ulpower UL260iSA piston engine
Year of Manufacture:	2013 (Serial no: LAA 329-15102)
Date & Time (UTC):	14 May 2017 at 1330 hrs
Location:	MOD Abingdon, Oxfordshire
Type of Flight:	Commercial operation
Persons on Board:	Crew - 1 Passengers - None
Injuries:	Crew - 1 (Serious) Passengers - N/A
Nature of Damage:	Aircraft and engine severely damaged
Commander's Licence:	Private Pilot's Licence
Commander's Age:	49 years
Commander's Flying Experience:	1,154 hours (of which 259 were on type) Last 90 days - 15 hours Last 28 days - 13 hours
Information Source:	AAIB Field Investigation

Synopsis

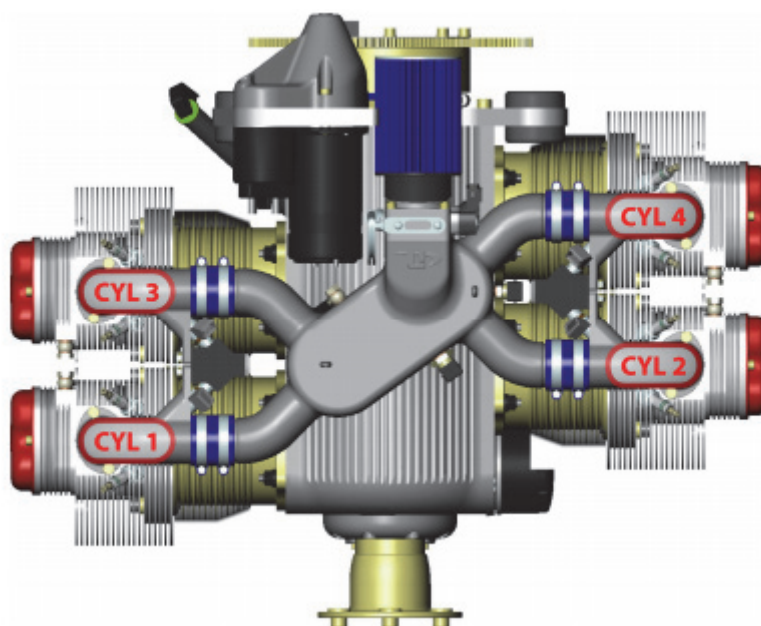
G-JINX was fitted with a 107 HP, UL260iSA four cylinder, air cooled, four stroke piston engine and a two blade fixed pitch propeller. The UL260iSA is a modified version of the UL260iS engine developed for use in aerobatic aircraft. The cylinders are numbered as shown in Figure 6 with cylinders 3 and 4 at the rear of the engine.

Numbering of engine cylinders
