Report on the investigation of the

Ocean Prefect

Umm Al Qaywayn, United Arab Emirates

REPORT NO 8/2018

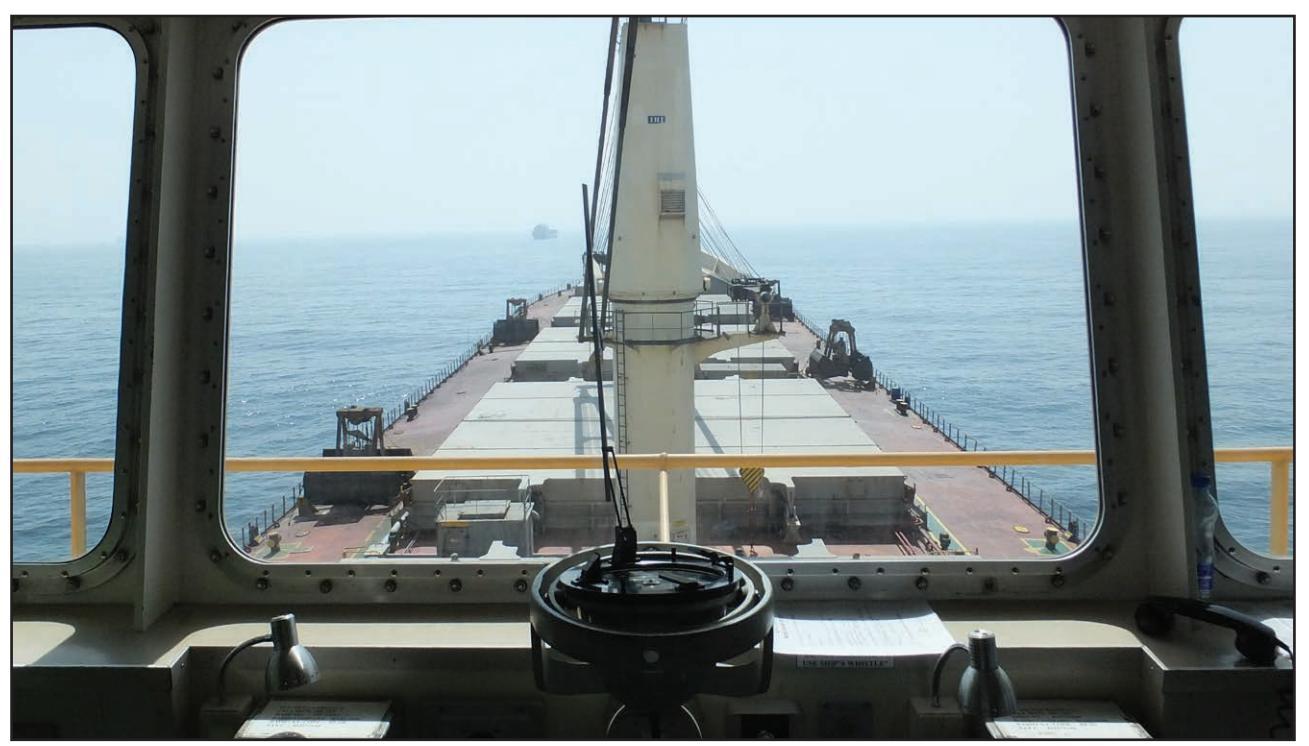
Figure 2: View from the bridge over the centreline gyro repeater

At 1236, the master handed the conn to the pilot. The pilot was standing by the centreline gyro repeater at the bridge front (**Figure 2**) while the berthing pilot was at the chart table completing paperwork. As *Ocean Prefect* continued towards the channel entrance, the master moved between the bridge front and the radar displays (**Figure 3**), which were set on the 1.5nm and 3nm range scales. The second officer operated the engine telegraph as required, but he also monitored the radars and periodically plotted the vessel's position on the paper chart on the chart table. The helmsman remained at the steering stand.
