*Ocean Way* – extract of Stability Booklet

***Report on aspects of the flooding  
which led to loss of FV 'Ocean Way'  
Marine Accident Investigation Branch***

***April 2017***

### Flooding and foundering of the trawler *Ocean Way* on 3 March 2017

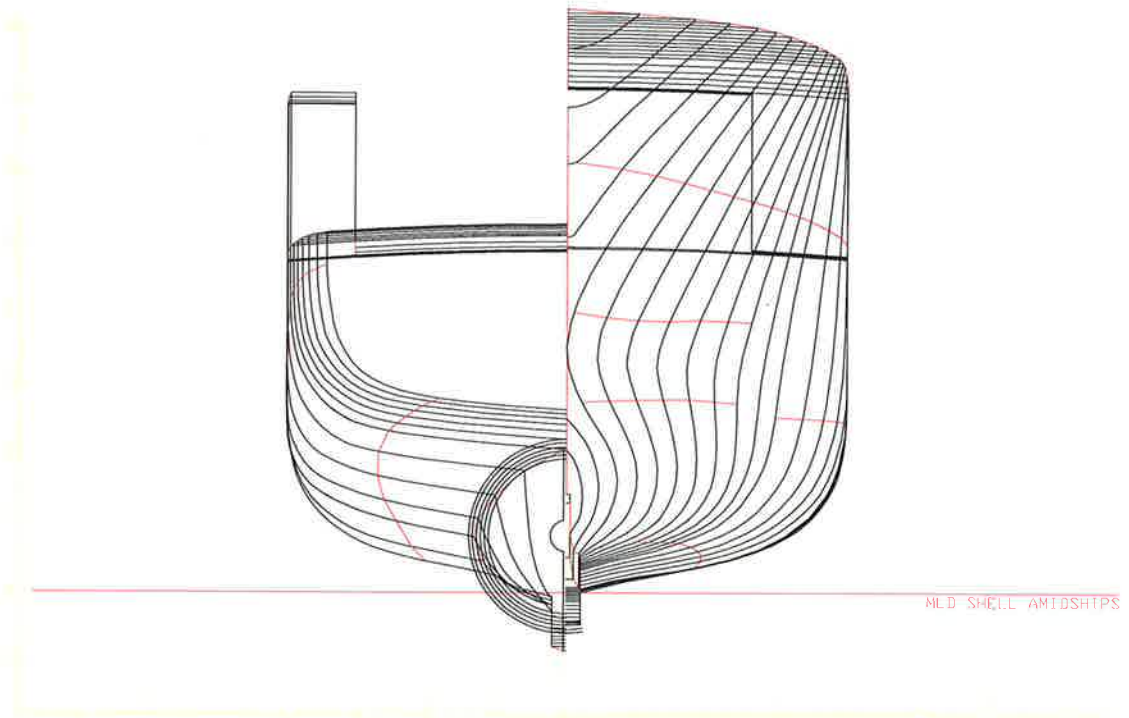
Diagram 1 – Hull sections

The computer model used for the production of the vessel's stability booklet was utilised for the analysis in this report. The original model was considered adequate for the production of general stability data but required some additional sections fore and aft to improve section area integration at the high trim angles evident during the course of the accident. Compartment models were derived from the hull model for the aft peak/accommodation and engine room bilge. External appendages for which there was sufficient information were also modelled. These included the nozzle, propeller, rudder and rudder skeg. Diagram 1 at the head of the next page is a plot of the hull sections (including the nozzle). Plots of the hull and compartment sections used in the analysis comprise Appendix 1.

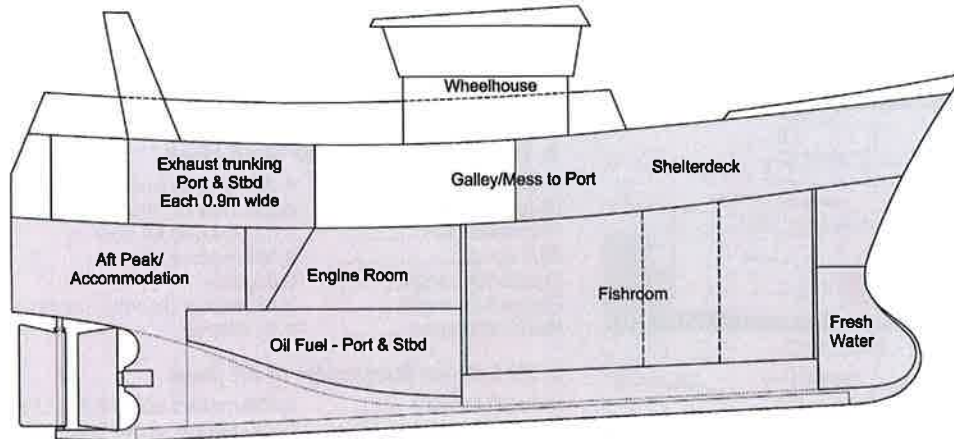
Diagram 3 – Volumes making a positive contribution to intact state

Volumes included in the intact stability calculations are shown in the diagram below.

The same volumes were included for the production of the stability information booklet data.
