Ocean Way – extract of Stability Booklet

Report on aspects of the flooding that led to the loss of *Ocean Way*

***Report on aspects of the flooding
which led to loss of FV 'Ocean Way'
Marine Accident Investigation Branch***

April 2017

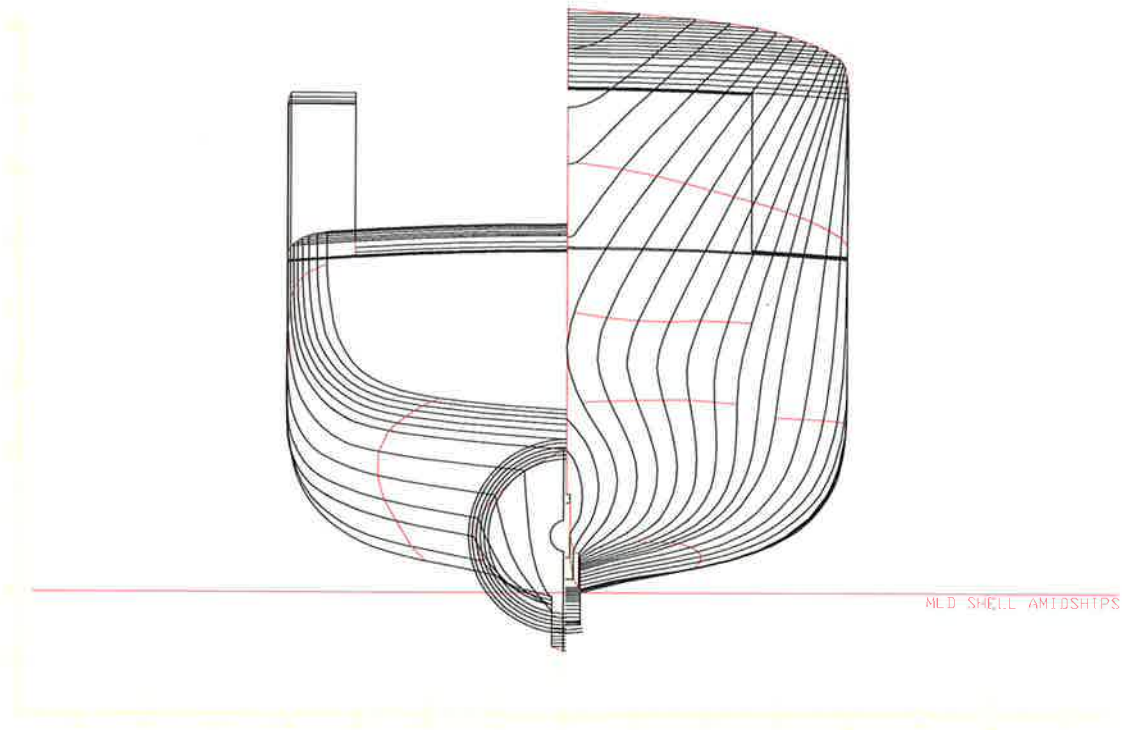
Diagram 1 – Hull sections

Examination of the hull sections in diagram 1 suggests it is likely that hull damage from a trawl door sufficient to cause such major flooding would probably occur longitudinally in the vicinity of the trawl blocks some 3 metres forward of the AP. It would seem likely that any damage would be sustained vertically between the inflexion points at the top and bottom of the turn of bilge (i.e. between the two curved red lines on the sections to the left of the centreline in diagram 1) which were close to and 1.8 metres below the waterline respectively before the damage occurred.
