Report on the investigation of the  
grounding and loss  
of the UK registered yacht  
**CV24**  
at Cape Peninsula, South Africa,  
on 31 October 2017

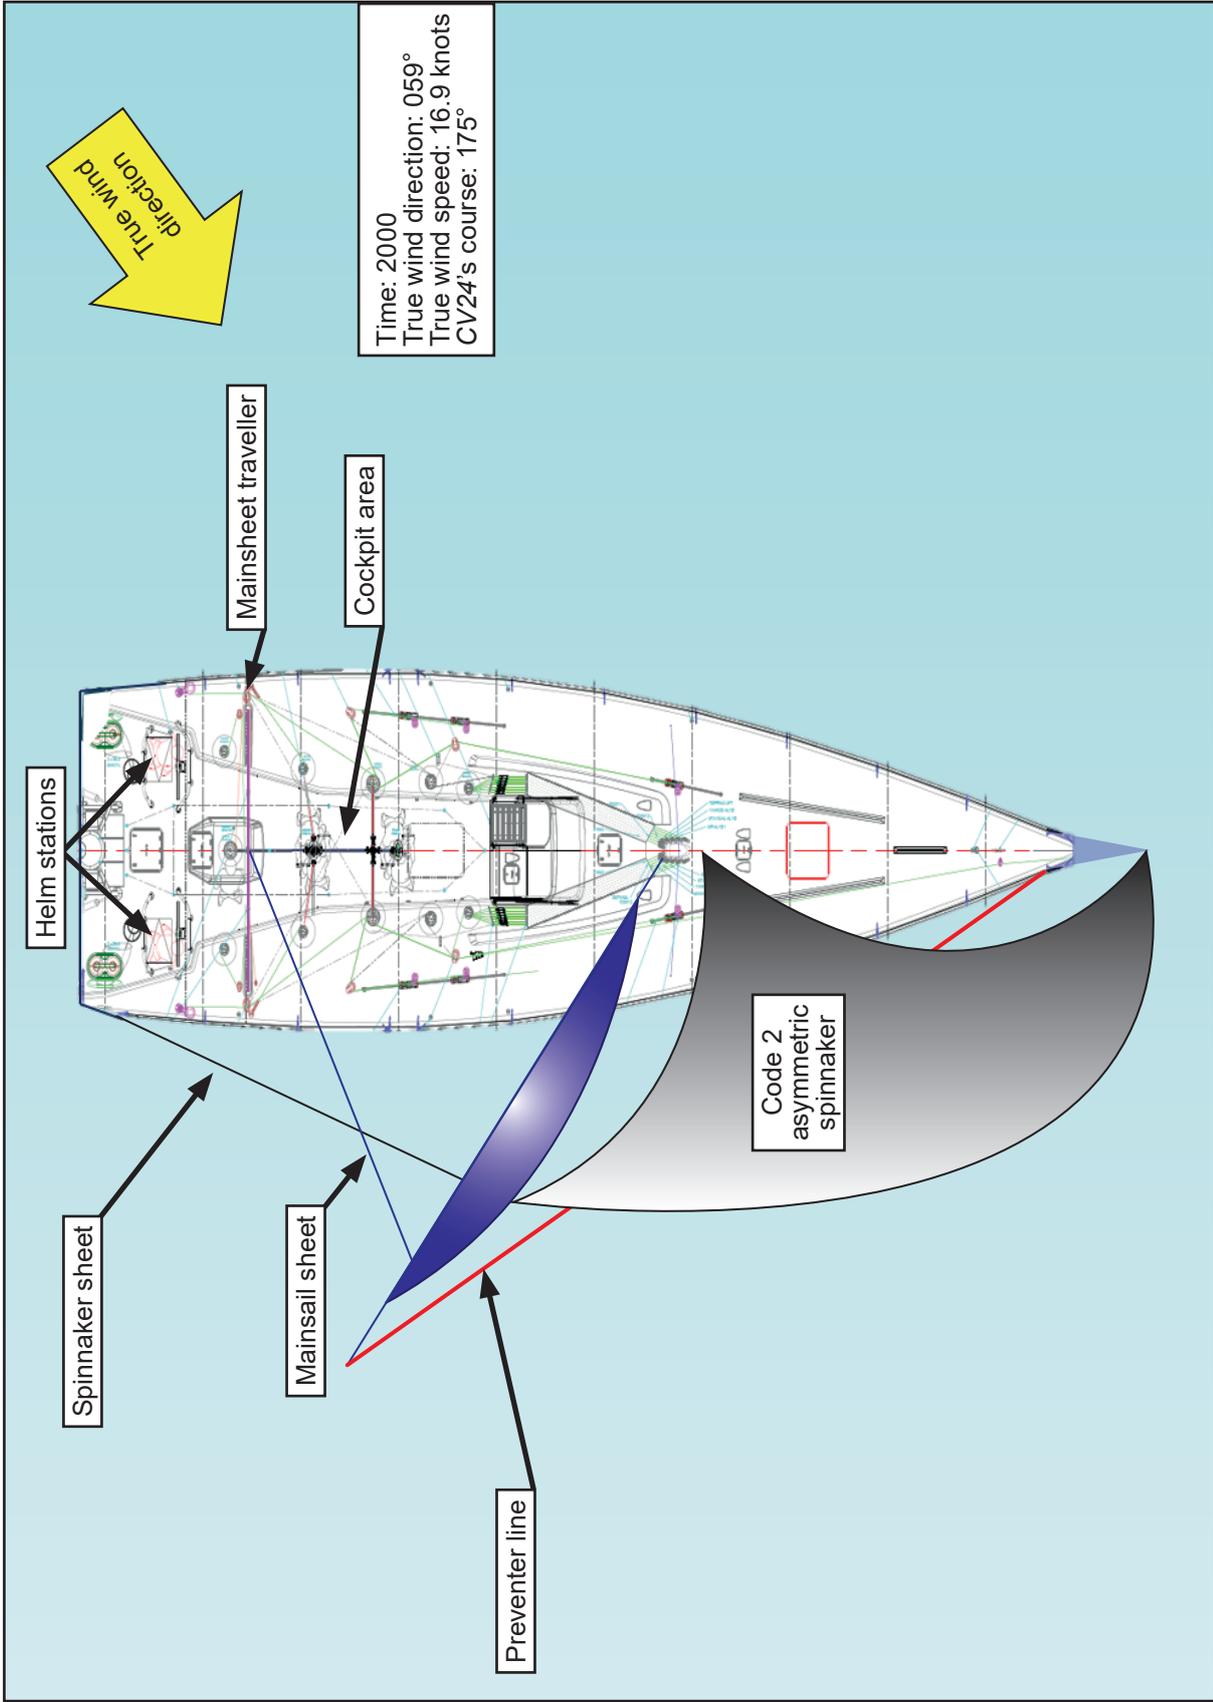
**Figure 2:** Diagram showing CV24's heading, sail configuration and the true wind direction, after the gybe at 1918

and sheets as directed by the watch leader. By then, the true wind had increased to about 23kts and had continued backing round to a northerly direction; CV24 had also increased speed to about 12kts.

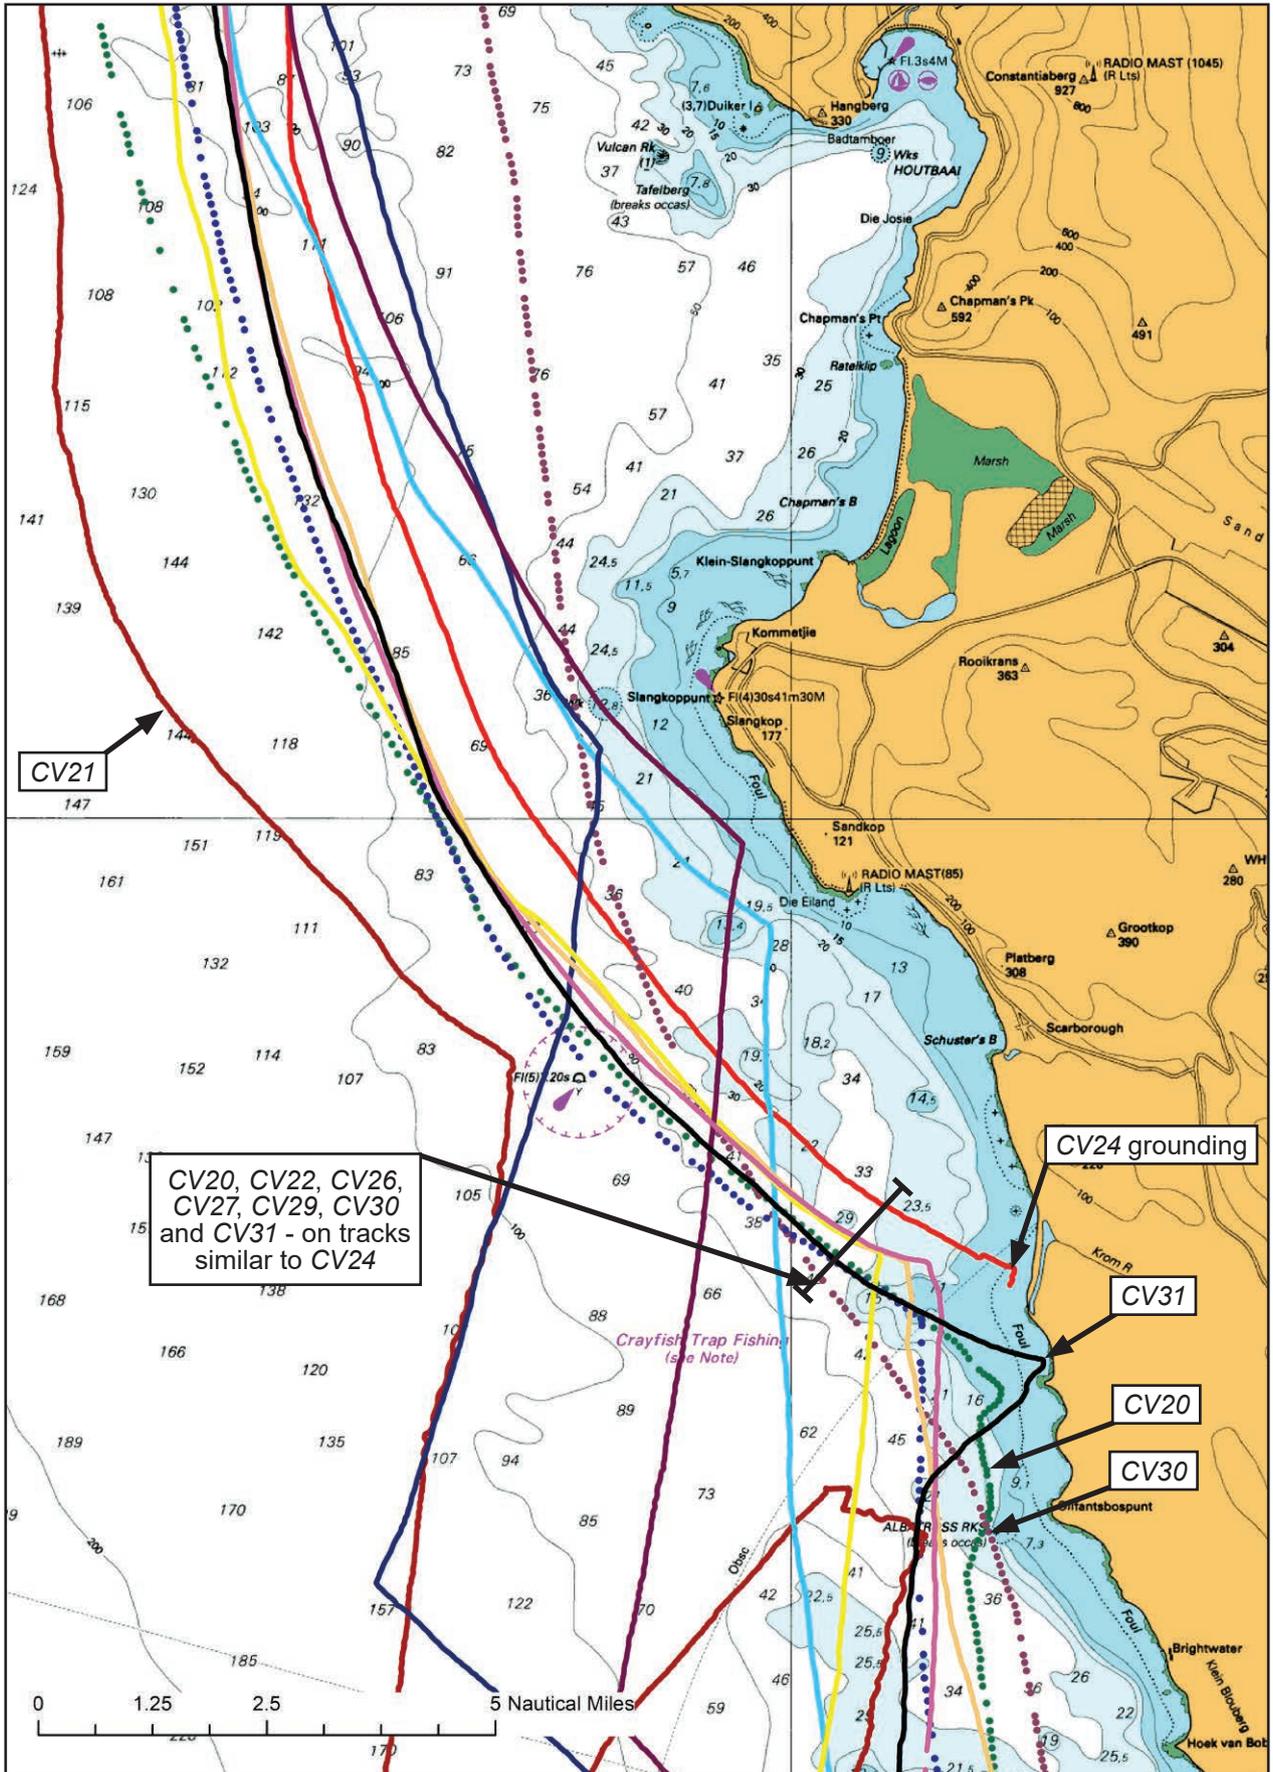
Figure 7: Chart showing the tracks of all 12 Clipper Ventures' yachts

CV20, CV22, CV26, CV27, CV29, CV30 and CV31 all followed tracks similar to CV24's, towards the shore (**Figure 7**).

At about 2130, CV30, which did not have a spinnaker hoisted, passed over the Albatross Rocks shoal about 2.5 nautical miles (nm) south of CV24's grounding position (**Figure 7**).

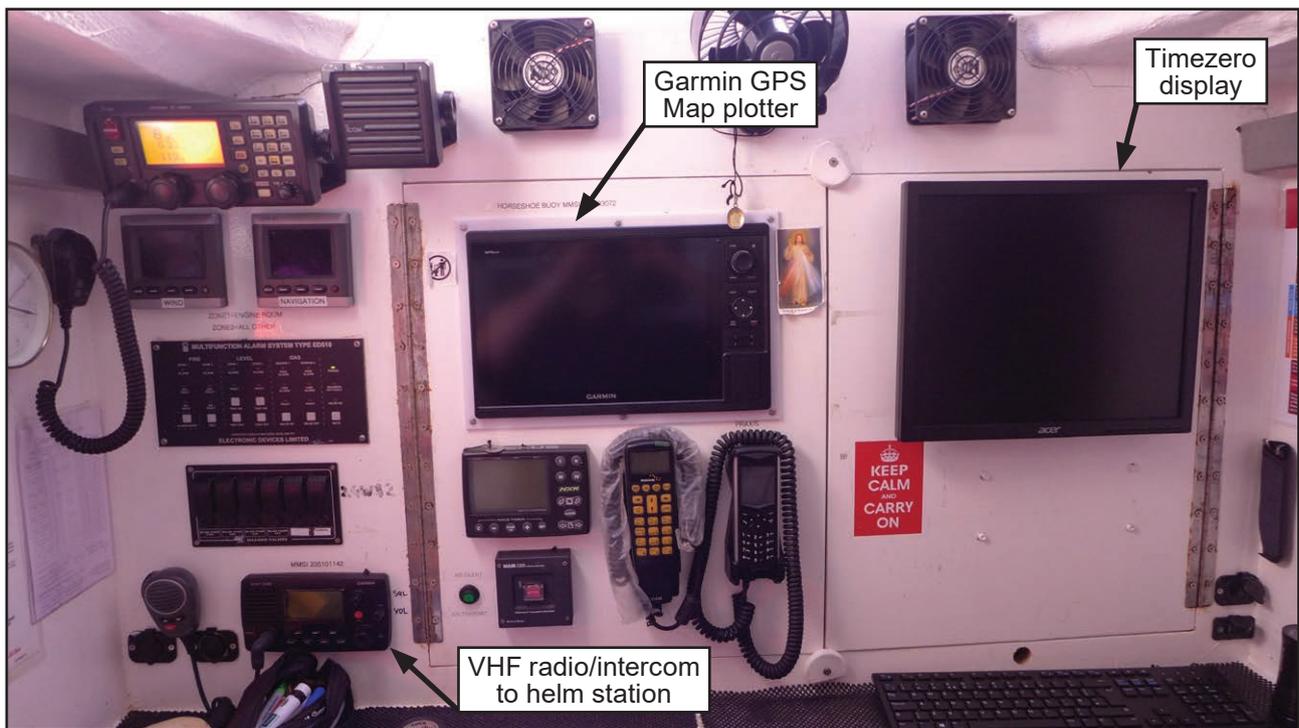
**Figure 8:** Clipper 70 navigation and communications station

The Clipper 70 nav station (**Figure 8**) was on the centreline near the stern of the vessel and directly underneath the helm station. CV24 was fitted with radar, automatic identification system (AIS), echo sounder, global position system (GPS) receivers, log speed, masthead wind instrument and a flux gate compass. An outfit of paper charts was also carried on board. Communications equipment included two VHF radios incorporating digital selective calling (DSC), an Inmarsat C satellite communications system with distress alert button and an Iridium satellite phone.

The electronic navigation systems were a Garmin plotter<sup>9</sup> and a separate computer installed with Timezero navigation software (**Figure 8**). The Garmin plotter in the nav station was not loaded with electronic charts other than a factory setting chart of the world. This plotter was used for situational awareness of other yachts' positions from AIS data and accessing digital information for log entries. The Timezero computer was loaded with C-Map electronic vector charts and received GPS data, AIS data and daily e-mailed weather maps (in the form of GRIB<sup>10</sup> files). The Timezero software had an extensive range of navigation and tactical planning software tools including planned track, cross track safety distances, danger areas and look ahead safety zones. The Timezero system was used for electronic navigation and tactical decision-making. Timezero data could only be accessed at the computer in the nav station.

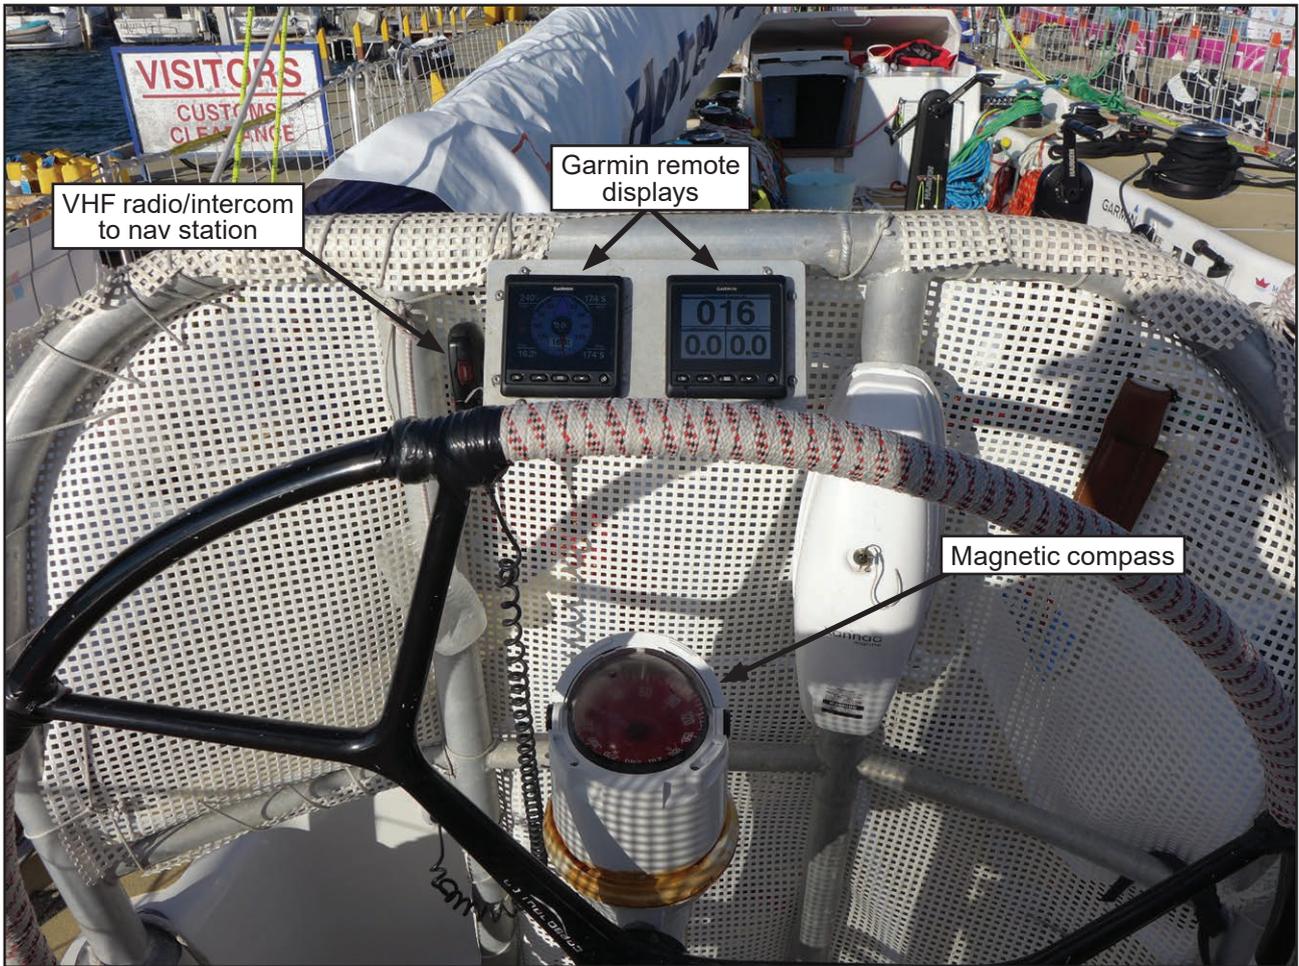
Figure 9: Clipper 70 - port helm station instrumentation

Digitised data from the yacht's GPS, log, echo sounder and wind instruments was also available for display at remote Garmin units at each helm station (**Figure 9**). These remote displays could not be used as chart plotters but had multi-function capability to show any of this digital navigation data in different formats, including split screens and plan displays for wind information. The remote displays had a shallow depth feature that included an audible alarm when crossing over the selected alarm depth setting. This feature was tested by MAIB staff on board CV23 on 27 November 2017 (**Figure 10**). The helm remote displays were operated by crew aft of the mainsheet traveller, and could not be seen by crew in the cockpit (**Figure 2**).

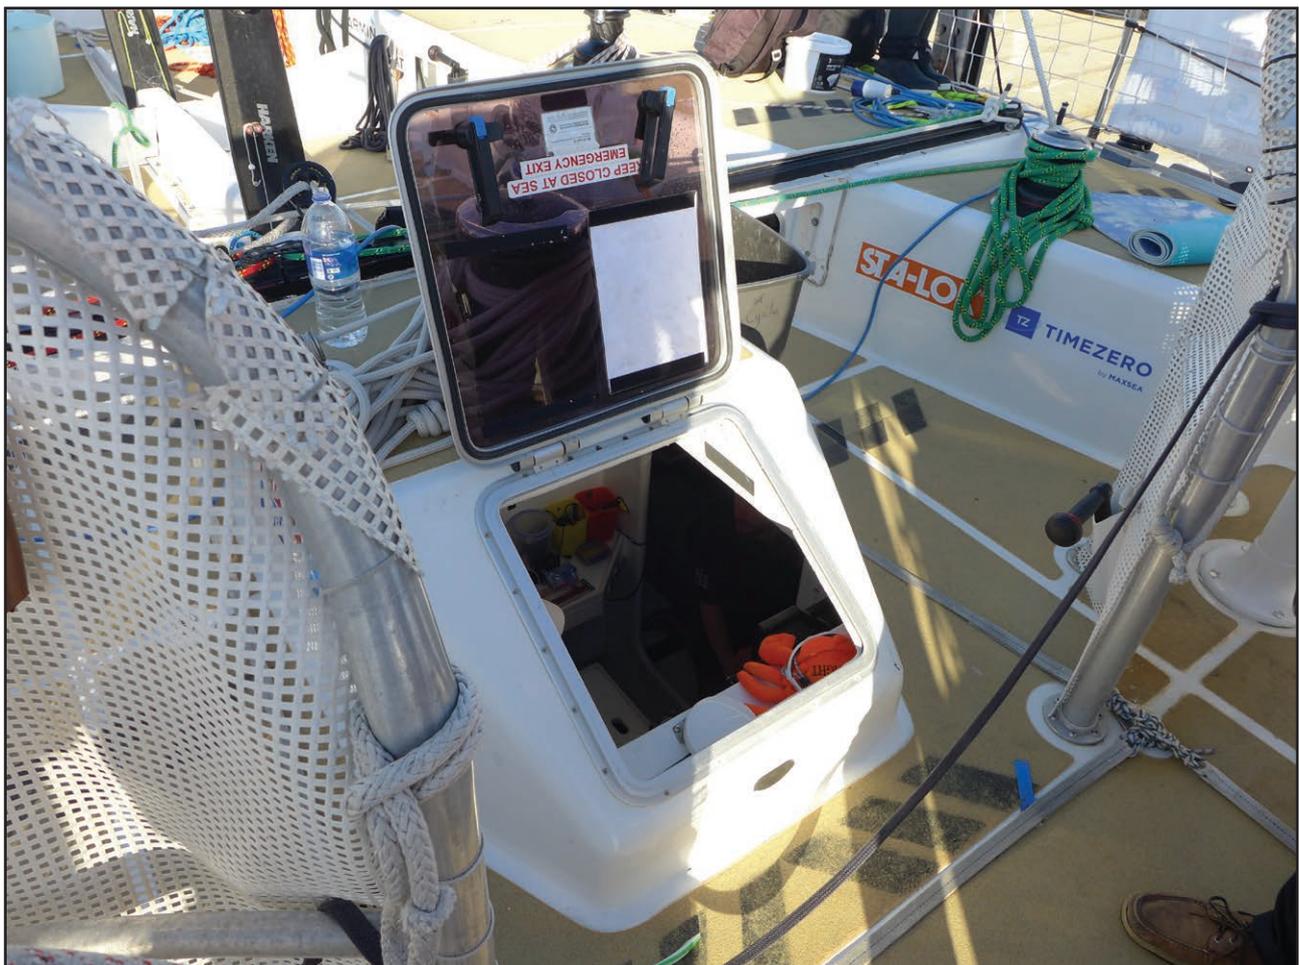
**Figure 11:** Clipper 70 - watertight hatch between the helm and nav stations

When describing the design of the Clipper 70 yacht, the Race Crew Manual<sup>11</sup> (**Annex E**) stated that *the navigation station is placed towards the stern, providing a closer link between the navigator and the helmsman*. Between the port and starboard helm positions, there was a hatch that led directly to the nav station (**Figure 11**). Prior to the 2017 - 2018 race, crews of Clipper 70s would sometimes open this hatch when at sea to permit direct dialogue between crew at the helm and nav stations (**Figure 12**). As a result of incidents of water ingress through this hatch when open, for the 2017 - 2018 race the yachts' crews were permitted to open it only for an actual emergency. Clipper Ventures had also fitted the nav station hatches with an anti-tamper device that would show the company's staff if it had been opened.

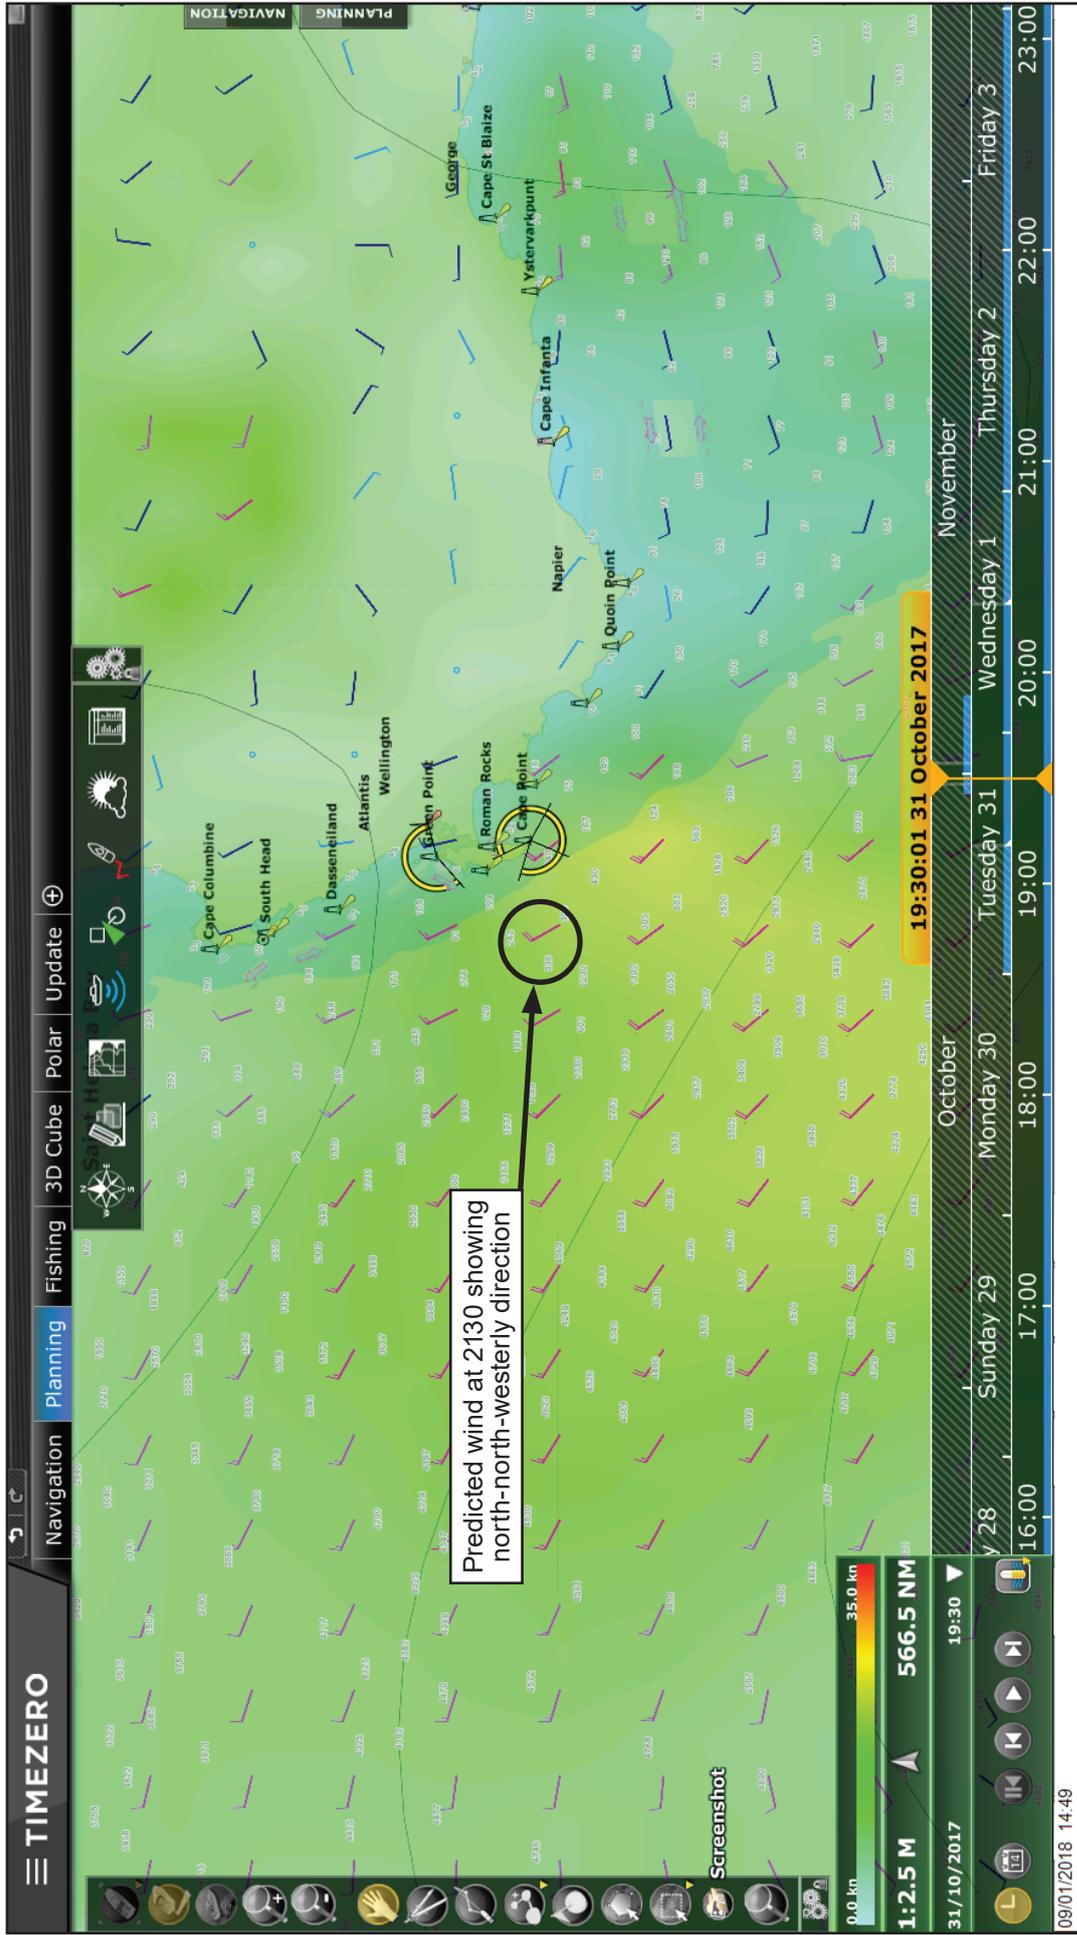
Figure 13: Predicted wind data recovered from CV24's Timezero navigation computer showing forecast north-north-westerly winds

Daily GRIB files were transmitted to all yachts in the race; this data was automatically plotted in the Timezero system, and displayed the forecast weather conditions for up to 5 days ahead. On the morning of the race start, CV24 had received the GRIB files, and this information was available on board. This data was recovered from CV24's Timezero computer hard drive after the accident; the forecast wind data for the time of the accident is at **Figure 13**.

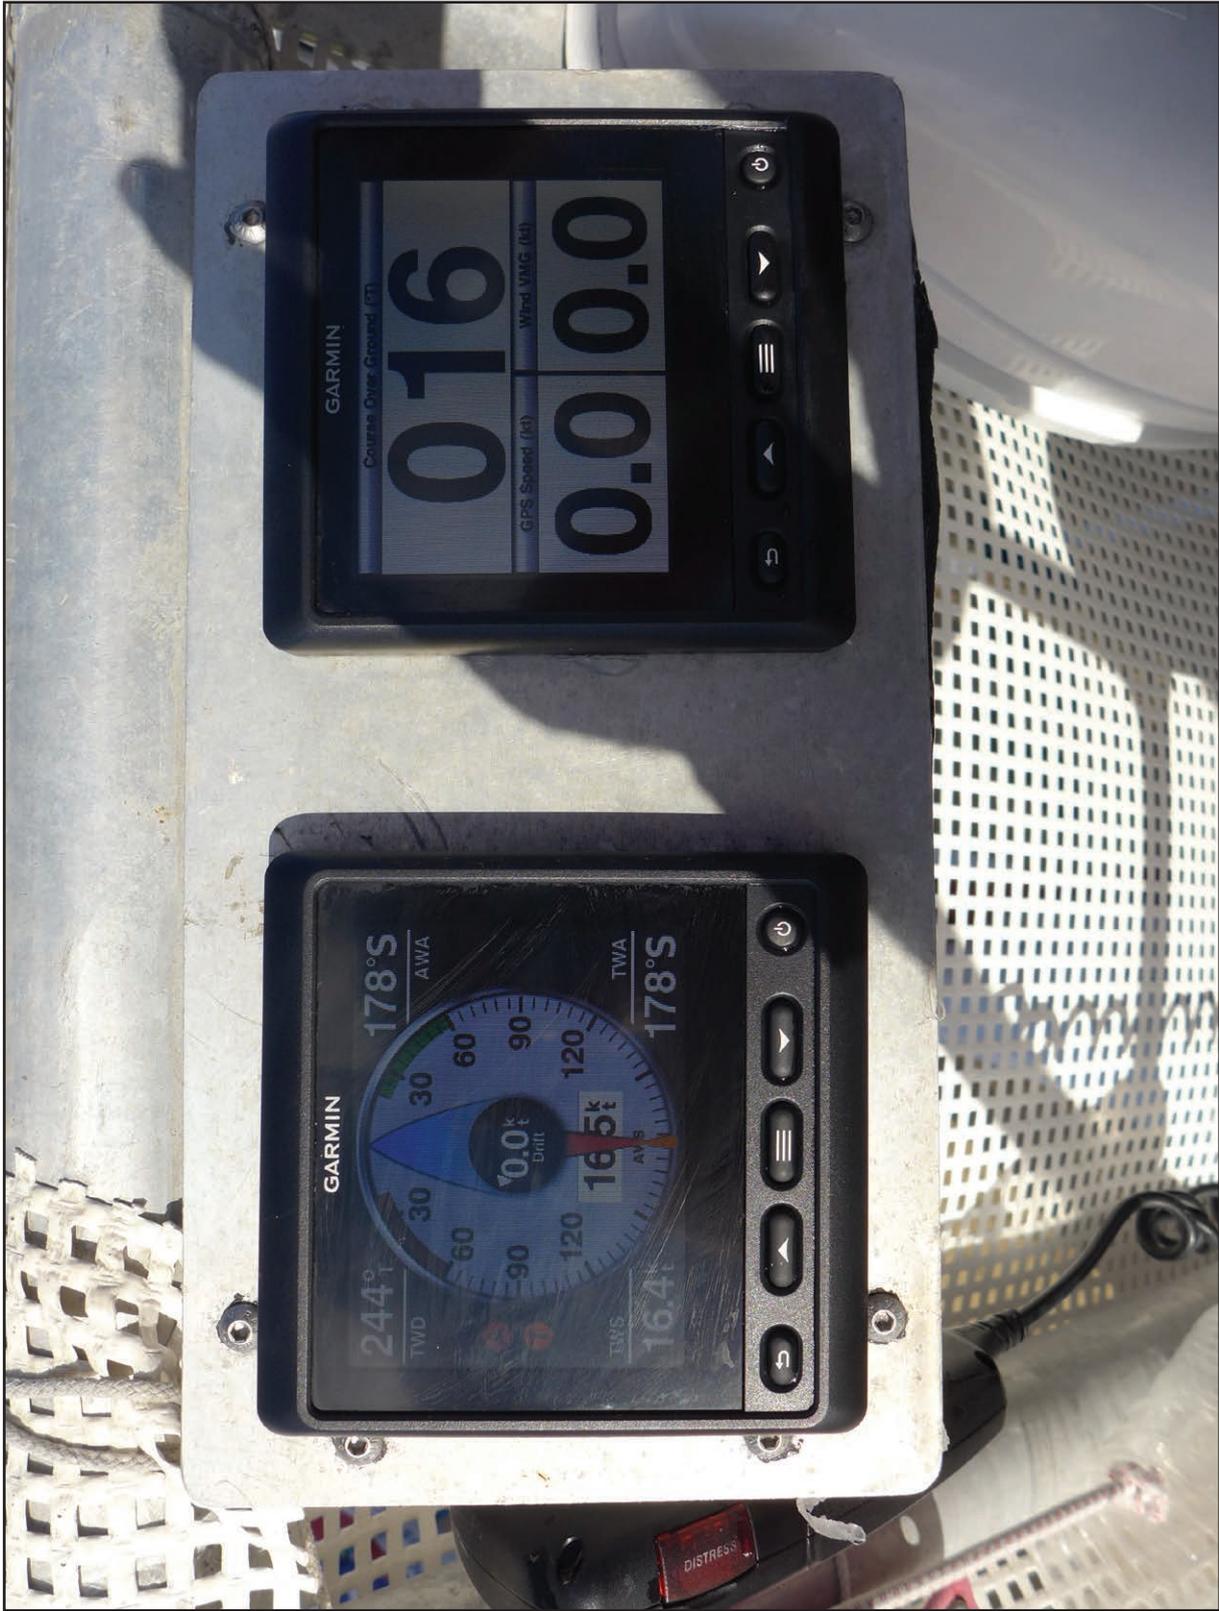
Figure 15: Reconstruction of CV24's port helm instrumentation on board CV23

The radar was off and the depth information was not on display at the port helm station. These settings were reconstructed by MAIB staff on board CV23 on 27 November 2017 (**Figure 15**).
