Fatal man overboard from fishing vessel *Varuna* west of Camusterrach on the north-west coast of Scotland 20 November 2017

SUMMARY

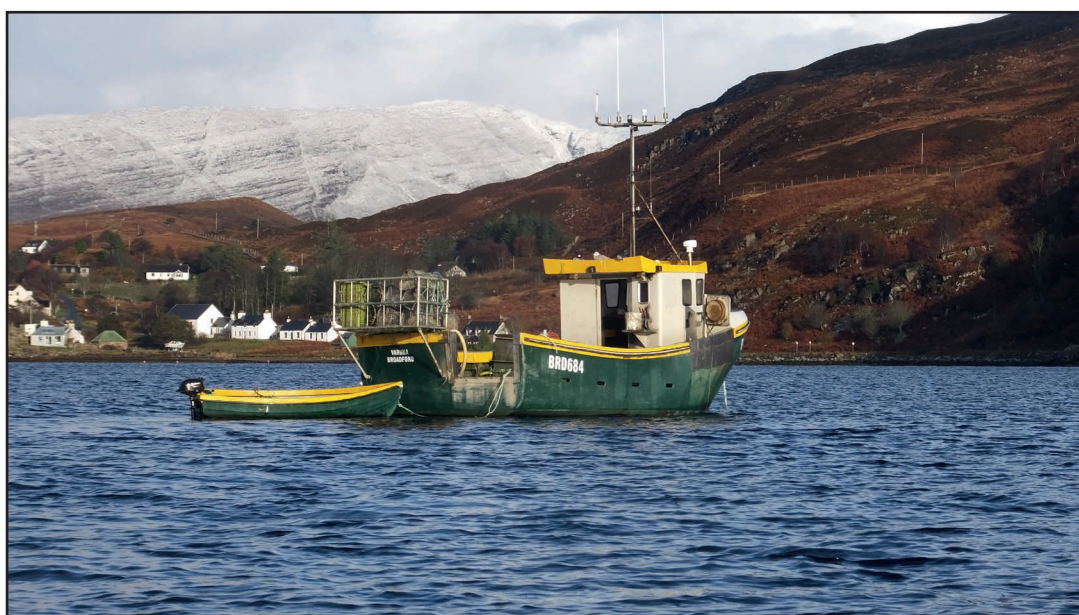
Figure 1: Fishing vessel *Varuna* moored at Poll Creadha

At about 0900 UTC on 20 November 2017, Alasdair Macleod, the owner/skipper of *Varuna*, left home to prepare his boat for a day's fishing. The boat was moored near Aird-Dhubh pier in Poll Creadha (**Figure 1**), and he accessed it by means of a small tender. *Varuna* departed the mooring and, at 1017, the boat's radar echo appeared on the BUTEC Range Control radar, which, shortly afterwards, was temporarily shut down for maintenance.
