Catastrophic engine failure, resulting in a fire and serious injuries to the engineer on board *Wight Sky*, off Yarmouth 12 September 2017

SUMMARY

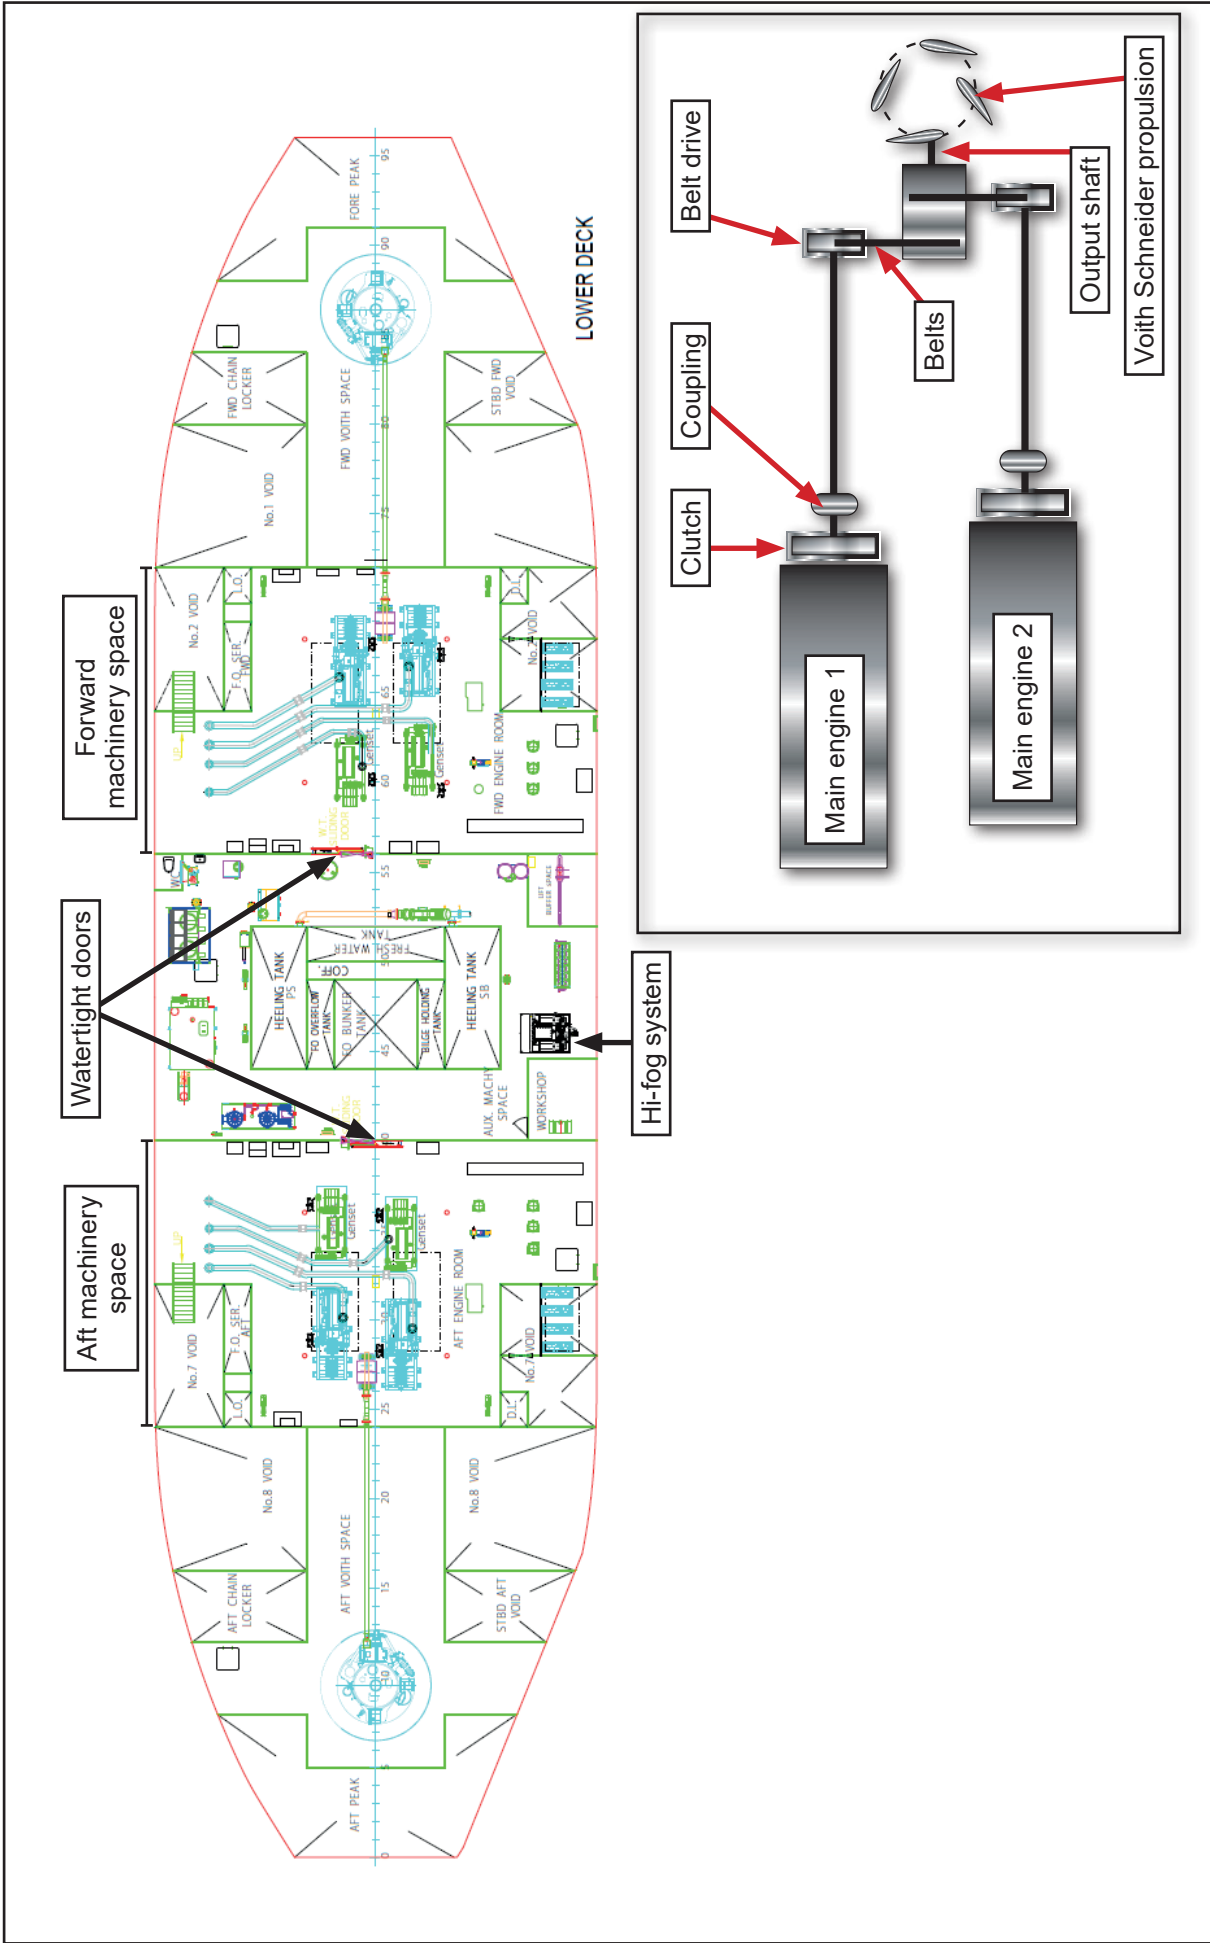
Figure 4: General arrangement of machinery spaces

Wight Sky had a Voith-Schneider cycloidal propulsion unit at each end of the vessel. Each propeller shaft was belt-driven by a pair of Volvo Penta D16C-A MH, six-cylinder engines, with an output of 485kW per engine at 1800rpm⁵. ME1 and ME2 were located in the forward engine room and ME3 and ME4 in the aft engine room. The Hi-fog fire-extinguishing system with its tanks, pumps and release switches was located in the space between the two engine rooms (**Figure 4**).

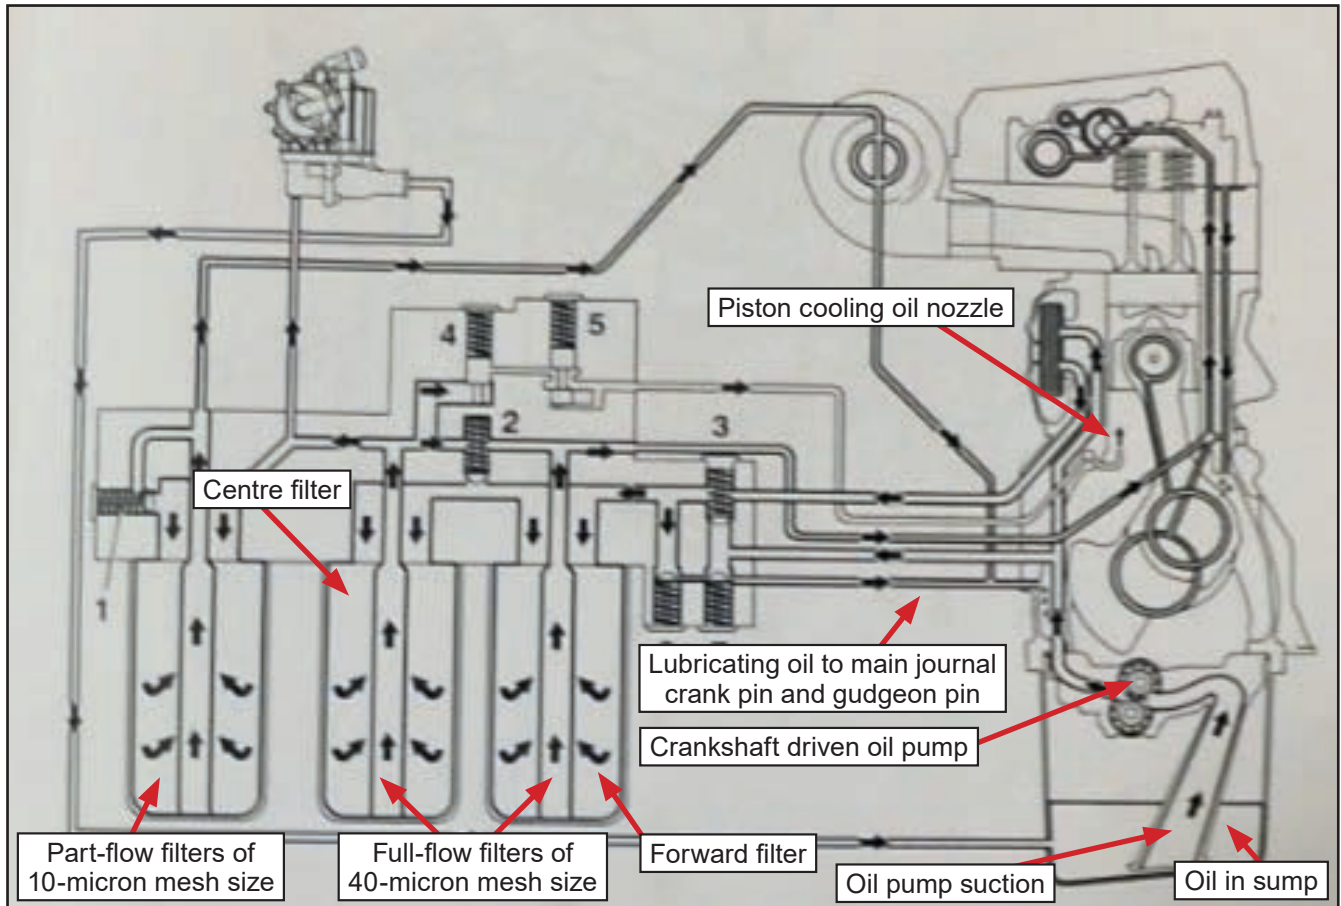
Figure 6: Engine lubricating oil system

The lubrication system (**Figure 6**) consisted of a crankshaft-driven oil pump, which delivered the sump oil through two full flow filters of 40-micron mesh size and a third, part-flow filter of 10-micron mesh size. The total quantity of lubricating oil was 55 litres. An oil channel along the inboard side of the engine block conveyed the lubricating oil to the main bearings. From the main bearing the oil was fed to the big end bearing immediately forward of it through a drilled channel. Piston cooling and lubrication oil was carried through a separate channel on the outboard side of the block.

The forward and centre filter (**Figure 6**), along with oil samples from forward filter housing and the engine sump were analysed independently for their physical and chemical characteristics and accumulated wear particles.
