M40 J4 / A404 Handy Cross Roundabout Economy Study

Produced for
Highways Agency

Prepared by
EnterpriseMouchel
Design Centre
1123 Mollison Avenue, Enfield EN3 7NJ

Report Title Economy Study

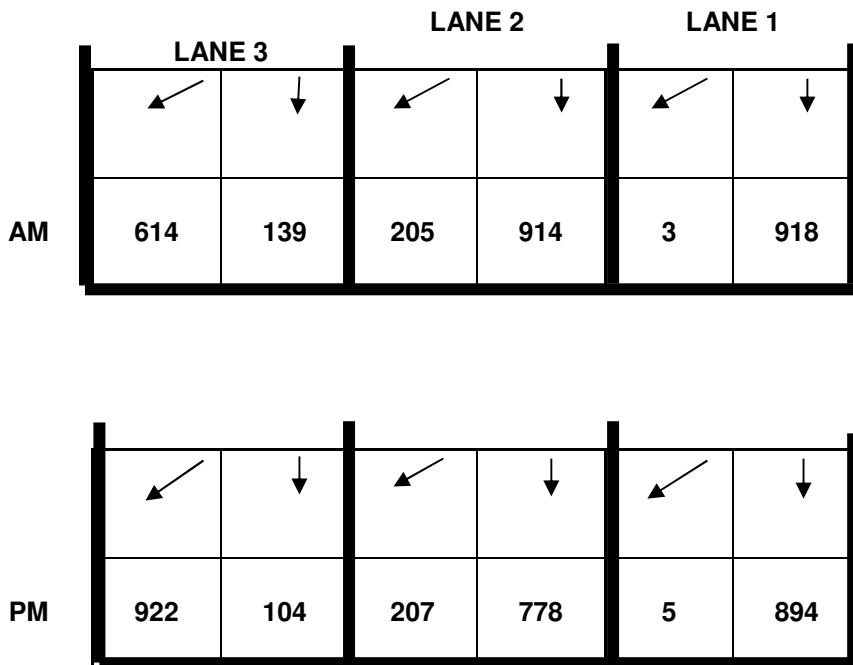
Figure 4.1 – AM & PM peak hour desire line flows (PCU)

It can be seen that 139 PCU use lane 3 to travel ahead on the A404 southbound in the AM peak hour, while 205 PCU contravened the 'Ahead Only' markings and turned right from lane 2. An example of this is shown in Figure 4.6 below where a bus can be seen turning right from lane 2 to exit via the Burroughs Grove Hill/Wycombe Road arm. This is the conflict reported frequently in the HAIL enquiries summarised in Appendix B.

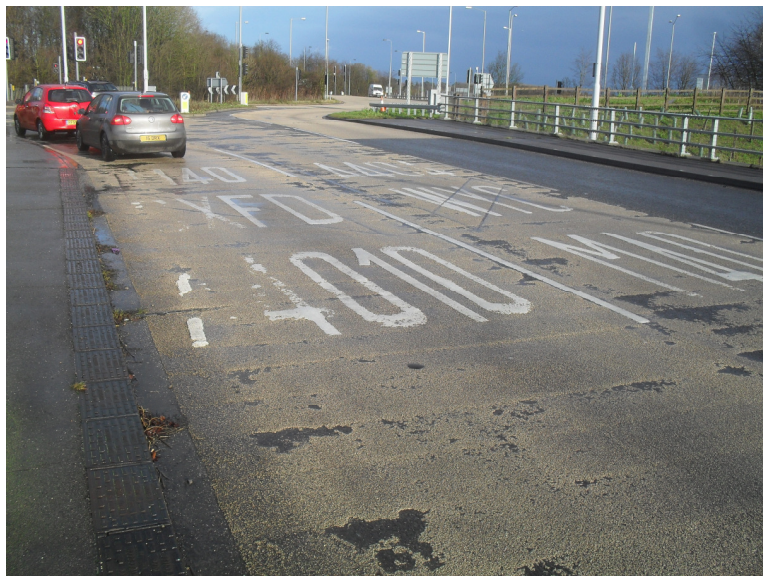
Figures 4.7 and 4.8 below show the general arrangement of Arm E, namely the entry (Figure 4.7) which is a 2 lane approach that flares abruptly to 3 lanes at the stop line, and the wide single lane exit from the roundabout (Figure 4.8).

Figure 4.7 – Arm E entry to roundabout

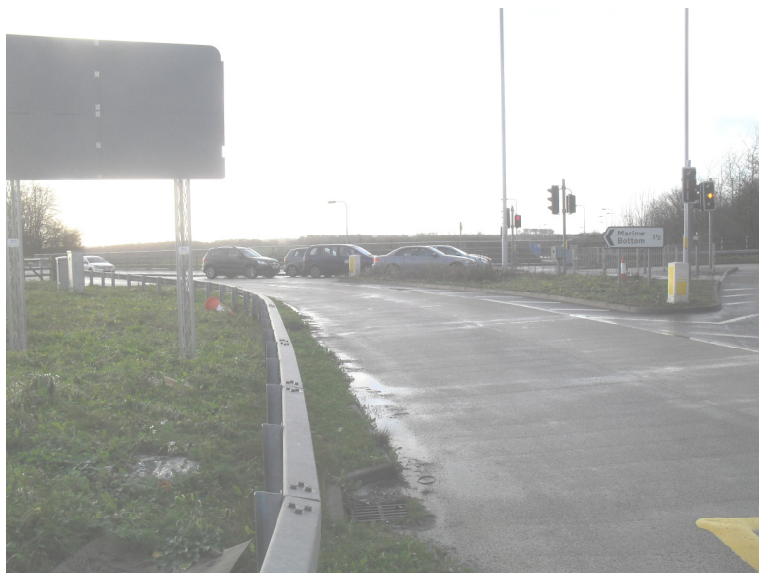
Figure 4.8 – Arm E exit from roundabout (view looking west)

Another measure stated in the brief for investigation on this arm is for the provision of a 2-to-1 merge on the immediate exit from the roundabout, adjacent to the existing splitter island. As can be seen in Fig. 4.8, although the existing layout on the exit from the roundabout is a wide single lane the existing carriageway width is insufficient for it to be re-marked as two lanes and therefore carriageway widening would be required.

It is considered that widening on the offside would mean that the approach would need to be reduced to a single lane entry and thus would reduce the capacity of this approach. Furthermore, there is concern that widening on the offside could result in opposing flows being too close to each other on a tight radius which could increase the likelihood of side-swipe collisions (see Figure 4.8).

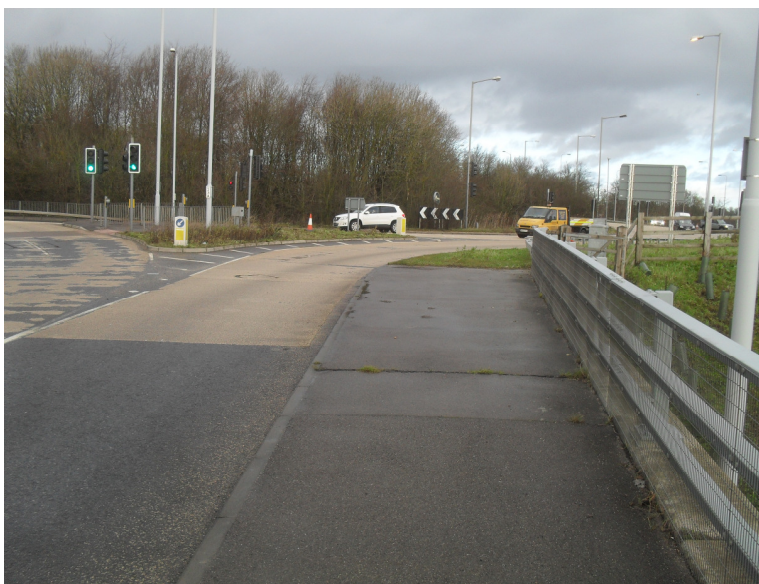
Figure 4.9 – Arm E exit from roundabout (view looking east)

Widening on the nearside to achieve a 2-lane exit would therefore appear to be the more preferable and practical option; however, the proximity of the adjacent underbridge (see Figure 4.9) suggests that the cost of widening at this location could well be prohibitively expensive.

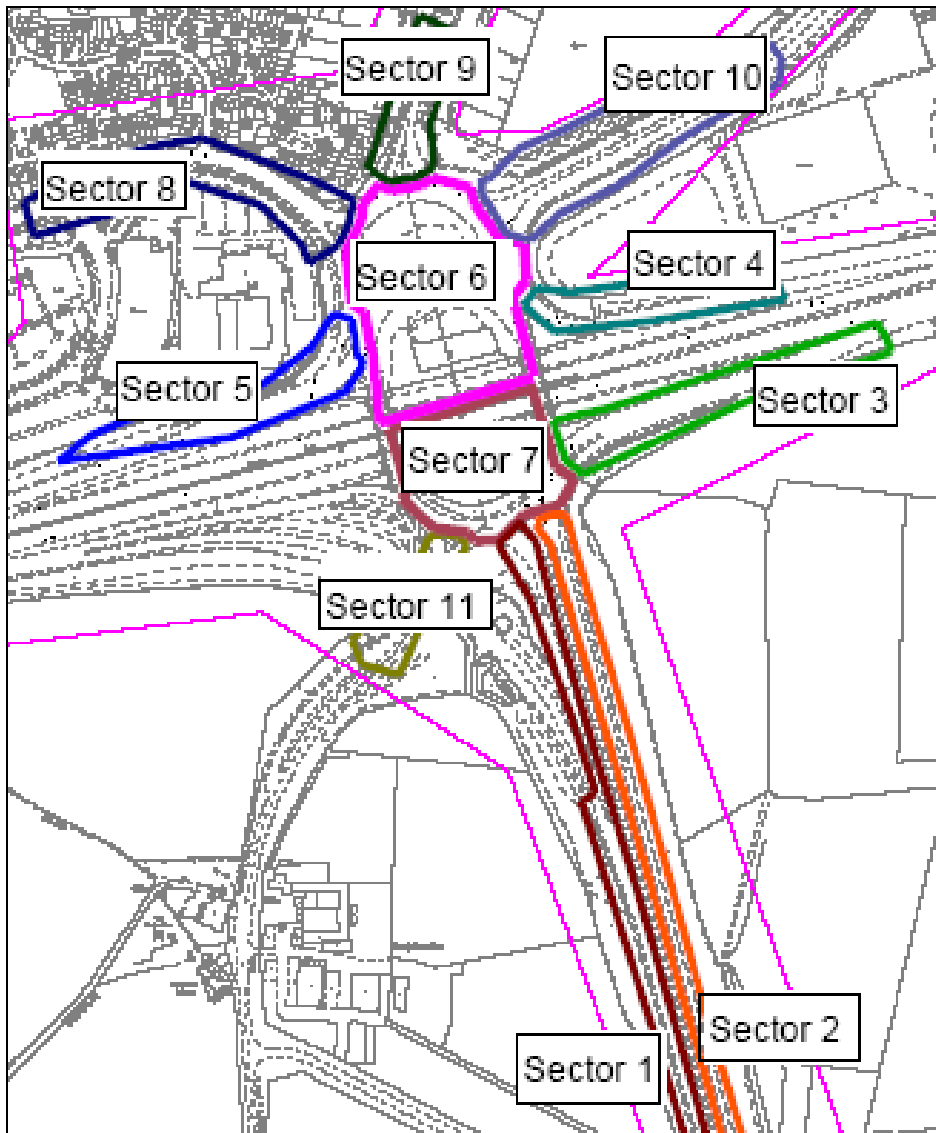
The Interchange has been broken down into 11 sectors in order to further analyse the incidents (See Figure 3.1).

Figure C.1: Collisions per Sector
