## ACCIDENT

<b>Aircraft Type and Registration:</b>	Piper PA-18-150 Super Cub, G-RWCA	
<b>No &amp; Type of Engines:</b>	1 Lycoming O-320-A2B piston engine	
<b>Year of Manufacture:</b>	1982 (Serial no: 18-8309010)	
<b>Date &amp; Time (UTC):</b>	7 April 2018 at 1225 hrs	
<b>Location:</b>	Beccles Airfield, Suffolk	
<b>Type of Flight:</b>	Private	
<b>Persons on Board:</b>	Crew - 1	Passengers - None
<b>Injuries:</b>	Crew - None	Passengers - N/A
<b>Nature of Damage:</b>	Propeller blade bent, engine shock-loaded and damage to wings, fin, rudder and windscreen	
<b>Commander's Licence:</b>	Private Pilot's Licence	
<b>Commander's Age:</b>	54 years	
<b>Commander's Flying Experience:</b>	188 hours (of which 9 were on type) Last 90 days - 7 hours Last 28 days - 3 hours	
<b>Information Source:</b>	Aircraft Accident Report Form submitted by the pilot

## Synopsis

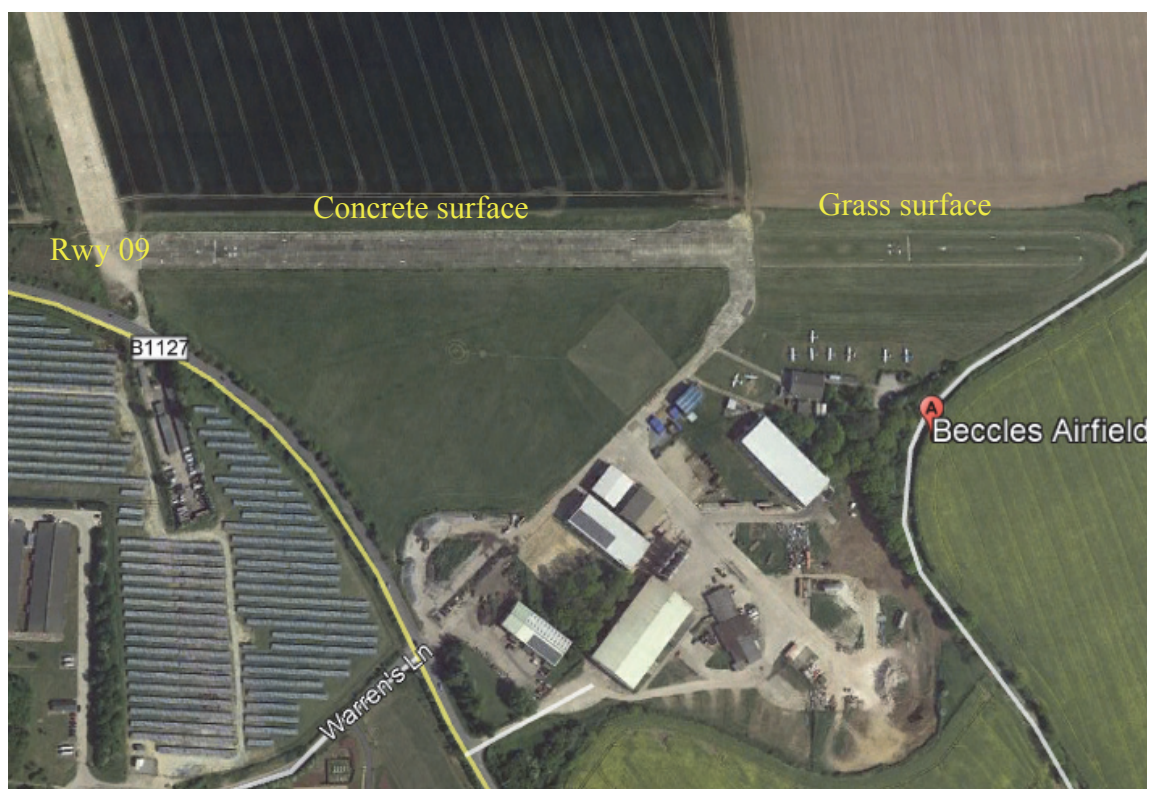
**Figure 2**  
Beccles Airfield

Beccles Airfield has one runway, aligned 09/27. The surface of the first 500 m of Runway 09 is concrete and the remaining 250 m is covered in grass. The LDA is 624 m. A Google Earth image of the airfield is at Figure 2.
