Published 13 September 2018

**CONTENTS****SPECIAL BULLETINS / INTERIM REPORTS**

Boeing 737-800	EI-DLV	15-Sep-17	3
----------------	--------	-----------	---

HPH Glasflugel 304 eS	G-GSGS	10-Aug-17	18
-----------------------	--------	-----------	----

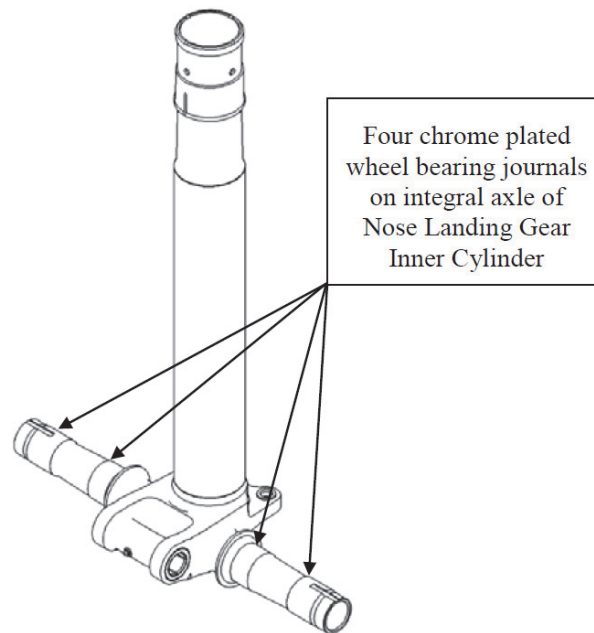
**Figure 3**

The nosewheel axles are integral parts of the NLG inner cylinder (Figure 3). Each axle has an inboard and an outboard journal onto which the two bearings from each nosewheel are fitted. The axles are made of a high strength steel alloy and the journals are chrome plated with a minimum chrome thickness of 0.003 inches. The highest stressed area of the axle is at the 6 o'clock position and the highest stress occurs during landing when the nosewheels touch down and load the axles upwards.

NLG inner cylinder with its four chrome plated wheel bearing journals

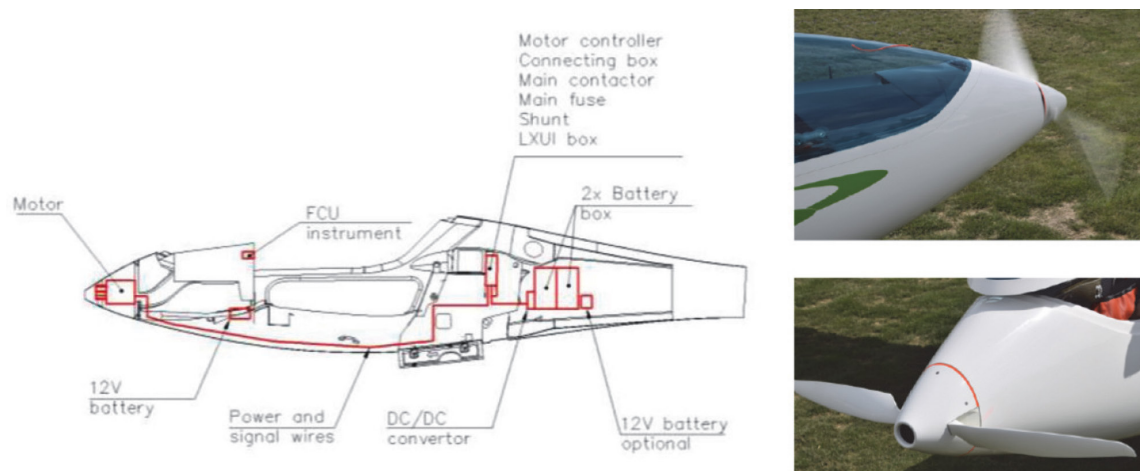
**Figure 2**

FES system installation in the HPH Glasflugel 304 eS powered sailplane  
(courtesy HPH Spol. S.r.o.)

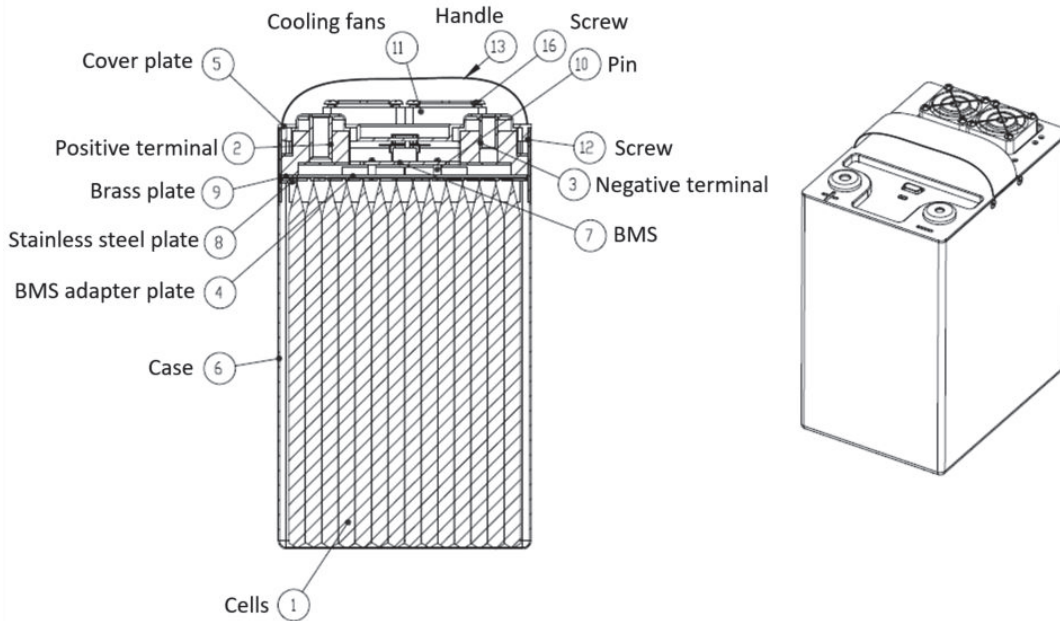
**Figure 3**  
FES battery assembly

The 'GEN2' FES battery packs are removable for charging remotely from the sailplane. Each battery pack is built up from 14 Kokam Superior Lithium Polymer Battery (SLPB) cells, connected in series and contained within a carbon fibre battery box with a machined aluminium alloy cover plate/heatsink (Figure 3). The inside of the battery box has layers of glass fibre to prevent the battery cells from contacting the carbon fibre case, which is electrically conductive. The maximum total voltage for each battery pack is 58.3 V, giving a maximum voltage of 116.6 V for the assembly of both battery packs connected in series. An integral battery management system (BMS) controls the charging and discharging of the individual cells to balance the cell voltages and also provides over- and under-voltage protection. The capacity of each SLPB cell is 41 Ampere-hours (Ah), providing a total capacity for each battery pack of 2.1 kWh, or 4.2 kWh for both battery packs connected together. Each battery pack has a mass of 15.7 kg.

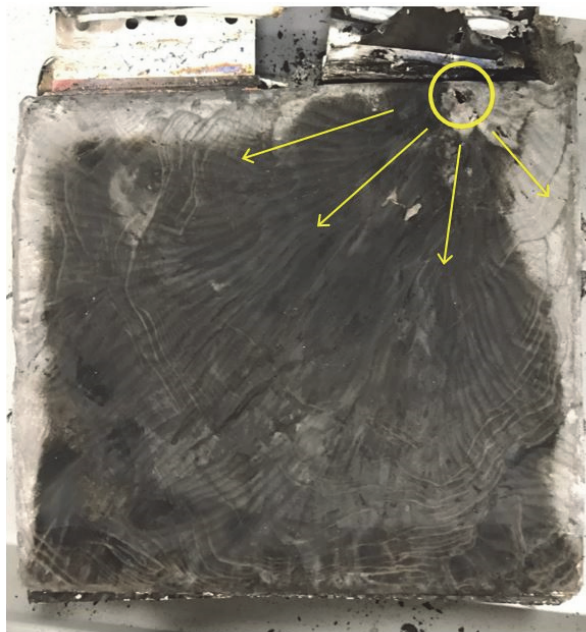
**Figure 13**

Examination of the steel nail after the tests showed that it had melted in the initial electrical arcing event, indicating that the temperature generated during the arcing was in excess of 1,400°C. The cell electrodes at the penetration site had a hole of larger size than the nail diameter, the edges of which were formed from solidified molten electrode material, consistent with the melting of the electrodes during the arcing event. The remaining copper and aluminium electrodes were relatively intact, demonstrating that the temperature reached during the combustion of the cell's gel electrolyte was relatively cool compared to the electrical arcing temperature. A pattern of combustion 'beachmarks' originating at the nail penetration site was observed (Figure 13) these were similar to those observed in the fire-damaged battery from G-GSGS.

Combustion beachmarks from AAIB cell penetration tests

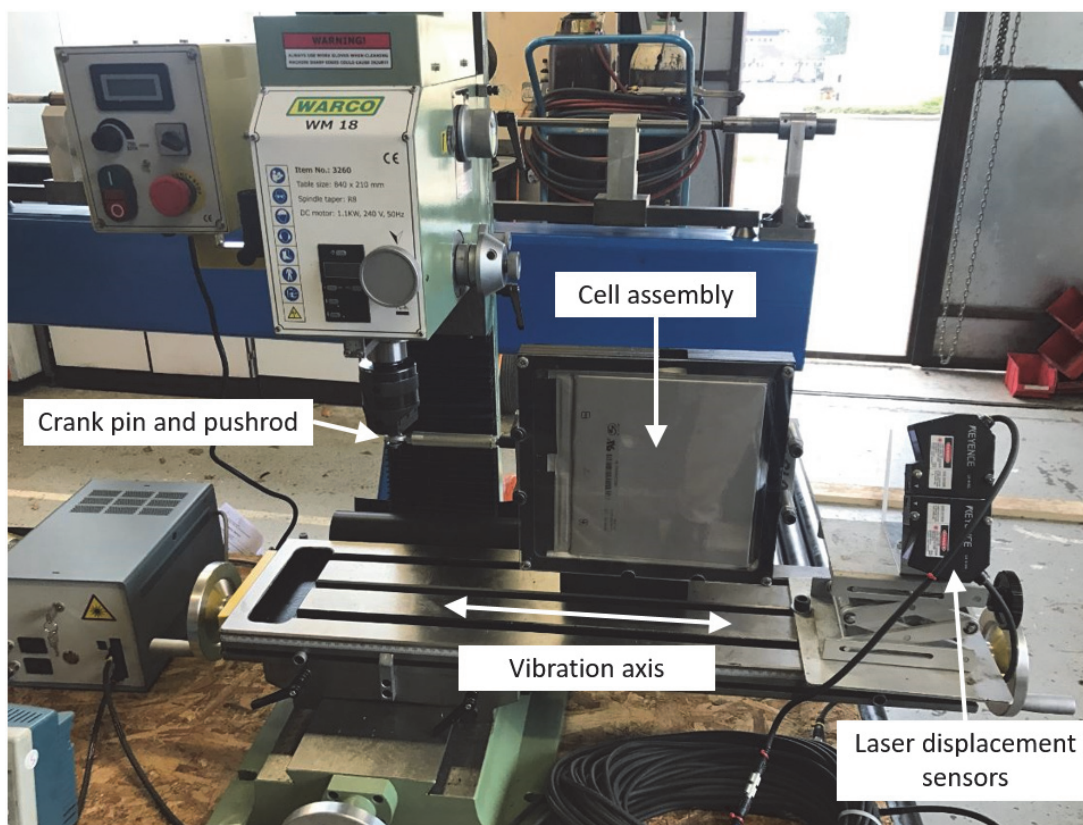
**Figure 15**

The cell fixture was mounted on a milling machine bed on a linear bearing allowing displacement along the machine bed axis only (Figure 15). The cell fixture was connected via a pushrod to a crank pin mounted in a boring bar head in the milling machine spindle. The eccentricity of the driving crank pin was adjusted to achieve the desired peak-to-peak amplitude displacement of the cell fixture of 2.5 mm for the frequency range 5 – 15 Hz, and 1.0 mm for 15 – 40Hz<sup>8</sup>. Using the variable spindle speed on the milling machine, the cell fixture could be vibrated across a frequency range of 1 – 40 Hz. Laser displacement sensors were used to measure the relative displacements between the cells within the cell fixture.

Cell vibration testing equipment

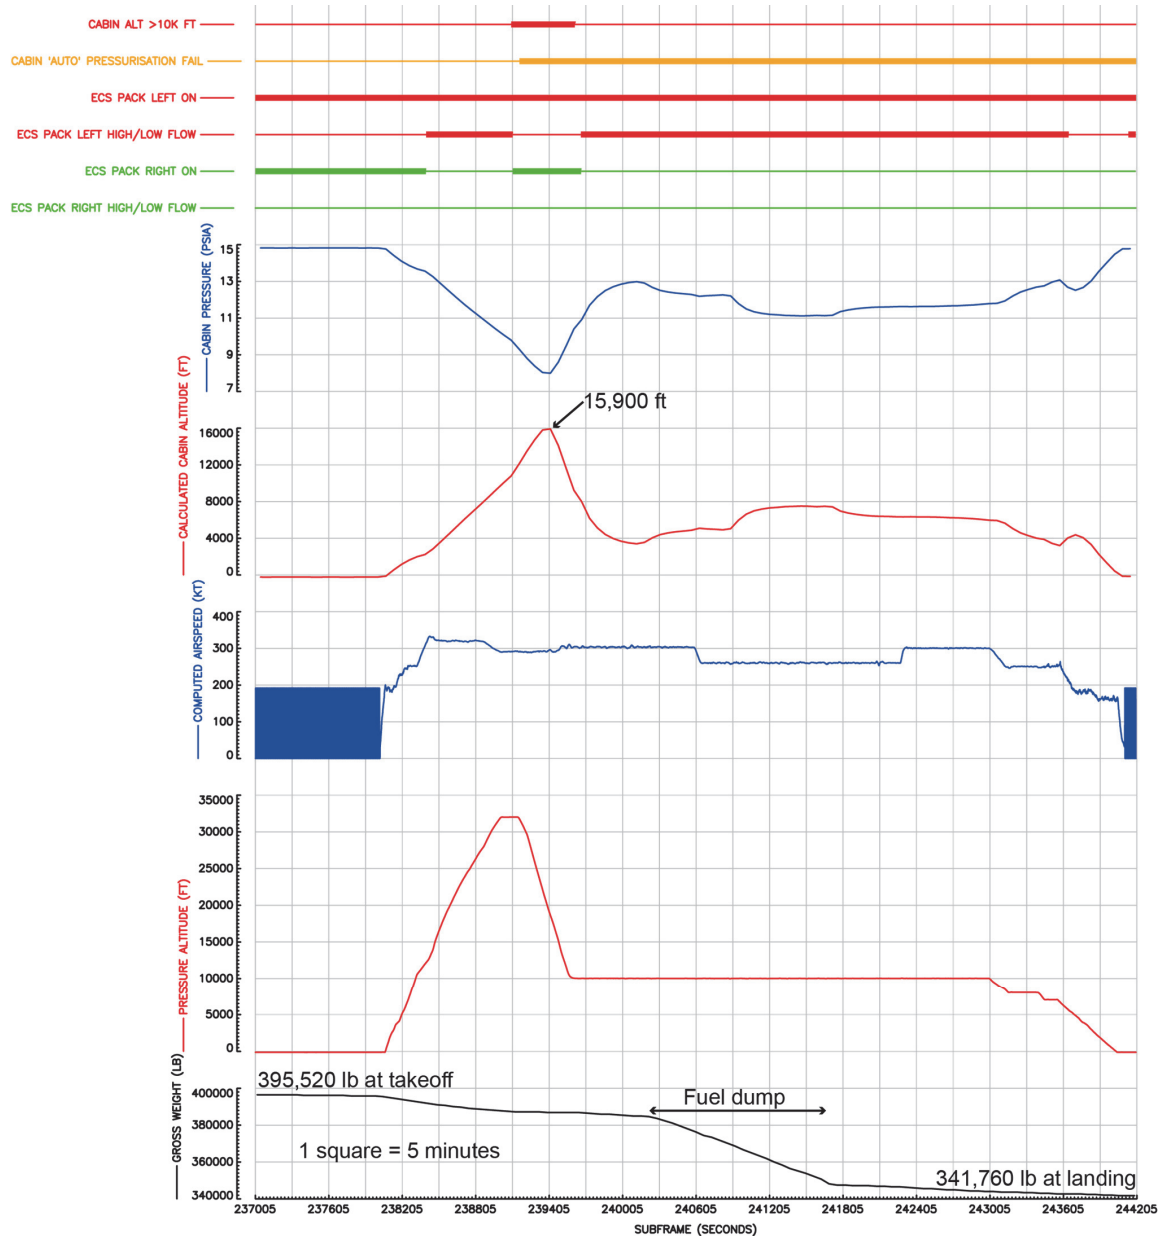
**Figure 1**

DFDR data at the time of the event – N1608, 13 August 2017
