## Safety Investigation Report

RAF BLSA LUGE ACCIDENT - NSI

29 January 2018

<b>Report Title:</b>	RAF BLSA LUGE ACCIDENT - NSI
<b>Reference:</b>	DAIB/18/003
<b>Issue:</b>	1
<b>Date:</b>	July 18
<b>Authors:</b>	Lt Cdr [REDACTED] (Eng) and WO1 [REDACTED] (Eng)
<b>Reviewed by:</b>	Wg Cdr [REDACTED]
<b>Approved by:</b>	Gp Capt [REDACTED]

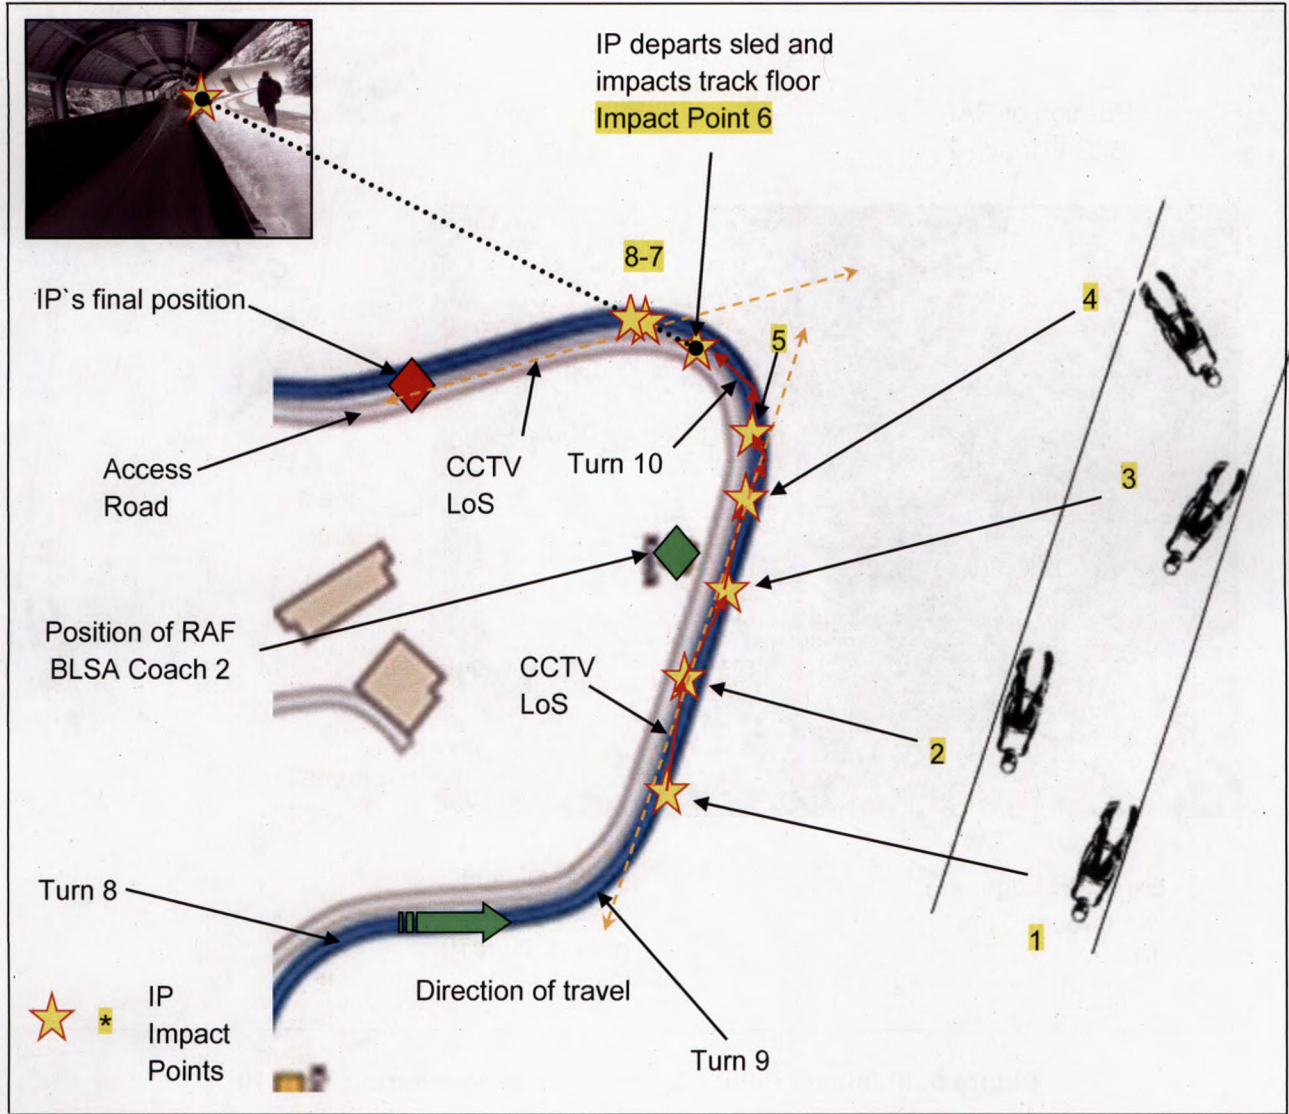
Figure 4: IP's 2nd Ice-Run Impact Points

At 1258 on 29 Jan 18 the IP commenced her 2nd ice-run and successfully navigated through Turn 8 into Turn 9. On the exit of Turn 9 the IP began to veer to the right-hand side (RHS) of the track and glanced the ice wall at Impact Point 1 (Figure 4). The IP appeared not to take any corrective action at this point and glanced the ice wall a second time on the left-hand side (LHS) of the track a further 9.3m on at Impact Point 2. This second impact caused the IP's sled to be deflected toward the RHS of the track; the IP appeared not take any corrective actions and further impacted the ice wall at Impact Point 3 approximately 28m from the previous impact (Figure 5). This third impact further exacerbated the IP's position within the track and dislodged her feet from the sled Bows.

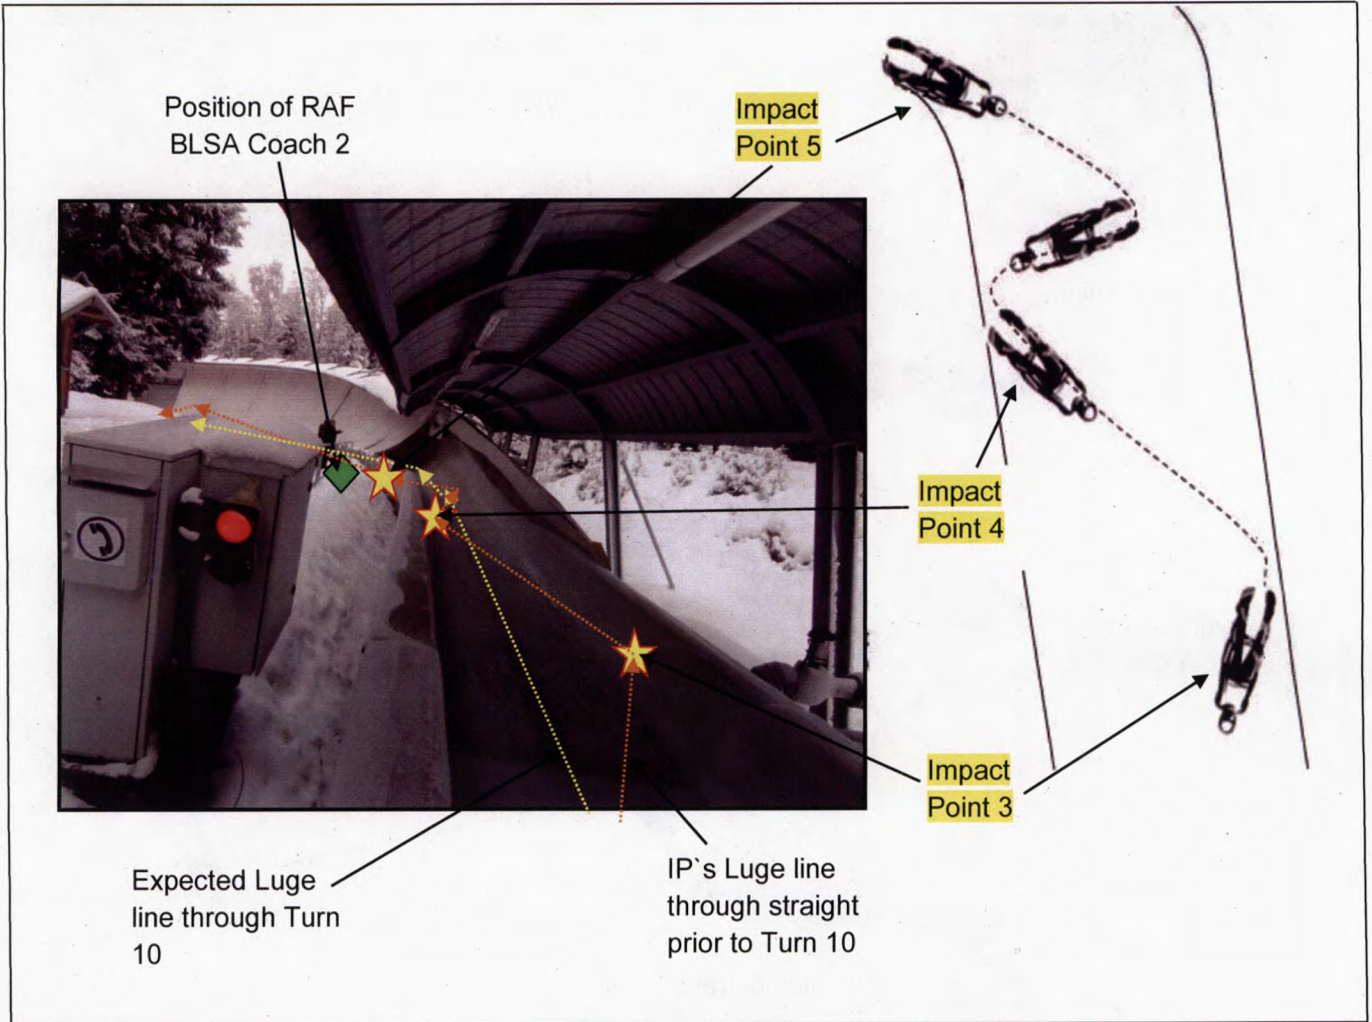
Figure 5: IP Impact Points 3, 4 and 5 prior to entering Turn 10

It has been established from CCTV footage that the IP was not steering the sled with her feet at this point and further impacted the LHS of the track 14.7m further down the track at Impact Point 4 at a speed of approximately 40 Km/h<sup>31</sup> and at an angle of approximately 70 degrees (Figure 5). Impact Point 4 was a violent impact which is likely to have damaged the sled and reduced the IP's speed into Turn 10; the IP remained on the sled after this impact but was deflected into Turn 10 entering at a high angle. Coach 2 witnessed this sequence of events and stated in interview that the IP "entered high and slow into Turn 10"<sup>32</sup>; he further stated that the IP was trying to steer hard at this point and could hear ice "cutting"<sup>33</sup> and the sled skidding" and stated that the IP was last seen heading up to the high point of Turn 10, well off the expected racing line.

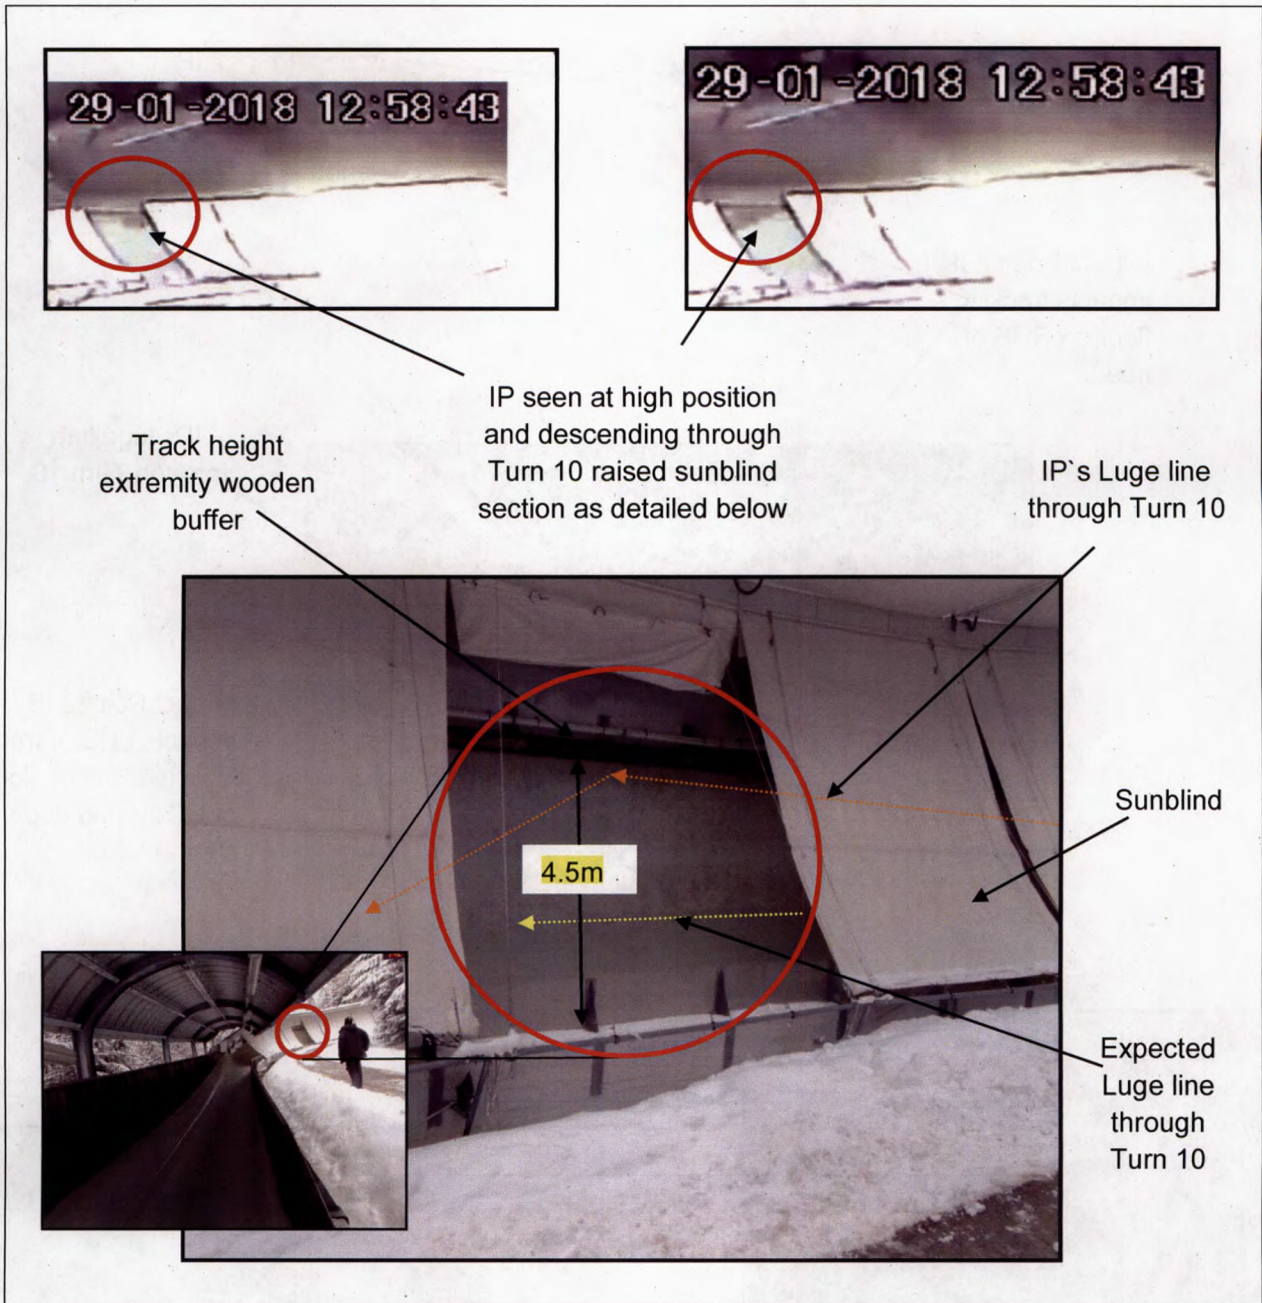
Figure 6: Turn 10 with mid-section sunblind raised

The IP was lost by the track CCTV, and from the view of Coach 2, by entering under the sunblinds<sup>34</sup> which were lowered around Turn 10 (Figure 6); the IP was captured moments later through one of the centre section sunblinds which had been raised at approximately the mid-turn position (Figure 5). The IP was seen at this point by the CCTV, and by Coach 2, and is noted to be at an usually high position on the banking of Turn 10 (Figure 6); the IP appears to be fully conscious throughout this phase of her accident run.

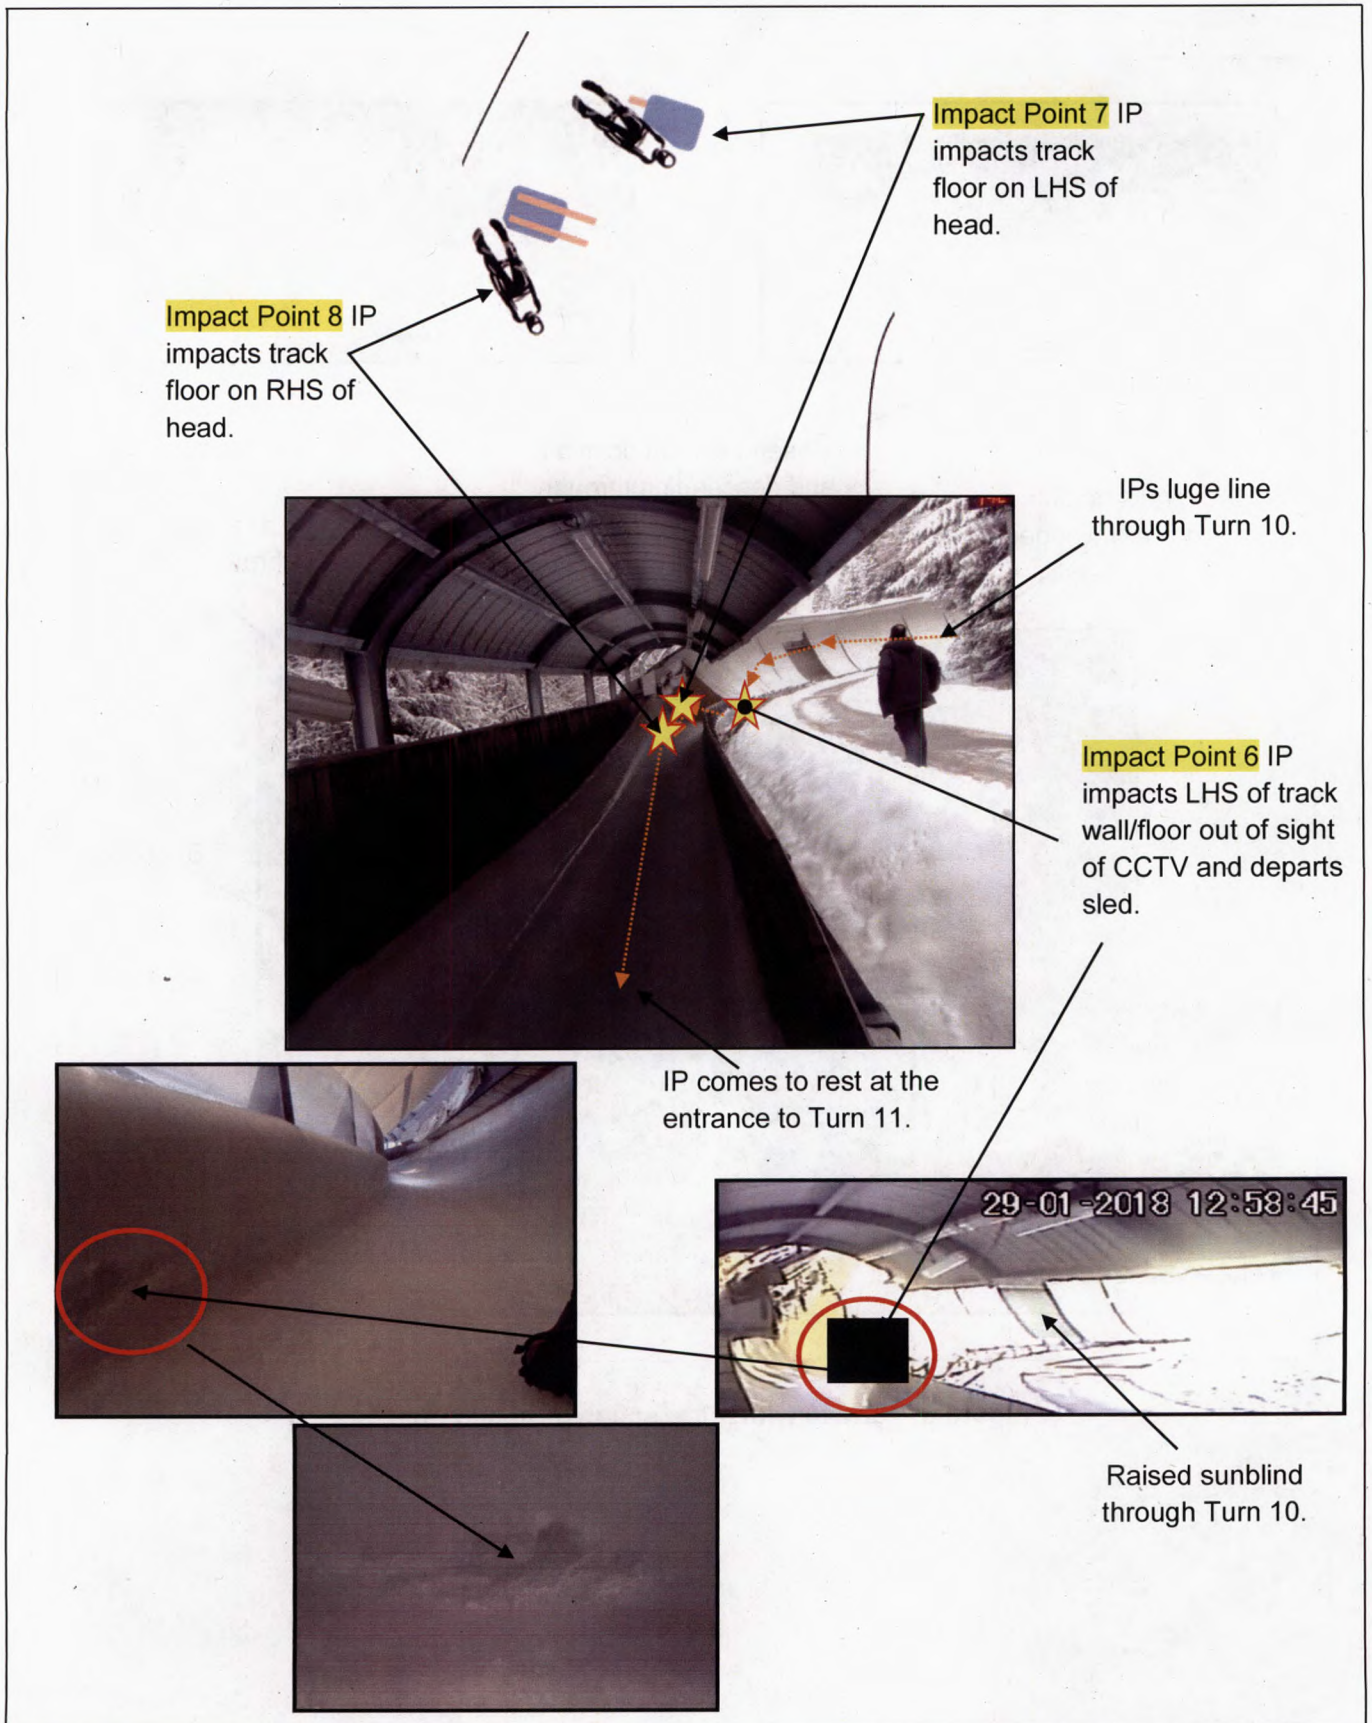
Figure 7: IP Impact Points 6, 7 and 8 on exit of Turn 10

The IP continued unsighted throughout the remainder of Turn 10 and impacted the LHS of the ice wall at Impact Point 6 (Figure 7); the IP was thrown from her sled after this impact and is captured by the CCTV footage as she departs the sled before further impacting the track floor at Impact Point 7 (Figure 7) onto the LHS of her head. The IP then rolls whilst in the air through 180 degrees and further impacted the RHS of her head on the track floor at Impact Point 8 (Figure 7). After this final impact the IP then continued to slide down the track on her back toward Turn 11 with her sled behind her<sup>35</sup>; the IP came to rest approximately two thirds along the straight beyond Turn 10<sup>36</sup>.

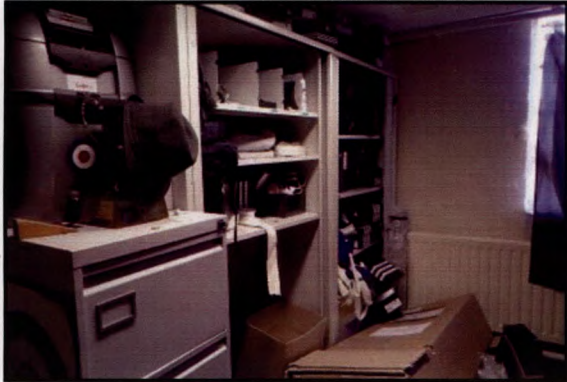
Figure 9: BLSA Luge Equipment Storage Facility Room 1, RAF Halton

It is advised by the OEM that in order to maximise life of the helmets that the optimum storage conditions are "cool, dry, protected from daylight, no contact with chemicals, pressure or stress"<sup>144</sup>. Daylight can be seen to protrude into the helmet and clothing store (Figure 9) which has a certain amount of mitigation against direct sunlight as some helmets are retained in bags or boxes; not all of the RAF BLSA helmets were stored this way.
