Report on the investigation of
unintentional release of carbon dioxide

Eddystone

in the Red Sea on 8 June 2016

in Southampton Water on 17 July 2017

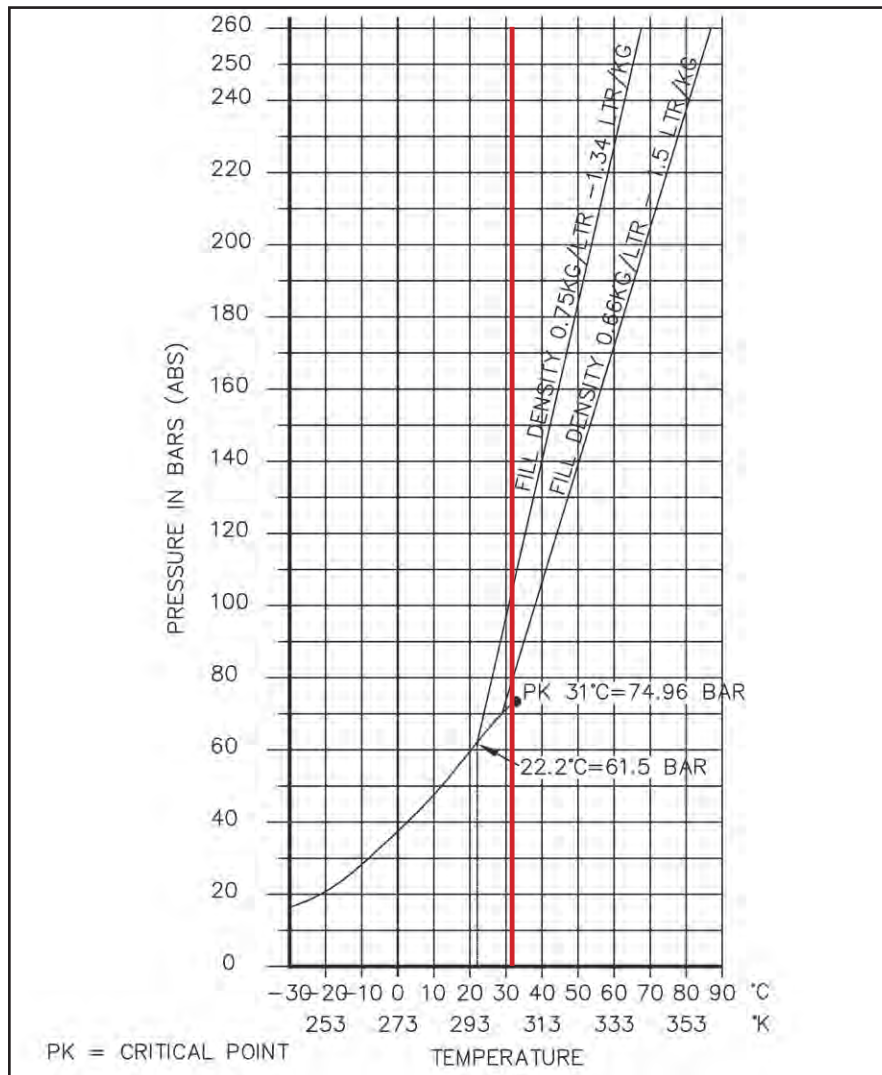
Figure 1: CO₂ cylinder pressure and temperature relationship

Above the critical temperature of 31.1°C, CO₂ cannot be liquified by the application of pressure. A typical fire-extinguishing system cylinder at 20°C will have a vapour pressure of approximately 57 bar; this will rise to 74 bar at the critical temperature. Further increase in temperature will lead to increased pressure within the cylinder (**Figure 1**).

bar at 32°C (**Figure 1**). Therefore, it is considered almost certain that the leakage on *Eddystone* was the result of one or more incorrectly torqued Schmöle valve set screws.

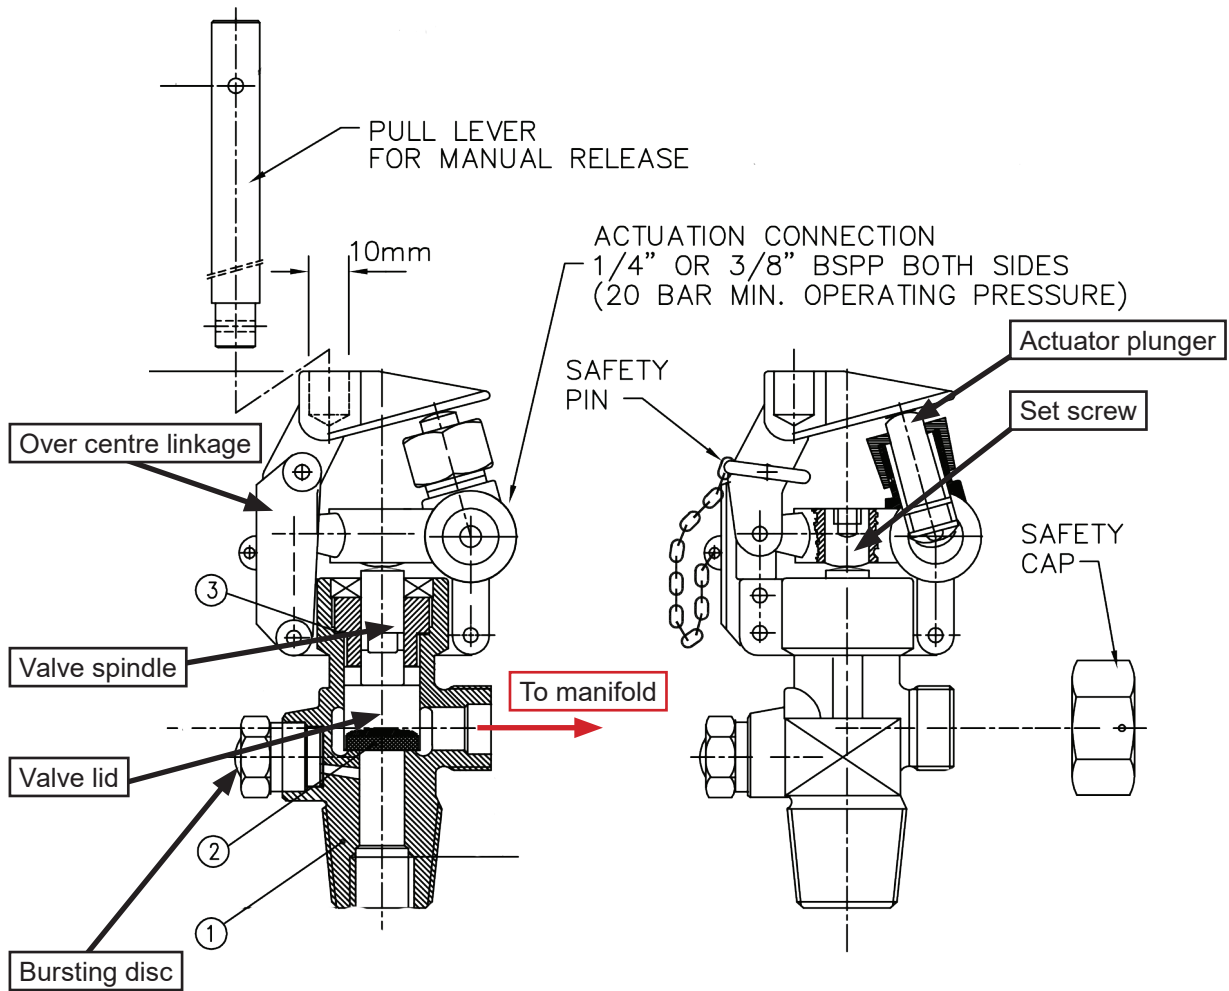
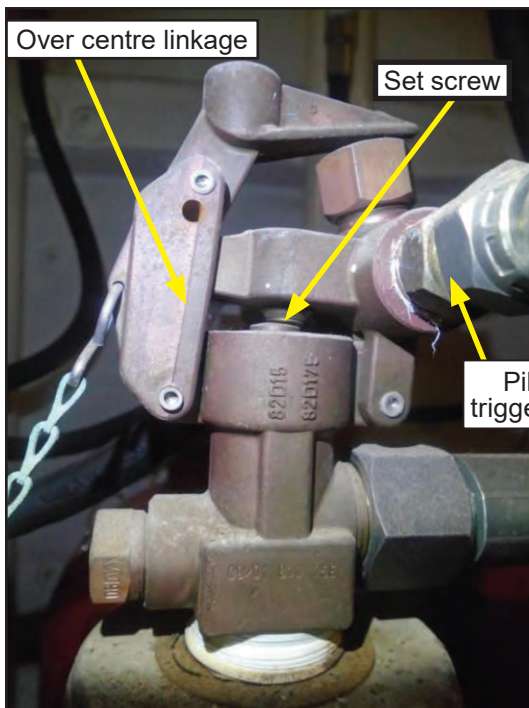
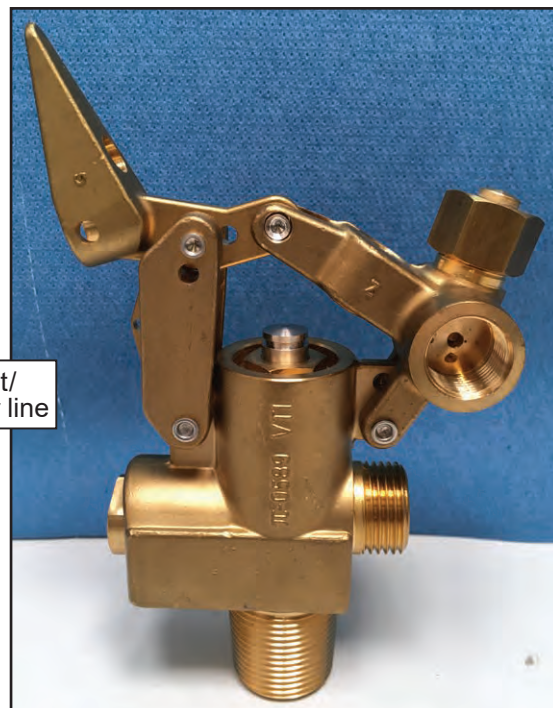
Figure 3: Schmöle cylinder valve

The system's main CO₂ cylinders were all fitted with Schmöle⁵ K85-50 cylinder valves (**Figure 3**). The internal mechanism of these valves consisted of a valve spindle and valve lid sealing against the seat. The seat sealing surface was made of polyether ether ketone or PEEK, a synthetic material with high resistance to thermal, chemical and aqueous degradation. The valve was kept closed by an over-centre linkage tensioned by a set screw acting on the top of the valve spindle. To ensure that the valves remained closed irrespective of the ambient temperature and the associated variation of cylinder pressure, the manufacturer required this set screw to be tightened to between 10Nm and 11Nm at installation. These valves also provided a bursting disc diaphragm to protect the cylinder against extreme overpressure.

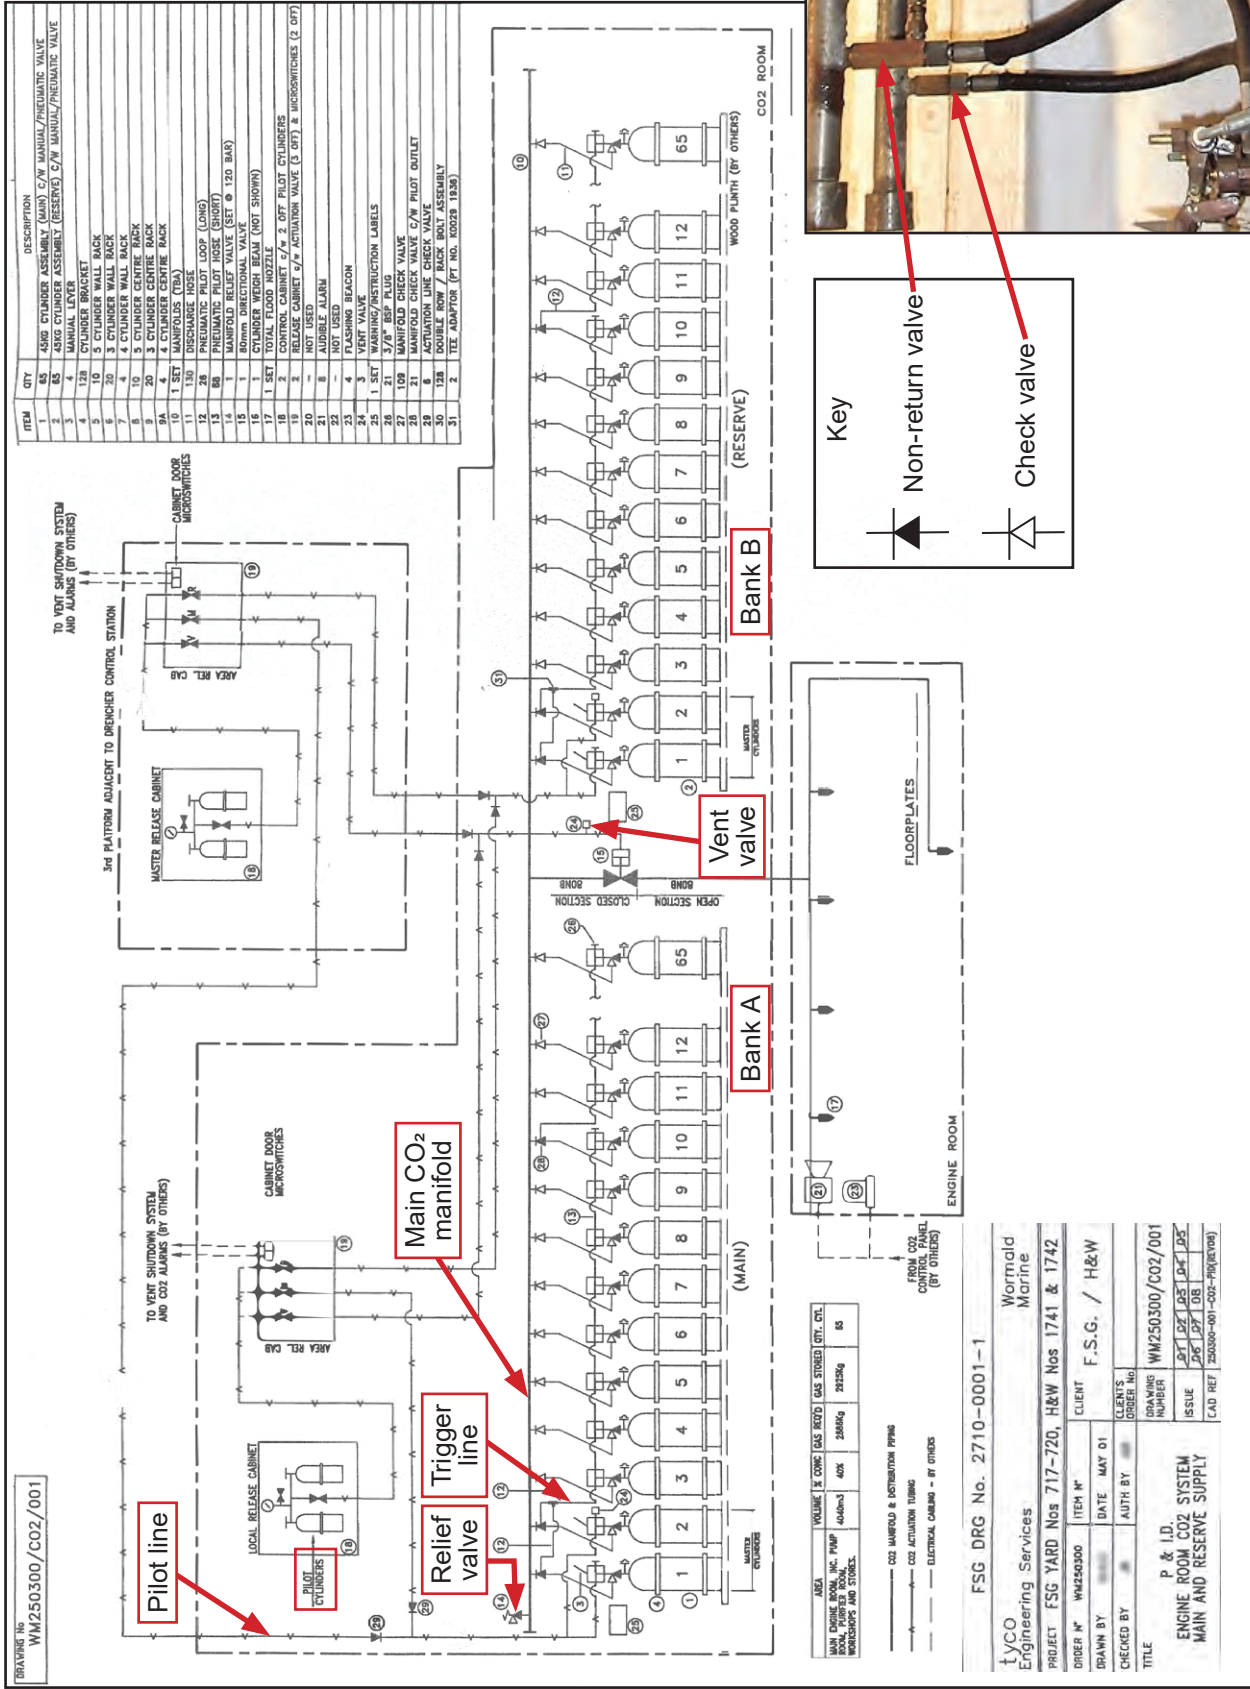
Figure 6: Edystone system drawing (inset: non-return valve in situ)

The MOD required a fully redundant fixed fire-extinguishing system for the engine room, so all six sister vessels had been fitted with an additional bank of CO₂ cylinders. *Eddystone*'s system had been supplied by Tyco Engineering Services, and comprised two banks, A and B, each of 65 cylinders including two master cylinders. There were also two remote release stations, each containing two pilot cylinders and capable of operating either bank (**Figure 6**).

The manifold was fitted with a pressure switch designed to trigger an alarm if minor leaks from the cylinder valves caused the pressure in the manifold to rise. This pressure switch was not shown in the system drawing. During a visit to the vessel by MAIB inspectors on 24 August 2017, the chief engineer removed the pressure switch, which had a stated range of 0 to 10 bar, and tested it; it was found to be set at 12 bar.

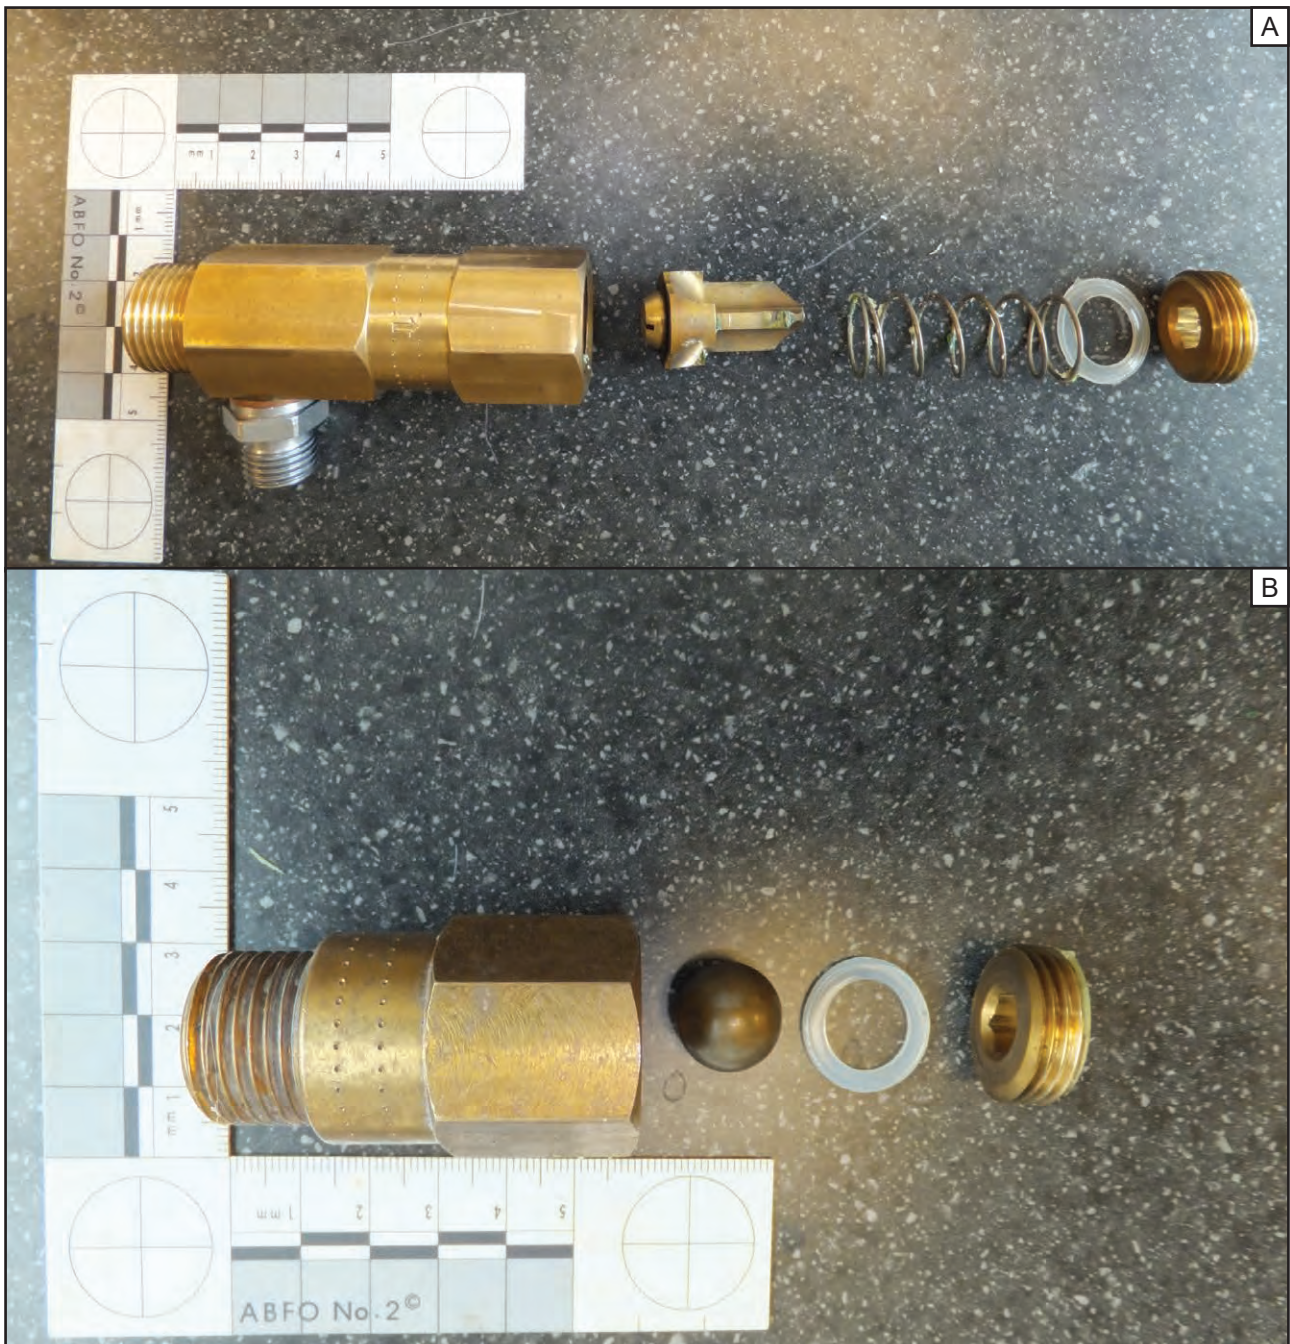
Figure 7: Non-return valve (A) and check valve (B)

In operation, the gas from the pilot cylinders was routed through two independent lines: one for opening the engine room distribution valve and the other for activating the master cylinders of the chosen bank. The CO₂ from the master cylinders released into the manifold through a spring-loaded non-return valve at the end of the cylinder rubber outlet hose. At the cylinder end of the non-return valve, a T-branch was fitted through which the gas was led, via the trigger line, to the release mechanism to trigger the remaining cylinders in the bank. Every tenth cylinder in each bank had a similar arrangement to maintain the trigger line pressure. The gas from each of the remaining cylinders was released to the manifold through a check valve, which consisted of a ball valve maintaining the seal by the weight of the ball. Check valves were not spring-loaded (**Figure 7**).

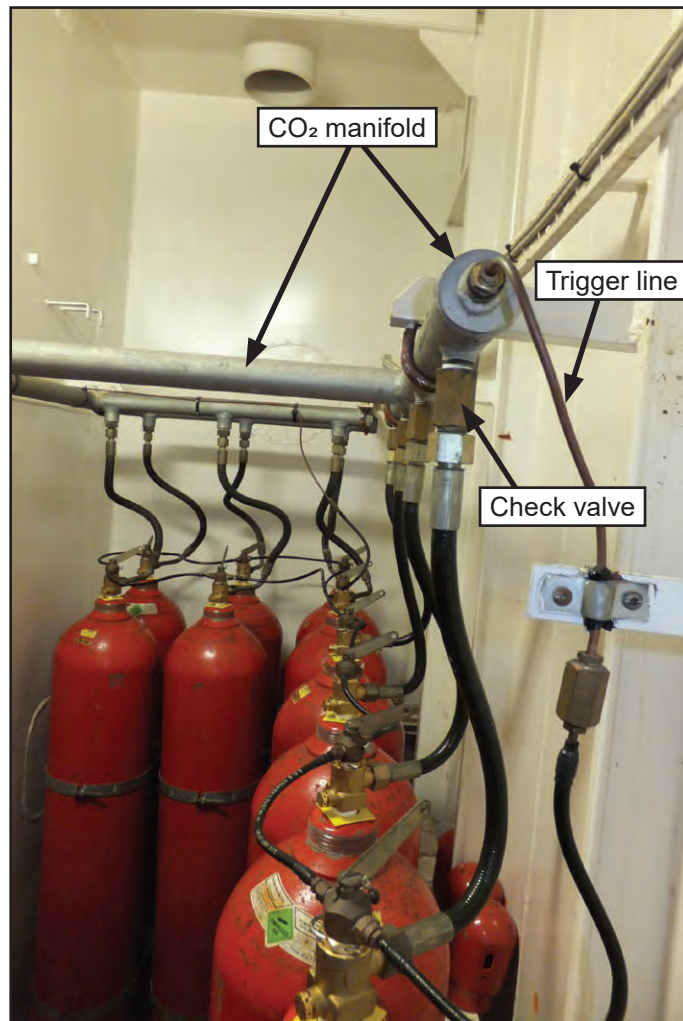
Figure 10: Trigger line

In operation, the pilot gas was routed through two independent lines: one for opening the engine room distribution valve and the other for activating the master cylinders. The CO₂ from the master cylinders released into the manifold through check valves at the end of the cylinder outlet hoses (**Figure 9**). From the end of the manifold, gas was led via the trigger line to the release mechanism of each cylinder valve in turn, causing them to open and release into the manifold through a check valve (**Figure 10**). The trigger line was not separated from the manifold as in the system on *Eddystone*.

Following the incident on *Red Eagle*, it was established that all but the two master cylinders had been released, despite the manual and remote releases remaining undisturbed. *Red Eagle*'s fixed fire-extinguishing system was designed such that pressurisation of the manifold, normally from the master cylinders, would lead to the release of all the remaining cylinders through a direct connection between the manifold to the trigger line (**Figure 10**). The unintended release was caused by one, or more, of the cylinders (other than a master cylinder) leaking into the manifold until the activation pressure was reached in the trigger line, when the remaining cylinders started being activated. Both master cylinders remained undischarged because their trigger lines were not connected to the main manifold.

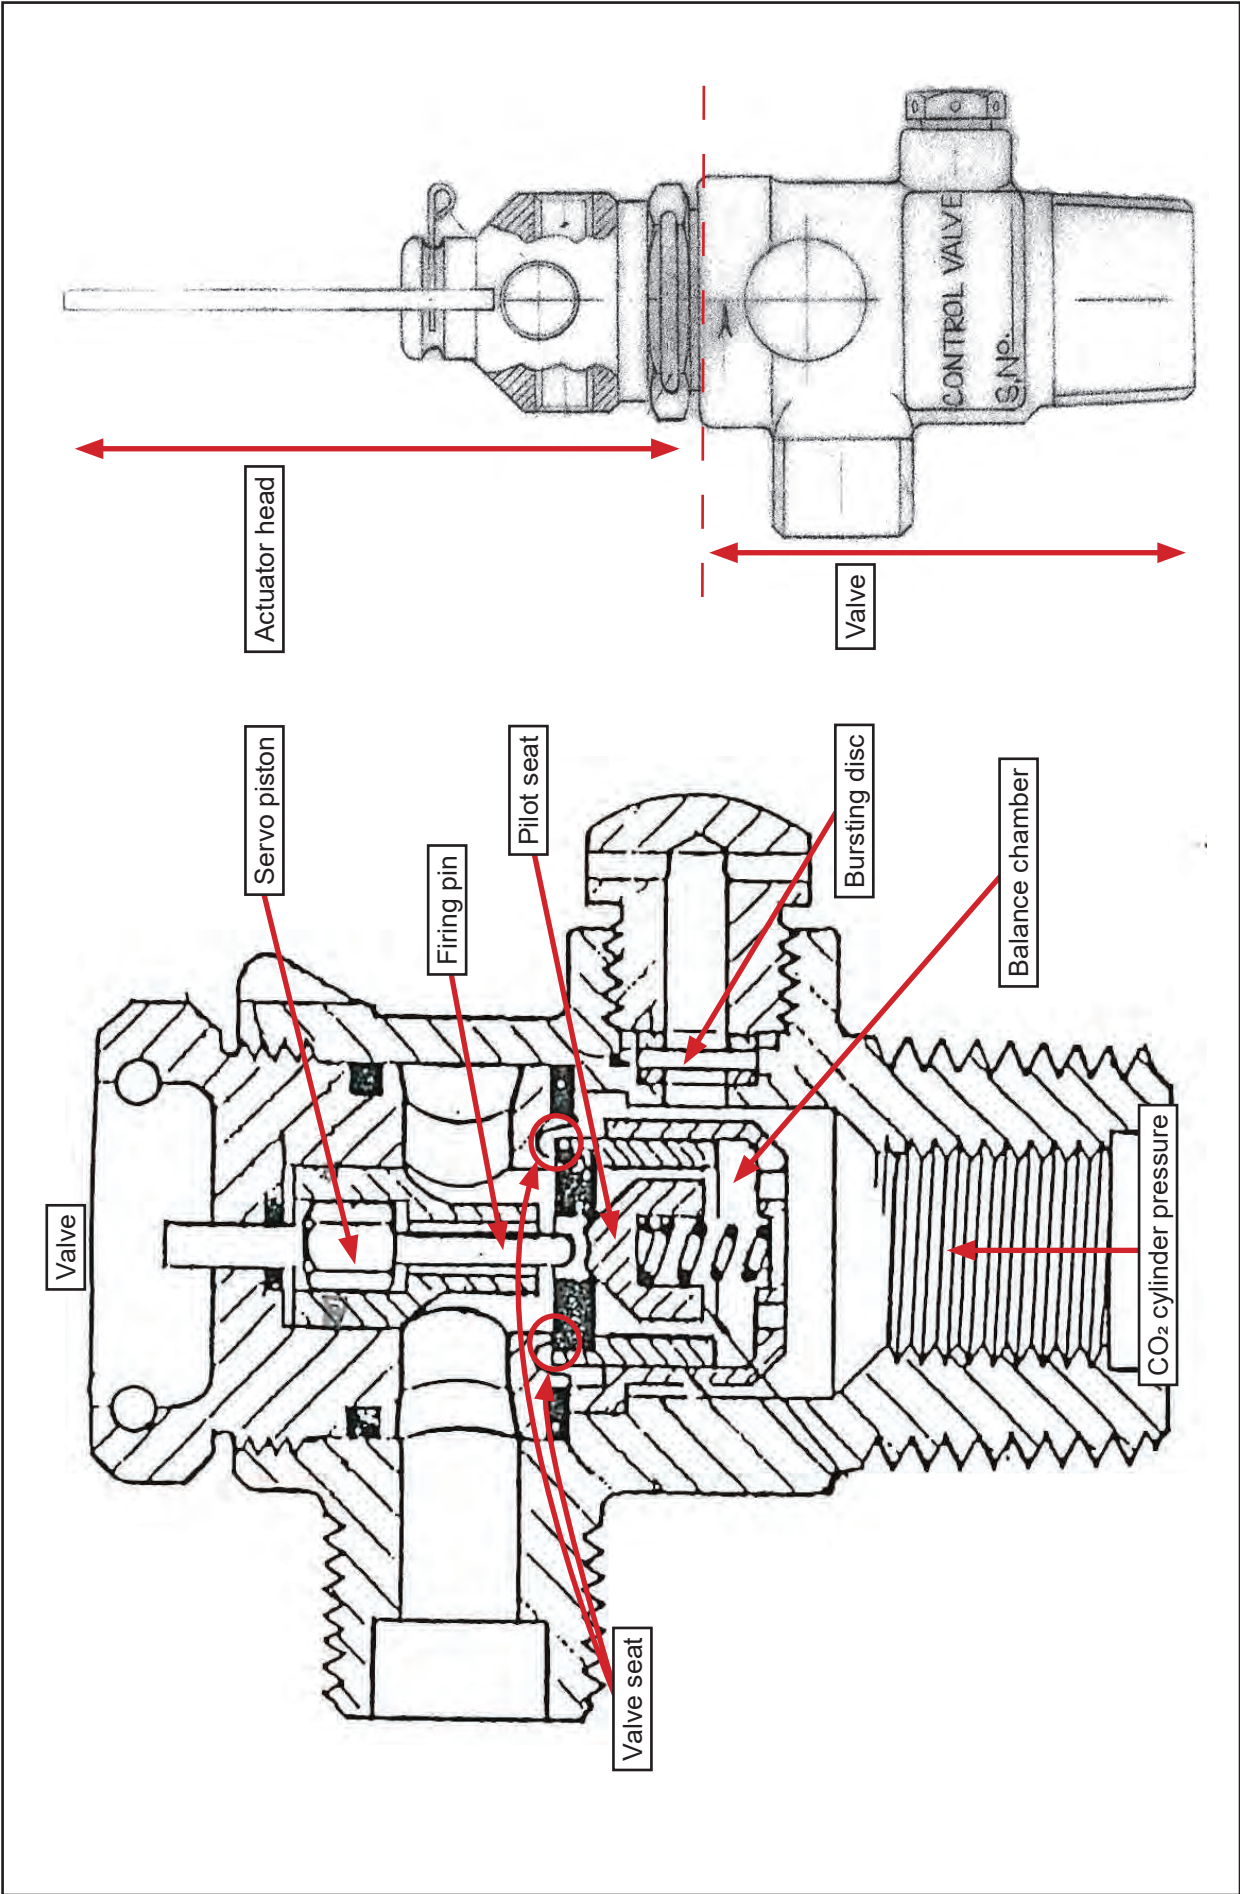
Figure 11: DAB D10963 1/2" CO₂ cylinder valves with D10964 manual/pneumatic actuator with detent

The system's main CO₂ cylinders were all fitted with DAB D10963 1/2" CO₂ cylinder valves (**Figure 11**), each of which had a D10964 manual/pneumatic actuator with detent fitted on top. When activated by pilot gas pressure or the manual release mechanism, the servo piston was pushed down, causing the firing pin to push the pilot seat down, opening the pilot valve. This allowed cylinder pressure to enter the top of the valve seat (made of a synthetic material called Nylon 6), pushing it

further down until the detent on the actuator locked, keeping the valve open. These valves also provided a bursting disc diaphragm to protect the cylinder from extreme overpressure.
