Rail Accident Report

**Extensive track damage between Ferryside and Llangennech, Carmarthenshire
30 October 2017**

Report 17/2018
v2 February 2023

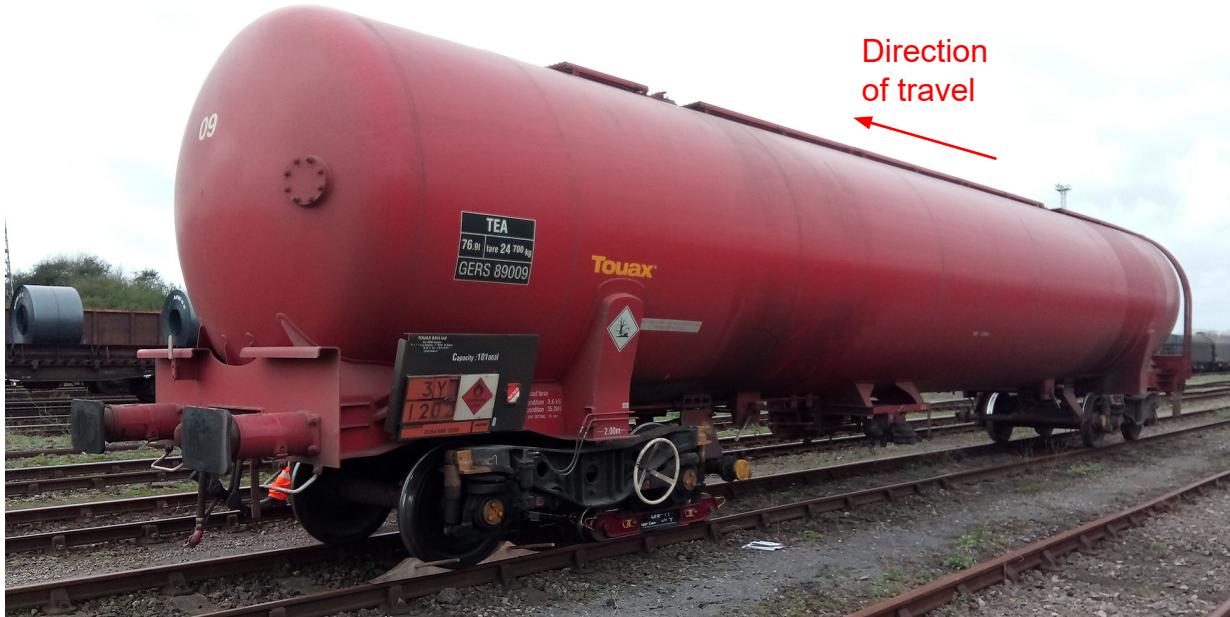
- 19 Only one of the vehicles in the train was involved in the accident; this was the first wagon behind the locomotive, numbered GERS89009 (figure 3). This was a wagon of type TEA, loaded with 90,889 litres of diesel (gross weight 101.2 tonnes).

Figure 3: Wagon GERS89009 at Margam after the accident (courtesy DB Cargo)

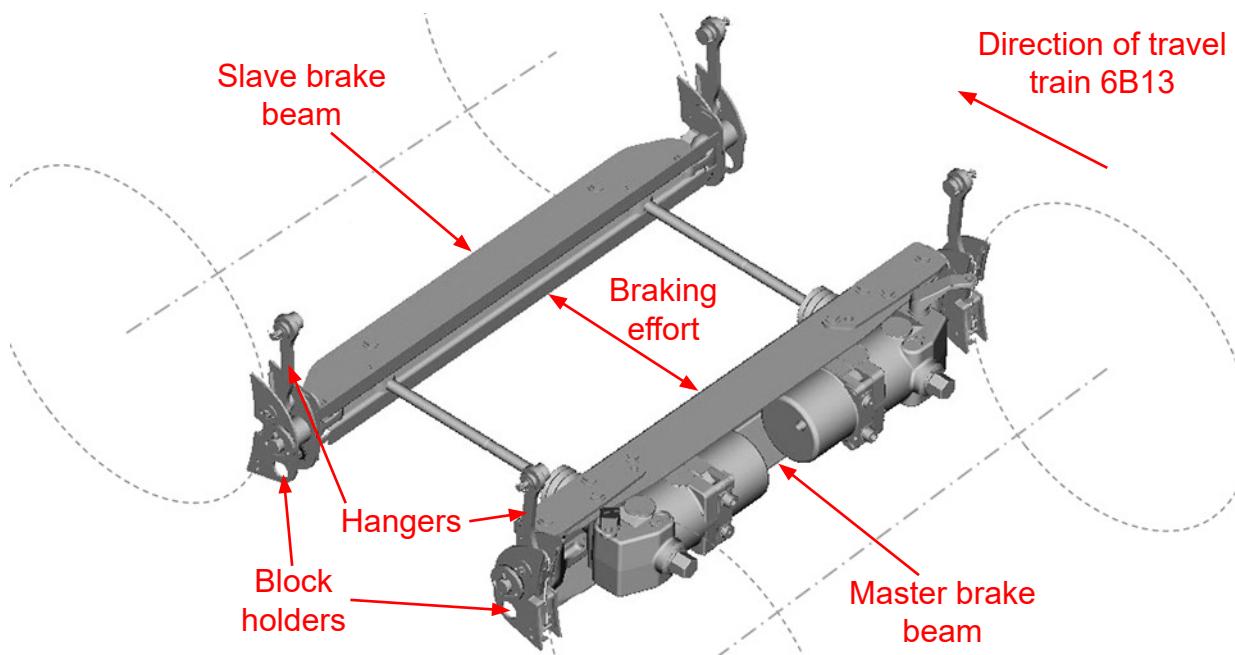
Figure 9: BFCB braking system for one bogie; brake blocks not shown (courtesy Wabtec Faiveley)

52 As fitted to each bogie of wagon GERS89009, the BFCB system consists of two transverse beams fitted between the axles (figure 9). The ends of each beam are attached to brake block holders, suspended from brackets on the bogie by hangers. The inner 'master' beam (ie nearest the centre of the wagon) carries a pair of actuators that operate by extending longitudinal spindles, which pass through the bogie frame. The spindles push the beams apart, pressing the brake blocks against the wheels with equal force (figure 10). The system is self-adjusting, automatically taking up excessive slack (for example caused by brake block wear) by means of a ratchet mechanism that operates when the brakes are applied and released.

- 83 The fitter who replaced the brake blocks stated that he had never seen one of these retaining pins to be missing, and that he would have noticed if one had been missing; there is also no record of such a failure in the rail industry's system for recording NIRs (national incident reports)¹⁸. In addition, loss of the pins from the block holders on the master brake beam would not explain why the brake blocks, keys and clevis pins were missing from both block holders on the slave brake beam (figure 9 and paragraph 63).

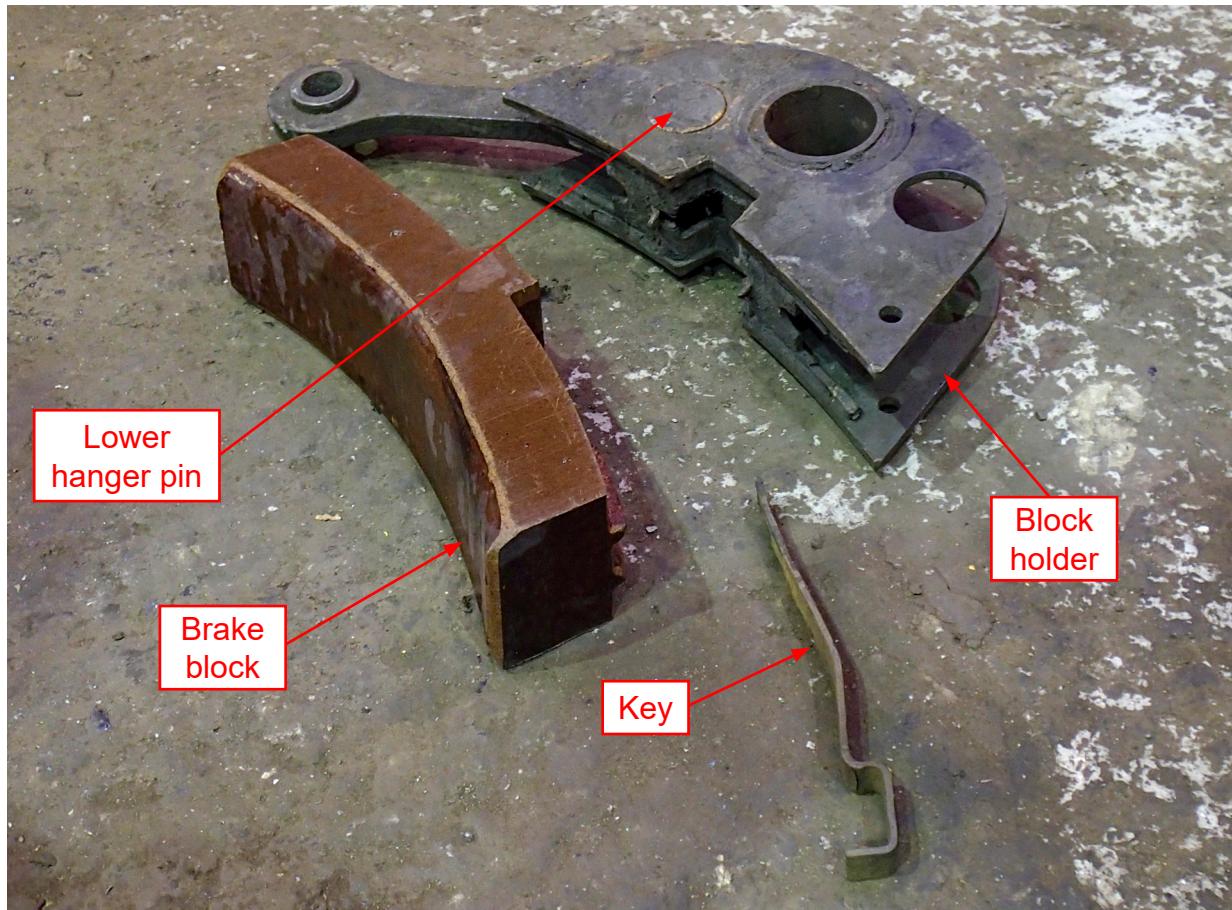
- 54 The brake blocks are attached to the block holders by keys that slot into lugs on the back of the blocks (figure 12).

Figure 12: Block holder, key and brake block

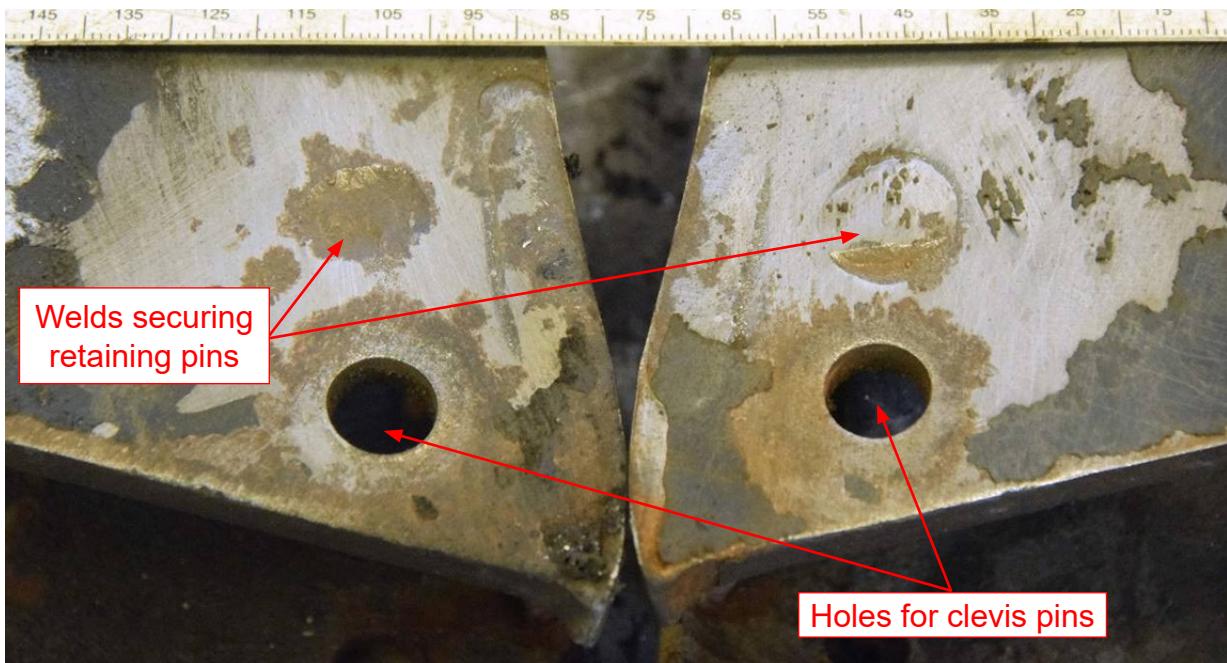
- 56 The fixed retaining pins are fitted through holes in the inner and outer plates of the block holders, and are welded to the faces of the plates (figure 14).

Figure 14: Outer faces of block holders from wheel positions 7 and 8, partially cleaned (courtesy Serco Rail Technical Services)

- 80 The fixed retaining pins that form part of the mechanism for attaching the brake blocks were missing from the block holders on the second wheelset of bogie 2741 (paragraph D9, appendix D). If one or both of these pins had fallen out, the associated key could also fall out and the brake block would no longer be restrained.
- 81 While the block holder from wheel position 6 (figure 8) was destroyed, accounting for the loss of that retaining pin, the block holder from wheel position 5 remained intact. The welds that secured the pin in position had failed (compare figure 16 with figure 14).

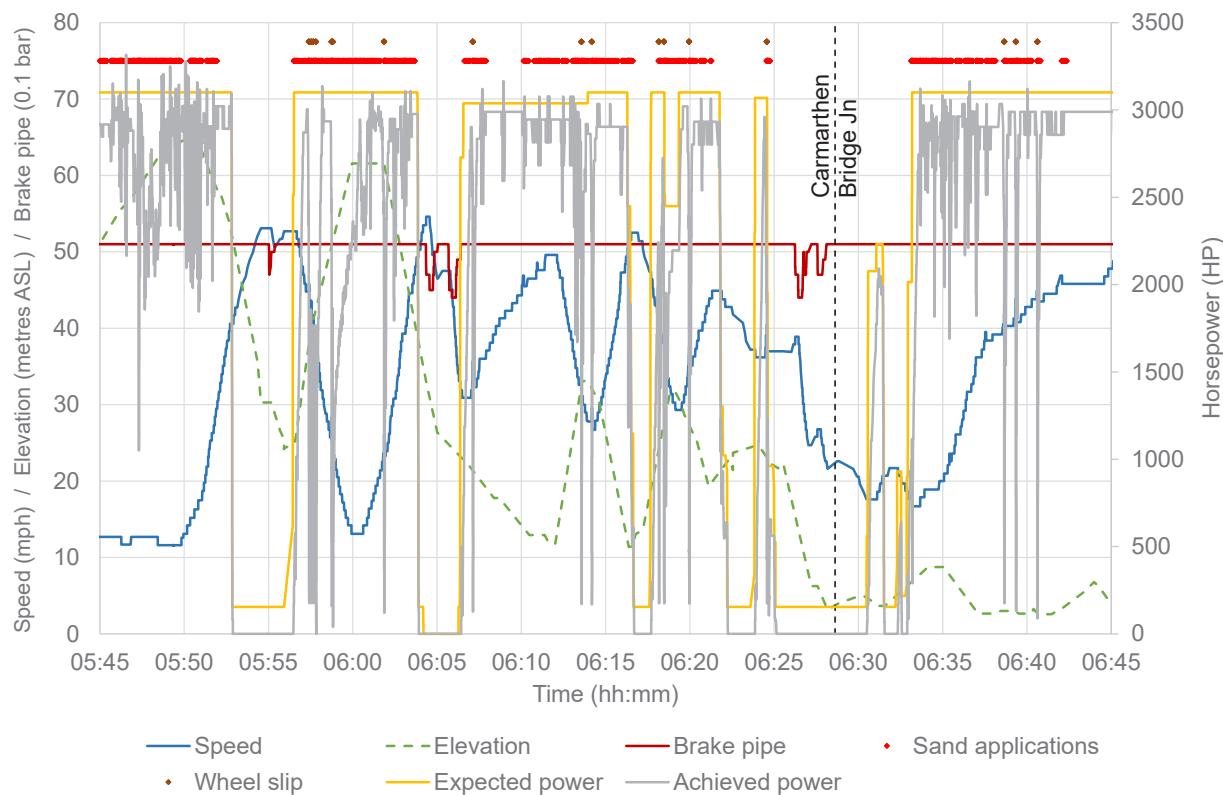
- H13 The anti-slip function is only in operation when the driver applies traction. Under braking, the control system of the class 60 locomotive does not apply sand in the event of wheel slide, and the OTDR data therefore does not provide any indication of the occurrence of wheel slide at the locomotive.³⁵

Figure H1: OTDR analysis for locomotive 60001 (05:45 to 06:45 hrs on 30 October 2017).

- H14 Following the accident, the first signs of damage to the railhead were found 41.6 miles (67.0 km) from Robeston (paragraph 33), 2.4 miles (3.8 km) after Carmarthen Bridge Junction. Train 6B13 passed this location at 06:35 hrs. This is an indication that the damaged wheelset on wagon GERS89009 had just started to rotate again.
- H15 Weather records (paragraph 27 and table H2) indicate that the ambient air temperature at Carmarthen, which is in between the listed weather stations, was approx. 1.0 to 1.8 °C above the dew point at 06:30 hrs. This may have been sufficiently close to the dew point to result in condensation forming on the rails and may have contributed to the low adhesion levels.
