Dragging anchor by the general cargo vessel *Celtic Spirit* and subsequent collisions with *Atlantic Explorer* and *Celtic Warrior* River Humber, England on 1 March 2018

SUMMARY

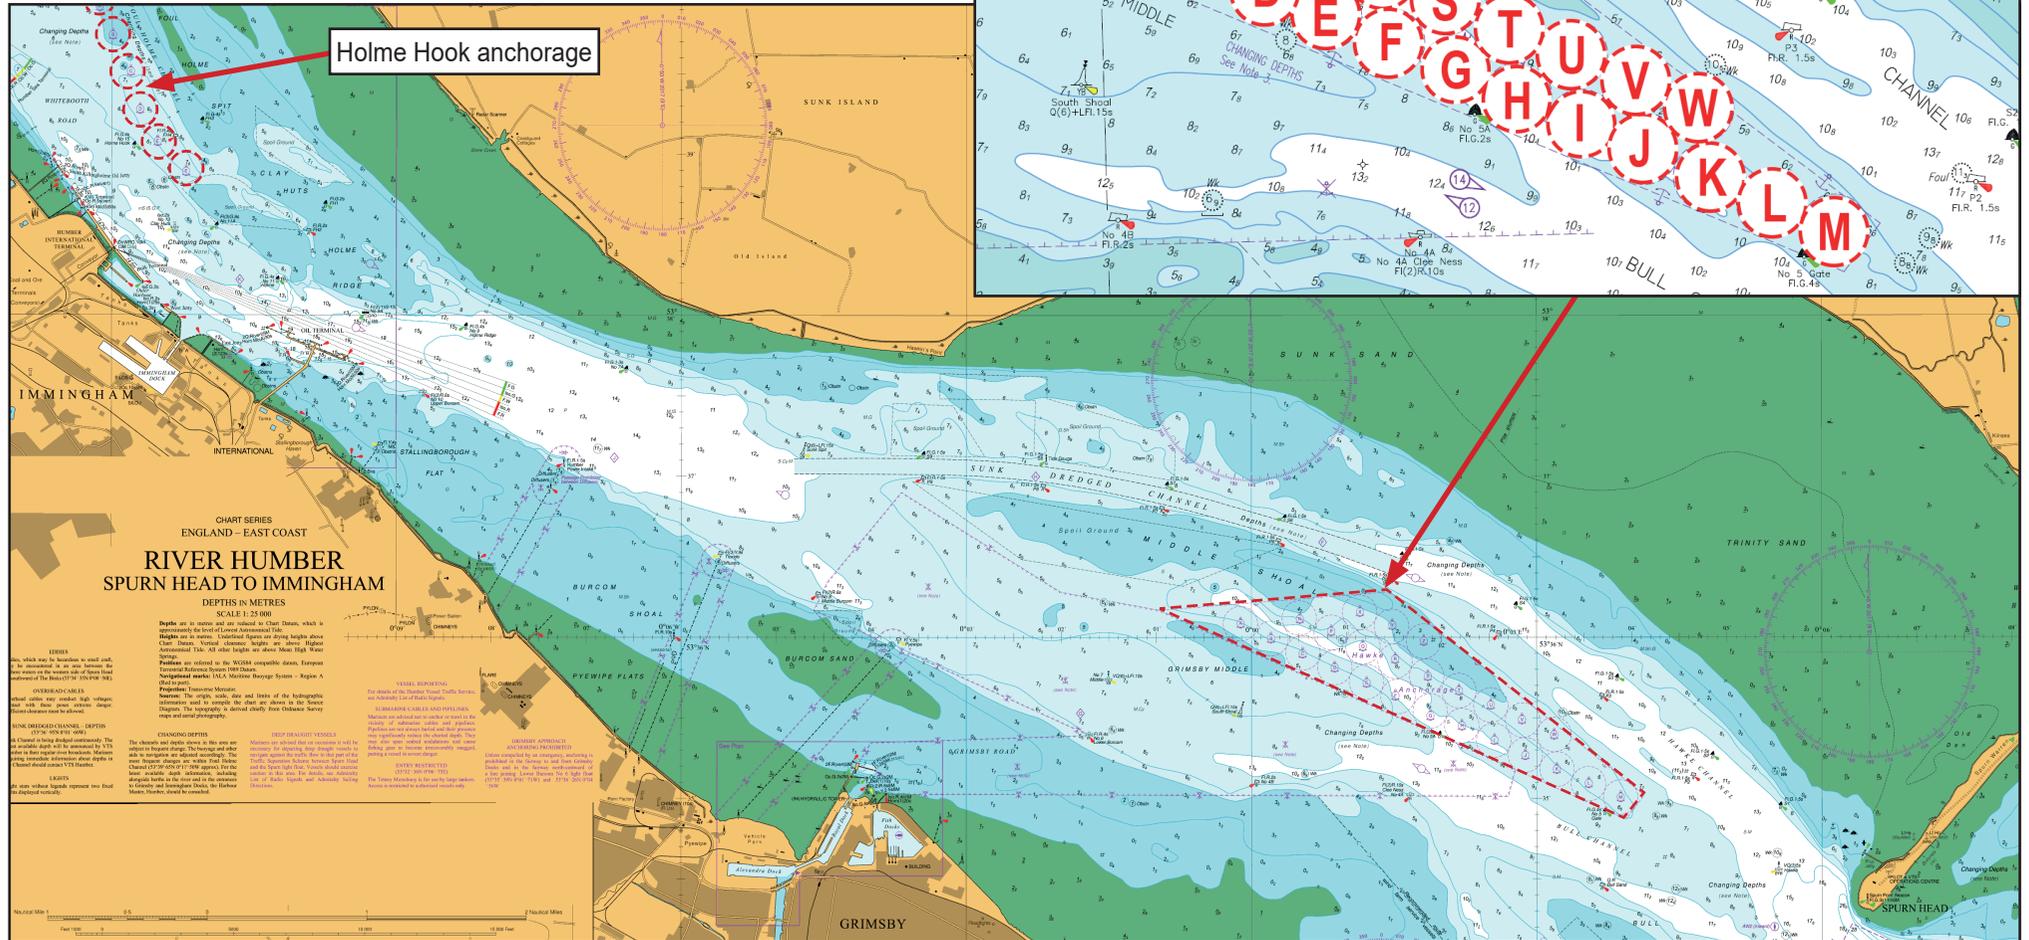
Figure 1: Extract of admiralty chart 1188 showing Holme Hook and Hawke anchorages

At 1630 on 28 February 2018, the general cargo vessel *Celtic Spirit* departed Groveport, England and headed down the River Trent to the Holme Hook anchorage on the River Humber (**Figure 1**). The master intended to load 40t of fuel from a bunker barge at the anchorage before commencing passage to Riga, Latvia. The vessel was in ballast and had a river pilot and a port authority marine apprentice on board.

At 1830, the inbound vessel, *Celtic Warrior*², anchored at position D in the Hawke anchorage (**Figure 1 inset**), close to the mouth of the River Humber. With 5 shackles of cable in the water, the vessel began to drag its anchor. The vessel's pilot instructed that a further shackle of cable be payed out and reported the incident to Humber Vessel Traffic Services (VTS). With 6 shackles in the water, the anchor held and *Celtic Warrior* came to rest between positions D and E. Before leaving the vessel, the pilot advised the master to keep his engine on standby; the pilot also communicated this information to VTS. In response, the master kept the vessel's main engine running in bridge control.

The Hawke anchorage (**Figure 1 inset**) was a short stay anchorage located to the north-west of the mouth of the Humber estuary. The seabed had a charted depth of between 8 and 10m, and the bottom composition was described as sand and mud. There were 25 designated anchorage positions, which were 2 cables in diameter and denominated alphabetically to enable VTS to easily direct ships to an anchorage position.

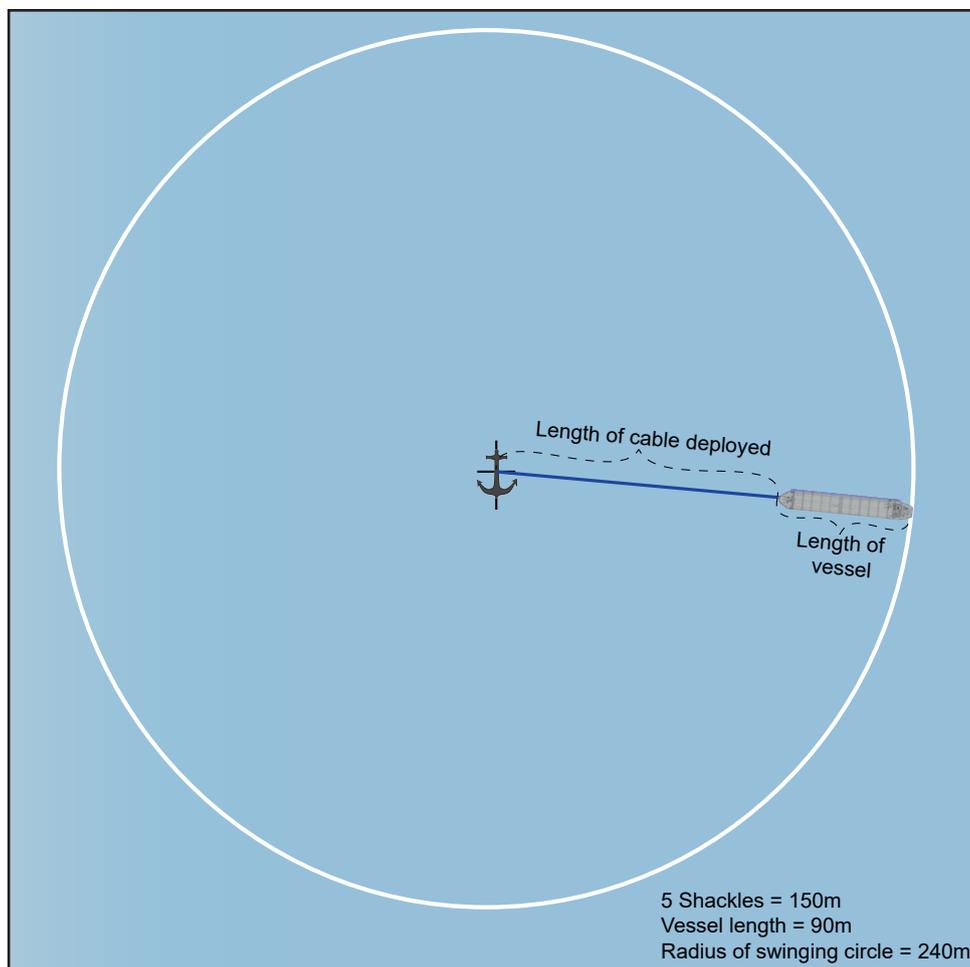
Figure 5: Swinging circle

A vessel's position should be checked at regular intervals while at anchor to confirm that it remains inside its swinging circle (**Figure 5**). All available means, both visual and electronic equipment such as GPS, radar and ECDIS, should be used to make an appraisal of the situation. If the vessel leaves the circle, it is likely to be dragging its anchor.

Once a vessel starts dragging, the following steps should be considered:

- Call the master and muster the anchor party.
- Start the main engine, thrusters and steering gear.
- Alert VTS and nearby vessels.
- Deploy more cable or drop the second anchor before the vessel's speed increases.
- Weigh anchor and put to sea (in extreme conditions require the cable to be released).
- Allow vessel to drift in a controlled manner.
