# AIRCRAFT ACCIDENT REPORT 2/2018

Report on the serious incident to  
**Boeing 737-86J, C-FWGH**  
Belfast International Airport  
on 21 July 2017

Published 21 November 2018

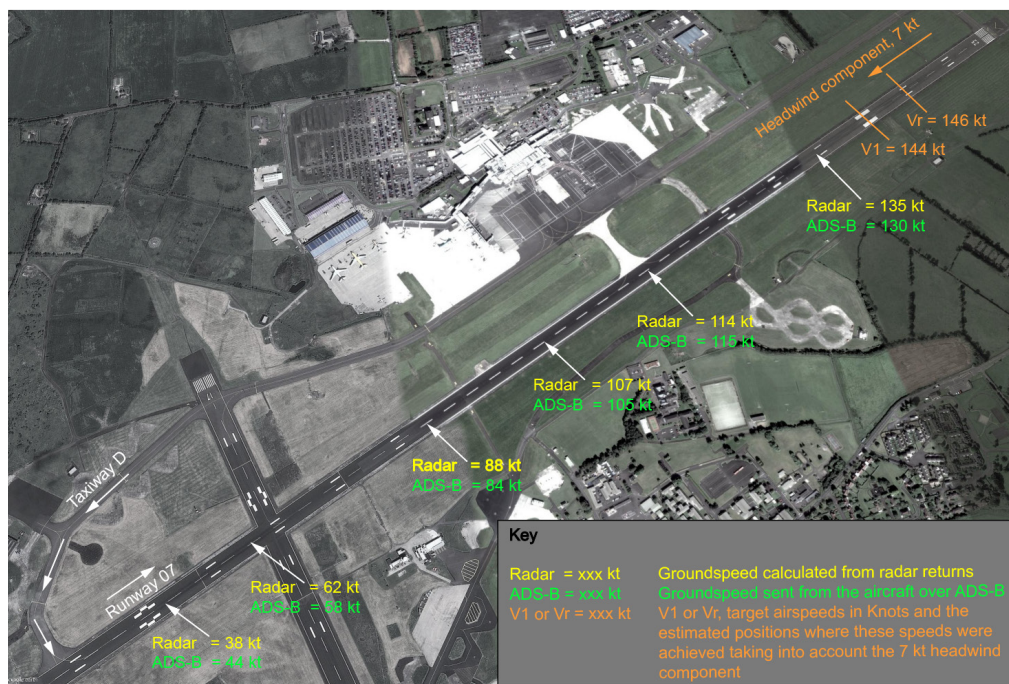
**Figure 1**

accelerating normally. They estimated, during post flight interviews, that they reached  $V_1$ <sup>7</sup> with around 900 m of the runway remaining and rotated shortly afterwards. The aircraft, which was seen by multiple witnesses, took a significant time to lift off before climbing at a very low rate. After the aircraft lifted off from the runway, one of the aircraft tyres struck a runway light, which was 36 cm tall and 29 m beyond the end of the TORA. Figure 1 shows an overhead view of BFS.

Overhead view of BFS

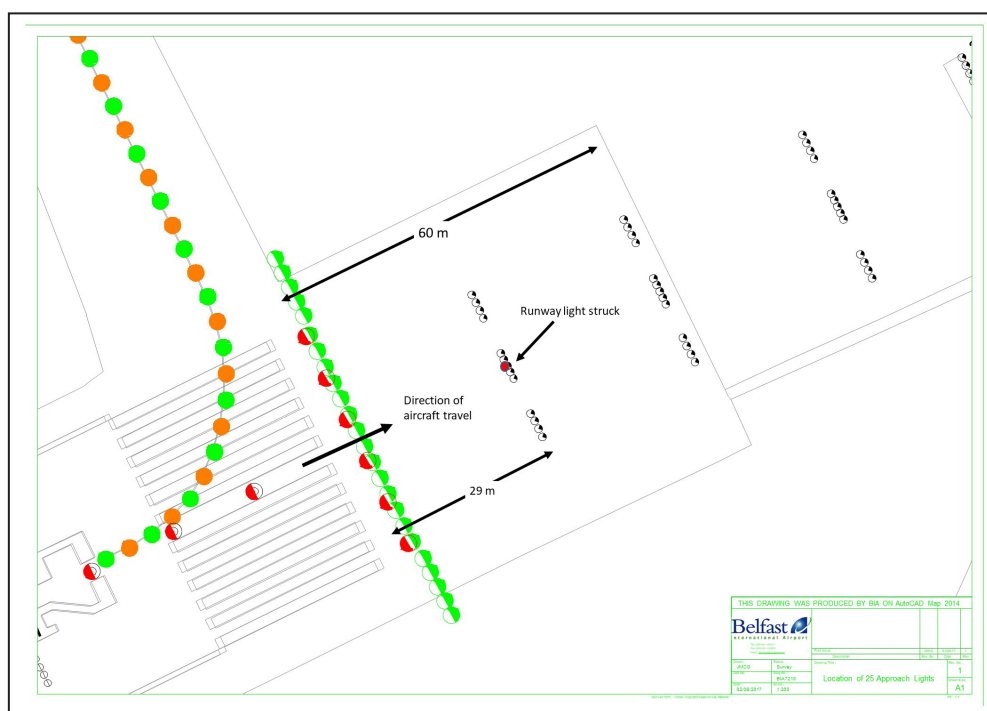
**Figure 5**

Within the stopway were two sets of supplementary approach lights for Runway 25. Each of these sets had thirteen lights set out in three groups across the tarmac. These lights were positioned 36 cm above the stopway surface. The first set of lights was 29 m beyond the end of Runway 07, with the stopway ending 60 m beyond the end of Runway 07. The aircraft struck the centre light within the first set of supplementary approach lights. Figure 5 shows the layout of the lights, together with the dimensions of the stopway and indicates the direction of travel of the aircraft and the light the aircraft struck. Figure 6 shows the view from the stopway with the centre light missing.

Dimensions of stopway and lighting positions

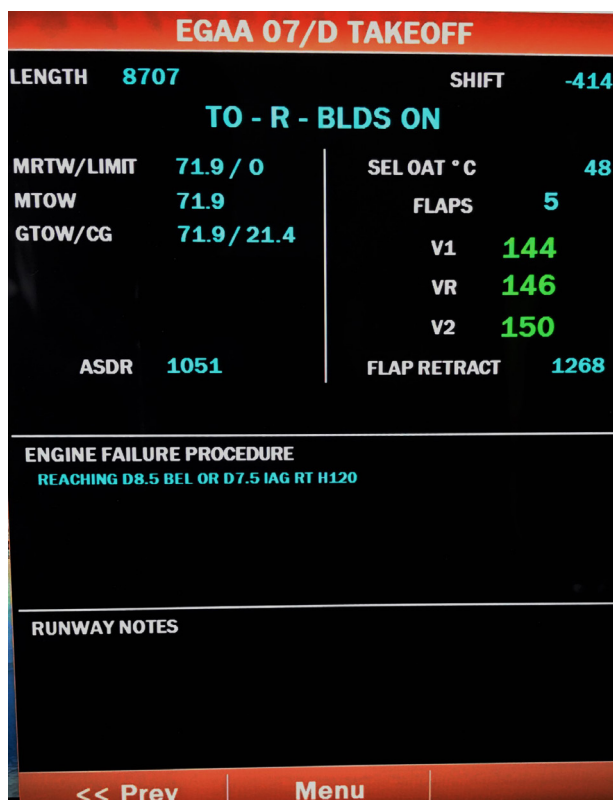
Figure 9

Using an assumed temperature of +48°C, the EFB calculated an  $N_1$  target of 92.7% for the takeoff from Runway 07, Taxiway D. This information was not available to the crew, however, because the calculation output page did not display  $N_1$  (Figure 9).

The EFB performance calculation output page

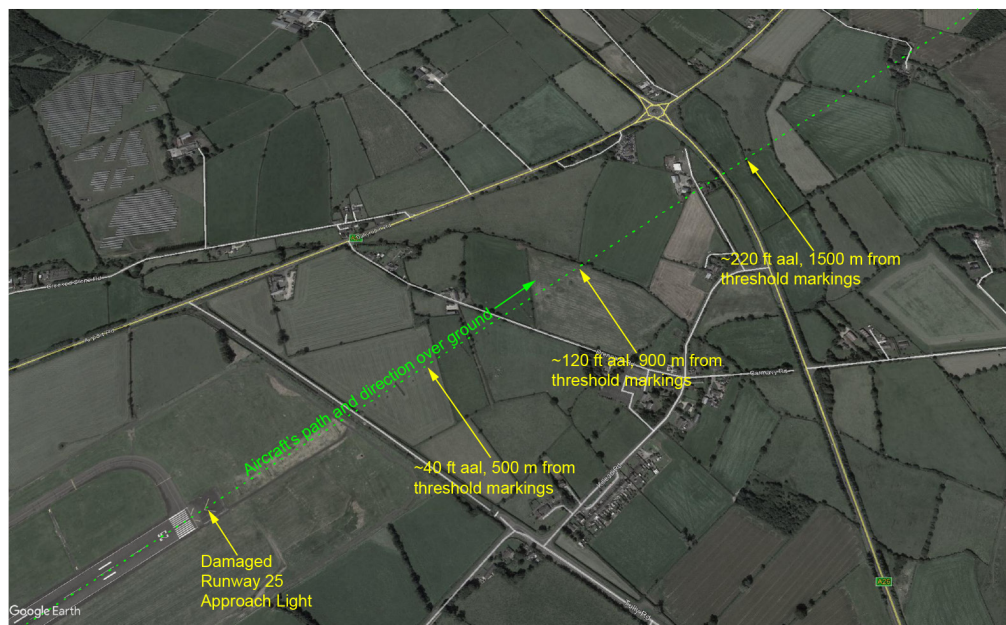
**Figure 11**

Figure 11 shows spot heights above the elevation of BFS (268 ft amsl) for the aircraft's initial climb, derived from the aircraft's ADS-B reports.

Vertical profile for the initial climb-out  
 © 2018 Google

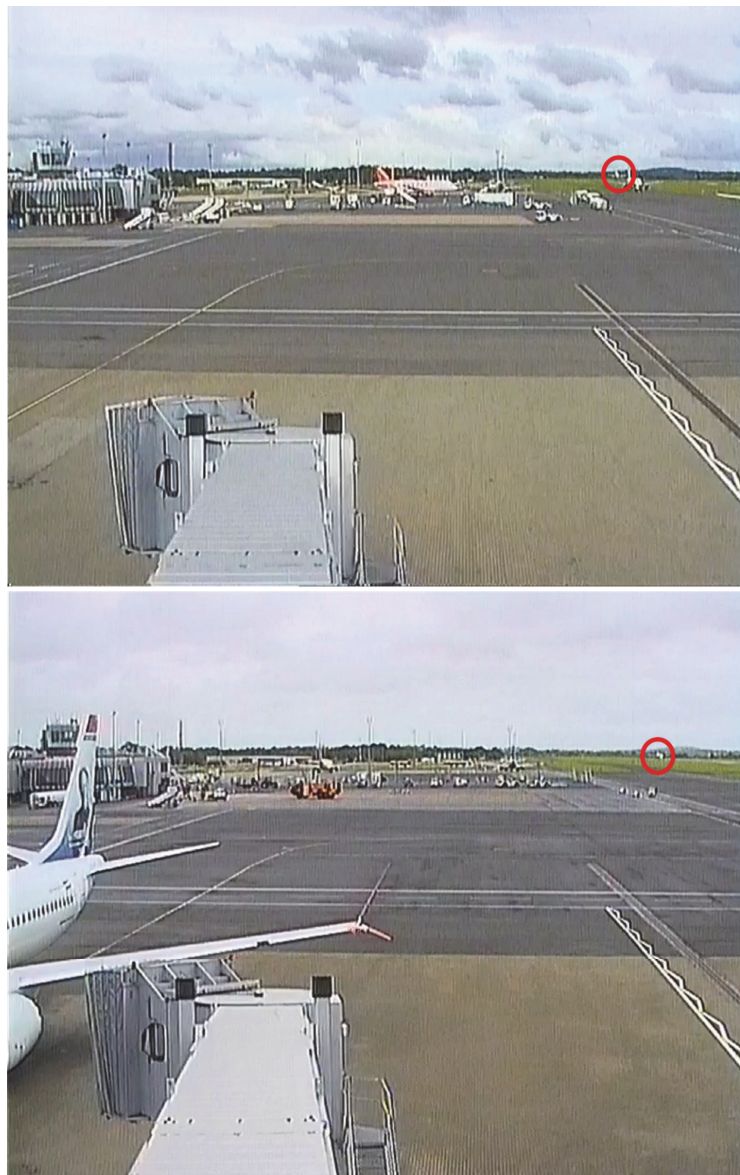
**Figure 13**

The second camera captured the rotation, lift off and initial climb-out of C-FWGH. The resolution and sightline angle of this CCTV recording did not allow calculations of distance to be made, but the airport operator provided another CCTV recording from the same camera of an aircraft lined up for departure on the reciprocal Runway 25. Using this recording, and the recording showing C-FWGH's departure, it was possible to confirm that C-FWGH lifted off at the extremity of Runway 07. Figure 13 shows a comparison of these recordings; C-FWGH is shown immediately after lift-off at the top of the figure, compared with the aircraft lined up on Runway 25 ready to depart at the bottom of the figure. In both images, the aircraft have been highlighted by a red circle.

The second CCTV recording showing C-FWGH's lift off at the top, compared with an aircraft lined up for departure on the reciprocal runway at the bottom

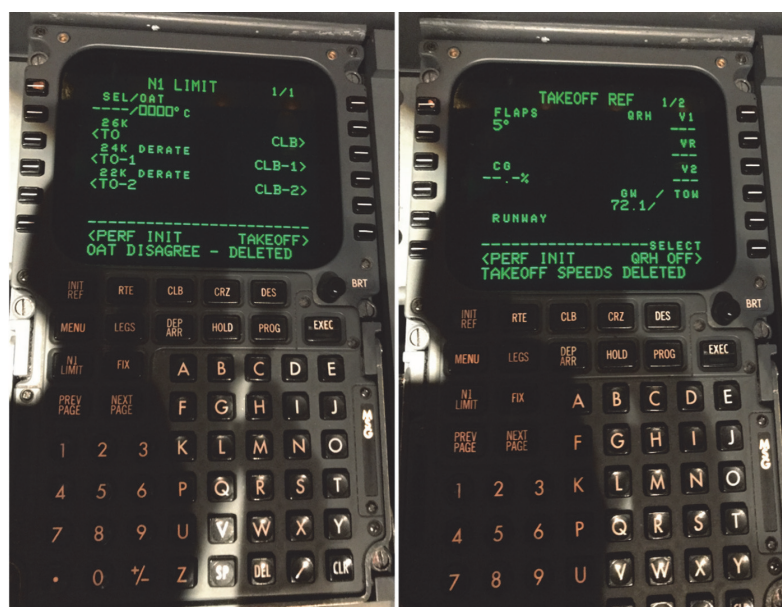
Figure 17

In addition to the release of the FCOM bulletin, the manufacturer added a crosscheck function to revision U12.0 and later versions of the FMC OPS software. The crosscheck compares the OAT entered by the crew, or accepted by the crew in the case of a data-linked OAT, against either that sensed by the Electronic Engine Controls or, on some older Boeing 737s (including the -100 to -500 series that pre-date Boeing 737NG aircraft), by the aspirated Total Air Temperature probe. The crosscheck runs once, approximately one minute after first engine start, and establishes whether a difference of more than six degrees in temperature exists between the value accepted by the FMC and that sensed by the external temperature sensor. If the difference is more than six degrees, it deletes the OAT entry, removes any assumed temperature or fixed derate that has been selected and deletes the takeoff reference speeds. It also displays two messages and illuminates the 'MSG' indicator on both CDUs to warn the crew that data has been deleted from the FMC; the messages shown are OAT DISAGREE – DELETED and TAKEOFF SPEEDS DELETED (Figure 17).

CDU messages associated with the FMC OPS U12.0 OAT crosscheck

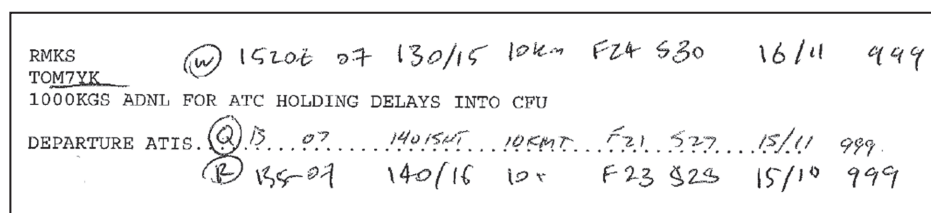
**Figure 21**

ATIS as recorded by PM on the pilot's log

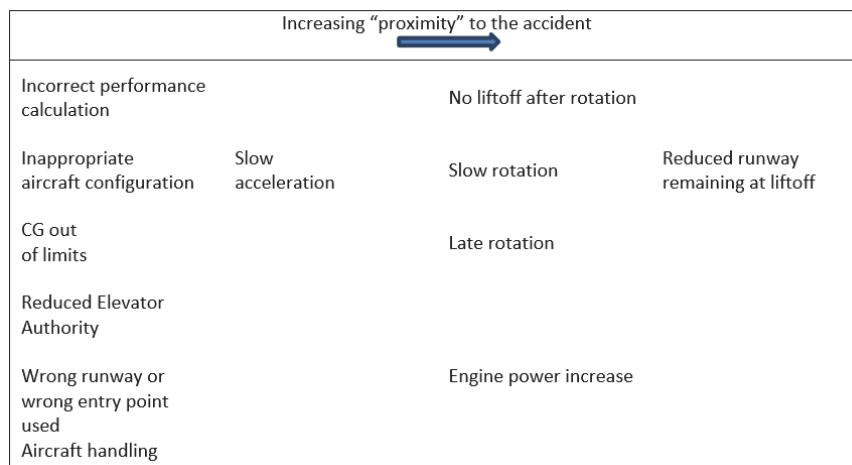
**Figure 22**

The EOFDM group carried out an analysis of the precursors to a runway overrun scenario. Two different cases were identified for this scenario: one in which a rejected takeoff was carried out and the other where no attempt was made to reject the takeoff. Their analysis of the precursors for the latter case, that most closely matches the serious incident to C-FWGH, is presented in Figure 22.

EOFDM Group precursor analysis of a runway overrun scenario, rejected takeoff not carried out

The precursor, incorrect performance calculation, was defined as: '*erroneous data entry or calculation errors [which] could lead to incorrect thrust settings or incorrect V speeds*'. Precursors from Figure 22 applicable in this event were: incorrect performance calculation, slow acceleration, late rotation, slow rotation, and reduced runway remaining at liftoff.
