Report on the investigation of a man overboard
from the creel fishing vessel
Annie T (CY 1)
with the loss of one life
in the Sound of Mingulay, Scotland
on 4 October 2015

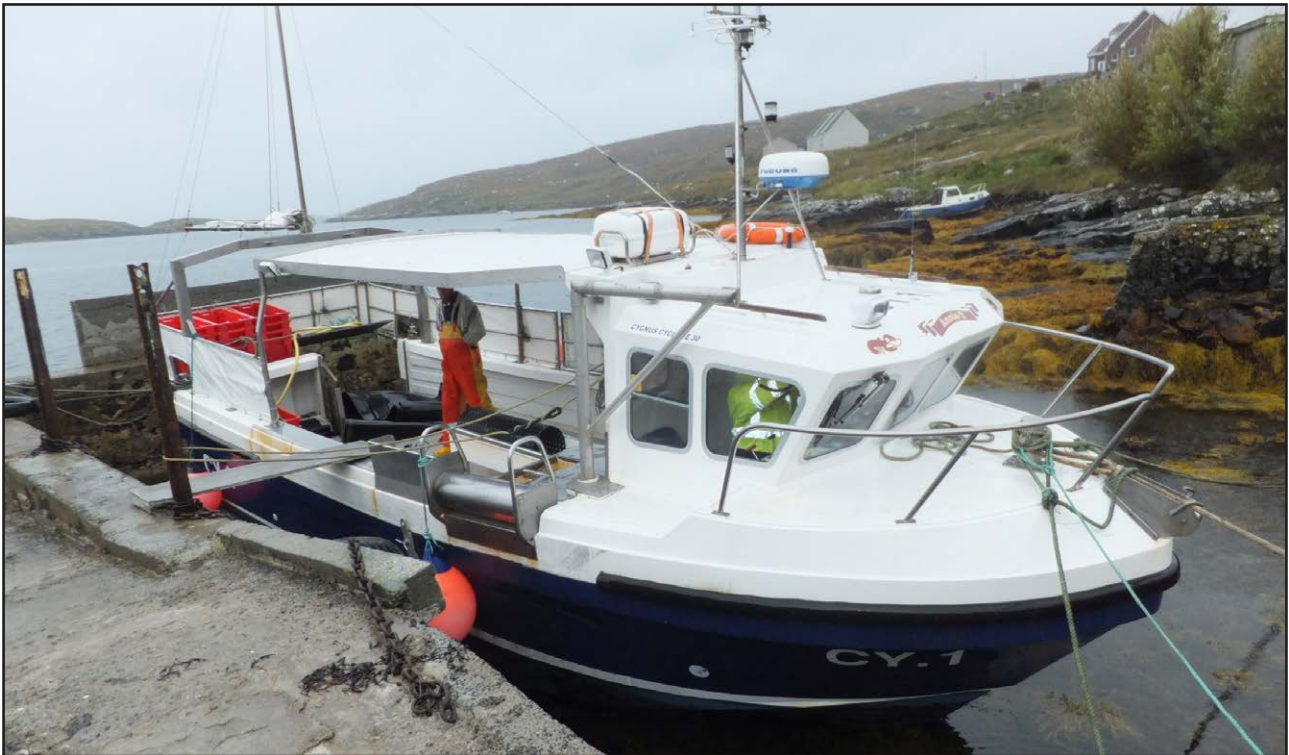
Figure 1: Fishing vessel *Annie T*

At around 0720 on 4 October 2015, the skipper of *Annie T* (**Figure 1**) and his crew member Gerard Gillies (known as Gerry) set off from Watersay to their lobster fishing grounds at the southern edge of the Western Isles. The environmental conditions were benign and *Annie T* was making a speed of about 3.5 knots (kts) through the water while shooting the gear. They worked five fleets of creels that were located to the west of Pabbay island for 2 to 3 hours and, at about noon, sailed around Mingulay to an area to the east of the Sound of Mingulay (**Figure 2**). Once in the Sound, they hauled and re-shot a further two fleets of creels, working one fleet at a time. Gerry was wearing oilskins, wellington boots and gloves. Neither he nor the skipper was wearing a lifejacket or any other buoyancy aid.

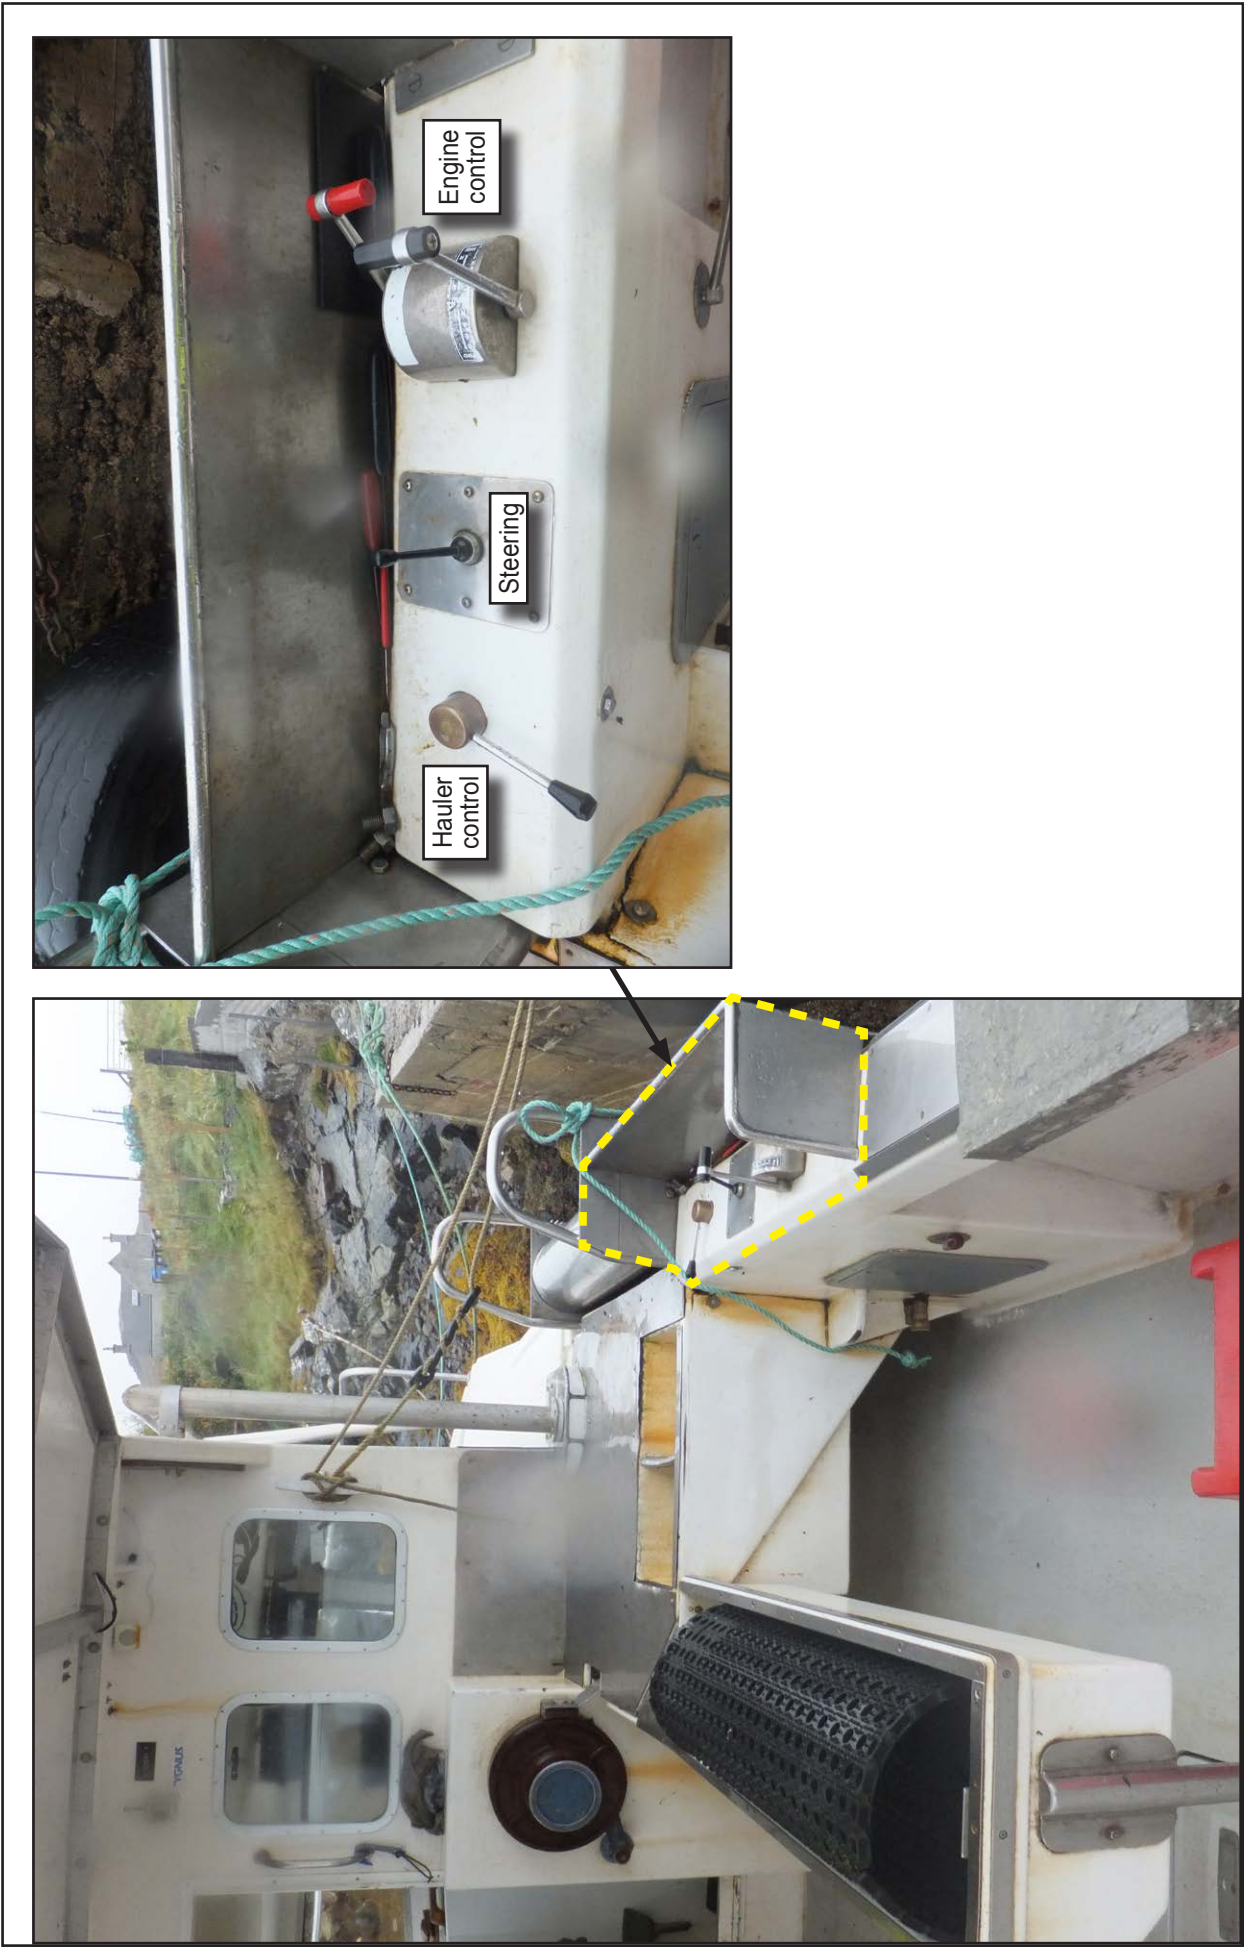
Figure 5: Hauler (inset: controls)

Annie T was a Cygnus model creel fishing vessel built in 2006. The main propulsion was a single screw, fixed pitch propeller driven by a 194kW Cummins diesel engine. In addition to the controls in the wheelhouse, the engine and steering could be controlled from the starboard side of the working deck, where the hauler control was located. The engine controls were active at both locations but the steering needed to be switched to either wheelhouse or deck control (**Figure 5**).

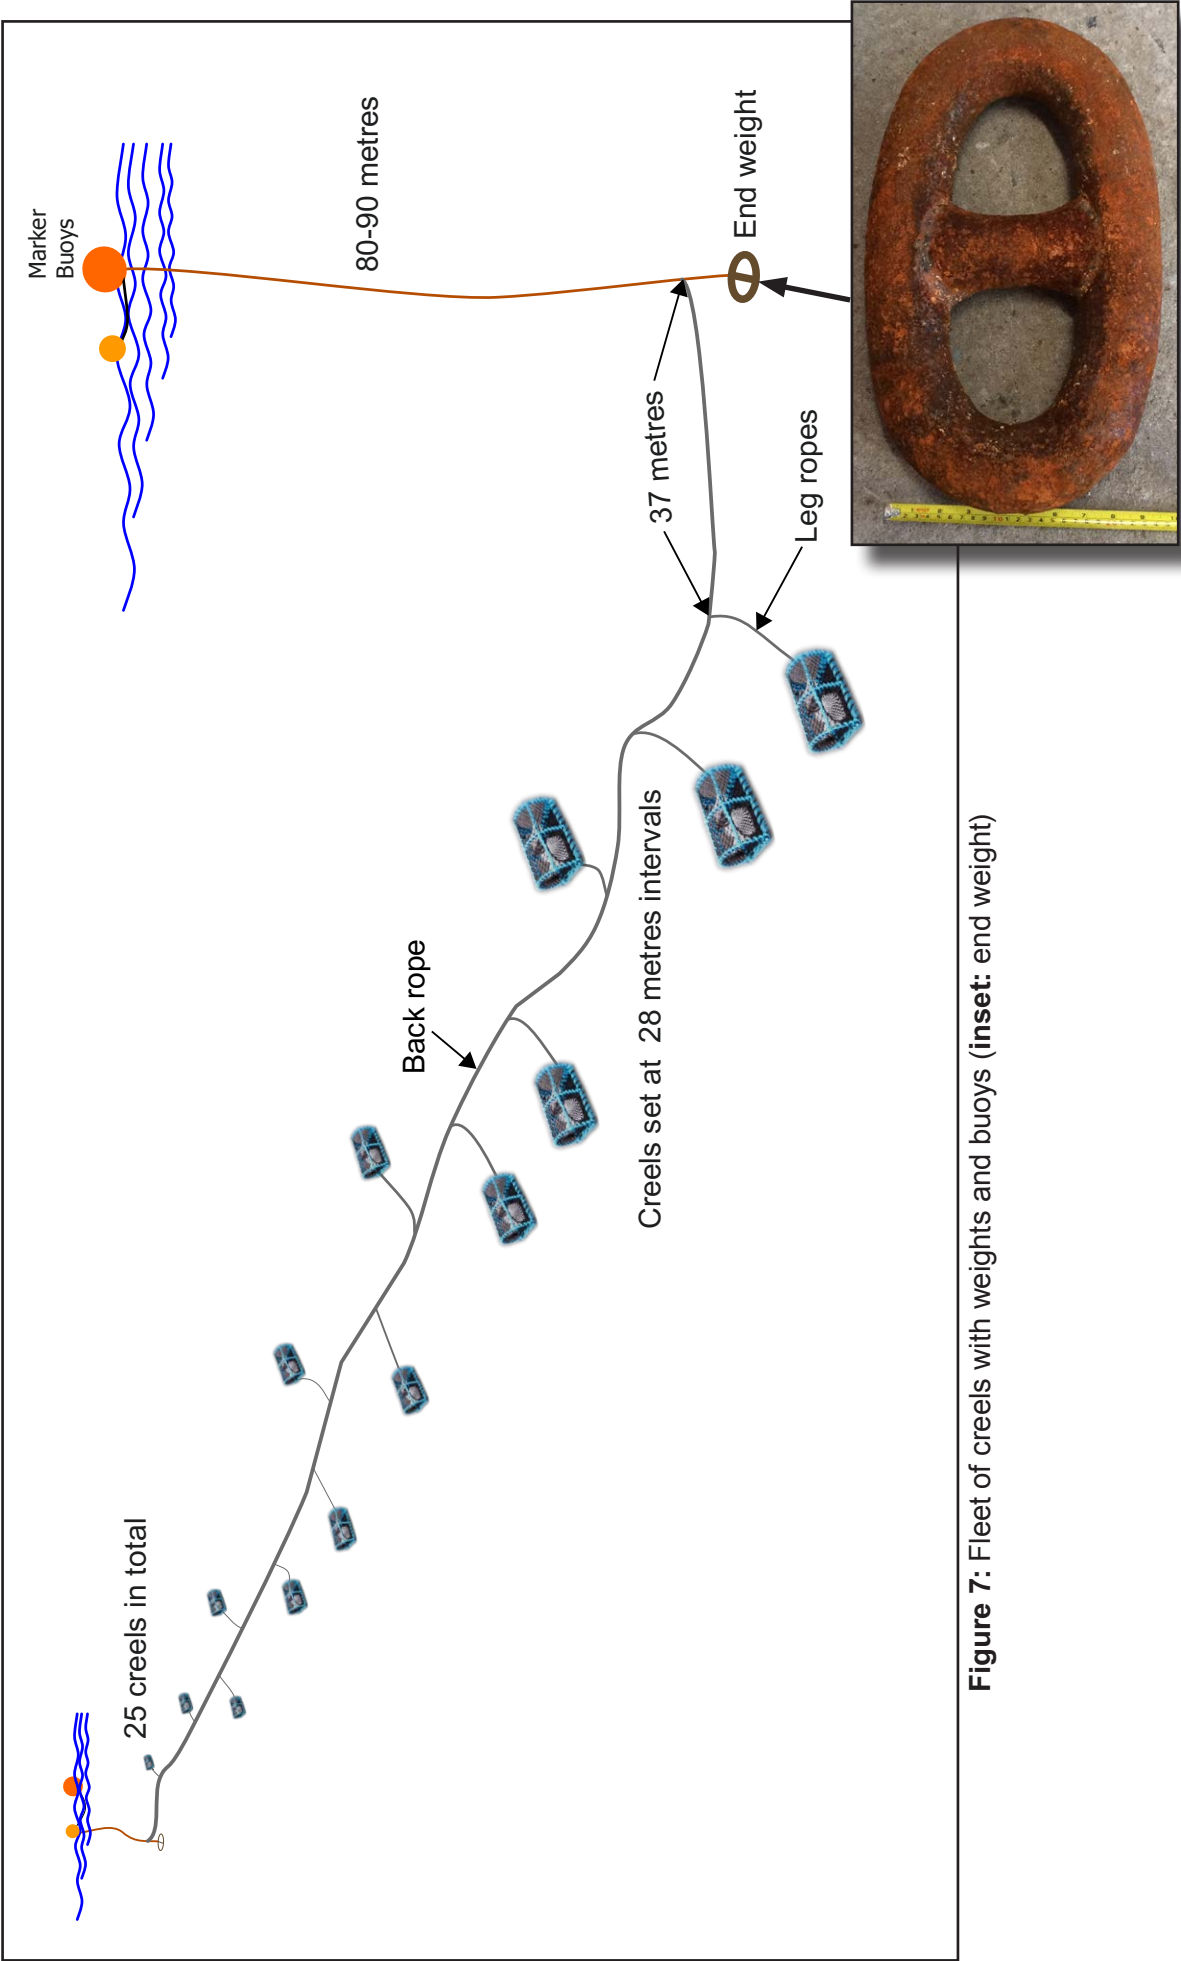
Figure 7: Fleet of creels with weights and buoys (inset: end weight)

Annie T was fishing for lobsters on the day of the accident. A fleet of lobster creels consisted of 25 creels, each weighing around 20kg when dry, spaced approximately 28m apart³, and hung by short tail ropes from a 900m long back rope. At either end of the back rope, separated by 80-90m of rope, were a marker buoy and a 36kg steel weight (**Figure 7** and **inset**).
