AIRCRAFT ACCIDENT REPORT 2/2018

Report on the serious incident to
Boeing 737-86J, C-FWGH
Belfast International Airport
on 21 July 2017

Air Accidents Investigation Branch

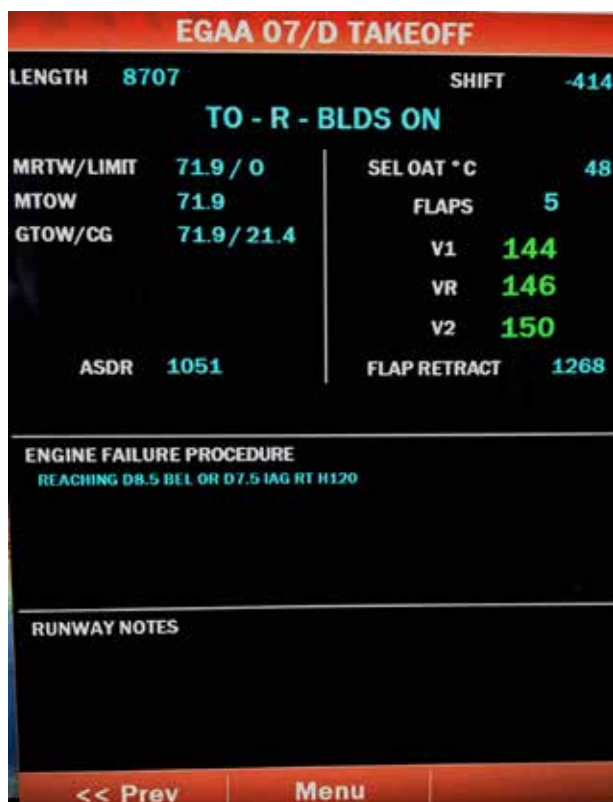
Figure 9

Using an assumed temperature of +48°C, the EFB calculated an N_1 target of 92.7% for the takeoff from Runway 07, Taxiway D. This information was not available to the crew, however, because the calculation output page did not display N_1 (Figure 9).

The EFB performance calculation output page

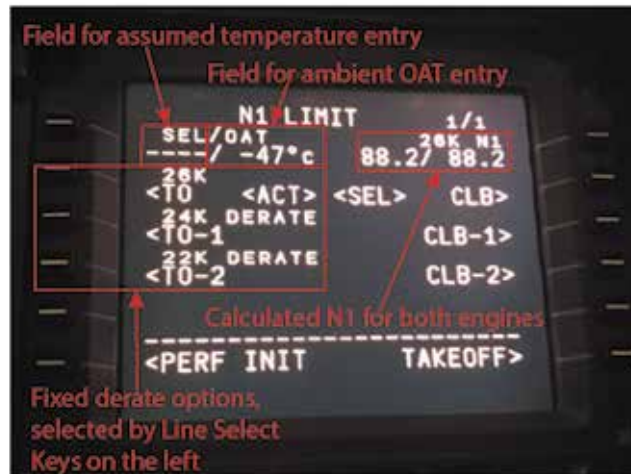
Figure 15

On the Boeing 737NG, the selection of a reduced takeoff thrust is achieved by selecting a fixed derate, and/or entering an assumed temperature into the SEL field, on the N_1 LIMIT page on either CDU (Figure 15). These thrust reduction methods can be used in isolation or combined, but the total thrust reduction when using the assumed temperature method is limited to 25% of the reference thrust used (either the full rated thrust or the fixed derate thrust). The operator of C-FWGH typically used the assumed temperature method¹⁵ to reduce takeoff thrust but not the fixed derate method.

N1 LIMIT CDU page

The text in green showing 'TO' at the top of the DU (Figure 14) indicates that a fixed derate had not been selected when this photo was taken. Had a fixed derate been selected, the text would have indicated 'TO 1' or 'TO 2' dependent on the level of derate selected on the CDU (Figure 15). The text 'TO' also indicates that an assumed temperature thrust reduction had not been selected. If an assumed temperature had been entered, it would have been shown on the DU as 'D-TO'.

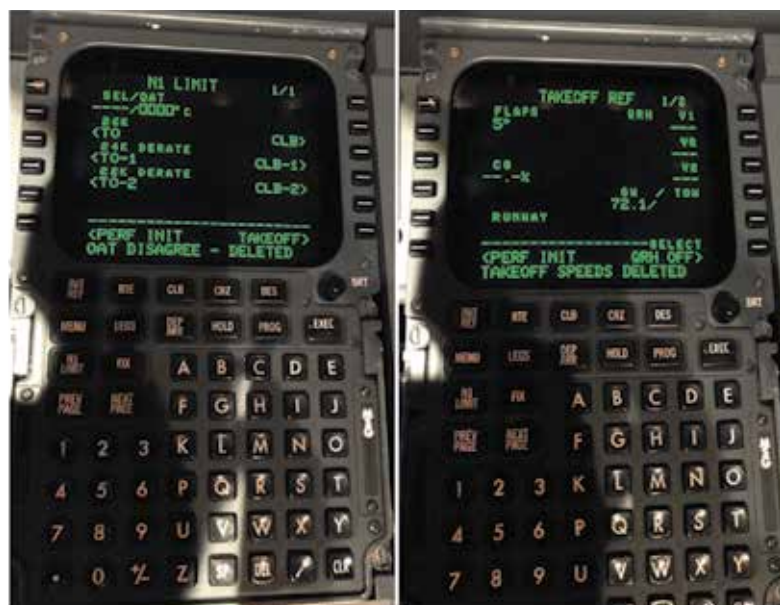
Figure 17

In addition to the release of the FCOM bulletin, the manufacturer added a crosscheck function to revision U12.0 and later versions of the FMC OPS software. The crosscheck compares the OAT entered by the crew, or accepted by the crew in the case of a data-linked OAT, against either that sensed by the Electronic Engine Controls or, on some older Boeing 737s (including the -100 to -500 series that pre-date Boeing 737NG aircraft), by the aspirated Total Air Temperature probe. The crosscheck runs once, approximately one minute after first engine start, and establishes whether a difference of more than six degrees in temperature exists between the value accepted by the FMC and that sensed by the external temperature sensor. If the difference is more than six degrees, it deletes the OAT entry, removes any assumed temperature or fixed derate that has been selected and deletes the takeoff reference speeds. It also displays two messages and illuminates the 'MSG' indicator on both CDUs to warn the crew that data has been deleted from the FMC; the messages shown are OAT DISAGREE – DELETED and TAKEOFF SPEEDS DELETED (Figure 17).

CDU messages associated with the FMC OPS U12.0 OAT crosscheck

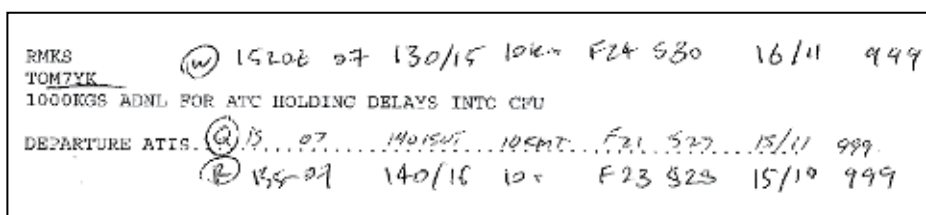
Figure 21

ATIS as recorded by PM on the pilot's log

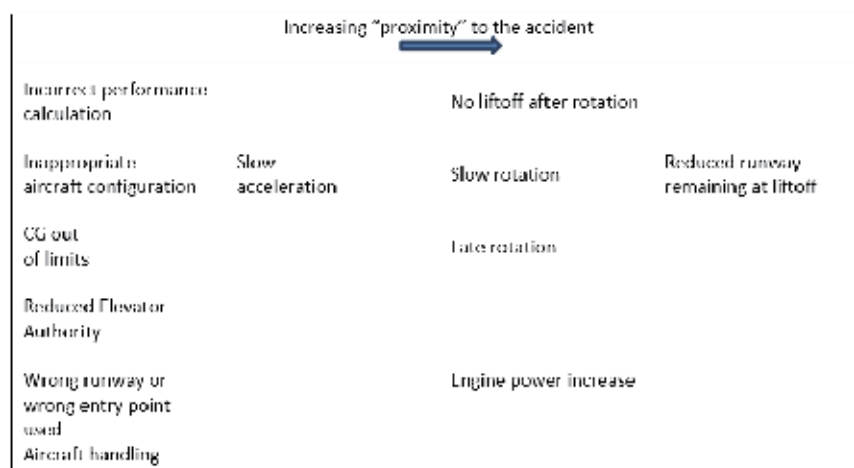
The EOFDM group carried out an analysis of the precursors to a runway overrun scenario. Two different cases were identified for this scenario: one in which a rejected takeoff was carried out and the other where no attempt was made to reject the takeoff. Their analysis of the precursors for the latter case, that most closely matches the serious incident to C-FWGH, is presented in Figure 22.

EOFDM Group precursor analysis of a runway overrun scenario, rejected takeoff not carried out

The precursor, incorrect performance calculation, was defined as: '*erroneous data entry or calculation errors [which] could lead to incorrect thrust settings or incorrect V speeds*'. Precursors from Figure 22 applicable in this event were: incorrect performance calculation, slow acceleration, late rotation, slow rotation, and reduced runway remaining at liftoff.
