Report on the investigation into
the capsize and foundering of the fishing vessel
Solstice (PH199)
resulting in one fatality
approximately 7 miles south of Plymouth, England
26 September 2017

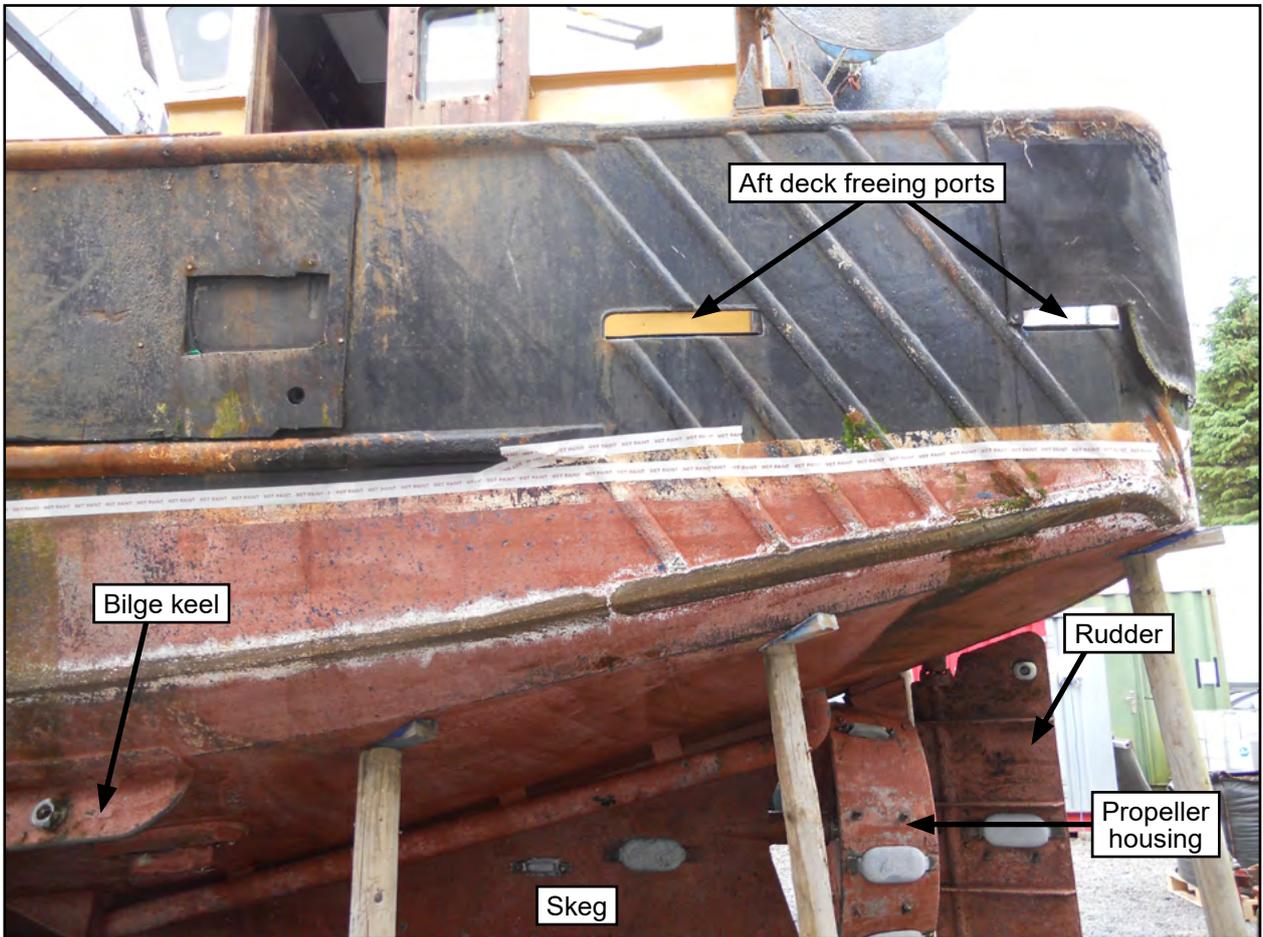
Solstice was built in 2000 at the Offshore Steel Boats shipyard in Barton, Humberside. It had an all steel construction, with an aft wheelhouse, all-round bulwark and a raked and curved transom. It had a conventional single screw propeller and blade-type rudder, and its hull had an aft skeg and was fitted with bilge keels (**Figures 11, 12 and 13**). Below deck from fore to aft was a forward store, insulated fish hold, engine room, full width cabin, and aft peak space that contained the steering gear. Access to the engine room and cabin space was via the wheelhouse, and access to the fish hold and forward store was via hatches on the forward working deck. The wheelhouse door was on the port side.

Figure 12: Pre-purchase survey – hull form aft end port side showing aft skleg design

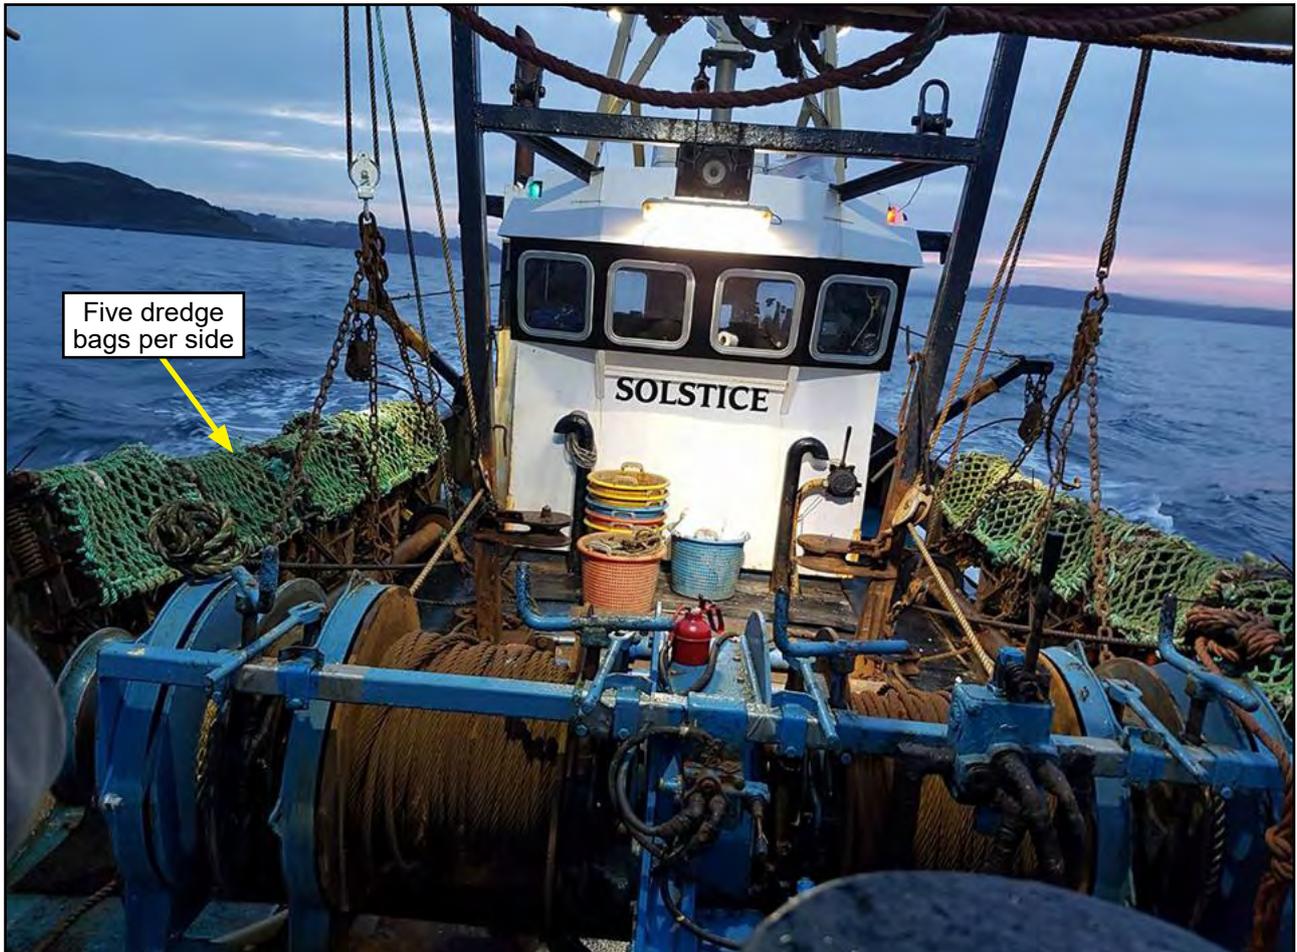
Between 23 May and 18 June 2017, modifications were made to *Solstice*'s bulwarks and dredge gear to improve working methods and increase the vessel's catch. Longer dredge beams with five bags instead of four were fitted and larger steel trays for landing the dredge bags were welded to the top of the forward deck gunwales (**Figure 16**).

Figure 16: Modifications carried out to *Solstice* in 2017 to improve dredging method

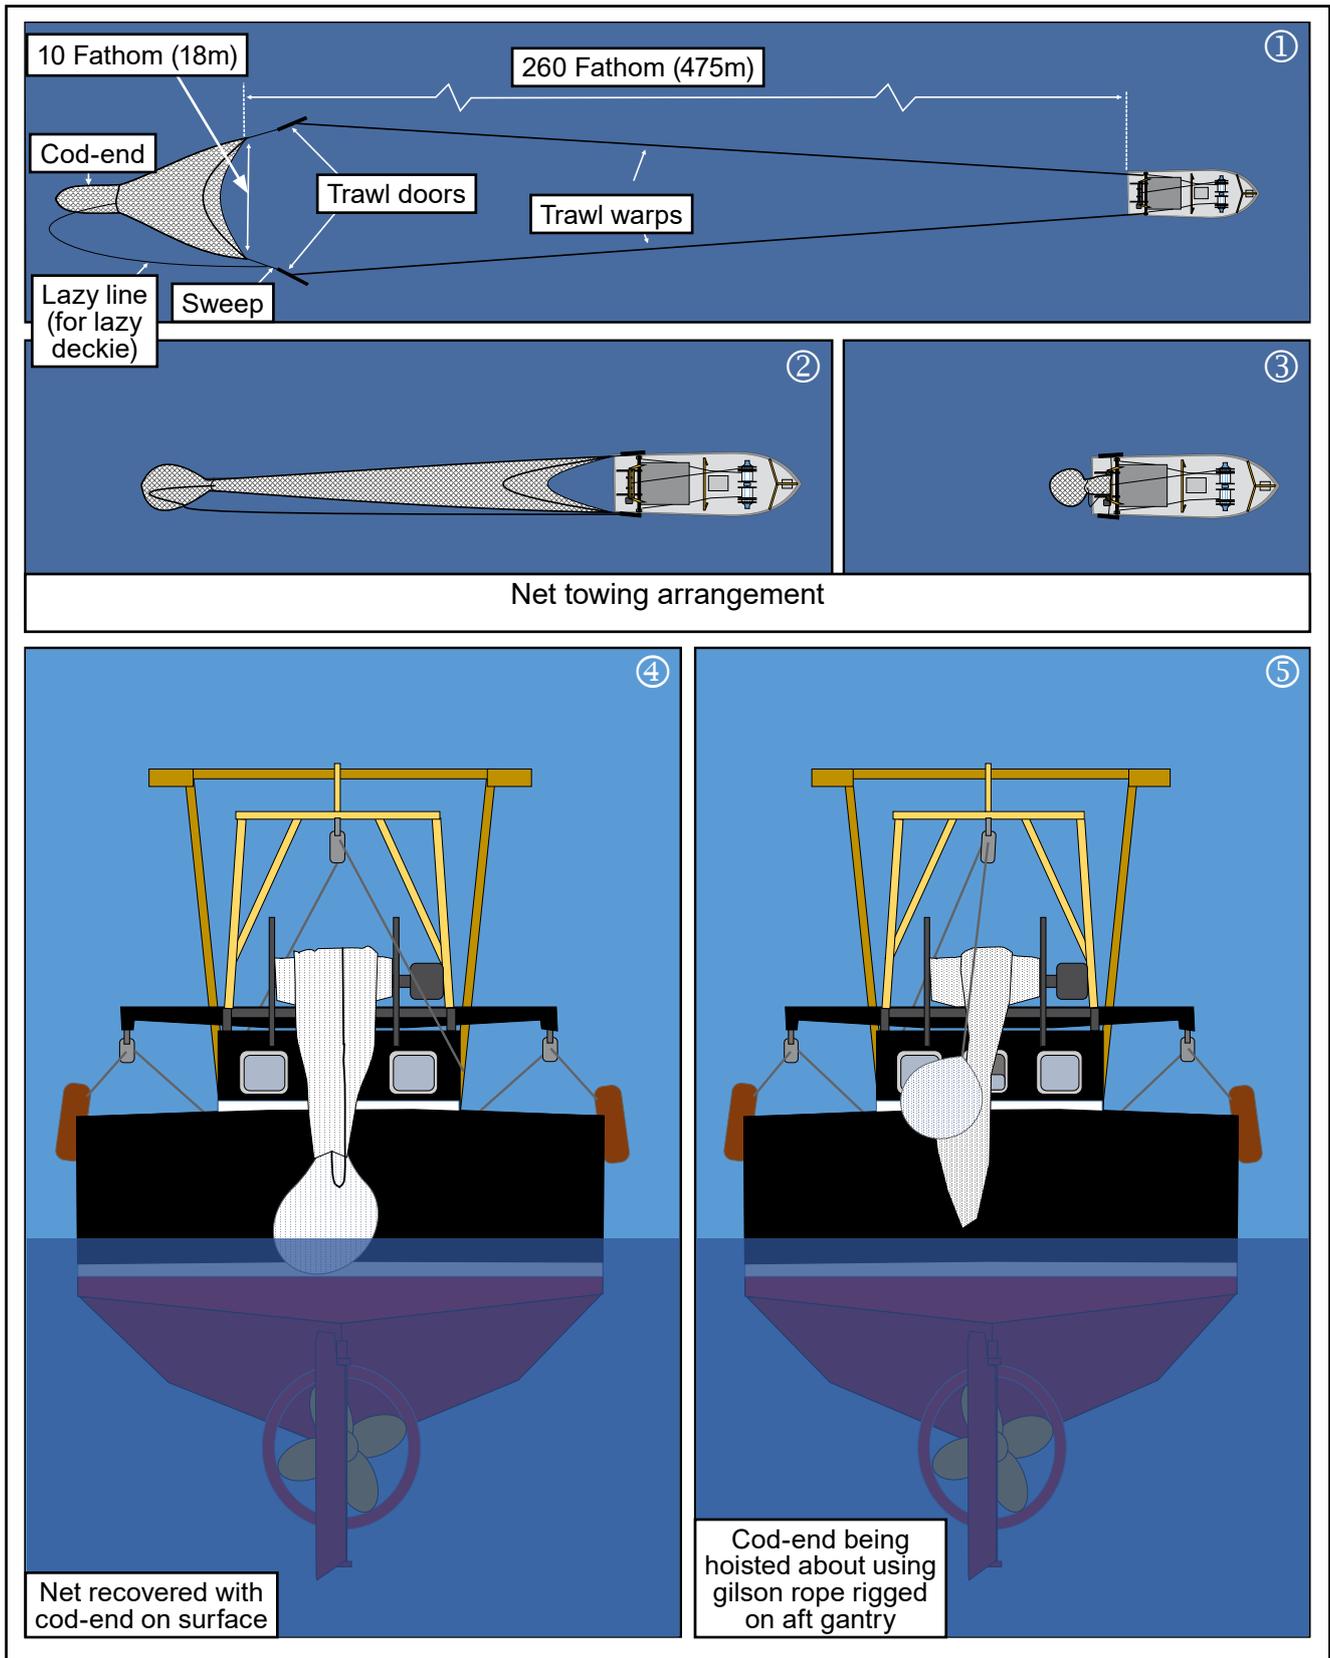
Solstice did not have a written risk assessment or safe system of work for trawling. The method (**Figure 17**) used by Tony to land the catch involved recovering the net over the stern and emptying the cod-end onto the deck area aft of the wheelhouse. To do this, the forward winch was used to haul in the trawl warps and sweeps. Once the trawl doors were secured, the net drum was used to haul the cod-end to the surface. The cod-end was then lifted over the stern deck bulwark using the deck winch and a gilson rope. The gilson rope was rigged through the block at the top of the aft gantry. The cod-end was emptied onto the aft deck between the pound boards (**Figure 18**). Once landed, the catch was processed, boxed up and taken forward to the fish hold.

Figure 17: Solstice net towing and catch recovery method

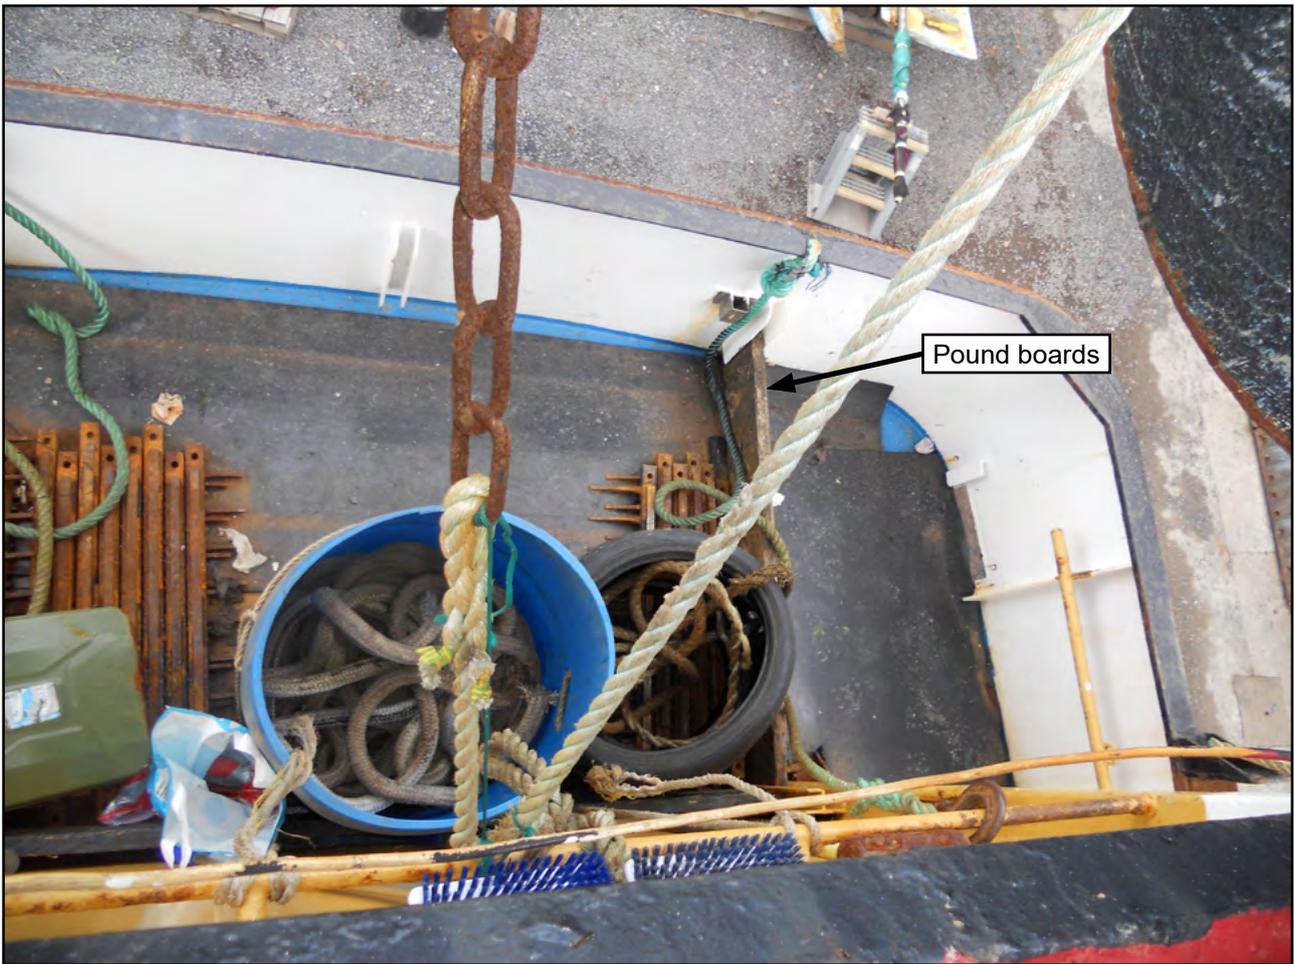
Figure 18: Aft deck

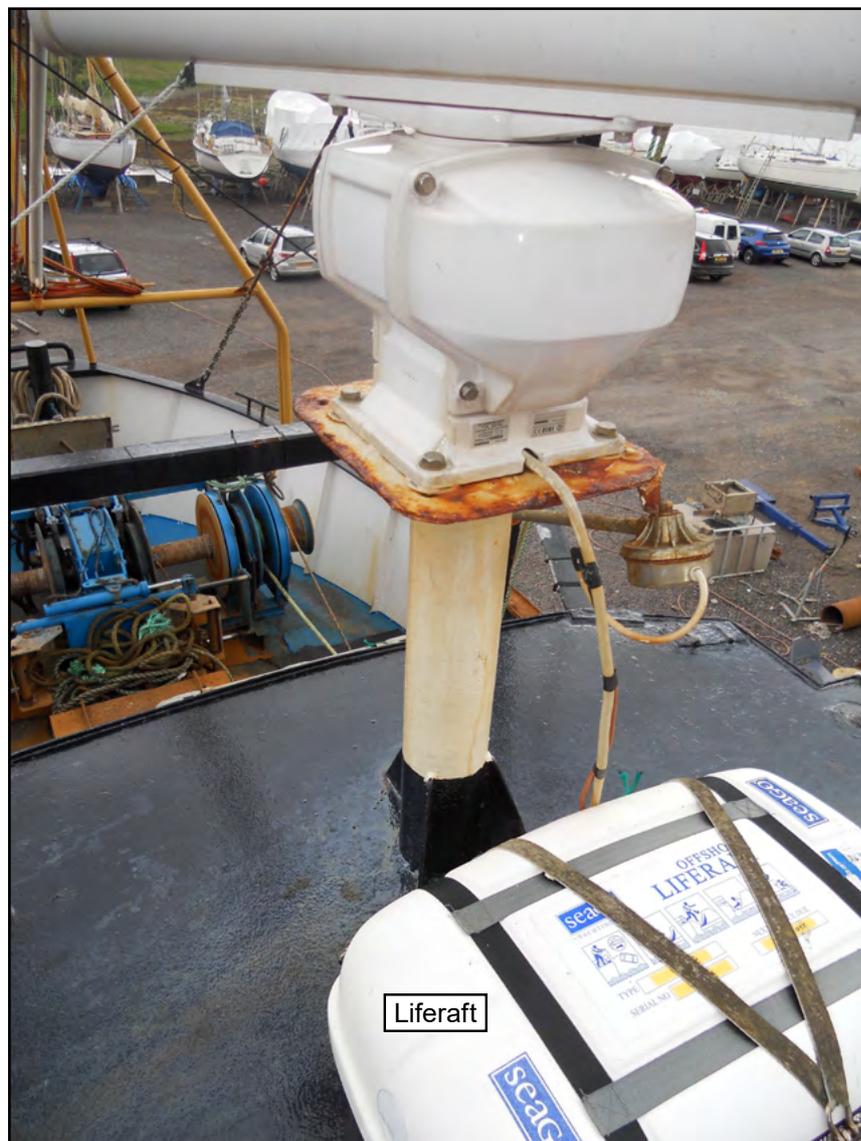
Solstice had two lifebuoys, one each side of the wheelhouse; the starboard lifebuoy had an 18m buoyant line. The vessel also had a four-person *Seago Offshore* liferaft that was stowed in a cradle on top of the wheelhouse roof (**Figure 19**) and secured in place by a hydrostatic release unit (HRU). The liferaft was on board when Tony purchased the boat and was overdue its periodic service (the service due date was May 2017).

Figure 19: Liferaft on top of wheelhouse

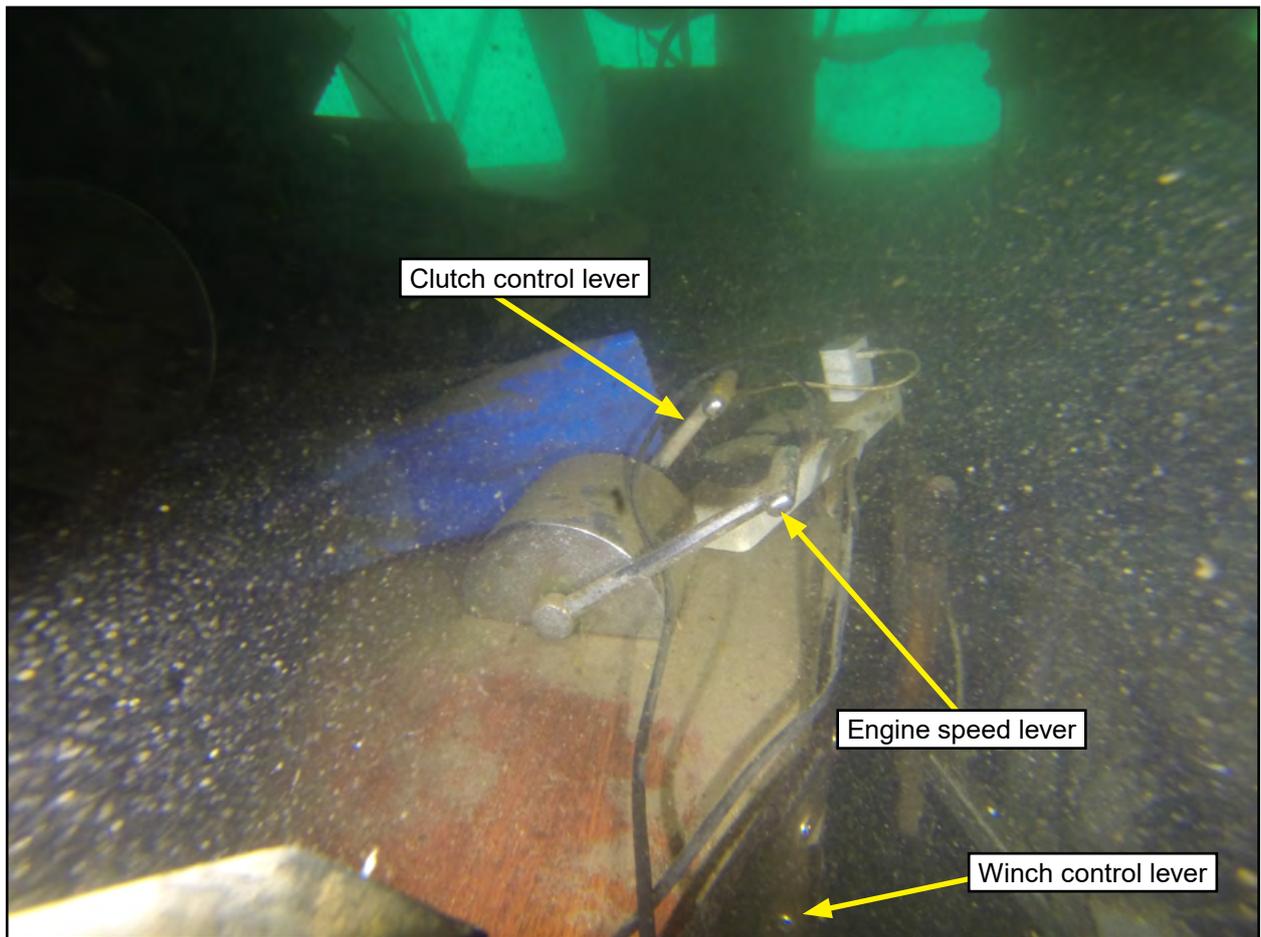
Figure 22: Wreck showing wheelhouse engine control

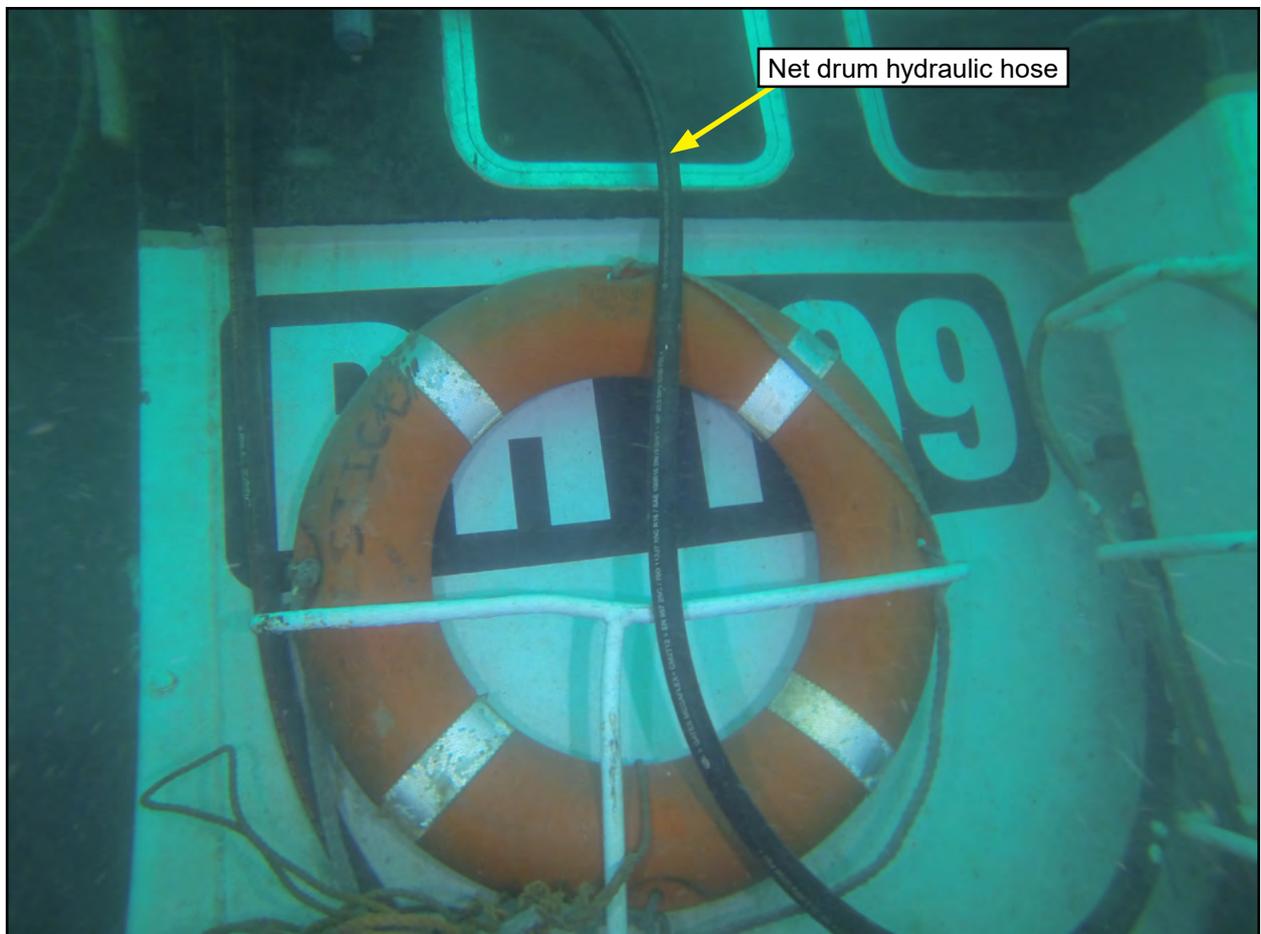
Figure 23: Wreck showing starboard lifebuoy

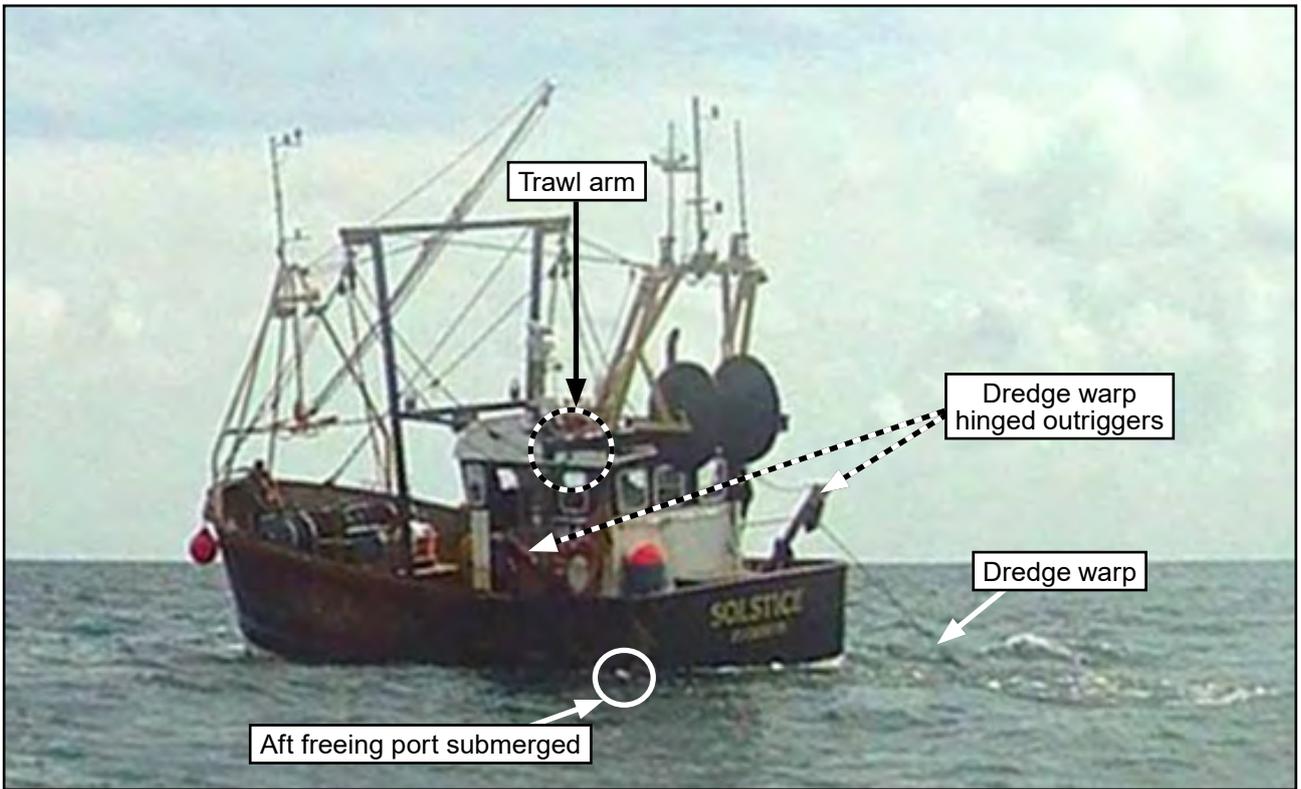
It was not unusual for water to wash onto *Solstice's* deck through its aft freeing ports when towing its dredge gear. This was due to the reduction of freeboard aft as the vessel trimmed by the stern (**Figure 33**).

Figure 33: *Solstice* trimmed by the stern and heeling to port

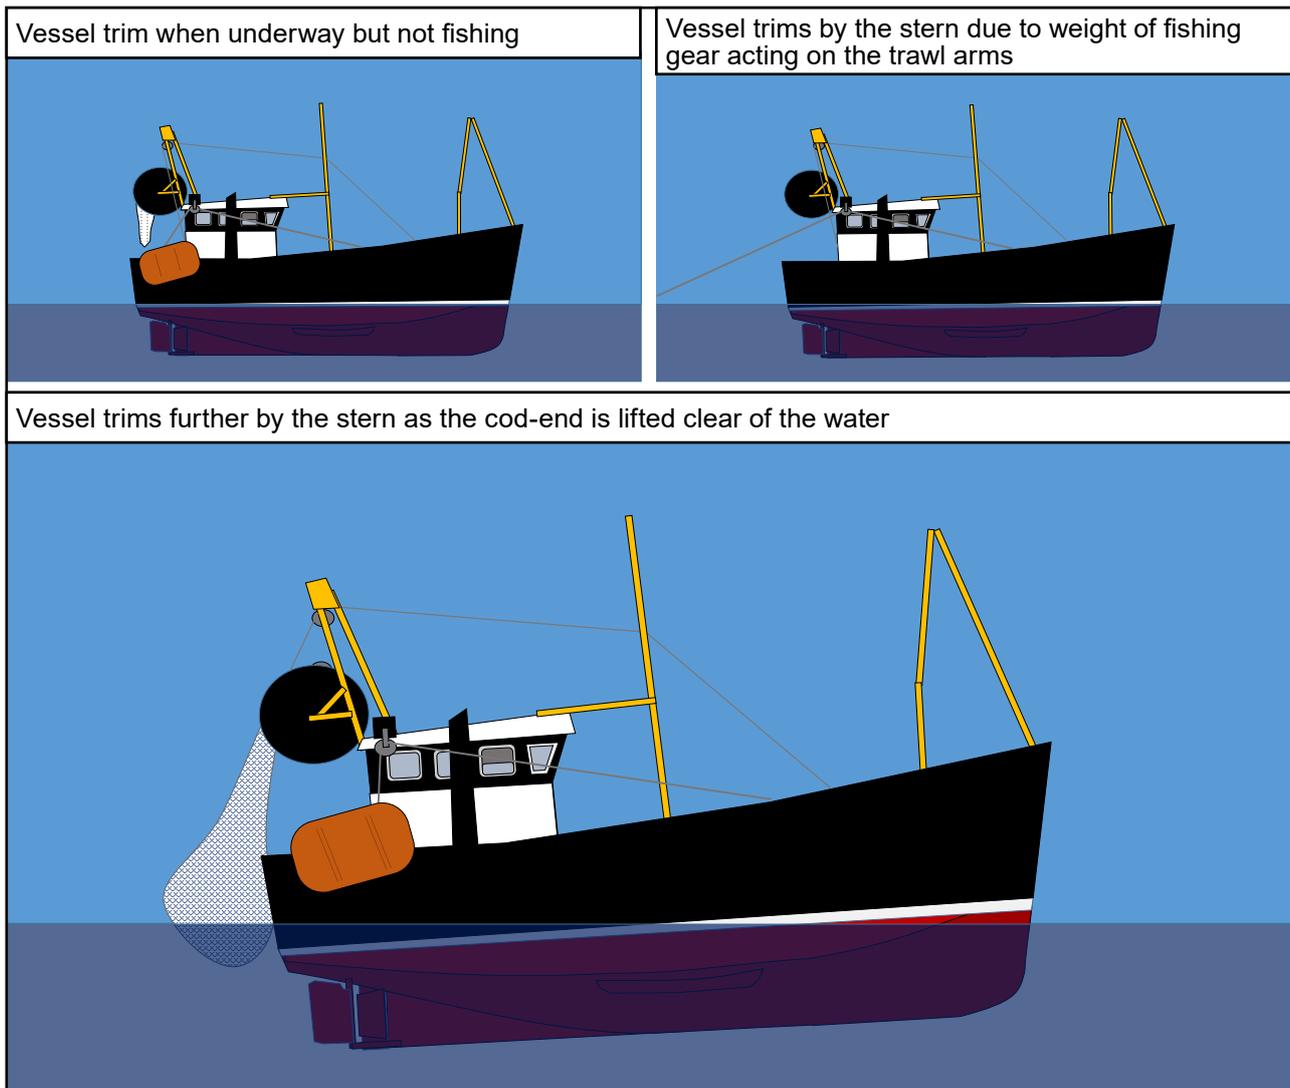
The wreck dive survey identified that the freeing ports on *Solstice's* aft deck had been wedged shut (**Figure 24**). The crew's reasoning for this was understandable as water on the aft deck would have been more problematic to the crew because that was their working area. Furthermore, the likelihood of the aft deck freeing ports being immersed would have been higher when stern trawling. This was because the trawl arms were positioned higher than the hinged dredge warp outriggers, which would have caused the vessel to trim further by the stern and therefore reduce the freeboard aft (**Figure 35**).

Figure 35: Large change of trim when lifting a weight at the stern
