Failure of a throw bag rescue line during a capsized drill on an unnamed rowing boat Widnes, UK 24 March 2018

SUMMARY

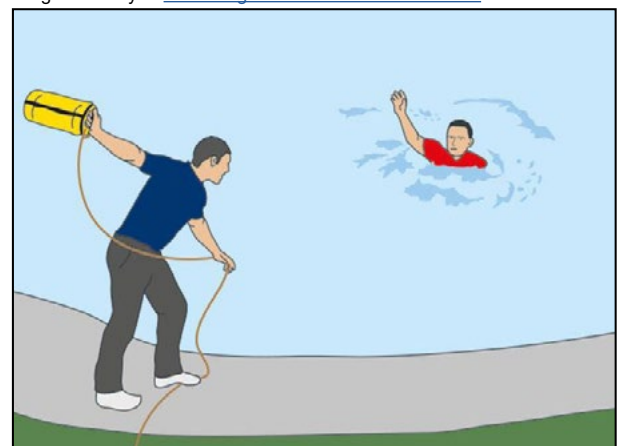
Figure 3: Illustration showing a throw bag being used to rescue a casualty

The primary purpose of a throw bag is to rescue people from the water. It is designed to pull a casualty to safety either to the side of a vessel or to a safe area away from deep and fast flowing waters. It is not designed to lift a person out of the water. A throw bag consists of a length of buoyant rope, the rescue line, contained in a bag with one end of the rope passing through the bottom of the bag and terminating in a knot or other handhold for the casualty. With the rescue line held at the free end, the bag containing the rescue line is thrown to the casualty in the water. Provided the rescue line is correctly 'flaked'², the weight of the line inside the bag carries it to the casualty while the rescue line unravels (**Figure 3**).
