Report on the investigation of the contact
and grounding of the ro-ro passenger ferry

Pride of Kent

Calais, France

10 December 2017

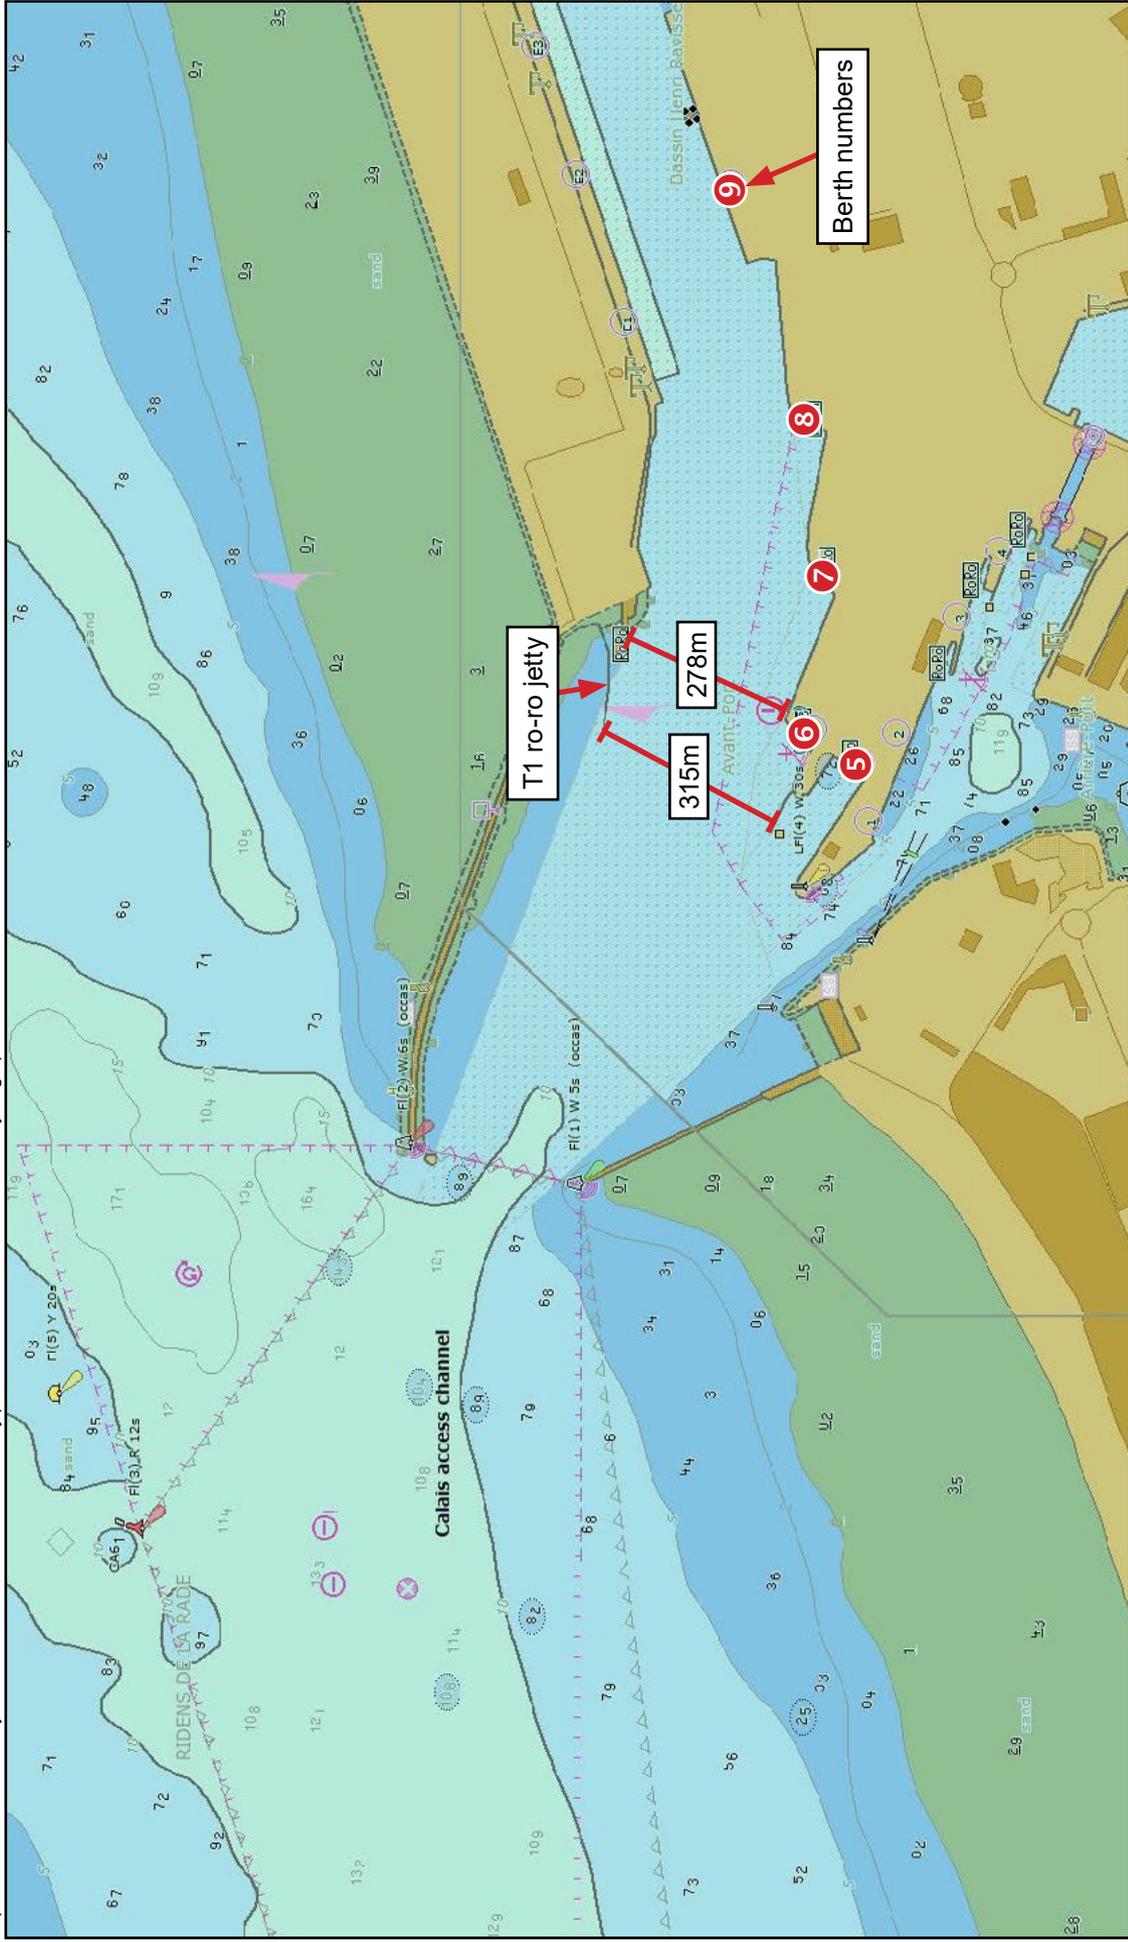
Figure 1: Port of Calais electronic chart extract from cells FR572580 and FR67258A

At 1005 on 10 December 2017, the ro-ro passenger ferry *Pride of Kent* was approaching Calais, France. On the bridge was the master, an officer of the watch (OOW), an assisting officer, and a helmsman. When the ferry was 1½ miles from the port entrance, the master took the conn from the OOW and briefed the bridge team that he would be keeping the vessel upwind during the approach to berth No.6 (**Figure 1**). The wind was from the south-south-west at 25 knots (kts).

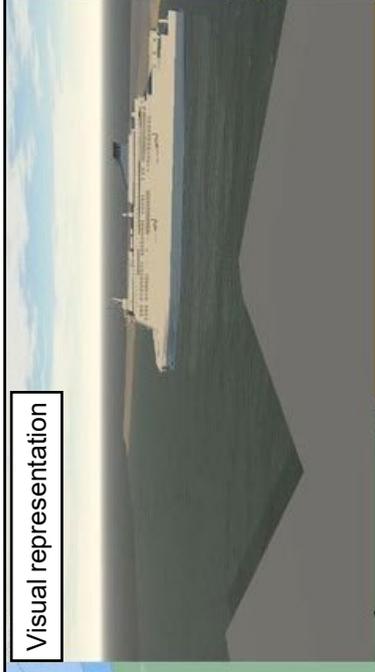
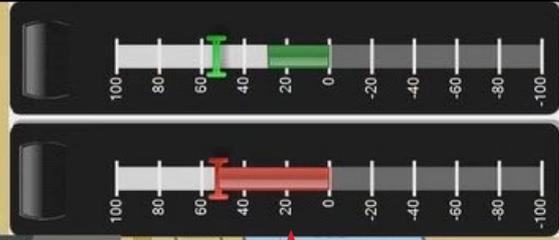
Figure 3: Vessel position at 11:41:51 – significant wind speed increase

By 1140, the mooring lines were clear and the stern had started to lift from the berth as intended. At 1141, the master manoeuvred the ferry astern, and then started to swing its bow to starboard (**Figure 3**). Seconds later, the wind speed increased to a steady 45kts, gusting to 55kts.

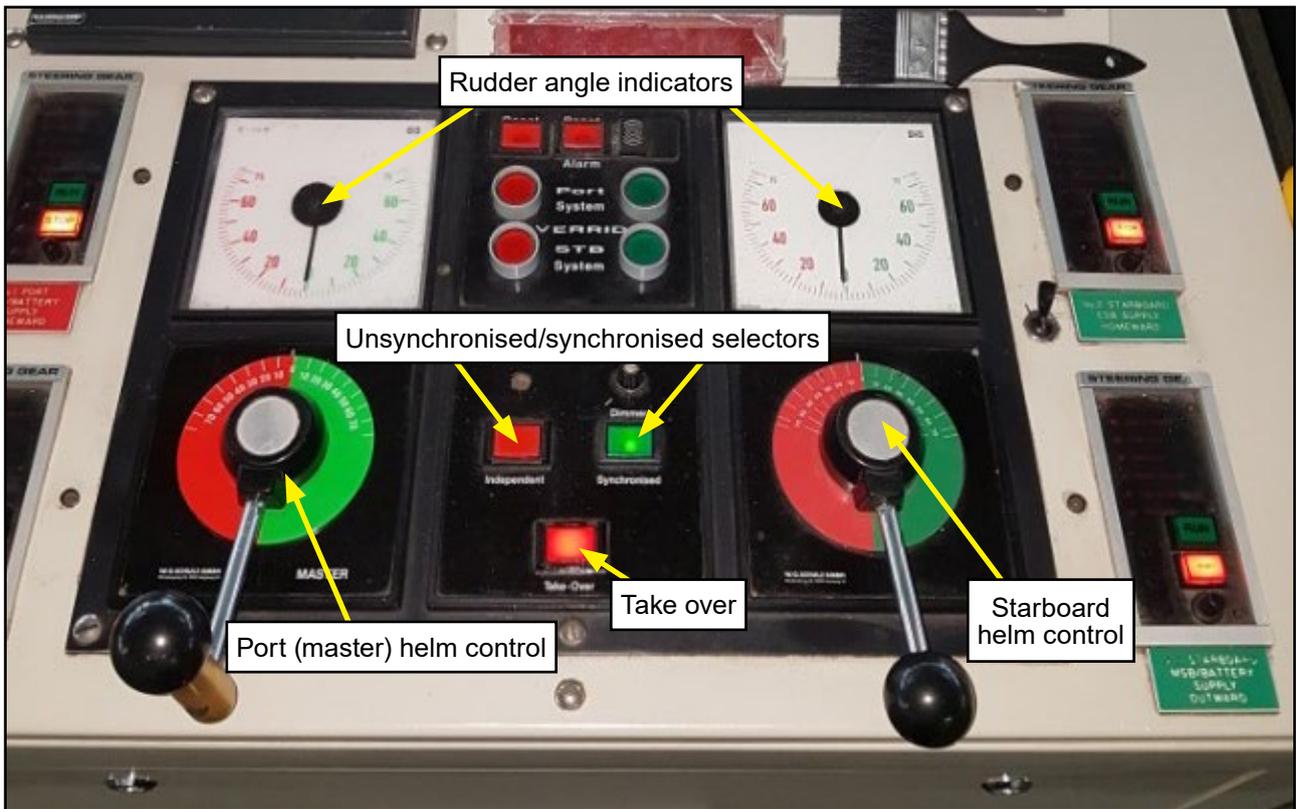
Figure 6: Main console steering control panel (centre console)

At 1144:55, *Pride of Kent's* master put both rudders to amidships as the ferry's heading approached 289° (**Figure 5**). He then requested the helmsman to take steering control at the centre console and steer for the green light on the southern breakwater. The helmsman pressed the take-over button and moved the port (master) control lever⁴ (**Figure 6**) to port 40°. The starboard helm control lever remained at amidships.

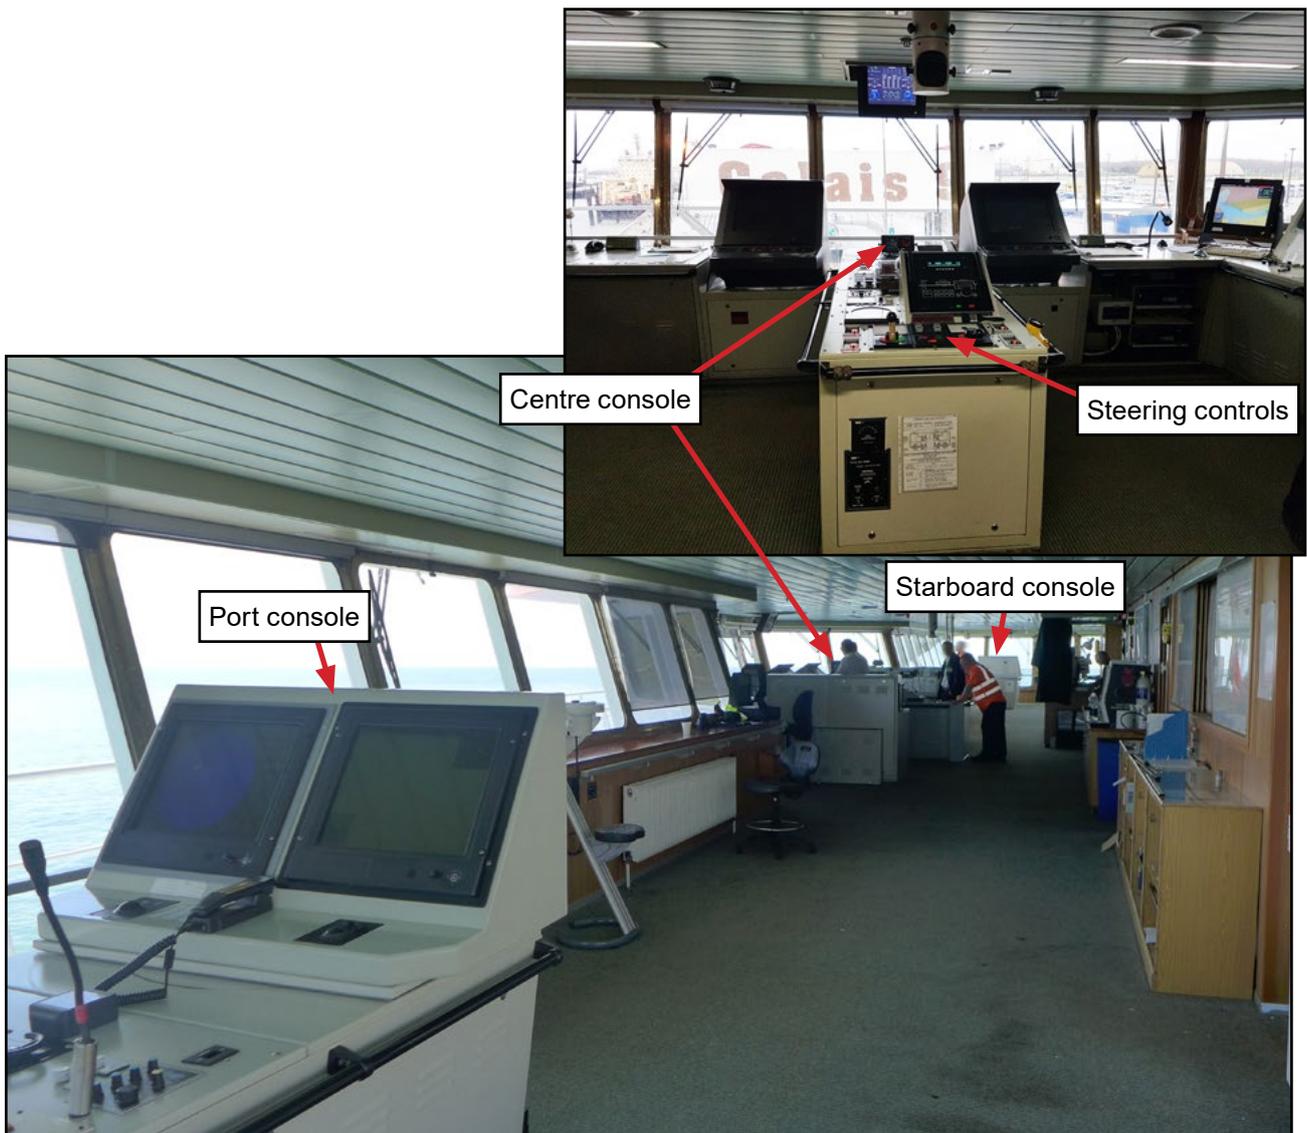
Figure 9: Fully enclosed bridge arrangement

Pride of Kent's enclosed bridge was fitted with three control consoles; one on the centreline and one on each bridge wing (**Figure 9**). Each of the consoles was equipped with a radar display, an ECDIS, VHF radio and control panels for the main engines, propeller pitch, bow thrusters and steering. Only the centre console was fitted with a talkback system for communicating with the engine control room, and a rate of turn indicator.
