Ministry  
of Defence

## Defence Infrastructure Organisation

Ref: EIR/2017/13719

September 2014

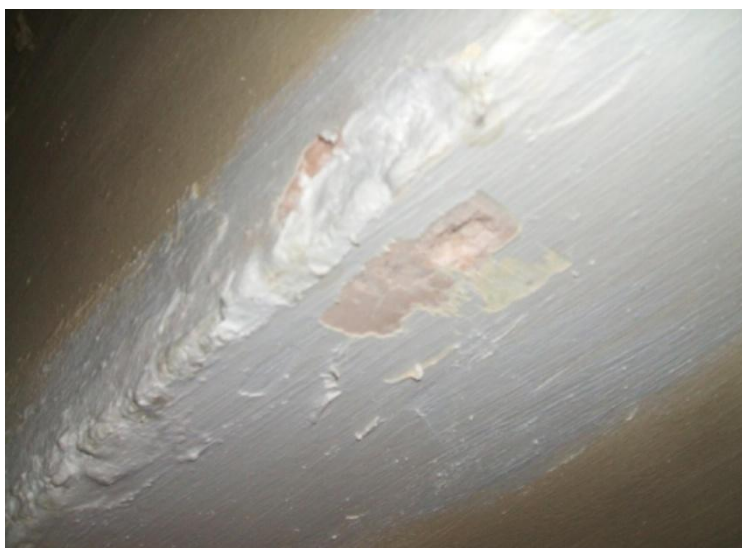
<b>Site Code/UPRN</b>	SD724P/86213	<b>Building</b>	Main Building
<b>Address</b>	The Old War Office Horse Guards Avenue Whitehall London  SW1A 2HB	<b>Floor</b>	Basement
		<b>Room</b>	Corridor WES 275
		<b>Quantity</b>	N/A
<b>Description</b>	Encapsulant to beam. Sample taken from beam directly adjacent to goods lift.	<b>Asbestos Suspected</b>	<b>No</b>

<b>Last Inspection Date</b>	-	03 Sep 2012	<b>Certificate N°</b>	-	BK30485
<b>Next Inspection Date</b>	-	03 Sep 2013	<b>Sample N°</b>	-	28
<b>Survey Type</b>	-	Refurbishment & Demolition Survey	<b>Photograph N°</b>	-	4667
<b>Position</b>	-	Sample Taken	<b>Location ID</b>	-	Loc19969

<b>Product Type</b>	-	N/A	<b>Surface Treatment</b>	-	N/A
<b>Asbestos Type</b>	-	No Asbestos Detected	<b>Damage Extent</b>	-	N/A
<b>Material Risk Score</b>	-	<b>0</b>	<b>Material Risk Band</b>	-	N/A

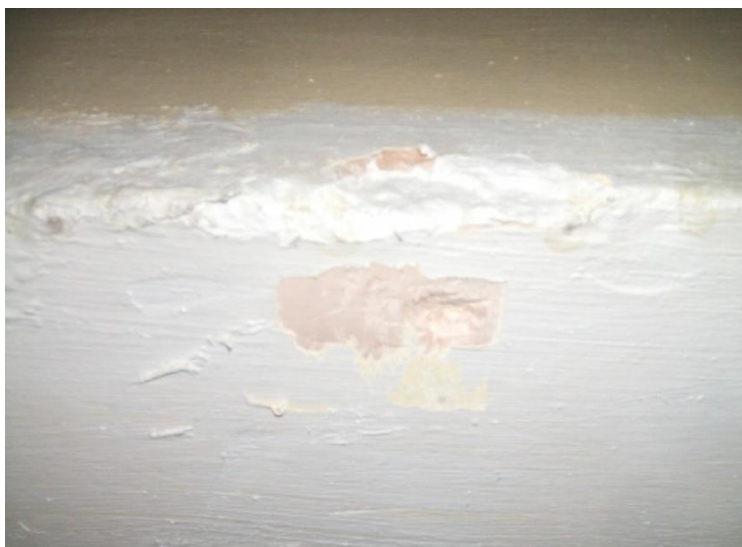
<b>Site Code/UPRN</b>	SD724P/86213	<b>Building</b>	Main Building
<b>Address</b>	The Old War Office Horse Guards Avenue Whitehall London	<b>Floor</b>	Basement
	SW1A 2HB	<b>Room</b>	Corridor WES 275
<b>Description</b>	Concrete to beam. Sample taken of render to concrete beam beneath encapsulant.	<b>Quantity</b>	N/A
		<b>Asbestos Suspected</b>	<b>No</b>

<b>Last Inspection Date</b>	-	03 Sep 2012	<b>Certificate N°</b>	-	BK30485
<b>Next Inspection Date</b>	-	03 Sep 2013	<b>Sample N°</b>	-	29
<b>Survey Type</b>	-	Refurbishment & Demolition Survey	<b>Photograph N°</b>	-	4668
<b>Position</b>	-	Sample Taken	<b>Location ID</b>	-	Loc19970

<b>Product Type</b>	-	N/A	<b>Surface Treatment</b>	-	N/A
<b>Asbestos Type</b>	-	No Asbestos Detected	<b>Damage Extent</b>	-	N/A
<b>Material Risk Score</b>	-	<b>0</b>	<b>Material Risk Band</b>	-	N/A

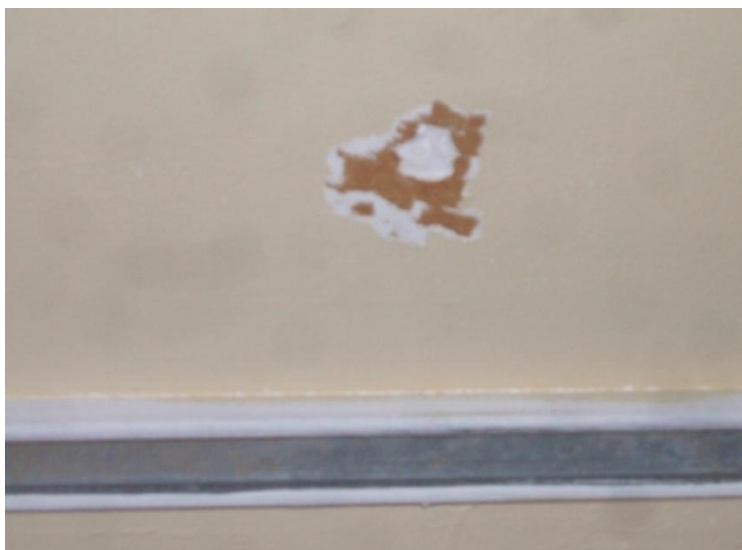
<b>Site Code/UPRN</b>	SD724P/86213	<b>Building</b>	Main Building
<b>Address</b>	The Old War Office Horse Guards Avenue Whitehall London	<b>Floor</b>	Basement
	SW1A 2HB	<b>Room</b>	Room B21
<b>Description</b>	Painted plasterboard ceiling. Present in front of RSJ.	<b>Quantity</b>	N/A
		<b>Asbestos Suspected</b>	<b>No</b>

<b>Last Inspection Date</b>	-	03 Sep 2012	<b>Certificate N°</b>	-	BK30485
<b>Next Inspection Date</b>	-	03 Sep 2013	<b>Sample N°</b>	-	10
<b>Survey Type</b>	-	Refurbishment & Demolition Survey	<b>Photograph N°</b>	-	4648
<b>Position</b>	-	Sample Taken	<b>Location ID</b>	-	Loc19951

<b>Product Type</b>	-	N/A	<b>Surface Treatment</b>	-	N/A
<b>Asbestos Type</b>	-	No Asbestos Detected	<b>Damage Extent</b>	-	N/A
<b>Material Risk Score</b>	-	<b>0</b>	<b>Material Risk Band</b>	-	N/A

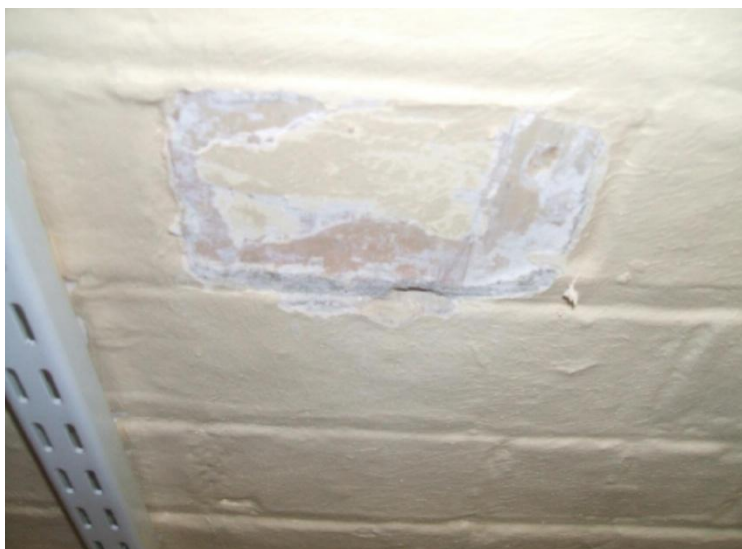
<b>Site Code/UPRN</b>	SD724P/86213	<b>Building</b>	Main Building
<b>Address</b>	The Old War Office Horse Guards Avenue Whitehall London	<b>Floor</b>	Basement
	SW1A 2HB	<b>Room</b>	Room B21
<b>Description</b>	Wall encapsulant. Present to left side wall.	<b>Quantity</b>	N/A
		<b>Asbestos Suspected</b>	<b>No</b>

<b>Last Inspection Date</b>	-	03 Sep 2012	<b>Certificate N°</b>	-	BK30485
<b>Next Inspection Date</b>	-	03 Sep 2013	<b>Sample N°</b>	-	06
<b>Survey Type</b>	-	Refurbishment & Demolition Survey	<b>Photograph N°</b>	-	4644
<b>Position</b>	-	Internal	<b>Location ID</b>	-	Loc19947

<b>Product Type</b>	-	N/A	<b>Surface Treatment</b>	-	N/A
<b>Asbestos Type</b>	-	No Asbestos Detected	<b>Damage Extent</b>	-	N/A
<b>Material Risk Score</b>	-	<b>0</b>	<b>Material Risk Band</b>	-	N/A

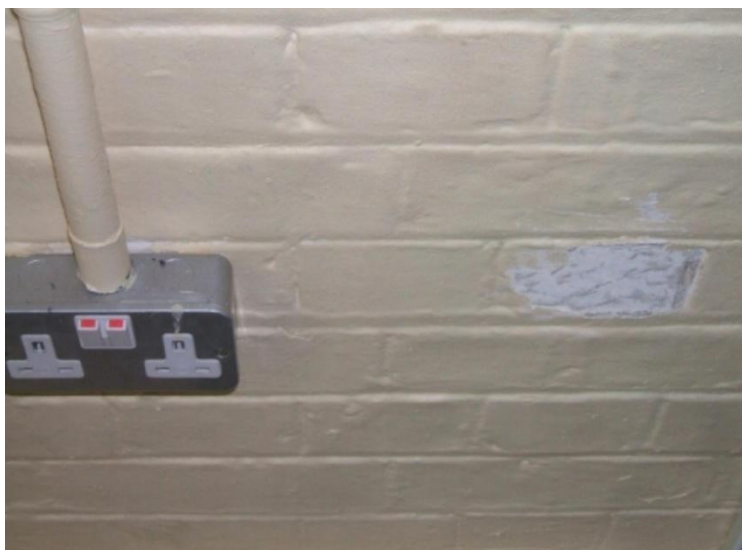
<b>Site Code/UPRN</b>	SD724P/86213	<b>Building</b>	Main Building
<b>Address</b>	The Old War Office Horse Guards Avenue Whitehall London	<b>Floor</b>	Basement
	SW1A 2HB	<b>Room</b>	Room B21
<b>Description</b>	Wall encapsulant. Present to right side wall within 300mm of socket.	<b>Quantity</b>	N/A
		<b>Asbestos Suspected</b>	<b>No</b>

<b>Last Inspection Date</b>	-	03 Sep 2012	<b>Certificate N°</b>	-	BK30485
<b>Next Inspection Date</b>	-	03 Sep 2013	<b>Sample N°</b>	-	08
<b>Survey Type</b>	-	Refurbishment & Demolition Survey	<b>Photograph N°</b>	-	4646
<b>Position</b>	-	Sample Taken	<b>Location ID</b>	-	Loc19949

<b>Product Type</b>	-	N/A	<b>Surface Treatment</b>	-	N/A
<b>Asbestos Type</b>	-	No Asbestos Detected	<b>Damage Extent</b>	-	N/A
<b>Material Risk Score</b>	-	<b>0</b>	<b>Material Risk Band</b>	-	N/A

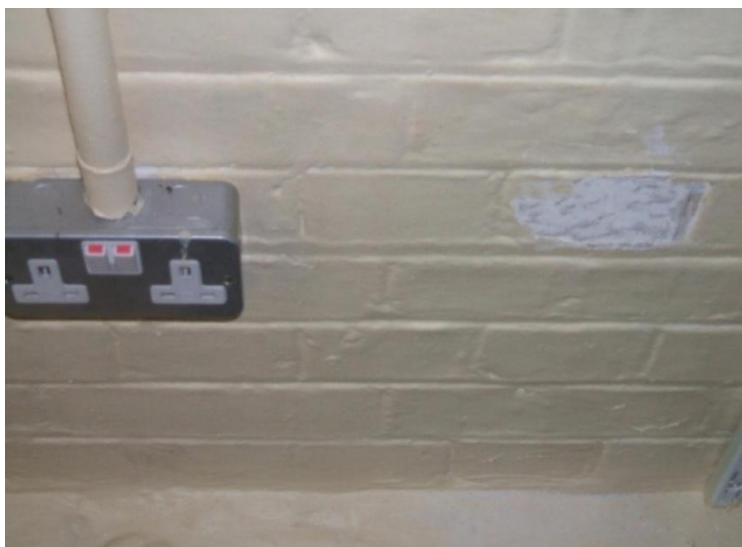
<b>Site Code/UPRN</b>	SD724P/86213	<b>Building</b>	Main Building
<b>Address</b>	The Old War Office Horse Guards Avenue Whitehall London	<b>Floor</b>	Basement
	SW1A 2HB	<b>Room</b>	Room B21
<b>Description</b>	Wall render/cement. Present to right side wall within 300mm of socket.	<b>Quantity</b>	N/A
		<b>Asbestos Suspected</b>	<b>No</b>

<b>Last Inspection Date</b>	-	03 Sep 2012	<b>Certificate N°</b>	-	BK30485
<b>Next Inspection Date</b>	-	03 Sep 2013	<b>Sample N°</b>	-	09
<b>Survey Type</b>	-	Refurbishment & Demolition Survey	<b>Photograph N°</b>	-	4647
<b>Position</b>	-	Sample Taken	<b>Location ID</b>	-	Loc19950

<b>Product Type</b>	-	N/A	<b>Surface Treatment</b>	-	N/A
<b>Asbestos Type</b>	-	No Asbestos Detected	<b>Damage Extent</b>	-	N/A
<b>Material Risk Score</b>	-	<b>0</b>	<b>Material Risk Band</b>	-	N/A

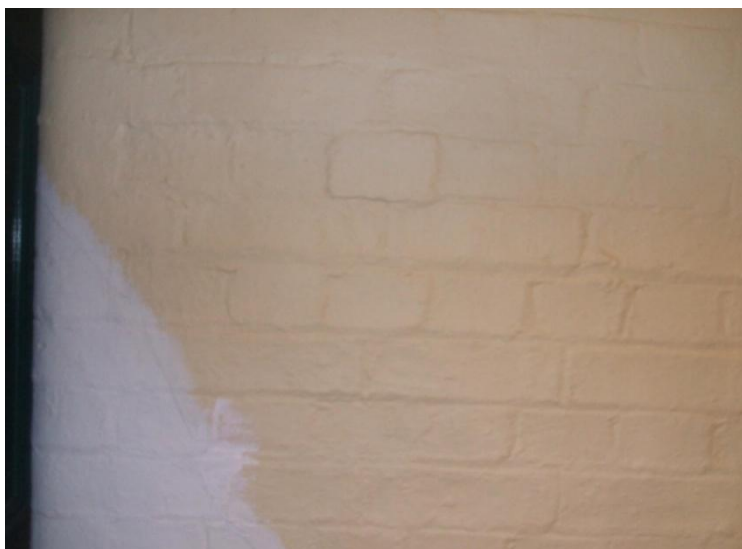
<b>Site Code/UPRN</b>	SD724P/86213	<b>Building</b>	Main Building
<b>Address</b>	The Old War Office Horse Guards Avenue Whitehall London	<b>Floor</b>	Basement
	SW1A 2HB	<b>Room</b>	Room B25
		<b>Quantity</b>	N/A
<b>Description</b>	Mortar to wall adjacent to door.	<b>Asbestos Suspected</b>	<b>No</b>

<b>Last Inspection Date</b>	-	03 Sep 2012	<b>Certificate N<sup>o</sup></b>	-	BK30485
<b>Next Inspection Date</b>	-	03 Sep 2013	<b>Sample N<sup>o</sup></b>	-	04
<b>Survey Type</b>	-	Refurbishment & Demolition Survey	<b>Photograph N<sup>o</sup></b>	-	4642
<b>Position</b>	-	Sample Taken	<b>Location ID</b>	-	Loc19945

<b>Product Type</b>	-	N/A	<b>Surface Treatment</b>	-	N/A
<b>Asbestos Type</b>	-	No Asbestos Detected	<b>Damage Extent</b>	-	N/A
<b>Material Risk Score</b>	-	<b>0</b>	<b>Material Risk Band</b>	-	N/A

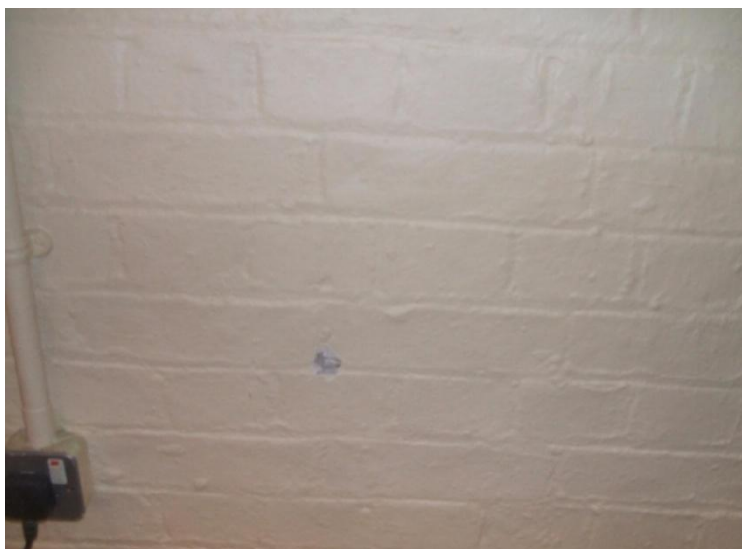
<b>Site Code/UPRN</b>	SD724P/86213	<b>Building</b>	Main Building
<b>Address</b>	The Old War Office Horse Guards Avenue Whitehall London	<b>Floor</b>	Basement
	SW1A 2HB	<b>Room</b>	Room B25
<b>Description</b>	Mortar to wall within 300mm of wall socket.	<b>Quantity</b>	N/A
		<b>Asbestos Suspected</b>	<b>No</b>

<b>Last Inspection Date</b>	-	03 Sep 2012	<b>Certificate N<sup>o</sup></b>	-	BK30485
<b>Next Inspection Date</b>	-	03 Sep 2013	<b>Sample N<sup>o</sup></b>	-	05
<b>Survey Type</b>	-	Refurbishment & Demolition Survey	<b>Photograph N<sup>o</sup></b>	-	4643
<b>Position</b>	-	Sample Taken	<b>Location ID</b>	-	Loc19946

<b>Product Type</b>	-	N/A	<b>Surface Treatment</b>	-	N/A
<b>Asbestos Type</b>	-	No Asbestos Detected	<b>Damage Extent</b>	-	N/A
<b>Material Risk Score</b>	-	<b>0</b>	<b>Material Risk Band</b>	-	N/A

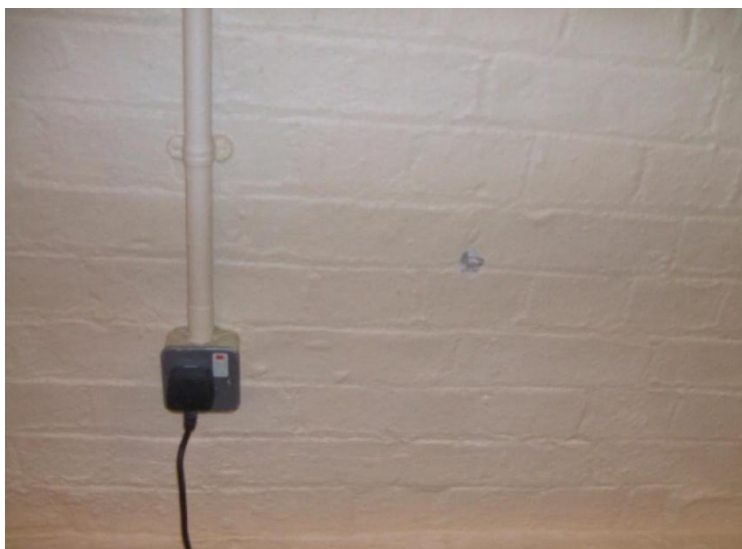
<b>Site Code/UPRN</b>	SD724P/86213	<b>Building</b>	Main Building
<b>Address</b>	The Old War Office Horse Guards Avenue Whitehall London	<b>Floor</b>	Basement
	SW1A 2HB	<b>Room</b>	Room B25
<b>Description</b>	Encapsulated to wall within 300mm of wall socket.	<b>Quantity</b>	N/A
		<b>Asbestos Suspected</b>	<b>No</b>

<b>Last Inspection Date</b>	-	03 Sep 2012	<b>Certificate N<sup>o</sup></b>	-	BK30485
<b>Next Inspection Date</b>	-	03 Sep 2013	<b>Sample N<sup>o</sup></b>	-	03
<b>Survey Type</b>	-	Refurbishment & Demolition Survey	<b>Photograph N<sup>o</sup></b>	-	4641
<b>Position</b>	-	Sample Taken	<b>Location ID</b>	-	Loc19944

<b>Product Type</b>	-	N/A	<b>Surface Treatment</b>	-	N/A
<b>Asbestos Type</b>	-	No Asbestos Detected	<b>Damage Extent</b>	-	N/A
<b>Material Risk Score</b>	-	<b>0</b>	<b>Material Risk Band</b>	-	N/A

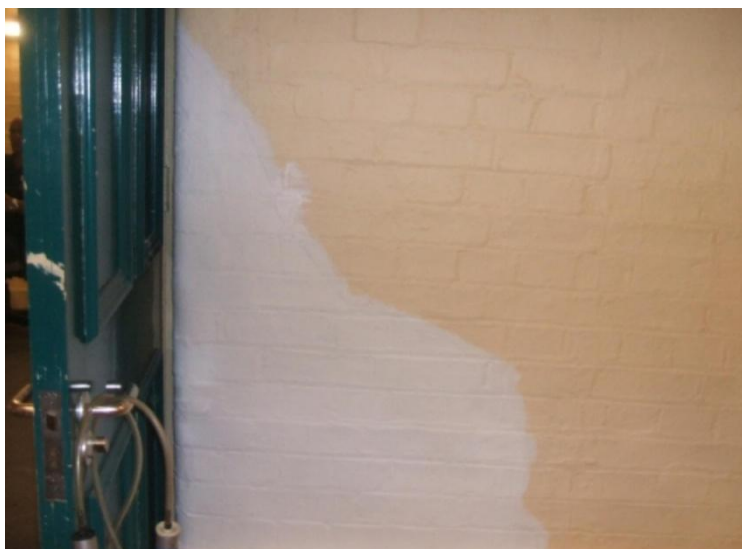
<b>Site Code/UPRN</b>	SD724P/86213	<b>Building</b>	Main Building
<b>Address</b>	The Old War Office Horse Guards Avenue Whitehall London	<b>Floor</b>	Basement
	SW1A 2HB	<b>Room</b>	Room B25
<b>Description</b>	Encapsulated to solid wall adjacent to door.	<b>Quantity</b>	N/A
		<b>Asbestos Suspected</b>	<b>No</b>

<b>Last Inspection Date</b>	-	03 Sep 2012	<b>Certificate N°</b>	-	BK30485
<b>Next Inspection Date</b>	-	03 Sep 2013	<b>Sample N°</b>	-	02
<b>Survey Type</b>	-	Refurbishment & Demolition Survey	<b>Photograph N°</b>	-	4640
<b>Position</b>	-	Sample Taken	<b>Location ID</b>	-	Loc19943

<b>Product Type</b>	-	N/A	<b>Surface Treatment</b>	-	N/A
<b>Asbestos Type</b>	-	No Asbestos Detected	<b>Damage Extent</b>	-	N/A
<b>Material Risk Score</b>	-	<b>0</b>	<b>Material Risk Band</b>	-	N/A

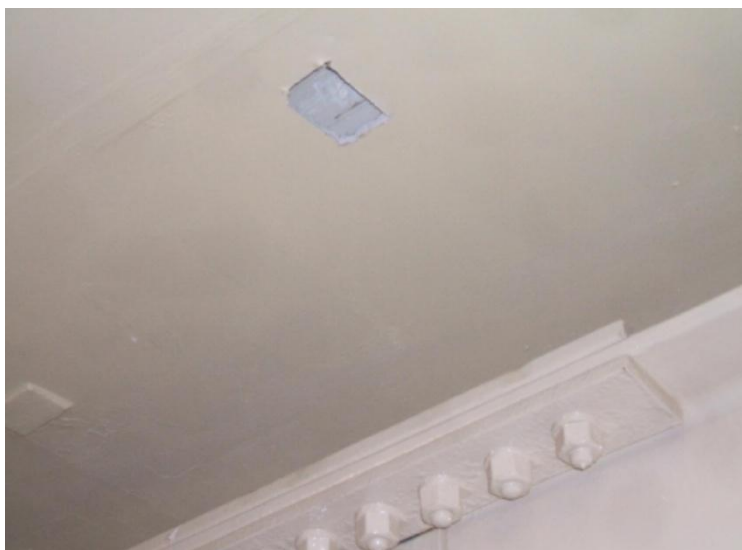
<b>Site Code/UPRN</b>	SD724P/86213	<b>Building</b>	Main Building
<b>Address</b>	The Old War Office Horse Guards Avenue Whitehall London	<b>Floor</b>	Basement
	SW1A 2HB	<b>Room</b>	Room B25
<b>Description</b>	Plasterboard ceiling board (beneath solid painted ceiling).	<b>Quantity</b>	N/A
		<b>Asbestos Suspected</b>	<b>No</b>

<b>Last Inspection Date</b>	-	03 Sep 2012	<b>Certificate N°</b>	-	BK30485
<b>Next Inspection Date</b>	-	03 Sep 2013	<b>Sample N°</b>	-	12
<b>Survey Type</b>	-	Refurbishment & Demolition Survey	<b>Photograph N°</b>	-	4651
<b>Position</b>	-	Sample Taken	<b>Location ID</b>	-	Loc19953

<b>Product Type</b>	-	N/A	<b>Surface Treatment</b>	-	N/A
<b>Asbestos Type</b>	-	No Asbestos Detected	<b>Damage Extent</b>	-	N/A
<b>Material Risk Score</b>	-	<b>0</b>	<b>Material Risk Band</b>	-	N/A

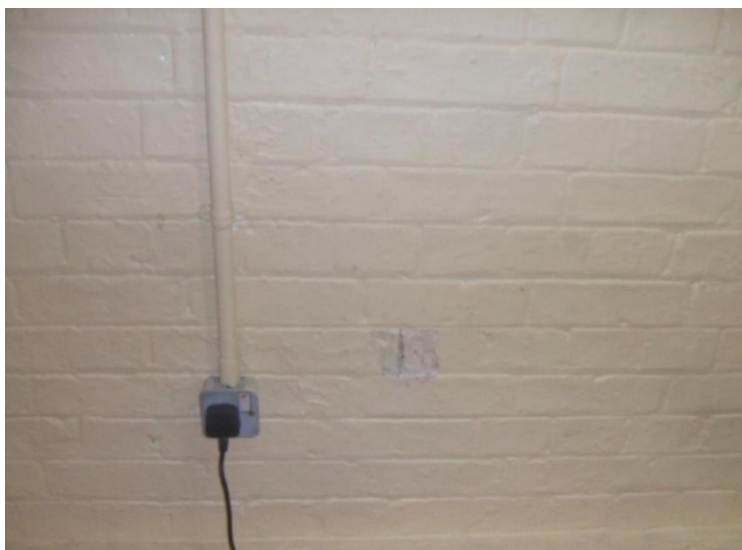
<b>Site Code/UPRN</b>	SD724P/86213	<b>Building</b>	Main Building
<b>Address</b>	The Old War Office Horse Guards Avenue Whitehall London	<b>Floor</b>	Basement
	SW1A 2HB	<b>Room</b>	Room B33
<b>Description</b>	Encapsulant to wall. Sample taken within 300mm of socket.	<b>Quantity</b>	N/A
		<b>Asbestos Suspected</b>	<b>No</b>

<b>Last Inspection Date</b>	-	03 Sep 2012	<b>Certificate N°</b>	-	BK30485
<b>Next Inspection Date</b>	-	03 Sep 2013	<b>Sample N°</b>	-	15
<b>Survey Type</b>	-	Refurbishment & Demolition Survey	<b>Photograph N°</b>	-	4654
<b>Position</b>	-	Sample Taken	<b>Location ID</b>	-	Loc19956

<b>Product Type</b>	-	N/A	<b>Surface Treatment</b>	-	N/A
<b>Asbestos Type</b>	-	No Asbestos Detected	<b>Damage Extent</b>	-	N/A
<b>Material Risk Score</b>	-	<b>0</b>	<b>Material Risk Band</b>	-	N/A

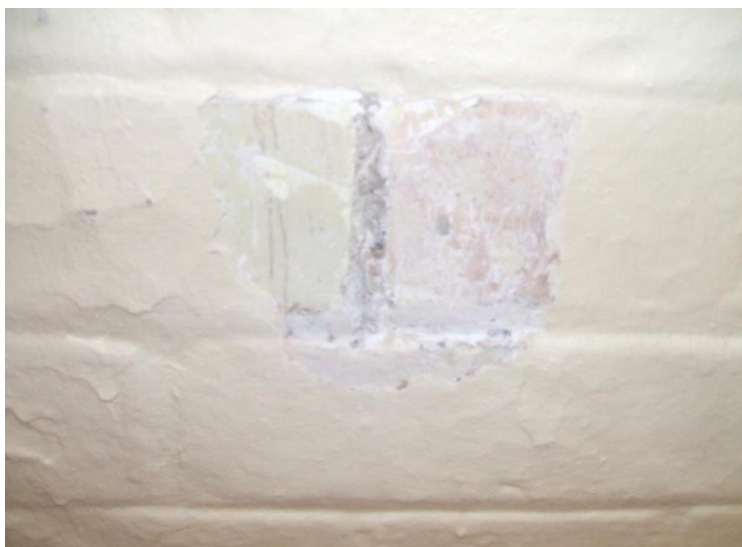
<b>Site Code/UPRN</b>	SD724P/86213	<b>Building</b>	Main Building
<b>Address</b>	The Old War Office Horse Guards Avenue Whitehall London	<b>Floor</b>	Basement
	SW1A 2HB	<b>Room</b>	Room B33
<b>Description</b>	Mortar to solid wall. Sample taken within 300mm of socket.	<b>Quantity</b>	N/A
		<b>Asbestos Suspected</b>	<b>No</b>

<b>Last Inspection Date</b>	-	03 Sep 2012	<b>Certificate N°</b>	-	BK30485
<b>Next Inspection Date</b>	-	03 Sep 2013	<b>Sample N°</b>	-	16
<b>Survey Type</b>	-	Refurbishment & Demolition Survey	<b>Photograph N°</b>	-	4655
<b>Position</b>	-	Sample Taken	<b>Location ID</b>	-	Loc19957

<b>Product Type</b>	-	N/A	<b>Surface Treatment</b>	-	N/A
<b>Asbestos Type</b>	-	No Asbestos Detected	<b>Damage Extent</b>	-	N/A
<b>Material Risk Score</b>	-	<b>0</b>	<b>Material Risk Band</b>	-	N/A

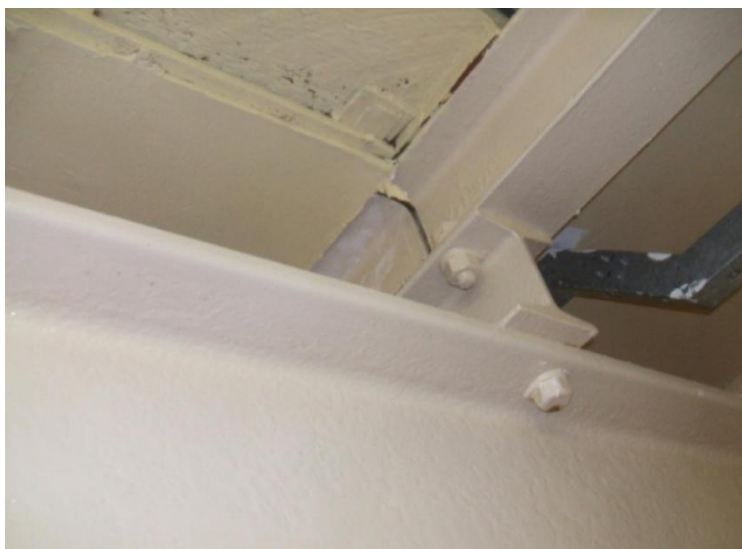
<b>Site Code/UPRN</b>	SD724P/86213	<b>Building</b>	Main Building
<b>Address</b>	The Old War Office Horse Guards Avenue Whitehall London	<b>Floor</b>	Basement
	SW1A 2HB	<b>Room</b>	Room B33
<b>Description</b>	Paper lining to plasterboard ceiling.	<b>Quantity</b>	N/A
		<b>Asbestos Suspected</b>	<b>No</b>

<b>Last Inspection Date</b>	-	03 Sep 2012	<b>Certificate N<sup>o</sup></b>	-	BK30485
<b>Next Inspection Date</b>	-	03 Sep 2013	<b>Sample N<sup>o</sup></b>	-	17
<b>Survey Type</b>	-	Refurbishment & Demolition Survey	<b>Photograph N<sup>o</sup></b>	-	4656
<b>Position</b>	-	Sample Taken	<b>Location ID</b>	-	Loc19958

<b>Product Type</b>	-	N/A	<b>Surface Treatment</b>	-	N/A
<b>Asbestos Type</b>	-	No Asbestos Detected	<b>Damage Extent</b>	-	N/A
<b>Material Risk Score</b>	-	<b>0</b>	<b>Material Risk Band</b>	-	N/A

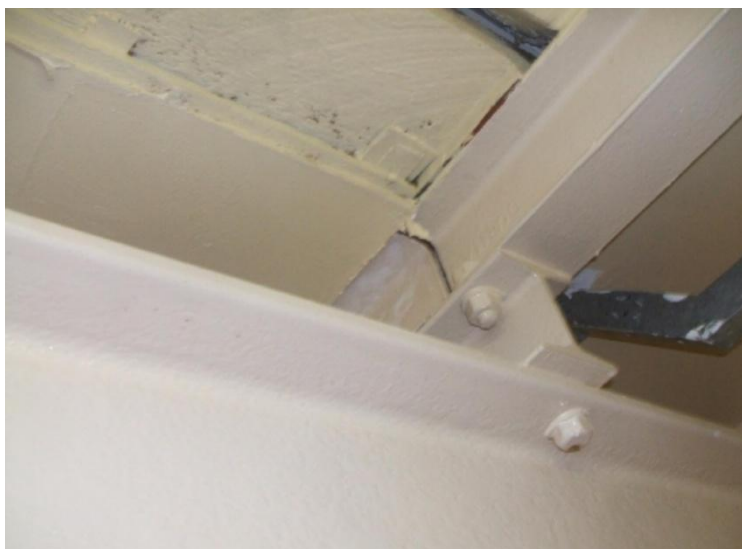
<b>Site Code/UPRN</b>	SD724P/86213	<b>Building</b>	Main Building
<b>Address</b>	The Old War Office Horse Guards Avenue Whitehall London	<b>Floor</b>	Basement
	SW1A 2HB	<b>Room</b>	Room B33
<b>Description</b>	Plasterboard ceiling.	<b>Quantity</b>	N/A
		<b>Asbestos Suspected</b>	<b>No</b>

<b>Last Inspection Date</b>	-	03 Sep 2012	<b>Certificate N°</b>	-	BK30485
<b>Next Inspection Date</b>	-	03 Sep 2013	<b>Sample N°</b>	-	18
<b>Survey Type</b>	-	Refurbishment & Demolition Survey	<b>Photograph N°</b>	-	4657
<b>Position</b>	-	Sample Taken	<b>Location ID</b>	-	Loc19959

<b>Product Type</b>	-	N/A	<b>Surface Treatment</b>	-	N/A
<b>Asbestos Type</b>	-	No Asbestos Detected	<b>Damage Extent</b>	-	N/A
<b>Material Risk Score</b>	-	<b>0</b>	<b>Material Risk Band</b>	-	N/A

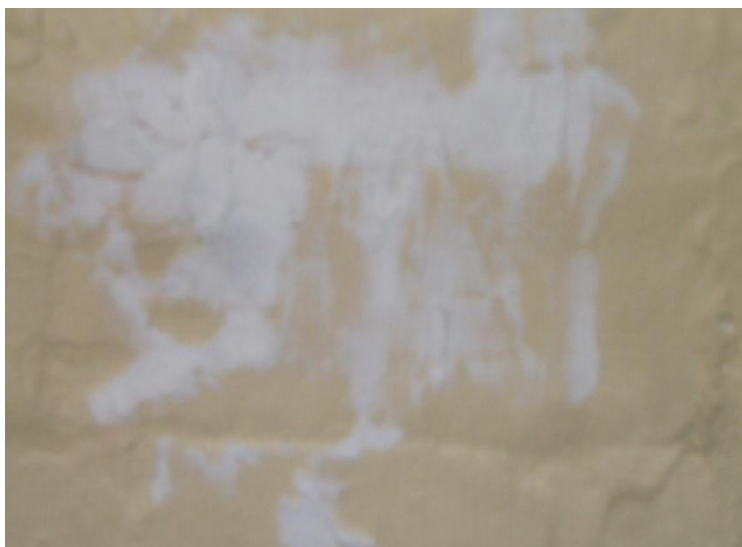
<b>Site Code/UPRN</b>	SD724P/86213	<b>Building</b>	Main Building
<b>Address</b>	The Old War Office Horse Guards Avenue Whitehall London	<b>Floor</b>	Basement
	SW1A 2HB	<b>Room</b>	Room B62 A
<b>Description</b>	Mortar to solid wall. Adjacent to wall light switch.	<b>Quantity</b>	N/A
		<b>Asbestos Suspected</b>	<b>No</b>

<b>Last Inspection Date</b>	-	03 Sep 2012	<b>Certificate N°</b>	-	BK30485
<b>Next Inspection Date</b>	-	03 Sep 2013	<b>Sample N°</b>	-	24
<b>Survey Type</b>	-	Refurbishment & Demolition Survey	<b>Photograph N°</b>	-	4663
<b>Position</b>	-	Sample Taken	<b>Location ID</b>	-	Loc19965

<b>Product Type</b>	-	N/A	<b>Surface Treatment</b>	-	N/A
<b>Asbestos Type</b>	-	No Asbestos Detected	<b>Damage Extent</b>	-	N/A
<b>Material Risk Score</b>	-	<b>0</b>	<b>Material Risk Band</b>	-	N/A

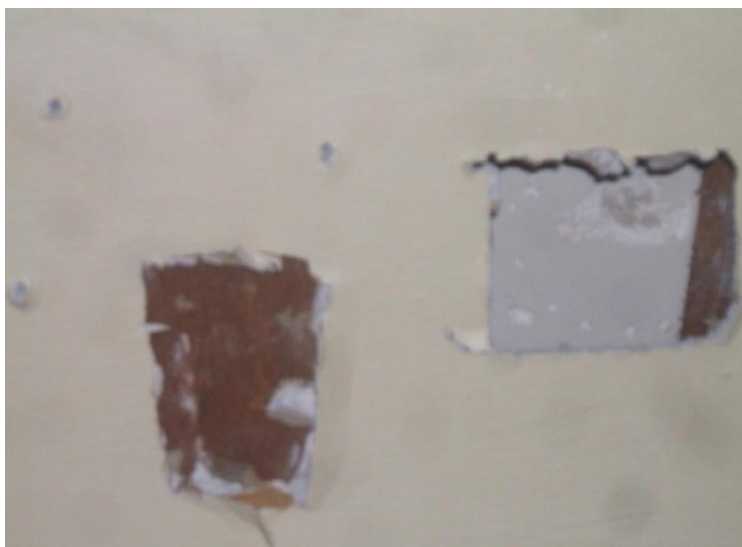
<b>Site Code/UPRN</b>	SD724P/86213	<b>Building</b>	Main Building
<b>Address</b>	The Old War Office Horse Guards Avenue Whitehall London	<b>Floor</b>	Basement
	SW1A 2HB	<b>Room</b>	Room B62 A
<b>Description</b>	Solid ceiling above void. Present above plasterboard false ceiling.	<b>Quantity</b>	N/A
		<b>Asbestos Suspected</b>	<b>No</b>

<b>Last Inspection Date</b>	-	03 Sep 2012	<b>Certificate N°</b>	-	BK30485
<b>Next Inspection Date</b>	-	03 Sep 2013	<b>Sample N°</b>	-	27
<b>Survey Type</b>	-	Refurbishment & Demolition Survey	<b>Photograph N°</b>	-	4666
<b>Position</b>	-	Sample Taken	<b>Location ID</b>	-	Loc19968

<b>Product Type</b>	-	N/A	<b>Surface Treatment</b>	-	N/A
<b>Asbestos Type</b>	-	No Asbestos Detected	<b>Damage Extent</b>	-	N/A
<b>Material Risk Score</b>	-	<b>0</b>	<b>Material Risk Band</b>	-	N/A

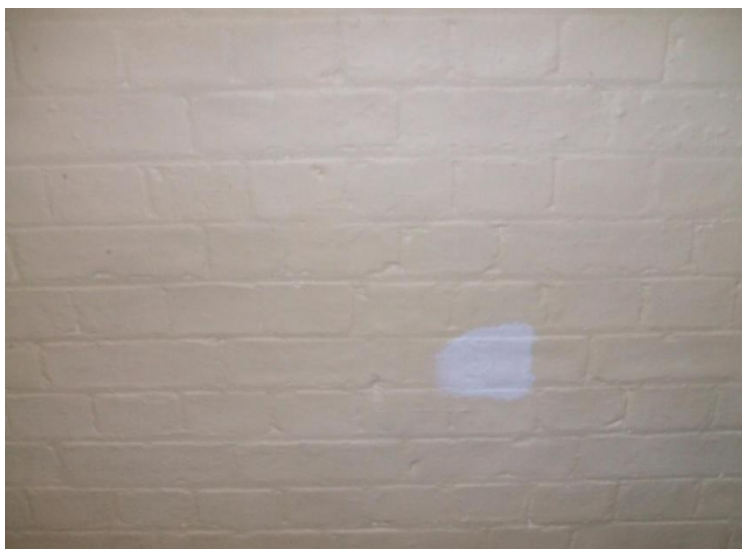
<b>Site Code/UPRN</b>	SD724P/86213	<b>Building</b>	Main Building
<b>Address</b>	The Old War Office Horse Guards Avenue Whitehall London	<b>Floor</b>	Basement
	SW1A 2HB	<b>Room</b>	Room B62 A
<b>Description</b>	Encapsulant to wall. Present to end wall.	<b>Quantity</b>	N/A
		<b>Asbestos Suspected</b>	<b>No</b>

<b>Last Inspection Date</b>	-	03 Sep 2012	<b>Certificate N°</b>	-	BK30485
<b>Next Inspection Date</b>	-	03 Sep 2013	<b>Sample N°</b>	-	21
<b>Survey Type</b>	-	Refurbishment & Demolition Survey	<b>Photograph N°</b>	-	4660
<b>Position</b>	-	Sample Taken	<b>Location ID</b>	-	Loc19962

<b>Product Type</b>	-	N/A	<b>Surface Treatment</b>	-	N/A
<b>Asbestos Type</b>	-	No Asbestos Detected	<b>Damage Extent</b>	-	N/A
<b>Material Risk Score</b>	-	<b>0</b>	<b>Material Risk Band</b>	-	N/A

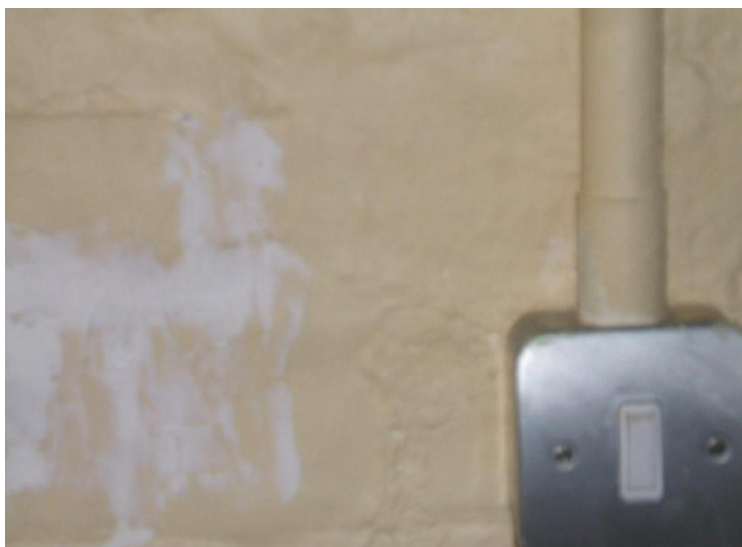
<b>Site Code/UPRN</b>	SD724P/86213	<b>Building</b>	Main Building
<b>Address</b>	The Old War Office Horse Guards Avenue Whitehall London	<b>Floor</b>	Basement
	SW1A 2HB	<b>Room</b>	Room B62 A
<b>Description</b>	Encapsulant to wall. Adjacent to wall light switch.	<b>Quantity</b>	N/A
		<b>Asbestos Suspected</b>	<b>No</b>

<b>Last Inspection Date</b>	-	03 Sep 2012	<b>Certificate N°</b>	-	BK30485
<b>Next Inspection Date</b>	-	03 Sep 2013	<b>Sample N°</b>	-	23
<b>Survey Type</b>	-	Refurbishment & Demolition Survey	<b>Photograph N°</b>	-	4662
<b>Position</b>	-	Sample Taken	<b>Location ID</b>	-	Loc19964

<b>Product Type</b>	-	N/A	<b>Surface Treatment</b>	-	N/A
<b>Asbestos Type</b>	-	No Asbestos Detected	<b>Damage Extent</b>	-	N/A
<b>Material Risk Score</b>	-	<b>0</b>	<b>Material Risk Band</b>	-	N/A

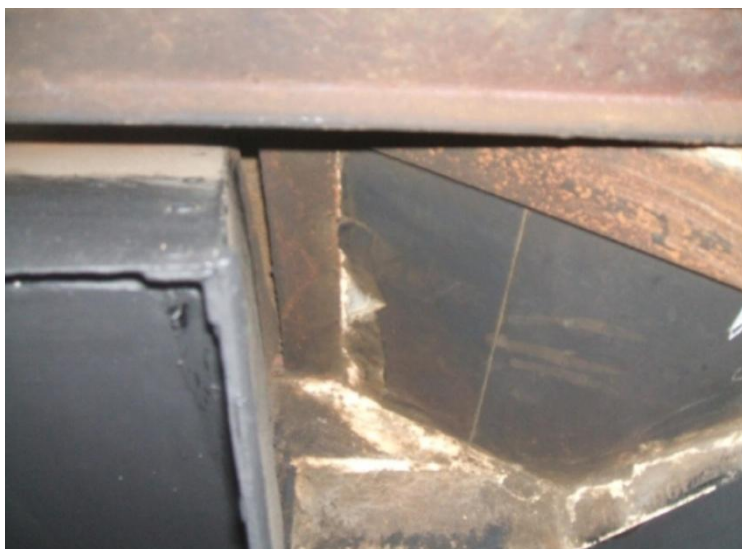
<b>Site Code/UPRN</b>	SD724P/86213	<b>Building</b>	Main Building
<b>Address</b>	The Old War Office Horse Guards Avenue Whitehall London	<b>Floor</b>	Ground (0)
	SW1A 2HB	<b>Room</b>	Room 045 A
<b>Description</b>	Fireplace (02) Firebrick within chimney.	<b>Quantity</b>	N/A
		<b>Asbestos Suspected</b>	<b>No</b>

<b>Last Inspection Date</b>	-	03 Sep 2012	<b>Certificate N<sup>o</sup></b>	-	BK30485
<b>Next Inspection Date</b>	-	03 Mar 2013	<b>Sample N<sup>o</sup></b>	-	65
<b>Survey Type</b>	-	Refurbishment & Demolition Survey	<b>Photograph N<sup>o</sup></b>	-	4704
<b>Position</b>	-	Internal	<b>Location ID</b>	-	Loc20006

<b>Product Type</b>	-	N/A	<b>Surface Treatment</b>	-	N/A
<b>Asbestos Type</b>	-	No Asbestos Detected	<b>Damage Extent</b>	-	N/A
<b>Material Risk Score</b>	-	<b>0</b>	<b>Material Risk Band</b>	-	N/A

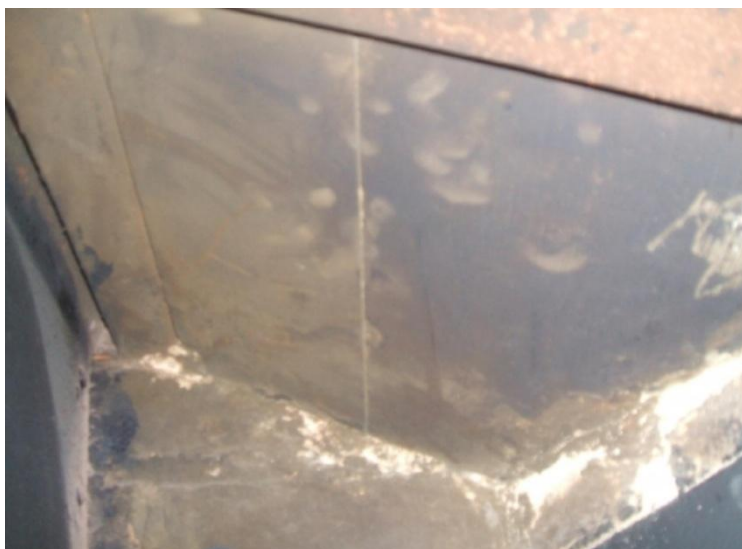
<b>Site Code/UPRN</b>	SD724P/86213	<b>Building</b>	Main Building
<b>Address</b>	The Old War Office Horse Guards Avenue Whitehall London	<b>Floor</b>	Ground (0)
	SW1A 2HB	<b>Room</b>	Room 045 A
<b>Description</b>	Fireplace (01) Firebrick within chimney.	<b>Quantity</b>	N/A
		<b>Asbestos Suspected</b>	<b>No</b>

<b>Last Inspection Date</b>	-	03 Sep 2012	<b>Certificate N°</b>	-	BK30485
<b>Next Inspection Date</b>	-	03 Sep 2013	<b>Sample N°</b>	-	63
<b>Survey Type</b>	-	Refurbishment & Demolition Survey	<b>Photograph N°</b>	-	4702
<b>Position</b>	-	Sample Taken	<b>Location ID</b>	-	Loc20004

<b>Product Type</b>	-	N/A	<b>Surface Treatment</b>	-	N/A
<b>Asbestos Type</b>	-	No Asbestos Detected	<b>Damage Extent</b>	-	N/A
<b>Material Risk Score</b>	-	<b>0</b>	<b>Material Risk Band</b>	-	N/A

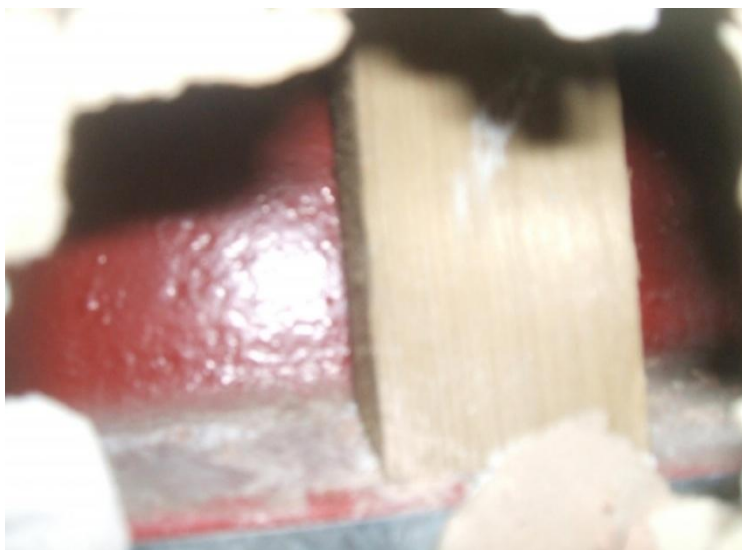
<b>Site Code/UPRN</b>	SD724P/86213	<b>Building</b>	Main Building
<b>Address</b>	The Old War Office Horse Guards Avenue Whitehall London	<b>Floor</b>	Lower Ground (00)
	SW1A 2HB	<b>Room</b>	Corridor WES 335
<b>Description</b>	Plaster to high level beam. Showing steel RSJ behind plasterboard boxing.	<b>Quantity</b>	N/A
		<b>Asbestos Suspected</b>	<b>No</b>

<b>Last Inspection Date</b>	-	03 Sep 2012	<b>Certificate N°</b>	-	BK30485
<b>Next Inspection Date</b>	-	03 Sep 2013	<b>Sample N°</b>	-	62
<b>Survey Type</b>	-	Refurbishment & Demolition Survey	<b>Photograph N°</b>	-	4701
<b>Position</b>	-	Sample Taken	<b>Location ID</b>	-	Loc20003

<b>Product Type</b>	-	N/A	<b>Surface Treatment</b>	-	N/A
<b>Asbestos Type</b>	-	No Asbestos Detected	<b>Damage Extent</b>	-	N/A
<b>Material Risk Score</b>	-	<b>0</b>	<b>Material Risk Band</b>	-	N/A

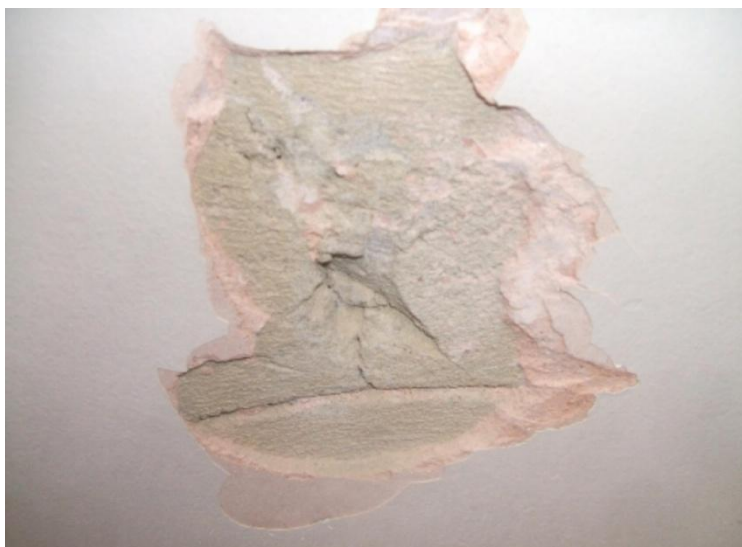
<b>Site Code/UPRN</b>	SD724P/86213	<b>Building</b>	Main Building
<b>Address</b>	The Old War Office Horse Guards Avenue Whitehall London	<b>Floor</b>	Lower Ground (00)
	SW1A 2HB	<b>Room</b>	Room 022
<b>Description</b>	Chimney Stack- PLaster finish to walls. Present to stack.	<b>Quantity</b>	N/A
		<b>Asbestos Suspected</b>	<b>No</b>

<b>Last Inspection Date</b>	-	03 Sep 2012	<b>Certificate N°</b>	-	BK30485
<b>Next Inspection Date</b>	-	03 Sep 2013	<b>Sample N°</b>	-	30
<b>Survey Type</b>	-	Refurbishment & Demolition Survey	<b>Photograph N°</b>	-	4669
<b>Position</b>	-	Sample Taken	<b>Location ID</b>	-	Loc19971

<b>Product Type</b>	-	N/A	<b>Surface Treatment</b>	-	N/A
<b>Asbestos Type</b>	-	No Asbestos Detected	<b>Damage Extent</b>	-	N/A
<b>Material Risk Score</b>	-	<b>0</b>	<b>Material Risk Band</b>	-	N/A

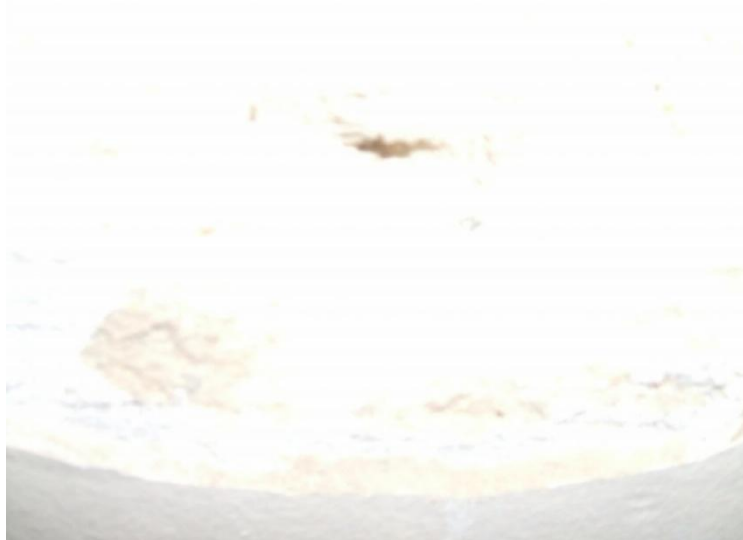
<b>Site Code/UPRN</b>	SD724P/86213	<b>Building</b>	Main Building
<b>Address</b>	The Old War Office Horse Guards Avenue Whitehall London	<b>Floor</b>	Lower Ground (00)
	SW1A 2HB	<b>Room</b>	Room 022
<b>Description</b>	Mortar ceiling above plaster.	<b>Quantity</b>	N/A
		<b>Asbestos Suspected</b>	<b>No</b>

<b>Last Inspection Date</b>	-	03 Sep 2012	<b>Certificate N°</b>	-	BK30485
<b>Next Inspection Date</b>	-	03 Sep 2013	<b>Sample N°</b>	-	38
<b>Survey Type</b>	-	Refurbishment & Demolition Survey	<b>Photograph N°</b>	-	4679
<b>Position</b>	-	Sample Taken	<b>Location ID</b>	-	Loc19979

<b>Product Type</b>	-	N/A	<b>Surface Treatment</b>	-	N/A
<b>Asbestos Type</b>	-	No Asbestos Detected	<b>Damage Extent</b>	-	N/A
<b>Material Risk Score</b>	-	<b>0</b>	<b>Material Risk Band</b>	-	N/A

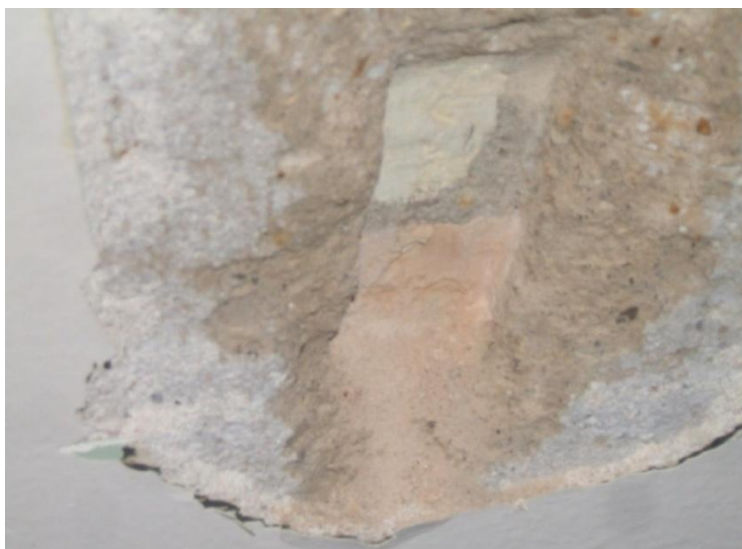
<b>Site Code/UPRN</b>	SD724P/86213	<b>Building</b>	Main Building
<b>Address</b>	The Old War Office Horse Guards Avenue Whitehall London	<b>Floor</b>	Lower Ground (00)
	SW1A 2HB	<b>Room</b>	Room 026
<b>Description</b>	Mortar line wall (corridor)	<b>Quantity</b>	N/A
		<b>Asbestos Suspected</b>	<b>No</b>

<b>Last Inspection Date</b>	-	03 Sep 2012	<b>Certificate N<sup>o</sup></b>	-	BK30485
<b>Next Inspection Date</b>	-	03 Sep 2013	<b>Sample N<sup>o</sup></b>	-	46
<b>Survey Type</b>	-	Refurbishment & Demolition Survey	<b>Photograph N<sup>o</sup></b>	-	4685
<b>Position</b>	-	Sample Taken	<b>Location ID</b>	-	Loc19987

<b>Product Type</b>	-	N/A	<b>Surface Treatment</b>	-	N/A
<b>Asbestos Type</b>	-	No Asbestos Detected	<b>Damage Extent</b>	-	N/A
<b>Material Risk Score</b>	-	<b>0</b>	<b>Material Risk Band</b>	-	N/A

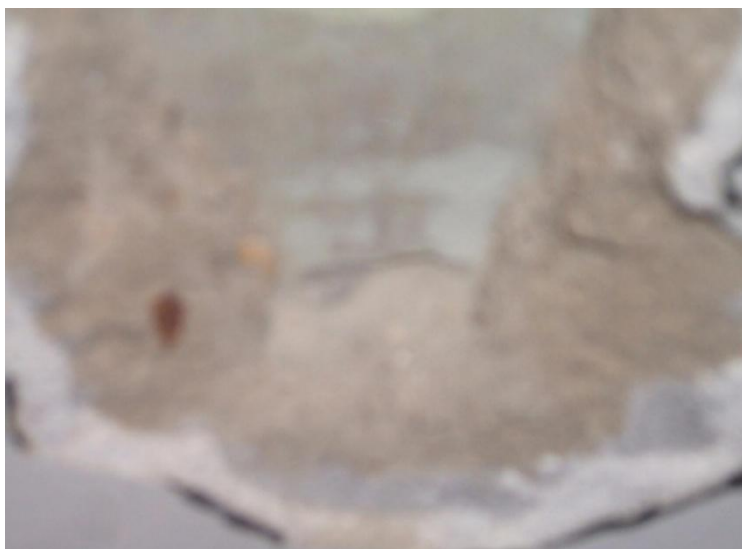
<b>Site Code/UPRN</b>	SD724P/86213	<b>Building</b>	Main Building
<b>Address</b>	The Old War Office Horse Guards Avenue Whitehall London	<b>Floor</b>	Lower Ground (00)
	SW1A 2HB	<b>Room</b>	Room 026
<b>Description</b>	Mortar lines to left side wall. Adjacent to wall socket.	<b>Quantity</b>	N/A
		<b>Asbestos Suspected</b>	<b>No</b>

<b>Last Inspection Date</b>	-	03 Sep 2012	<b>Certificate N<sup>o</sup></b>	-	BK30485
<b>Next Inspection Date</b>	-	03 Sep 2013	<b>Sample N<sup>o</sup></b>	-	44
<b>Survey Type</b>	-	Refurbishment & Demolition Survey	<b>Photograph N<sup>o</sup></b>	-	4683
<b>Position</b>	-	Sample Taken	<b>Location ID</b>	-	Loc19985

<b>Product Type</b>	-	N/A	<b>Surface Treatment</b>	-	N/A
<b>Asbestos Type</b>	-	No Asbestos Detected	<b>Damage Extent</b>	-	N/A
<b>Material Risk Score</b>	-	<b>0</b>	<b>Material Risk Band</b>	-	N/A

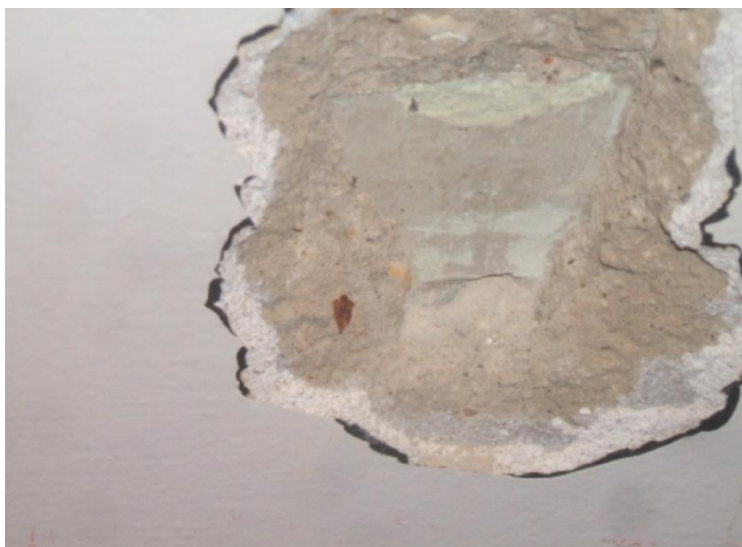
<b>Site Code/UPRN</b>	SD724P/86213	<b>Building</b>	Main Building
<b>Address</b>	The Old War Office Horse Guards Avenue Whitehall London	<b>Floor</b>	Lower Ground (00)
	SW1A 2HB	<b>Room</b>	Room 026
<b>Description</b>	Plaster & render to left side wall. Adjacent to wall socket.	<b>Quantity</b>	N/A
		<b>Asbestos Suspected</b>	<b>No</b>

<b>Last Inspection Date</b>	-	03 Sep 2012	<b>Certificate N°</b>	-	BK30485
<b>Next Inspection Date</b>	-	03 Sep 2013	<b>Sample N°</b>	-	43
<b>Survey Type</b>	-	Refurbishment & Demolition Survey	<b>Photograph N°</b>	-	4682
<b>Position</b>	-	Sample Taken	<b>Location ID</b>	-	Loc19984

<b>Product Type</b>	-	N/A	<b>Surface Treatment</b>	-	N/A
<b>Asbestos Type</b>	-	No Asbestos Detected	<b>Damage Extent</b>	-	N/A
<b>Material Risk Score</b>	-	<b>0</b>	<b>Material Risk Band</b>	-	N/A

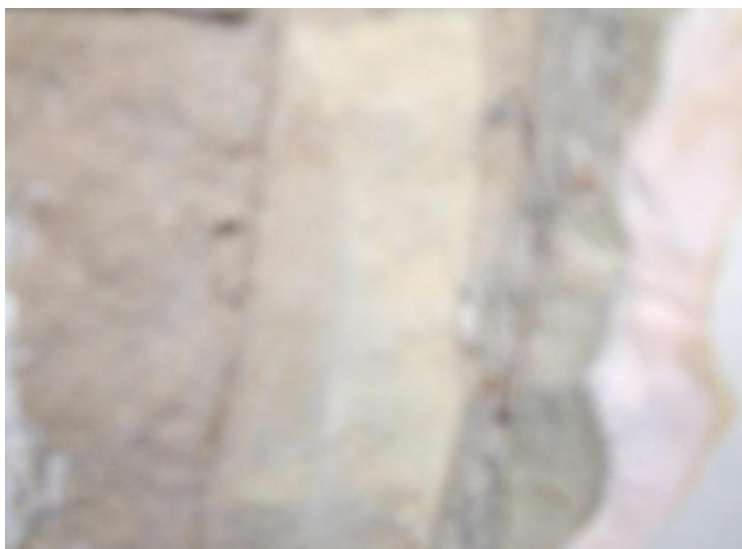
<b>Site Code/UPRN</b>	SD724P/86213	<b>Building</b>	Main Building
<b>Address</b>	The Old War Office Horse Guards Avenue Whitehall London	<b>Floor</b>	Lower Ground (00)
	SW1A 2HB	<b>Room</b>	Room 036
<b>Description</b>	Mortar line wall.	<b>Quantity</b>	N/A
		<b>Asbestos Suspected</b>	<b>No</b>

<b>Last Inspection Date</b>	-	03 Sep 2012	<b>Certificate N<sup>o</sup></b>	-	BK30485
<b>Next Inspection Date</b>	-	03 Sep 2013	<b>Sample N<sup>o</sup></b>	-	60
<b>Survey Type</b>	-	Refurbishment & Demolition Survey	<b>Photograph N<sup>o</sup></b>	-	4699
<b>Position</b>	-	Sample Taken	<b>Location ID</b>	-	Loc20001

<b>Product Type</b>	-	N/A	<b>Surface Treatment</b>	-	N/A
<b>Asbestos Type</b>	-	No Asbestos Detected	<b>Damage Extent</b>	-	N/A
<b>Material Risk Score</b>	-	<b>0</b>	<b>Material Risk Band</b>	-	N/A

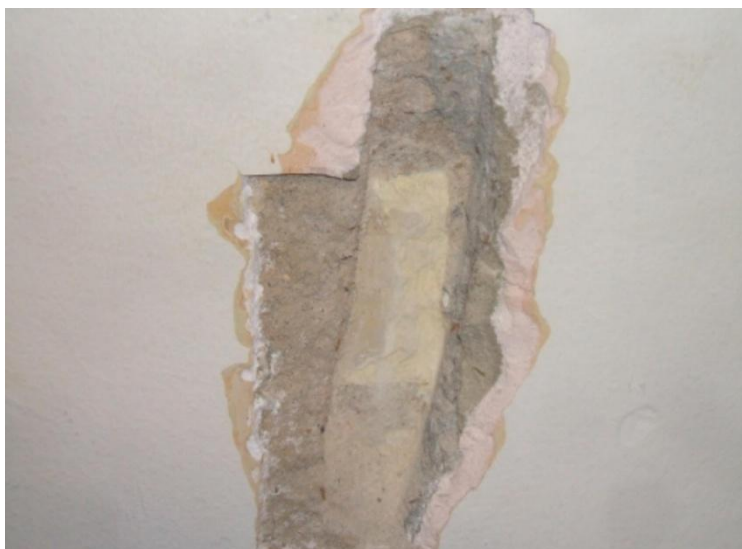
<b>Site Code/UPRN</b>	SD724P/86213	<b>Building</b>	Main Building
<b>Address</b>	The Old War Office Horse Guards Avenue Whitehall London	<b>Floor</b>	Lower Ground (00)
	SW1A 2HB	<b>Room</b>	Room 036
		<b>Quantity</b>	N/A
<b>Description</b>	Plaster & render wall.	<b>Asbestos Suspected</b>	<b>No</b>

<b>Last Inspection Date</b>	-	03 Sep 2012	<b>Certificate N<sup>o</sup></b>	-	BK30485
<b>Next Inspection Date</b>	-	03 Sep 2013	<b>Sample N<sup>o</sup></b>	-	59
<b>Survey Type</b>	-	Refurbishment & Demolition Survey	<b>Photograph N<sup>o</sup></b>	-	4698
<b>Position</b>	-	Sample Taken	<b>Location ID</b>	-	Loc20000

<b>Product Type</b>	-	N/A	<b>Surface Treatment</b>	-	N/A
<b>Asbestos Type</b>	-	No Asbestos Detected	<b>Damage Extent</b>	-	N/A
<b>Material Risk Score</b>	-	<b>0</b>	<b>Material Risk Band</b>	-	N/A

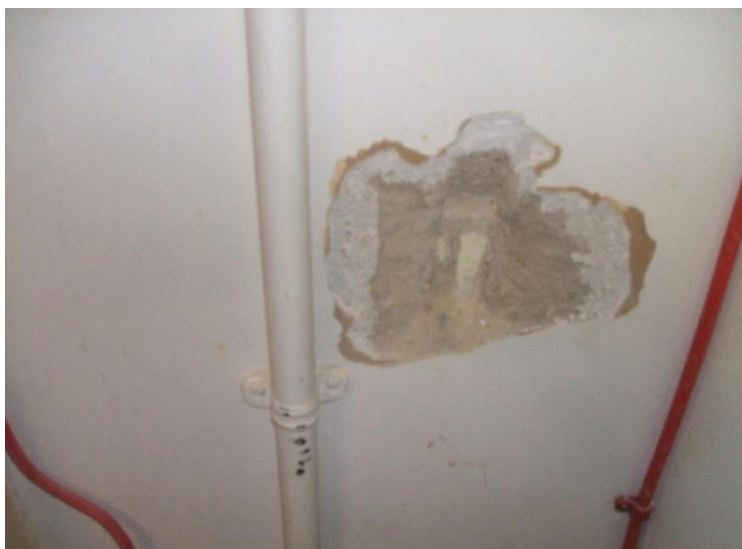
<b>Site Code/UPRN</b>	SD724P/86213	<b>Building</b>	Main Building
<b>Address</b>	The Old War Office Horse Guards Avenue Whitehall London	<b>Floor</b>	Lower Ground (00)
	SW1A 2HB	<b>Room</b>	Room 036
<b>Description</b>	Plaster & render above socket over corridor wall.	<b>Quantity</b>	N/A
		<b>Asbestos Suspected</b>	<b>No</b>

<b>Last Inspection Date</b>	-	03 Sep 2012	<b>Certificate N<sup>o</sup></b>	-	BK30485
<b>Next Inspection Date</b>	-	03 Sep 2013	<b>Sample N<sup>o</sup></b>	-	57
<b>Survey Type</b>	-	Refurbishment & Demolition Survey	<b>Photograph N<sup>o</sup></b>	-	4696
<b>Position</b>	-	Sample Taken	<b>Location ID</b>	-	Loc19998

<b>Product Type</b>	-	N/A	<b>Surface Treatment</b>	-	N/A
<b>Asbestos Type</b>	-	No Asbestos Detected	<b>Damage Extent</b>	-	N/A
<b>Material Risk Score</b>	-	<b>0</b>	<b>Material Risk Band</b>	-	N/A

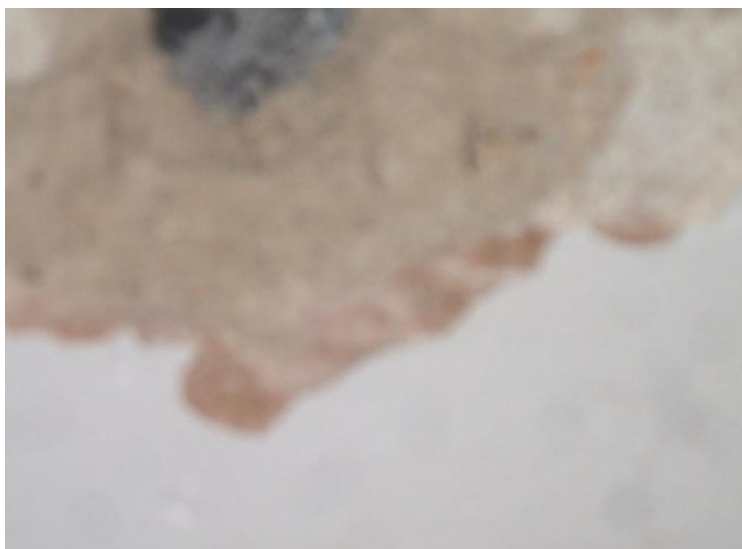
<b>Site Code/UPRN</b>	SD724P/86213	<b>Building</b>	Main Building
<b>Address</b>	The Old War Office Horse Guards Avenue Whitehall London	<b>Floor</b>	Lower Ground (00)
	SW1A 2HB	<b>Room</b>	Room 036
		<b>Quantity</b>	N/A
<b>Description</b>	Concrete plaster over ceiling.	<b>Asbestos Suspected</b>	<b>No</b>

<b>Last Inspection Date</b>	-	03 Sep 2012	<b>Certificate N<sup>o</sup></b>	-	BK30485
<b>Next Inspection Date</b>	-	03 Sep 2013	<b>Sample N<sup>o</sup></b>	-	56
<b>Survey Type</b>	-	Refurbishment & Demolition Survey	<b>Photograph N<sup>o</sup></b>	-	4695
<b>Position</b>	-	Sample Taken	<b>Location ID</b>	-	Loc19997

<b>Product Type</b>	-	N/A	<b>Surface Treatment</b>	-	N/A
<b>Asbestos Type</b>	-	No Asbestos Detected	<b>Damage Extent</b>	-	N/A
<b>Material Risk Score</b>	-	<b>0</b>	<b>Material Risk Band</b>	-	N/A

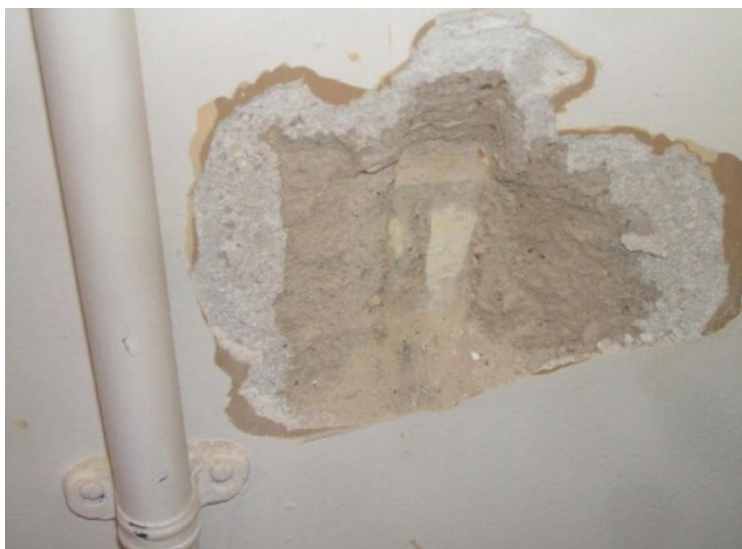
<b>Site Code/UPRN</b>	SD724P/86213	<b>Building</b>	Main Building
<b>Address</b>	The Old War Office Horse Guards Avenue Whitehall London	<b>Floor</b>	Lower Ground (00)
	SW1A 2HB	<b>Room</b>	Room 036
<b>Description</b>	Mortar line above socket over corridor wall.	<b>Quantity</b>	N/A
		<b>Asbestos Suspected</b>	<b>No</b>

<b>Last Inspection Date</b>	-	03 Sep 2012	<b>Certificate N°</b>	-	BK30485
<b>Next Inspection Date</b>	-	03 Sep 2013	<b>Sample N°</b>	-	58
<b>Survey Type</b>	-	Refurbishment & Demolition Survey	<b>Photograph N°</b>	-	4697
<b>Position</b>	-	Sample Taken	<b>Location ID</b>	-	Loc19999

<b>Product Type</b>	-	N/A	<b>Surface Treatment</b>	-	N/A
<b>Asbestos Type</b>	-	No Asbestos Detected	<b>Damage Extent</b>	-	N/A
<b>Material Risk Score</b>	-	<b>0</b>	<b>Material Risk Band</b>	-	N/A

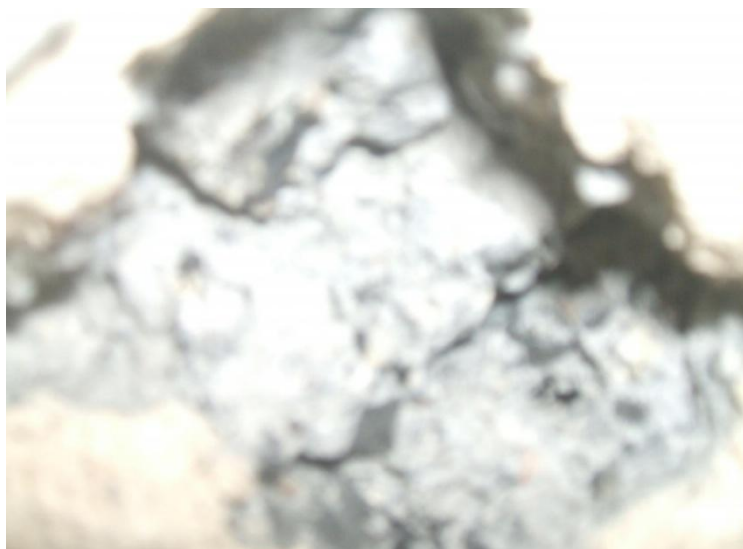
<b>Site Code/UPRN</b>	SD724P/86213	<b>Building</b>	Whitehall
<b>Address</b>	The Old War Office Horse Guards Avenue Whitehall London	<b>Floor</b>	First Floor
	SW1A 2HB	<b>Room</b>	Room 125 A
<b>Description</b>	Asphlat/ concrete ceiling.	<b>Quantity</b>	N/A
		<b>Asbestos Suspected</b>	<b>No</b>

<b>Last Inspection Date</b>	-	03 Sep 2012	<b>Certificate N<sup>o</sup></b>	-	BK30786
<b>Next Inspection Date</b>	-	03 Sep 2013	<b>Sample N<sup>o</sup></b>	-	182
<b>Survey Type</b>	-	Refurbishment & Demolition Survey	<b>Photograph N<sup>o</sup></b>	-	4903
<b>Position</b>	-	Sample Taken	<b>Location ID</b>	-	Loc20126

<b>Product Type</b>	-	N/A	<b>Surface Treatment</b>	-	N/A
<b>Asbestos Type</b>	-	No Asbestos Detected	<b>Damage Extent</b>	-	N/A
<b>Material Risk Score</b>	-	<b>0</b>	<b>Material Risk Band</b>	-	N/A

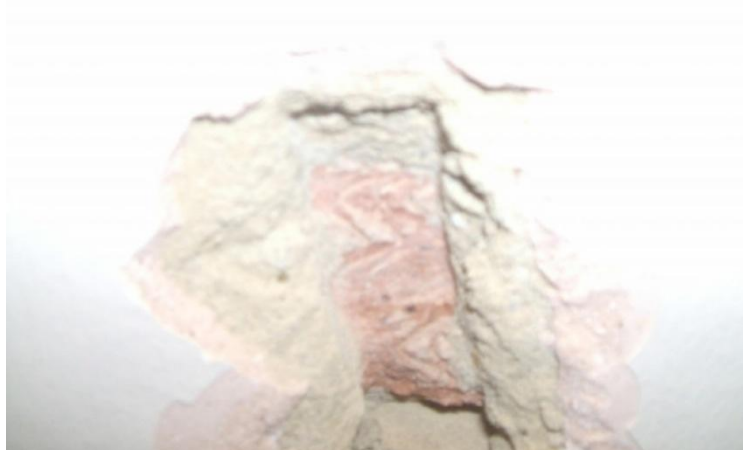
<b>Site Code/UPRN</b>	SD724P/86213	<b>Building</b>	Whitehall
<b>Address</b>	The Old War Office Horse Guards Avenue Whitehall London	<b>Floor</b>	First Floor
	SW1A 2HB	<b>Room</b>	Room 125 A
<b>Description</b>	Plaster & render walls.	<b>Quantity</b>	N/A
		<b>Asbestos Suspected</b>	<b>No</b>

<b>Last Inspection Date</b>	-	03 Sep 2012	<b>Certificate N<sup>o</sup></b>	-	BK30786
<b>Next Inspection Date</b>	-	03 Sep 2013	<b>Sample N<sup>o</sup></b>	-	183
<b>Survey Type</b>	-	Refurbishment & Demolition Survey	<b>Photograph N<sup>o</sup></b>	-	4904
<b>Position</b>	-	Sample Taken	<b>Location ID</b>	-	Loc20127

<b>Product Type</b>	-	N/A	<b>Surface Treatment</b>	-	N/A
<b>Asbestos Type</b>	-	No Asbestos Detected	<b>Damage Extent</b>	-	N/A
<b>Material Risk Score</b>	-	<b>0</b>	<b>Material Risk Band</b>	-	N/A

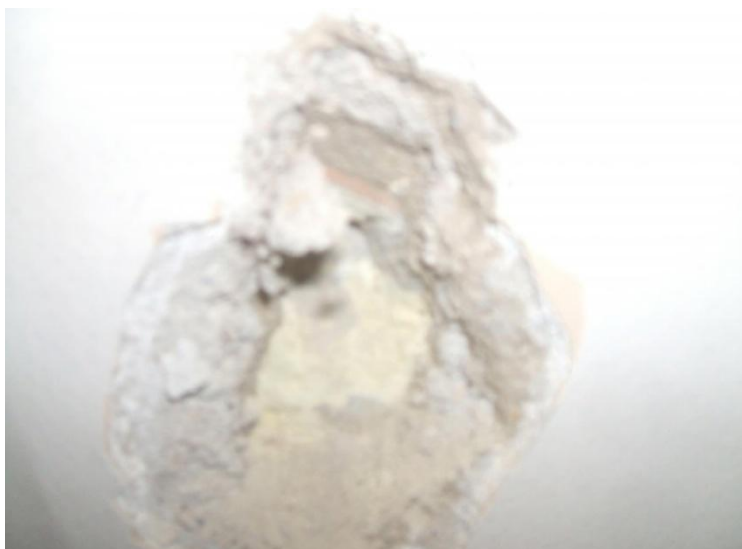
<b>Site Code/UPRN</b>	SD724P/86213	<b>Building</b>	Whitehall
<b>Address</b>	The Old War Office Horse Guards Avenue Whitehall London	<b>Floor</b>	First Floor
	SW1A 2HB	<b>Room</b>	Room 125 A
<b>Description</b>	Plaster/ render walls.	<b>Quantity</b>	N/A
		<b>Asbestos Suspected</b>	<b>No</b>

<b>Last Inspection Date</b>	-	03 Sep 2012	<b>Certificate N<sup>o</sup></b>	-	BK30786
<b>Next Inspection Date</b>	-	03 Sep 2013	<b>Sample N<sup>o</sup></b>	-	187
<b>Survey Type</b>	-	Refurbishment & Demolition Survey	<b>Photograph N<sup>o</sup></b>	-	4908
<b>Position</b>	-	Sample Taken	<b>Location ID</b>	-	Loc20131

<b>Product Type</b>	-	N/A	<b>Surface Treatment</b>	-	N/A
<b>Asbestos Type</b>	-	No Asbestos Detected	<b>Damage Extent</b>	-	N/A
<b>Material Risk Score</b>	-	<b>0</b>	<b>Material Risk Band</b>	-	N/A
