Ministry  
of Defence

## Defence Infrastructure Organisation

Ref: EIR/2017/13719

September 2014

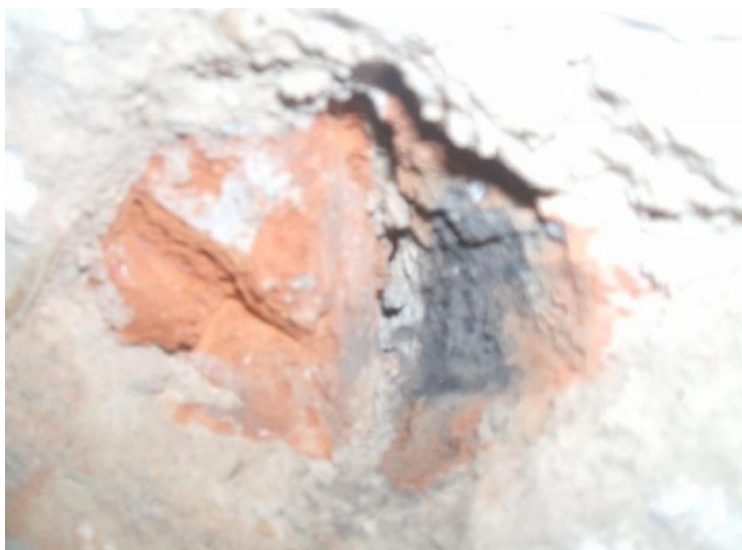
<b>Site Code/UPRN</b>	SD724P/86213	<b>Building</b>	Whitehall
<b>Address</b>	The Old War Office Horse Guards Avenue Whitehall London	<b>Floor</b>	First Floor
	SW1A 2HB	<b>Room</b>	Room 127
<b>Description</b>	Plaster & render wall. Adjacent wall- window recess.	<b>Quantity</b>	N/A
		<b>Asbestos Suspected</b>	<b>No</b>

<b>Last Inspection Date</b>	-	03 Sep 2012	<b>Certificate N°</b>	-	BK30786
<b>Next Inspection Date</b>	-	03 Sep 2013	<b>Sample N°</b>	-	179
<b>Survey Type</b>	-	Refurbishment & Demolition Survey	<b>Photograph N°</b>	-	4897
<b>Position</b>	-	Sample Taken	<b>Location ID</b>	-	Loc20123

<b>Product Type</b>	-	N/A	<b>Surface Treatment</b>	-	N/A
<b>Asbestos Type</b>	-	No Asbestos Detected	<b>Damage Extent</b>	-	N/A
<b>Material Risk Score</b>	-	<b>0</b>	<b>Material Risk Band</b>	-	N/A

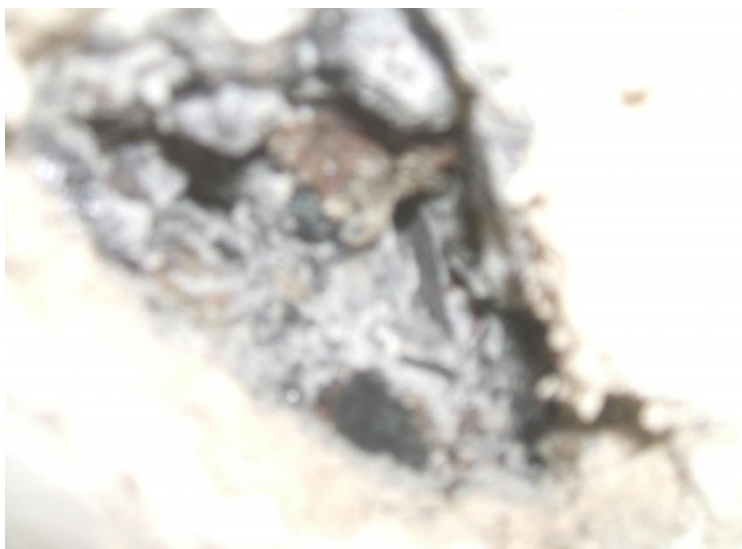
<b>Site Code/UPRN</b>	SD724P/86213	<b>Building</b>	Whitehall
<b>Address</b>	The Old War Office Horse Guards Avenue Whitehall London	<b>Floor</b>	First Floor
	SW1A 2HB	<b>Room</b>	Room 127
		<b>Quantity</b>	N/A
<b>Description</b>	Asphalt/ mortar ceiling.	<b>Asbestos Suspected</b>	<b>No</b>

<b>Last Inspection Date</b>	-	03 Sep 2012	<b>Certificate N°</b>	-	BK30786
<b>Next Inspection Date</b>	-	03 Sep 2013	<b>Sample N°</b>	-	174
<b>Survey Type</b>	-	Refurbishment & Demolition Survey	<b>Photograph N°</b>	-	4892
<b>Position</b>	-	Sample Taken	<b>Location ID</b>	-	Loc20118

<b>Product Type</b>	-	N/A	<b>Surface Treatment</b>	-	N/A
<b>Asbestos Type</b>	-	No Asbestos Detected	<b>Damage Extent</b>	-	N/A
<b>Material Risk Score</b>	-	<b>0</b>	<b>Material Risk Band</b>	-	N/A

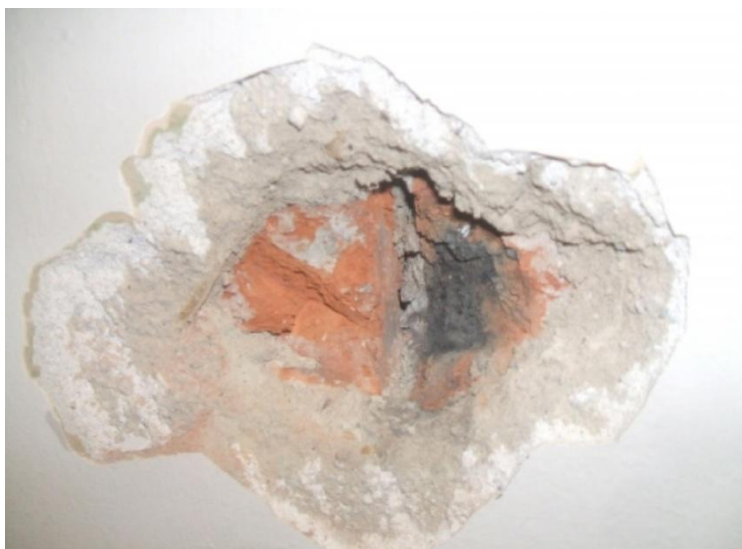
<b>Site Code/UPRN</b>	SD724P/86213	<b>Building</b>	Whitehall
<b>Address</b>	The Old War Office Horse Guards Avenue Whitehall London	<b>Floor</b>	First Floor
	SW1A 2HB	<b>Room</b>	Room 127
<b>Description</b>	Mortar line wall. Adjacent to socket.	<b>Quantity</b>	N/A
		<b>Asbestos Suspected</b>	<b>No</b>

<b>Last Inspection Date</b>	-	03 Sep 2012	<b>Certificate N<sup>o</sup></b>	-	BK30786
<b>Next Inspection Date</b>	-	03 Sep 2013	<b>Sample N<sup>o</sup></b>	-	178
<b>Survey Type</b>	-	Refurbishment & Demolition Survey	<b>Photograph N<sup>o</sup></b>	-	4896
<b>Position</b>	-	Sample Taken	<b>Location ID</b>	-	Loc20122

<b>Product Type</b>	-	N/A	<b>Surface Treatment</b>	-	N/A
<b>Asbestos Type</b>	-	No Asbestos Detected	<b>Damage Extent</b>	-	N/A
<b>Material Risk Score</b>	-	<b>0</b>	<b>Material Risk Band</b>	-	N/A

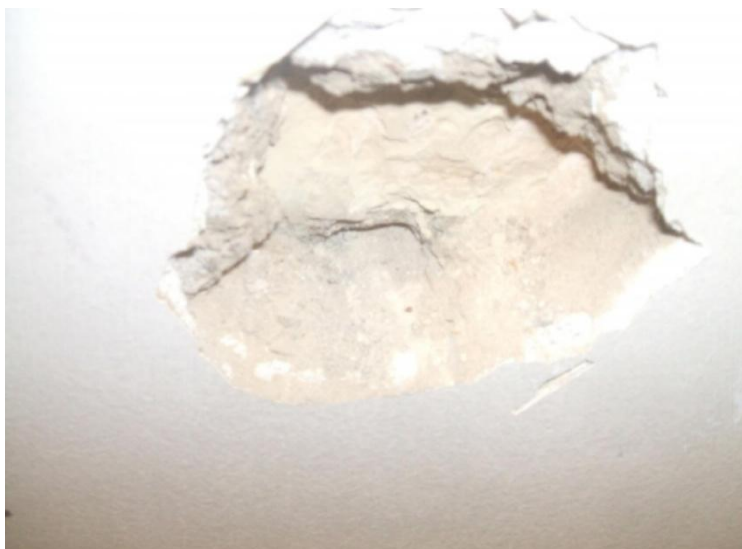
<b>Site Code/UPRN</b>	SD724P/86213	<b>Building</b>	Whitehall
<b>Address</b>	The Old War Office Horse Guards Avenue Whitehall London	<b>Floor</b>	First Floor
	SW1A 2HB	<b>Room</b>	Room 128
<b>Description</b>	Mortar line walls.	<b>Quantity</b>	N/A
		<b>Asbestos Suspected</b>	<b>No</b>

<b>Last Inspection Date</b>	-	03 Sep 2012	<b>Certificate N°</b>	-	BK30786
<b>Next Inspection Date</b>	-	03 Sep 2013	<b>Sample N°</b>	-	164
<b>Survey Type</b>	-	Refurbishment & Demolition Survey	<b>Photograph N°</b>	-	4882
<b>Position</b>	-	Sample Taken	<b>Location ID</b>	-	Loc20108

<b>Product Type</b>	-	N/A	<b>Surface Treatment</b>	-	N/A
<b>Asbestos Type</b>	-	No Asbestos Detected	<b>Damage Extent</b>	-	N/A
<b>Material Risk Score</b>	-	<b>0</b>	<b>Material Risk Band</b>	-	N/A

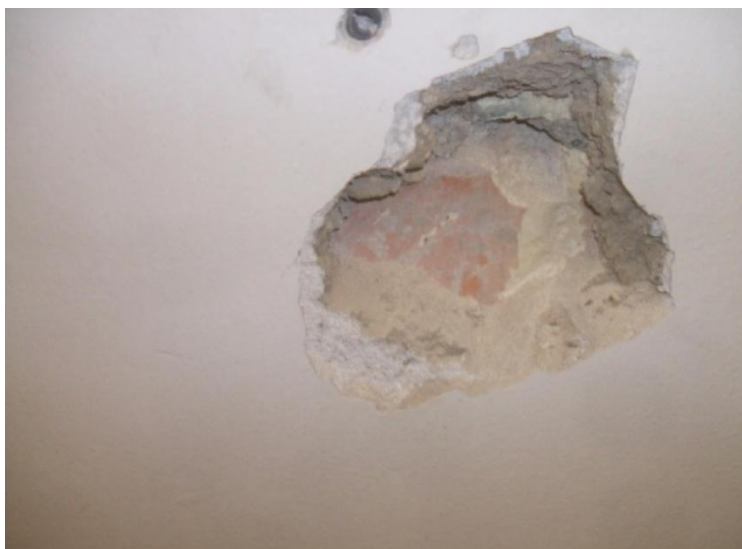
<b>Site Code/UPRN</b>	SD724P/86213	<b>Building</b>	Whitehall
<b>Address</b>	The Old War Office Horse Guards Avenue Whitehall London	<b>Floor</b>	First Floor
	SW1A 2HB	<b>Room</b>	Room 128
<b>Description</b>	Mortar line walls.	<b>Quantity</b>	N/A
		<b>Asbestos Suspected</b>	<b>No</b>

<b>Last Inspection Date</b>	-	03 Sep 2012	<b>Certificate N<sup>o</sup></b>	-	BK30786
<b>Next Inspection Date</b>	-	03 Sep 2013	<b>Sample N<sup>o</sup></b>	-	166
<b>Survey Type</b>	-	Refurbishment & Demolition Survey	<b>Photograph N<sup>o</sup></b>	-	4884
<b>Position</b>	-	Sample Taken	<b>Location ID</b>	-	Loc20110

<b>Product Type</b>	-	N/A	<b>Surface Treatment</b>	-	N/A
<b>Asbestos Type</b>	-	No Asbestos Detected	<b>Damage Extent</b>	-	N/A
<b>Material Risk Score</b>	-	<b>0</b>	<b>Material Risk Band</b>	-	N/A

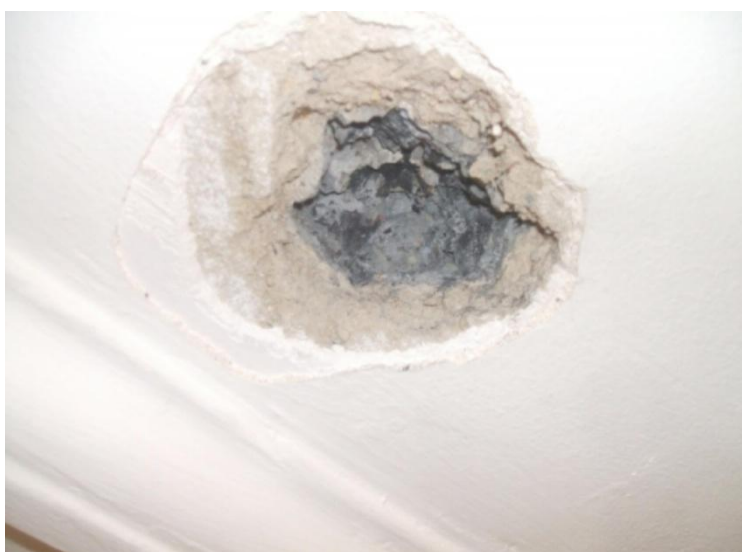
<b>Site Code/UPRN</b>	SD724P/86213	<b>Building</b>	Whitehall
<b>Address</b>	The Old War Office Horse Guards Avenue Whitehall London	<b>Floor</b>	First Floor
	SW1A 2HB	<b>Room</b>	Room 128
<b>Description</b>	Plaster finish ceiling.	<b>Quantity</b>	N/A
		<b>Asbestos Suspected</b>	<b>No</b>

<b>Last Inspection Date</b>	-	03 Sep 2012	<b>Certificate N<sup>o</sup></b>	-	BK30786
<b>Next Inspection Date</b>	-	03 Sep 2013	<b>Sample N<sup>o</sup></b>	-	161
<b>Survey Type</b>	-	Refurbishment & Demolition Survey	<b>Photograph N<sup>o</sup></b>	-	4880
<b>Position</b>	-	Sample Taken	<b>Location ID</b>	-	Loc20105

<b>Product Type</b>	-	N/A	<b>Surface Treatment</b>	-	N/A
<b>Asbestos Type</b>	-	No Asbestos Detected	<b>Damage Extent</b>	-	N/A
<b>Material Risk Score</b>	-	<b>0</b>	<b>Material Risk Band</b>	-	N/A

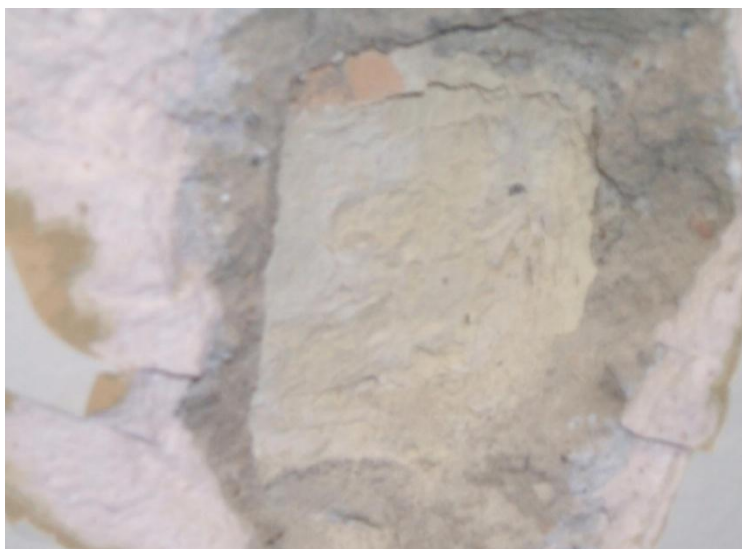
<b>Site Code/UPRN</b>	SD724P/86213	<b>Building</b>	Whitehall
<b>Address</b>	The Old War Office Horse Guards Avenue Whitehall London	<b>Floor</b>	First Floor
	SW1A 2HB	<b>Room</b>	Room 144 A
<b>Description</b>	Mortar line walls.	<b>Quantity</b>	N/A
		<b>Asbestos Suspected</b>	<b>No</b>

<b>Last Inspection Date</b>	-	03 Sep 2012	<b>Certificate N<sup>o</sup></b>	-	BK30786
<b>Next Inspection Date</b>	-	03 Sep 2013	<b>Sample N<sup>o</sup></b>	-	196
<b>Survey Type</b>	-	Refurbishment & Demolition Survey	<b>Photograph N<sup>o</sup></b>	-	4913
<b>Position</b>	-	Sample Taken	<b>Location ID</b>	-	Loc20140

<b>Product Type</b>	-	N/A	<b>Surface Treatment</b>	-	N/A
<b>Asbestos Type</b>	-	No Asbestos Detected	<b>Damage Extent</b>	-	N/A
<b>Material Risk Score</b>	-	<b>0</b>	<b>Material Risk Band</b>	-	N/A

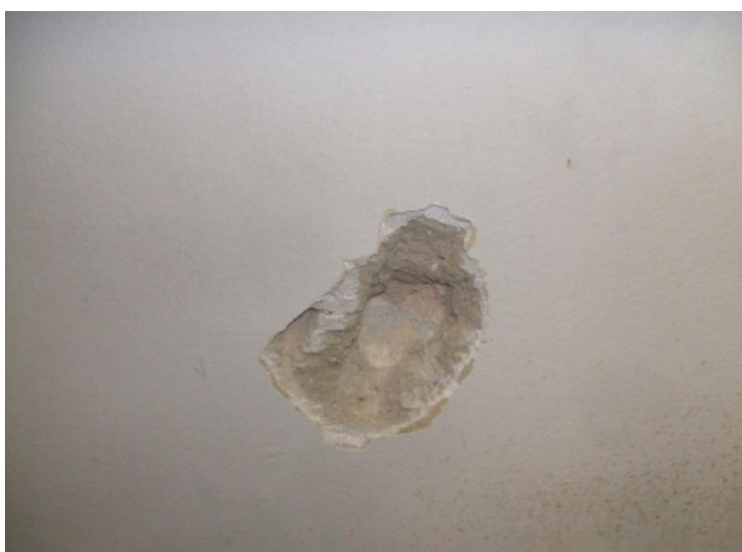
<b>Site Code/UPRN</b>	SD724P/86213	<b>Building</b>	Whitehall
<b>Address</b>	The Old War Office Horse Guards Avenue Whitehall London	<b>Floor</b>	First Floor
	SW1A 2HB	<b>Room</b>	Room 144 A
<b>Description</b>	Plaster/ render walls.	<b>Quantity</b>	N/A
		<b>Asbestos Suspected</b>	<b>No</b>

<b>Last Inspection Date</b>	-	03 Sep 2012	<b>Certificate N°</b>	-	BK30786
<b>Next Inspection Date</b>	-	03 Sep 2013	<b>Sample N°</b>	-	193
<b>Survey Type</b>	-	Refurbishment & Demolition Survey	<b>Photograph N°</b>	-	4914
<b>Position</b>	-	Sample Taken	<b>Location ID</b>	-	Loc20141

<b>Product Type</b>	-	N/A	<b>Surface Treatment</b>	-	N/A
<b>Asbestos Type</b>	-	No Asbestos Detected	<b>Damage Extent</b>	-	N/A
<b>Material Risk Score</b>	-	<b>0</b>	<b>Material Risk Band</b>	-	N/A

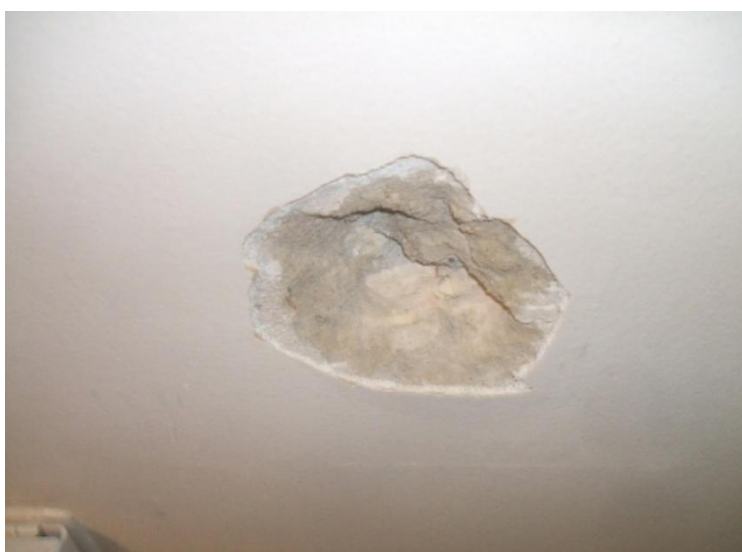
<b>Site Code/UPRN</b>	SD724P/86213	<b>Building</b>	Whitehall
<b>Address</b>	The Old War Office Horse Guards Avenue Whitehall London	<b>Floor</b>	First Floor
	SW1A 2HB	<b>Room</b>	Room 144 A
<b>Description</b>	Plaster/ render to walls.	<b>Quantity</b>	N/A
		<b>Asbestos Suspected</b>	<b>No</b>

<b>Last Inspection Date</b>	-	03 Sep 2012	<b>Certificate N<sup>o</sup></b>	-	BK30786
<b>Next Inspection Date</b>	-	03 Sep 2013	<b>Sample N<sup>o</sup></b>	-	195
<b>Survey Type</b>	-	Refurbishment & Demolition Survey	<b>Photograph N<sup>o</sup></b>	-	4916
<b>Position</b>	-	Sample Taken	<b>Location ID</b>	-	Loc20143

<b>Product Type</b>	-	N/A	<b>Surface Treatment</b>	-	N/A
<b>Asbestos Type</b>	-	No Asbestos Detected	<b>Damage Extent</b>	-	N/A
<b>Material Risk Score</b>	-	<b>0</b>	<b>Material Risk Band</b>	-	N/A

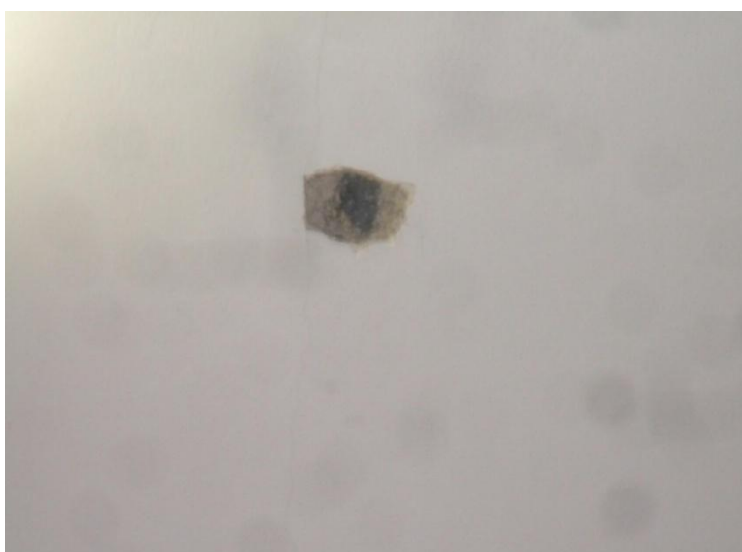
<b>Site Code/UPRN</b>	SD724P/86213	<b>Building</b>	Whitehall
<b>Address</b>	The Old War Office Horse Guards Avenue Whitehall London	<b>Floor</b>	First Floor
	SW1A 2HB	<b>Room</b>	Room 144 A
		<b>Quantity</b>	N/A
<b>Description</b>	Asphalt/ concrete ceiling.	<b>Asbestos Suspected</b>	<b>No</b>

<b>Last Inspection Date</b>	-	03 Sep 2012	<b>Certificate N<sup>o</sup></b>	-	BK30786
<b>Next Inspection Date</b>	-	03 Sep 2013	<b>Sample N<sup>o</sup></b>	-	190
<b>Survey Type</b>	-	Refurbishment & Demolition Survey	<b>Photograph N<sup>o</sup></b>	-	4911
<b>Position</b>	-	Sample Taken	<b>Location ID</b>	-	Loc20134

<b>Product Type</b>	-	N/A	<b>Surface Treatment</b>	-	N/A
<b>Asbestos Type</b>	-	No Asbestos Detected	<b>Damage Extent</b>	-	N/A
<b>Material Risk Score</b>	-	<b>0</b>	<b>Material Risk Band</b>	-	N/A

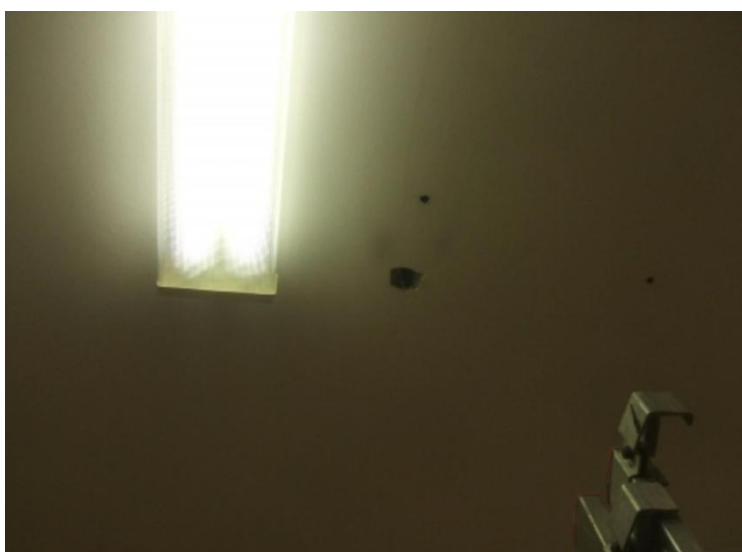
<b>Site Code/UPRN</b>	SD724P/86213	<b>Building</b>	Whitehall
<b>Address</b>	The Old War Office Horse Guards Avenue Whitehall London	<b>Floor</b>	First Floor
	SW1A 2HB	<b>Room</b>	Room 144 A
<b>Description</b>	Ceiling plaster.	<b>Quantity</b>	N/A
		<b>Asbestos Suspected</b>	<b>No</b>

<b>Last Inspection Date</b>	-	03 Sep 2012	<b>Certificate N°</b>	-	BK30786
<b>Next Inspection Date</b>	-	03 Sep 2013	<b>Sample N°</b>	-	189
<b>Survey Type</b>	-	Refurbishment & Demolition Survey	<b>Photograph N°</b>	-	4910
<b>Position</b>	-	Sample Taken	<b>Location ID</b>	-	Loc20133

<b>Product Type</b>	-	N/A	<b>Surface Treatment</b>	-	N/A
<b>Asbestos Type</b>	-	No Asbestos Detected	<b>Damage Extent</b>	-	N/A
<b>Material Risk Score</b>	-	<b>0</b>	<b>Material Risk Band</b>	-	N/A

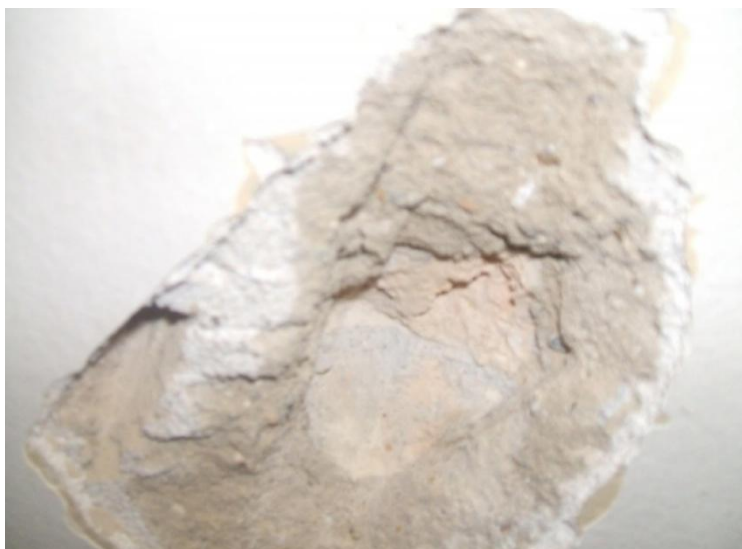
<b>Site Code/UPRN</b>	SD724P/86213	<b>Building</b>	Whitehall
<b>Address</b>	The Old War Office Horse Guards Avenue Whitehall London	<b>Floor</b>	First Floor
	SW1A 2HB	<b>Room</b>	Room 144 A
<b>Description</b>	Mortar line to walls.	<b>Quantity</b>	N/A
		<b>Asbestos Suspected</b>	<b>No</b>

<b>Last Inspection Date</b>	-	03 Sep 2012	<b>Certificate N°</b>	-	BK30786
<b>Next Inspection Date</b>	-	03 Sep 2013	<b>Sample N°</b>	-	194
<b>Survey Type</b>	-	Refurbishment & Demolition Survey	<b>Photograph N°</b>	-	4915
<b>Position</b>	-	Sample Taken	<b>Location ID</b>	-	Loc20142

<b>Product Type</b>	-	N/A	<b>Surface Treatment</b>	-	N/A
<b>Asbestos Type</b>	-	No Asbestos Detected	<b>Damage Extent</b>	-	N/A
<b>Material Risk Score</b>	-	<b>0</b>	<b>Material Risk Band</b>	-	N/A

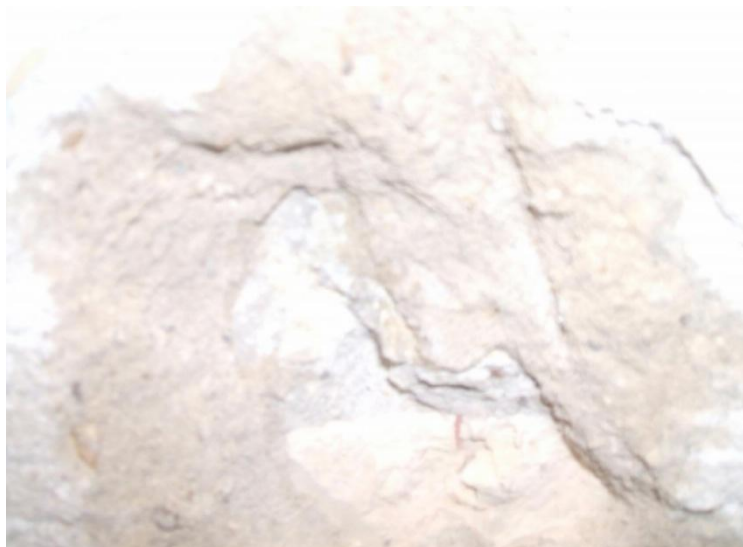
<b>Site Code/UPRN</b>	SD724P/86213	<b>Building</b>	Whitehall
<b>Address</b>	The Old War Office Horse Guards Avenue Whitehall London	<b>Floor</b>	First Floor
	SW1A 2HB	<b>Room</b>	Room 144 A
<b>Description</b>	Mortar line walls.	<b>Quantity</b>	N/A
		<b>Asbestos Suspected</b>	<b>No</b>

<b>Last Inspection Date</b>	-	03 Sep 2012	<b>Certificate N<sup>o</sup></b>	-	BK30786
<b>Next Inspection Date</b>	-	03 Sep 2013	<b>Sample N<sup>o</sup></b>	-	196
<b>Survey Type</b>	-	Refurbishment & Demolition Survey	<b>Photograph N<sup>o</sup></b>	-	4917
<b>Position</b>	-	Sample Taken	<b>Location ID</b>	-	Loc20144

<b>Product Type</b>	-	N/A	<b>Surface Treatment</b>	-	N/A
<b>Asbestos Type</b>	-	No Asbestos Detected	<b>Damage Extent</b>	-	N/A
<b>Material Risk Score</b>	-	<b>0</b>	<b>Material Risk Band</b>	-	N/A

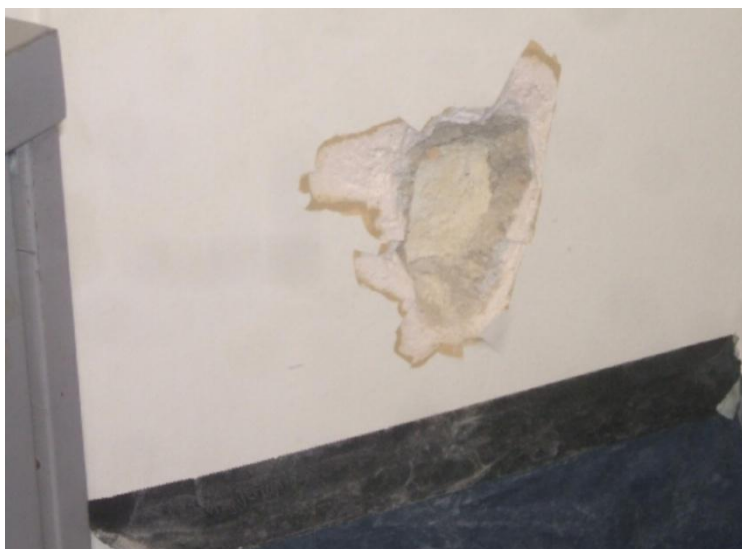
<b>Site Code/UPRN</b>	SD724P/86213	<b>Building</b>	Whitehall
<b>Address</b>	The Old War Office Horse Guards Avenue Whitehall London	<b>Floor</b>	First Floor
	SW1A 2HB	<b>Room</b>	Room 144 A
<b>Description</b>	Plaster & render walls.	<b>Quantity</b>	N/A
		<b>Asbestos Suspected</b>	<b>No</b>

<b>Last Inspection Date</b>	-	03 Sep 2012	<b>Certificate N<sup>o</sup></b>	-	BK30786
<b>Next Inspection Date</b>	-	03 Sep 2013	<b>Sample N<sup>o</sup></b>	-	191
<b>Survey Type</b>	-	Refurbishment & Demolition Survey	<b>Photograph N<sup>o</sup></b>	-	4912
<b>Position</b>	-	Sample Taken	<b>Location ID</b>	-	Loc20135

<b>Product Type</b>	-	N/A	<b>Surface Treatment</b>	-	N/A
<b>Asbestos Type</b>	-	No Asbestos Detected	<b>Damage Extent</b>	-	N/A
<b>Material Risk Score</b>	-	<b>0</b>	<b>Material Risk Band</b>	-	N/A

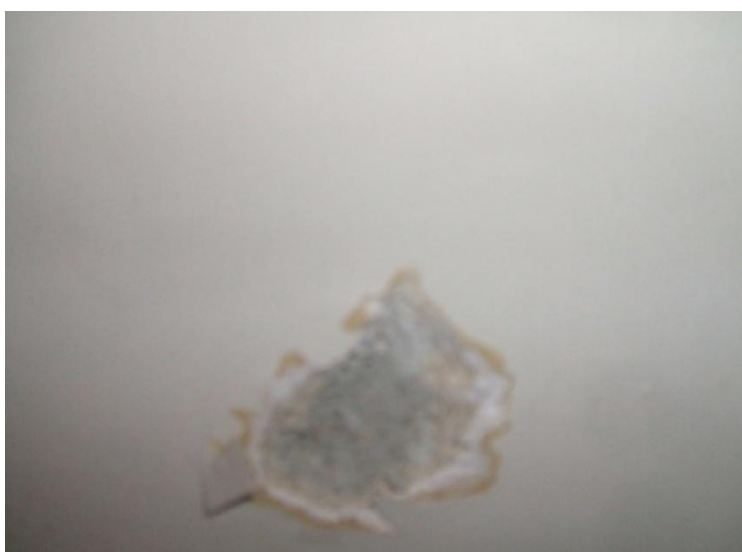
<b>Site Code/UPRN</b>	SD724P/86213	<b>Building</b>	Whitehall
<b>Address</b>	The Old War Office Horse Guards Avenue Whitehall London	<b>Floor</b>	First Floor
	SW1A 2HB	<b>Room</b>	Stair (1) Lobby
<b>Description</b>	Plaster/ render to beam.	<b>Quantity</b>	N/A
		<b>Asbestos Suspected</b>	<b>No</b>

<b>Last Inspection Date</b>	-	03 Sep 2012	<b>Certificate N<sup>o</sup></b>	-	BK30786
<b>Next Inspection Date</b>	-	03 Sep 2013	<b>Sample N<sup>o</sup></b>	-	199
<b>Survey Type</b>	-	Refurbishment & Demolition Survey	<b>Photograph N<sup>o</sup></b>	-	4920
<b>Position</b>	-	Sample Taken	<b>Location ID</b>	-	Loc20147

<b>Product Type</b>	-	N/A	<b>Surface Treatment</b>	-	N/A
<b>Asbestos Type</b>	-	No Asbestos Detected	<b>Damage Extent</b>	-	N/A
<b>Material Risk Score</b>	-	<b>0</b>	<b>Material Risk Band</b>	-	N/A

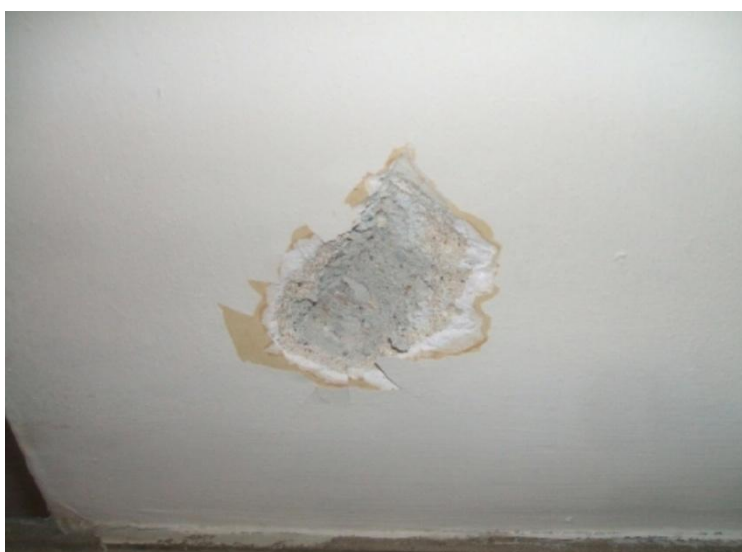
<b>Site Code/UPRN</b>	SD724P/86213	<b>Building</b>	Whitehall
<b>Address</b>	The Old War Office Horse Guards Avenue Whitehall London	<b>Floor</b>	First Floor
	SW1A 2HB	<b>Room</b>	Stair (1) Lobby
<b>Description</b>	Concrete beam.	<b>Quantity</b>	N/A
		<b>Asbestos Suspected</b>	<b>No</b>

<b>Last Inspection Date</b>	-	03 Sep 2012	<b>Certificate N°</b>	-	BK30786
<b>Next Inspection Date</b>	-	03 Sep 2013	<b>Sample N°</b>	-	200
<b>Survey Type</b>	-	Refurbishment & Demolition Survey	<b>Photograph N°</b>	-	4921
<b>Position</b>	-	Sample Taken	<b>Location ID</b>	-	Loc20148

<b>Product Type</b>	-	N/A	<b>Surface Treatment</b>	-	N/A
<b>Asbestos Type</b>	-	No Asbestos Detected	<b>Damage Extent</b>	-	N/A
<b>Material Risk Score</b>	-	<b>0</b>	<b>Material Risk Band</b>	-	N/A

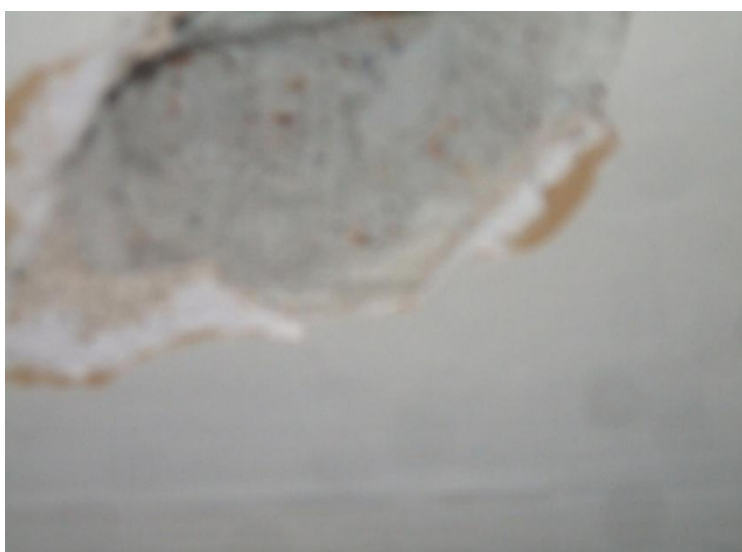
<b>Site Code/UPRN</b>	SD724P/86213	<b>Building</b>	Whitehall
<b>Address</b>	The Old War Office Horse Guards Avenue Whitehall London	<b>Floor</b>	First Floor
	SW1A 2HB	<b>Room</b>	Stair (2) Lobby
<b>Description</b>	Concrete beam.	<b>Quantity</b>	N/A
		<b>Asbestos Suspected</b>	<b>No</b>

<b>Last Inspection Date</b>	-	03 Sep 2012	<b>Certificate N<sup>o</sup></b>	-	BK30786
<b>Next Inspection Date</b>	-	03 Sep 2013	<b>Sample N<sup>o</sup></b>	-	198
<b>Survey Type</b>	-	Refurbishment & Demolition Survey	<b>Photograph N<sup>o</sup></b>	-	4919
<b>Position</b>	-	Sample Taken	<b>Location ID</b>	-	Loc20146

<b>Product Type</b>	-	N/A	<b>Surface Treatment</b>	-	N/A
<b>Asbestos Type</b>	-	No Asbestos Detected	<b>Damage Extent</b>	-	N/A
<b>Material Risk Score</b>	-	<b>0</b>	<b>Material Risk Band</b>	-	N/A

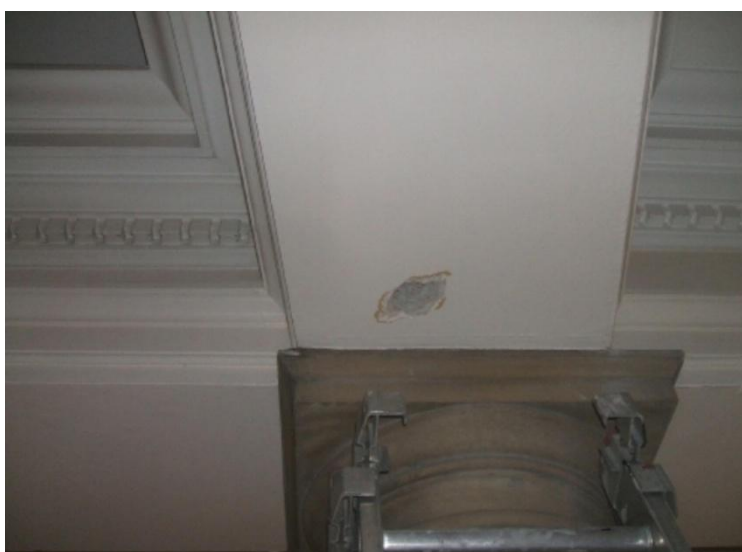
<b>Site Code/UPRN</b>	SD724P/86213	<b>Building</b>	Whitehall
<b>Address</b>	The Old War Office Horse Guards Avenue Whitehall London	<b>Floor</b>	First Floor
	SW1A 2HB	<b>Room</b>	Stair (2) Lobby
<b>Description</b>	Plaster/ render to beam.	<b>Quantity</b>	N/A
		<b>Asbestos Suspected</b>	<b>No</b>

<b>Last Inspection Date</b>	-	03 Sep 2012	<b>Certificate N<sup>o</sup></b>	-	BK30786
<b>Next Inspection Date</b>	-	03 Sep 2013	<b>Sample N<sup>o</sup></b>	-	197
<b>Survey Type</b>	-	Refurbishment & Demolition Survey	<b>Photograph N<sup>o</sup></b>	-	4918
<b>Position</b>	-	Sample Taken	<b>Location ID</b>	-	Loc20145

<b>Product Type</b>	-	N/A	<b>Surface Treatment</b>	-	N/A
<b>Asbestos Type</b>	-	No Asbestos Detected	<b>Damage Extent</b>	-	N/A
<b>Material Risk Score</b>	-	<b>0</b>	<b>Material Risk Band</b>	-	N/A

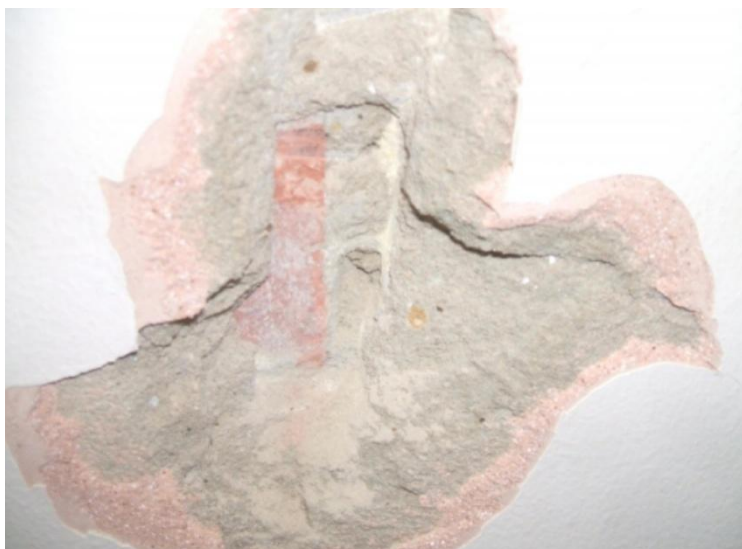
<b>Site Code/UPRN</b>	SD724P/86213	<b>Building</b>	Whitehall
<b>Address</b>	The Old War Office Horse Guards Avenue Whitehall London	<b>Floor</b>	Fourth Floor
	SW1A 2HB	<b>Room</b>	Room 417
<b>Description</b>	Mortar line to brickwork walls.	<b>Quantity</b>	N/A
		<b>Asbestos Suspected</b>	<b>No</b>

<b>Last Inspection Date</b>	-	03 Sep 2012	<b>Certificate N<sup>o</sup></b>	-	BK30669
<b>Next Inspection Date</b>	-	03 Sep 2013	<b>Sample N<sup>o</sup></b>	-	76
<b>Survey Type</b>	-	Refurbishment & Demolition Survey	<b>Photograph N<sup>o</sup></b>	-	4796
<b>Position</b>	-	Sample Taken	<b>Location ID</b>	-	Loc20017

<b>Product Type</b>	-	N/A	<b>Surface Treatment</b>	-	N/A
<b>Asbestos Type</b>	-	No Asbestos Detected	<b>Damage Extent</b>	-	N/A
<b>Material Risk Score</b>	-	<b>0</b>	<b>Material Risk Band</b>	-	N/A

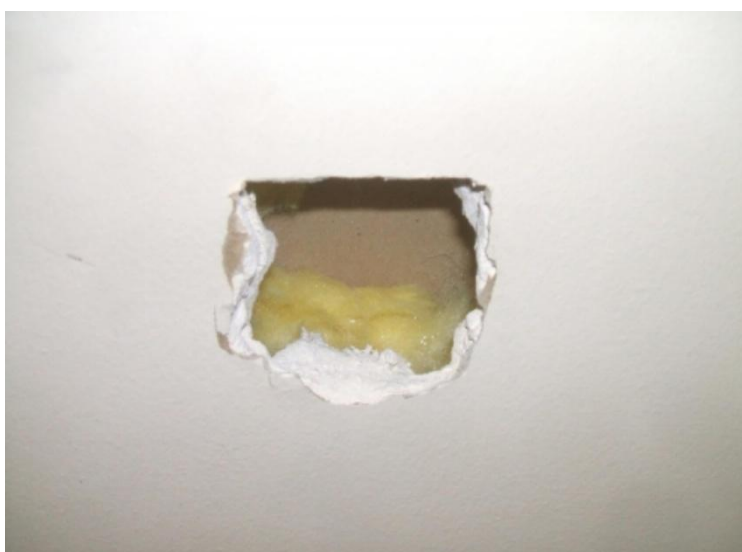
<b>Site Code/UPRN</b>	SD724P/86213	<b>Building</b>	Whitehall
<b>Address</b>	The Old War Office Horse Guards Avenue Whitehall London	<b>Floor</b>	Fourth Floor
	SW1A 2HB	<b>Room</b>	Room 417
<b>Description</b>	Plaster finish to board.	<b>Quantity</b>	N/A
		<b>Asbestos Suspected</b>	<b>No</b>

<b>Last Inspection Date</b>	-	03 Sep 2012	<b>Certificate N<sup>o</sup></b>	-	BK30669
<b>Next Inspection Date</b>	-	03 Sep 2013	<b>Sample N<sup>o</sup></b>	-	77
<b>Survey Type</b>	-	Refurbishment & Demolition Survey	<b>Photograph N<sup>o</sup></b>	-	4791
<b>Position</b>	-	Sample Taken	<b>Location ID</b>	-	Loc20018

<b>Product Type</b>	-	N/A	<b>Surface Treatment</b>	-	N/A
<b>Asbestos Type</b>	-	No Asbestos Detected	<b>Damage Extent</b>	-	N/A
<b>Material Risk Score</b>	-	<b>0</b>	<b>Material Risk Band</b>	-	N/A

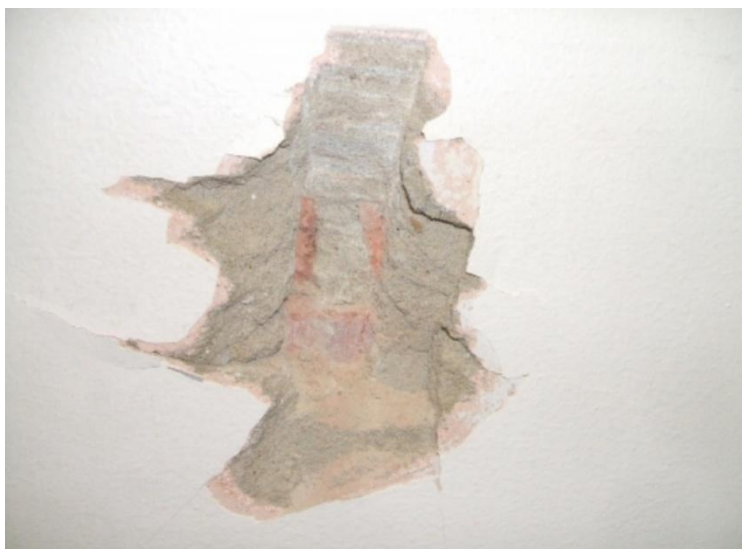
<b>Site Code/UPRN</b>	SD724P/86213	<b>Building</b>	Whitehall
<b>Address</b>	The Old War Office Horse Guards Avenue Whitehall London	<b>Floor</b>	Fourth Floor
	SW1A 2HB	<b>Room</b>	Room 417
<b>Description</b>	Plaster & render finish to left side of power socket.	<b>Quantity</b>	N/A
		<b>Asbestos Suspected</b>	<b>No</b>

<b>Product Type</b>	-	N/A	<b>Surface Treatment</b>	-	N/A
<b>Asbestos Type</b>	-	No Asbestos Detected	<b>Damage Extent</b>	-	N/A
<b>Material Risk Score</b>	-	<b>0</b>	<b>Material Risk Band</b>	-	N/A

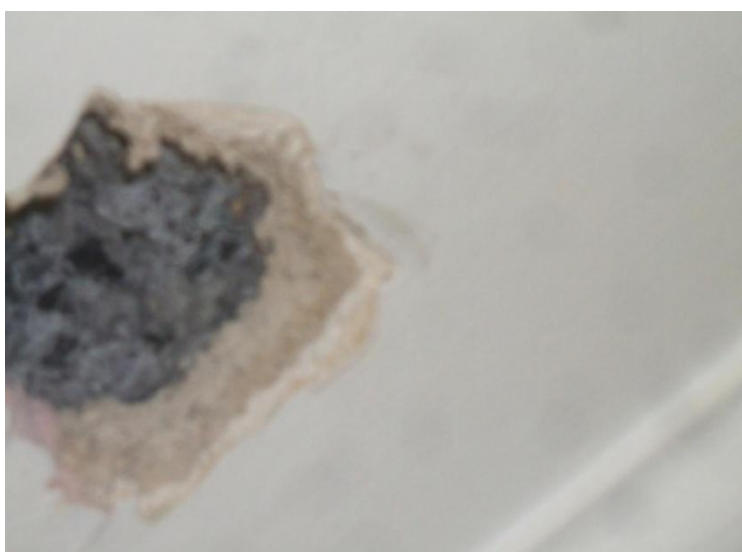
<b>Site Code/UPRN</b>	SD724P/86213	<b>Building</b>	Whitehall
<b>Address</b>	The Old War Office Horse Guards Avenue Whitehall London	<b>Floor</b>	Fourth Floor
	SW1A 2HB	<b>Room</b>	Room 417
<b>Description</b>	Plaster & render finish.	<b>Quantity</b>	N/A
		<b>Asbestos Suspected</b>	<b>No</b>

<b>Product Type</b>	-	N/A	<b>Surface Treatment</b>	-	N/A
<b>Asbestos Type</b>	-	No Asbestos Detected	<b>Damage Extent</b>	-	N/A
<b>Material Risk Score</b>	-	<b>0</b>	<b>Material Risk Band</b>	-	N/A

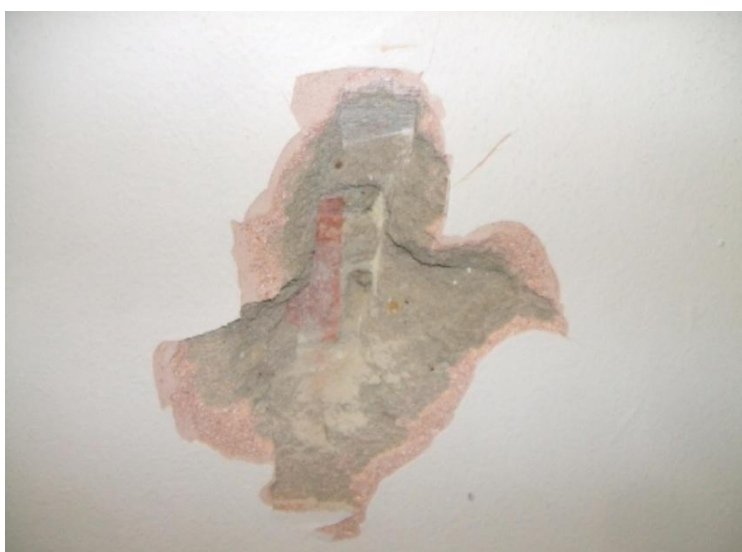
<b>Site Code/UPRN</b>	SD724P/86213	<b>Building</b>	Whitehall
<b>Address</b>	The Old War Office Horse Guards Avenue Whitehall London	<b>Floor</b>	Fourth Floor
	SW1A 2HB	<b>Room</b>	Room 417
<b>Description</b>	Plaster & render finish to walls.	<b>Quantity</b>	N/A
		<b>Asbestos Suspected</b>	<b>No</b>

<b>Product Type</b>	-	N/A	<b>Surface Treatment</b>	-	N/A
<b>Asbestos Type</b>	-	No Asbestos Detected	<b>Damage Extent</b>	-	N/A
<b>Material Risk Score</b>	-	<b>0</b>	<b>Material Risk Band</b>	-	N/A

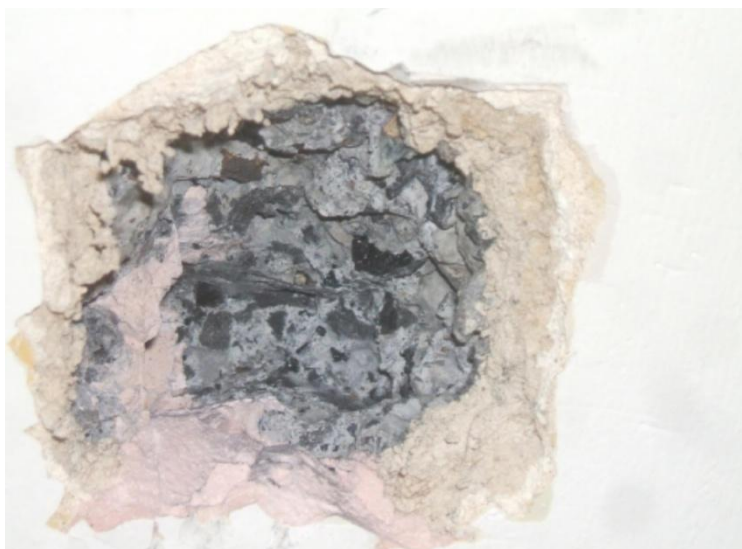
<b>Site Code/UPRN</b>	SD724P/86213	<b>Building</b>	Whitehall
<b>Address</b>	The Old War Office Horse Guards Avenue Whitehall London	<b>Floor</b>	Fourth Floor
	SW1A 2HB	<b>Room</b>	Room 417
<b>Description</b>	Asphalt over plaster.	<b>Quantity</b>	N/A
		<b>Asbestos Suspected</b>	<b>No</b>

<b>Product Type</b>	-	N/A	<b>Surface Treatment</b>	-	N/A
<b>Asbestos Type</b>	-	No Asbestos Detected	<b>Damage Extent</b>	-	N/A
<b>Material Risk Score</b>	-	<b>0</b>	<b>Material Risk Band</b>	-	N/A

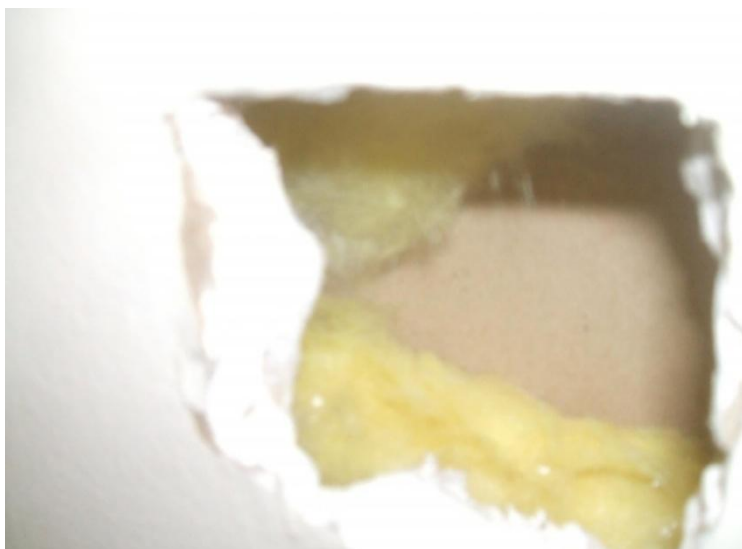
<b>Site Code/UPRN</b>	SD724P/86213	<b>Building</b>	Whitehall
<b>Address</b>	The Old War Office Horse Guards Avenue Whitehall London	<b>Floor</b>	Fourth Floor
	SW1A 2HB	<b>Room</b>	Room 417
<b>Description</b>	Board (party wall)	<b>Quantity</b>	N/A
		<b>Asbestos Suspected</b>	<b>No</b>

<b>Product Type</b>	-	N/A	<b>Surface Treatment</b>	-	N/A
<b>Asbestos Type</b>	-	No Asbestos Detected	<b>Damage Extent</b>	-	N/A
<b>Material Risk Score</b>	-	<b>0</b>	<b>Material Risk Band</b>	-	N/A

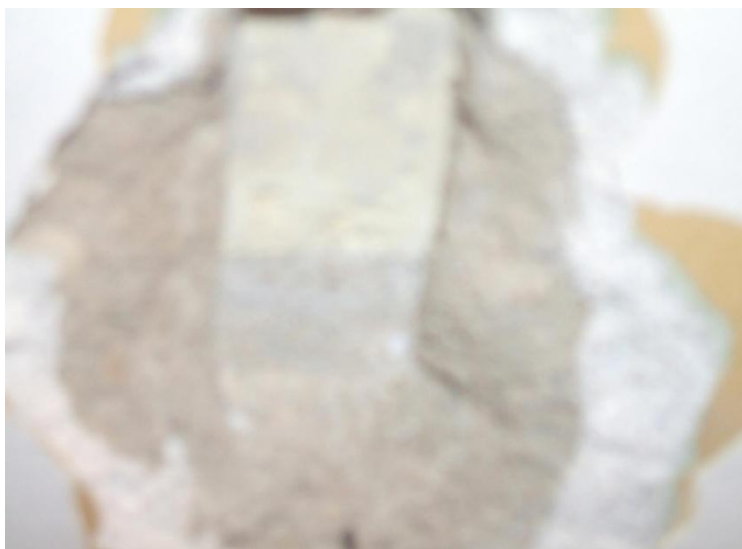
<b>Site Code/UPRN</b>	SD724P/86213	<b>Building</b>	Whitehall
<b>Address</b>	The Old War Office Horse Guards Avenue Whitehall London	<b>Floor</b>	Fourth Floor
	SW1A 2HB	<b>Room</b>	Room 423
<b>Description</b>	Mortar line walls.	<b>Quantity</b>	N/A
		<b>Asbestos Suspected</b>	<b>No</b>

<b>Product Type</b>	-	N/A	<b>Surface Treatment</b>	-	N/A
<b>Asbestos Type</b>	-	No Asbestos Detected	<b>Damage Extent</b>	-	N/A
<b>Material Risk Score</b>	-	<b>0</b>	<b>Material Risk Band</b>	-	N/A

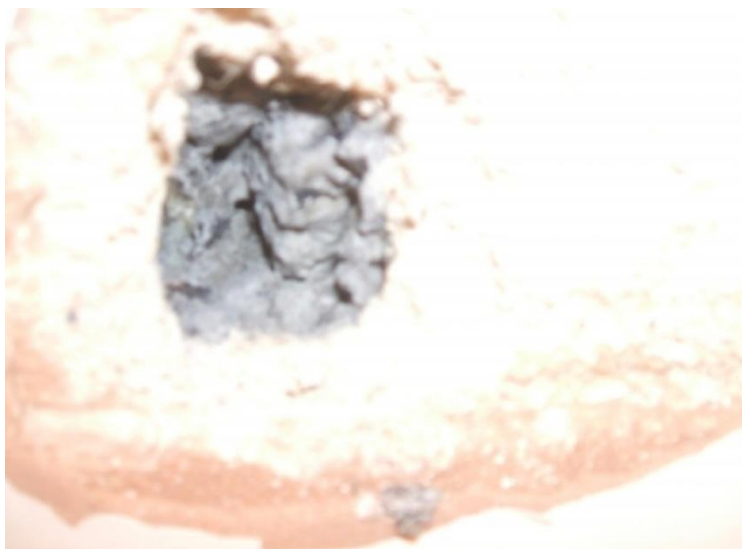
<b>Site Code/UPRN</b>	SD724P/86213	<b>Building</b>	Whitehall
<b>Address</b>	The Old War Office Horse Guards Avenue Whitehall London	<b>Floor</b>	Fourth Floor
	SW1A 2HB	<b>Room</b>	Room 423
<b>Description</b>	Asphalt ceiling.	<b>Quantity</b>	N/A
		<b>Asbestos Suspected</b>	<b>No</b>

<b>Product Type</b>	-	N/A	<b>Surface Treatment</b>	-	N/A
<b>Asbestos Type</b>	-	No Asbestos Detected	<b>Damage Extent</b>	-	N/A
<b>Material Risk Score</b>	-	<b>0</b>	<b>Material Risk Band</b>	-	N/A

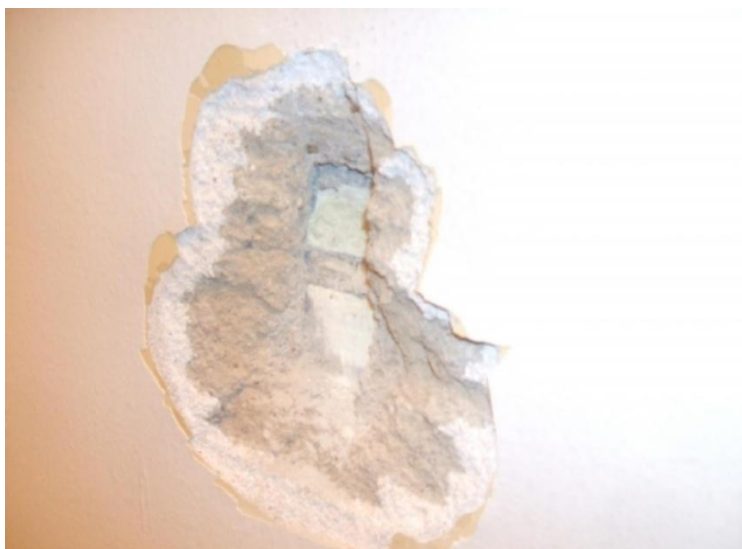
<b>Site Code/UPRN</b>	SD724P/86213	<b>Building</b>	Whitehall
<b>Address</b>	The Old War Office Horse Guards Avenue Whitehall London	<b>Floor</b>	Fourth Floor
	SW1A 2HB	<b>Room</b>	Room 423
<b>Description</b>	Plaster & render finish to wall.	<b>Quantity</b>	N/A
		<b>Asbestos Suspected</b>	<b>No</b>

<b>Product Type</b>	-	N/A	<b>Surface Treatment</b>	-	N/A
<b>Asbestos Type</b>	-	N/A	<b>Damage Extent</b>	-	N/A
<b>Material Risk Score</b>	-	<b>0</b>	<b>Material Risk Band</b>	-	N/A

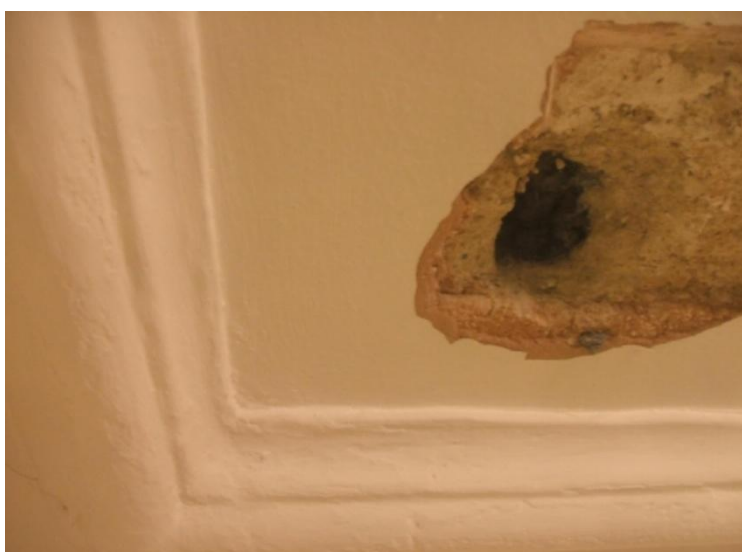
<b>Site Code/UPRN</b>	SD724P/86213	<b>Building</b>	Whitehall
<b>Address</b>	The Old War Office Horse Guards Avenue Whitehall London	<b>Floor</b>	Fourth Floor
	SW1A 2HB	<b>Room</b>	Room 423
<b>Description</b>	Plaster & render ceiling.	<b>Quantity</b>	N/A
		<b>Asbestos Suspected</b>	<b>No</b>

<b>Product Type</b>	-	N/A	<b>Surface Treatment</b>	-	N/A
<b>Asbestos Type</b>	-	No Asbestos Detected	<b>Damage Extent</b>	-	N/A
<b>Material Risk Score</b>	-	<b>0</b>	<b>Material Risk Band</b>	-	N/A

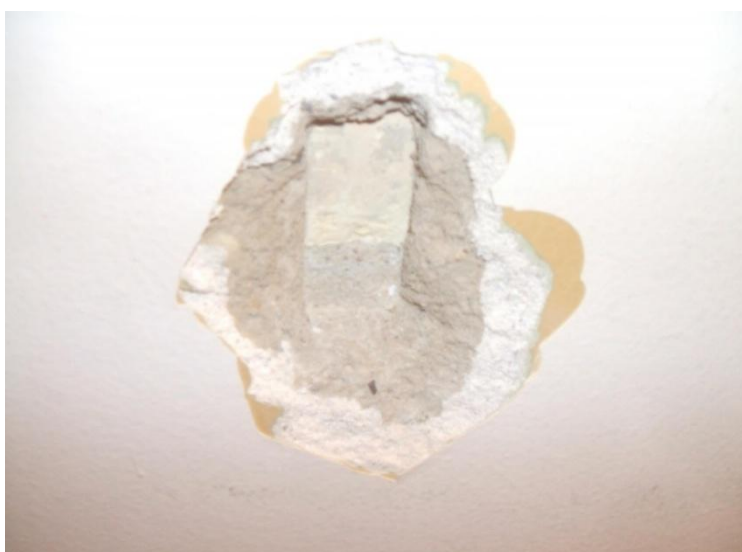
<b>Site Code/UPRN</b>	SD724P/86213	<b>Building</b>	Whitehall
<b>Address</b>	The Old War Office Horse Guards Avenue Whitehall London	<b>Floor</b>	Fourth Floor
	SW1A 2HB	<b>Room</b>	Room 423
<b>Description</b>	Plaster & render walls.	<b>Quantity</b>	N/A
		<b>Asbestos Suspected</b>	<b>No</b>

<b>Product Type</b>	-	N/A	<b>Surface Treatment</b>	-	N/A
<b>Asbestos Type</b>	-	No Asbestos Detected	<b>Damage Extent</b>	-	N/A
<b>Material Risk Score</b>	-	<b>0</b>	<b>Material Risk Band</b>	-	N/A

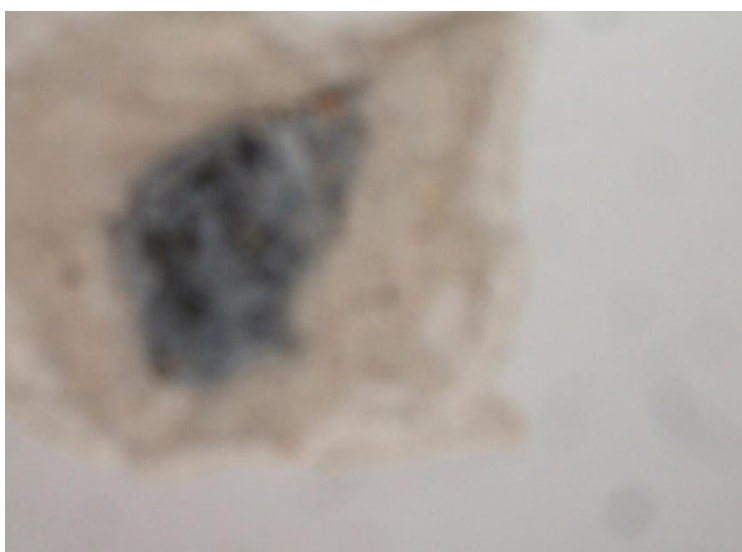
<b>Site Code/UPRN</b>	SD724P/86213	<b>Building</b>	Whitehall
<b>Address</b>	The Old War Office Horse Guards Avenue Whitehall London	<b>Floor</b>	Fourth Floor
	SW1A 2HB	<b>Room</b>	Room 428
<b>Description</b>	Asphalt ceiling.	<b>Quantity</b>	N/A
		<b>Asbestos Suspected</b>	<b>No</b>

<b>Product Type</b>	-	N/A	<b>Surface Treatment</b>	-	N/A
<b>Asbestos Type</b>	-	No Asbestos Detected	<b>Damage Extent</b>	-	N/A
<b>Material Risk Score</b>	-	<b>0</b>	<b>Material Risk Band</b>	-	N/A

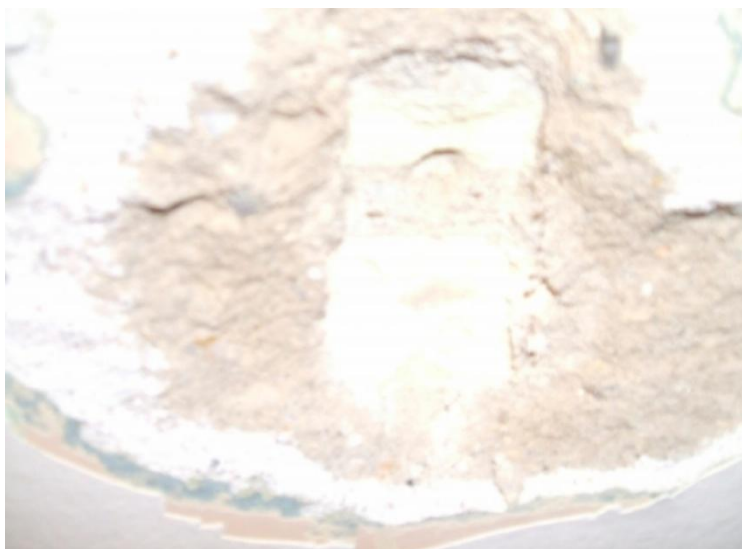
<b>Site Code/UPRN</b>	SD724P/86213	<b>Building</b>	Whitehall
<b>Address</b>	The Old War Office Horse Guards Avenue Whitehall London	<b>Floor</b>	Fourth Floor
	SW1A 2HB	<b>Room</b>	Room 428
<b>Description</b>	Mortar line to walls.	<b>Quantity</b>	N/A
		<b>Asbestos Suspected</b>	<b>No</b>

<b>Product Type</b>	-	N/A	<b>Surface Treatment</b>	-	N/A
<b>Asbestos Type</b>	-	No Asbestos Detected	<b>Damage Extent</b>	-	N/A
<b>Material Risk Score</b>	-	<b>0</b>	<b>Material Risk Band</b>	-	N/A

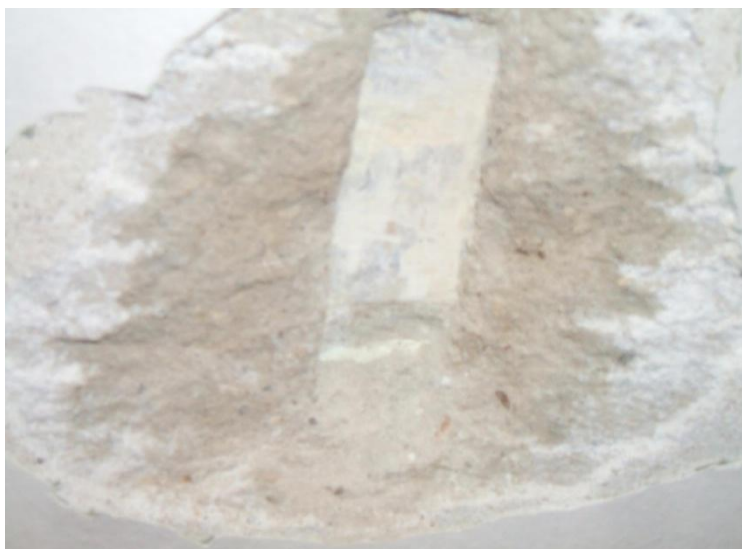
<b>Site Code/UPRN</b>	SD724P/86213	<b>Building</b>	Whitehall
<b>Address</b>	The Old War Office Horse Guards Avenue Whitehall London	<b>Floor</b>	Fourth Floor
	SW1A 2HB	<b>Room</b>	Room 428
<b>Description</b>	Mortar line to walls.	<b>Quantity</b>	N/A
		<b>Asbestos Suspected</b>	<b>No</b>

<b>Product Type</b>	-	N/A	<b>Surface Treatment</b>	-	N/A
<b>Asbestos Type</b>	-	No Asbestos Detected	<b>Damage Extent</b>	-	N/A
<b>Material Risk Score</b>	-	<b>0</b>	<b>Material Risk Band</b>	-	N/A

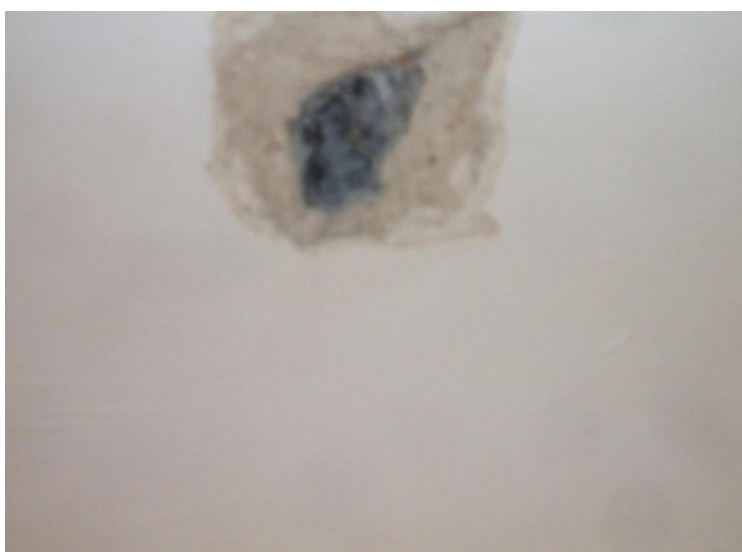
<b>Site Code/UPRN</b>	SD724P/86213	<b>Building</b>	Whitehall
<b>Address</b>	The Old War Office Horse Guards Avenue Whitehall London	<b>Floor</b>	Fourth Floor
	SW1A 2HB	<b>Room</b>	Room 428
<b>Description</b>	Plaster & render to walls.	<b>Quantity</b>	N/A
		<b>Asbestos Suspected</b>	<b>No</b>

<b>Product Type</b>	-	N/A	<b>Surface Treatment</b>	-	N/A
<b>Asbestos Type</b>	-	No Asbestos Detected	<b>Damage Extent</b>	-	N/A
<b>Material Risk Score</b>	-	<b>0</b>	<b>Material Risk Band</b>	-	N/A

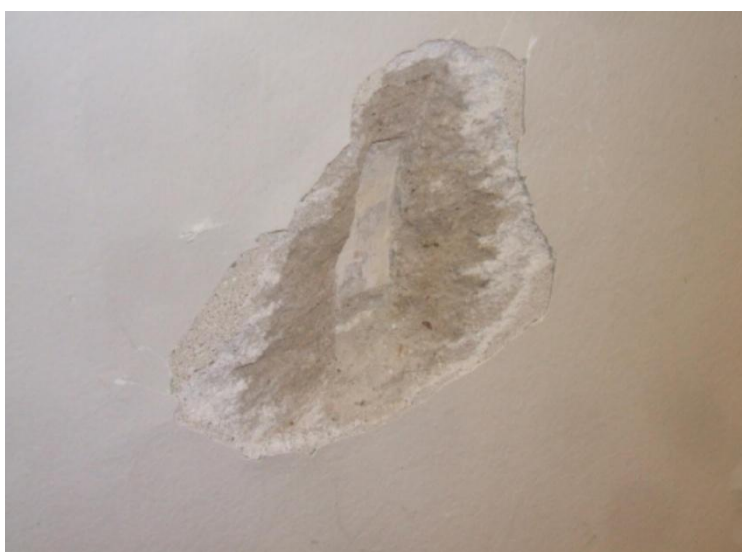
<b>Site Code/UPRN</b>	SD724P/86213	<b>Building</b>	Whitehall
<b>Address</b>	The Old War Office Horse Guards Avenue Whitehall London	<b>Floor</b>	Fourth Floor
	SW1A 2HB	<b>Room</b>	Room 428
<b>Description</b>	Plaster & render to walls.	<b>Quantity</b>	N/A
		<b>Asbestos Suspected</b>	<b>No</b>

<b>Product Type</b>	-	N/A	<b>Surface Treatment</b>	-	N/A
<b>Asbestos Type</b>	-	No Asbestos Detected	<b>Damage Extent</b>	-	N/A
<b>Material Risk Score</b>	-	<b>0</b>	<b>Material Risk Band</b>	-	N/A

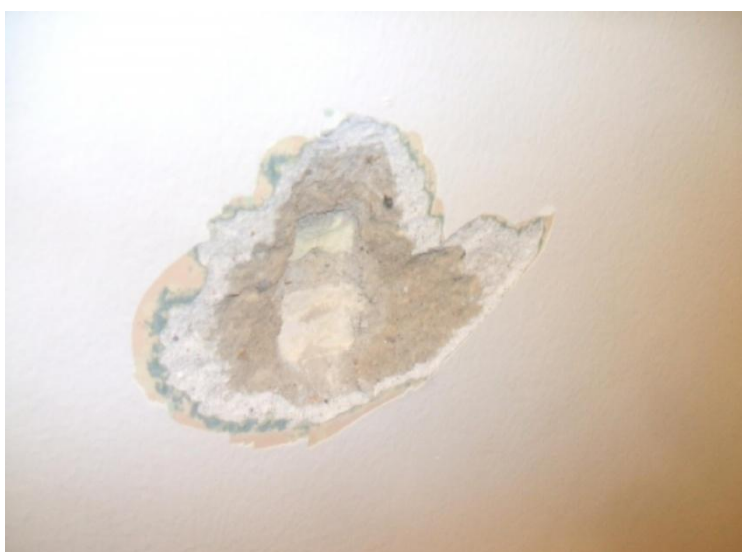
<b>Site Code/UPRN</b>	SD724P/86213	<b>Building</b>	Whitehall
<b>Address</b>	The Old War Office Horse Guards Avenue Whitehall London	<b>Floor</b>	Fourth Floor
	SW1A 2HB	<b>Room</b>	Room 428
<b>Description</b>	Plaster & render walls.	<b>Quantity</b>	N/A
		<b>Asbestos Suspected</b>	<b>No</b>

<b>Product Type</b>	-	N/A	<b>Surface Treatment</b>	-	N/A
<b>Asbestos Type</b>	-	No Asbestos Detected	<b>Damage Extent</b>	-	N/A
<b>Material Risk Score</b>	-	<b>0</b>	<b>Material Risk Band</b>	-	N/A

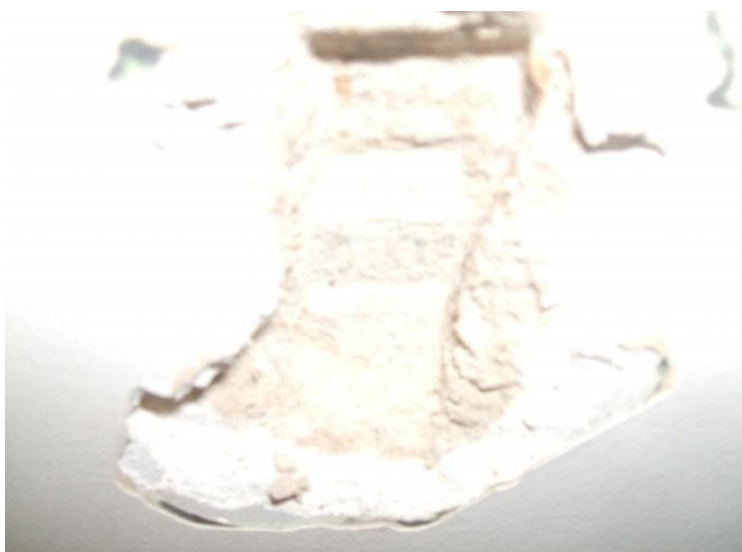
<b>Site Code/UPRN</b>	SD724P/86213	<b>Building</b>	Whitehall
<b>Address</b>	The Old War Office Horse Guards Avenue Whitehall London	<b>Floor</b>	Fourth Floor
	SW1A 2HB	<b>Room</b>	Room 466
<b>Description</b>	Mortar line to walls adjacent to light socket.	<b>Quantity</b>	N/A
		<b>Asbestos Suspected</b>	<b>No</b>

<b>Last Inspection Date</b>	-	03 Sep 2012	<b>Certificate N<sup>o</sup></b>	-	BK30669
<b>Next Inspection Date</b>	-	03 Sep 2013	<b>Sample N<sup>o</sup></b>	-	92
<b>Survey Type</b>	-	Refurbishment & Demolition Survey	<b>Photograph N<sup>o</sup></b>	-	4810
<b>Position</b>	-	Sample Taken	<b>Location ID</b>	-	Loc20033

<b>Product Type</b>	-	N/A	<b>Surface Treatment</b>	-	N/A
<b>Asbestos Type</b>	-	No Asbestos Detected	<b>Damage Extent</b>	-	N/A
<b>Material Risk Score</b>	-	<b>0</b>	<b>Material Risk Band</b>	-	N/A
