Ministry  
of Defence

## Defence Infrastructure Organisation

Ref: EIR/2017/13719

September 2014

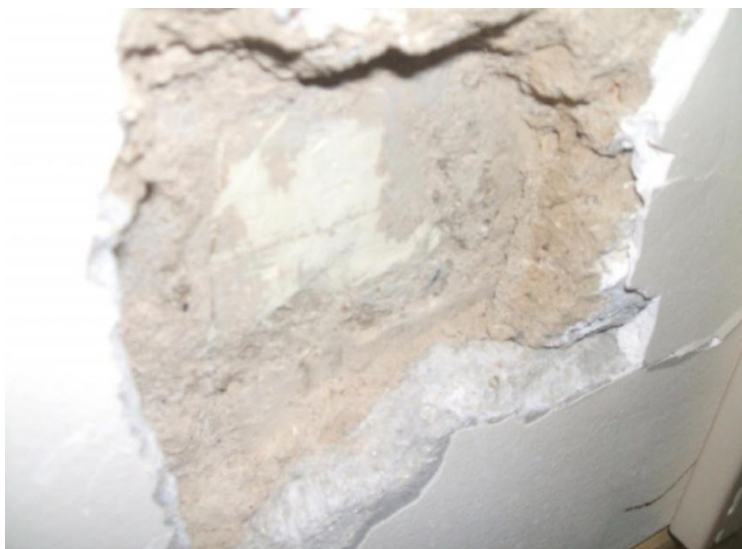
<b>Site Code/UPRN</b>	SD724P/86213	<b>Building</b>	Whitehall
<b>Address</b>	The Old War Office Horse Guards Avenue Whitehall London	<b>Floor</b>	Fourth Floor
	SW1A 2HB	<b>Room</b>	Room 466
<b>Description</b>	mortar line to walls adjacent to plug socket.	<b>Quantity</b>	N/A
		<b>Asbestos Suspected</b>	<b>No</b>

<b>Last Inspection Date</b>	-	03 Sep 2012	<b>Certificate N<sup>o</sup></b>	-	BK30669
<b>Next Inspection Date</b>	-	03 Sep 2013	<b>Sample N<sup>o</sup></b>	-	94
<b>Survey Type</b>	-	Refurbishment & Demolition Survey	<b>Photograph N<sup>o</sup></b>	-	4812
<b>Position</b>	-	Sample Taken	<b>Location ID</b>	-	Loc20035

<b>Product Type</b>	-	N/A	<b>Surface Treatment</b>	-	N/A
<b>Asbestos Type</b>	-	No Asbestos Detected	<b>Damage Extent</b>	-	N/A
<b>Material Risk Score</b>	-	<b>0</b>	<b>Material Risk Band</b>	-	N/A

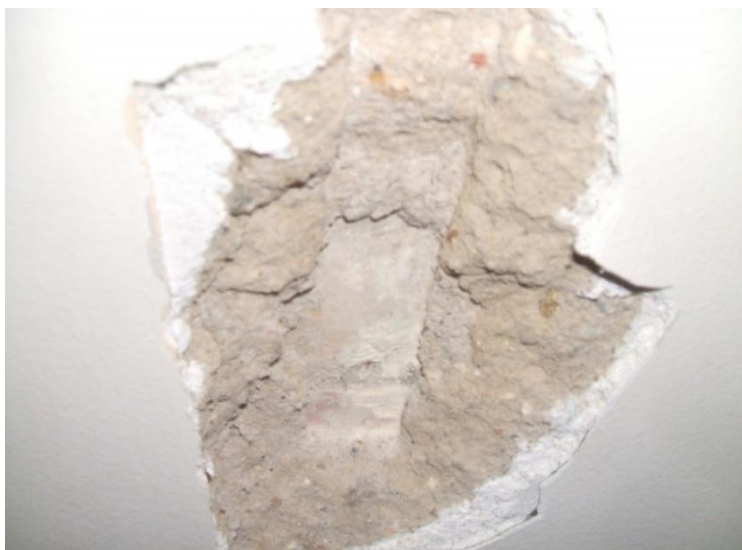
<b>Site Code/UPRN</b>	SD724P/86213	<b>Building</b>	Whitehall
<b>Address</b>	The Old War Office Horse Guards Avenue Whitehall London	<b>Floor</b>	Fourth Floor
	SW1A 2HB	<b>Room</b>	Room 466
<b>Description</b>	mortar line to walls adjacent to BT switch & wall socket.	<b>Quantity</b>	N/A
		<b>Asbestos Suspected</b>	<b>No</b>

<b>Last Inspection Date</b>	-	03 Sep 2012	<b>Certificate N°</b>	-	BK30669
<b>Next Inspection Date</b>	-	03 Sep 2013	<b>Sample N°</b>	-	96
<b>Survey Type</b>	-	Refurbishment & Demolition Survey	<b>Photograph N°</b>	-	4814
<b>Position</b>	-	Sample Taken	<b>Location ID</b>	-	Loc20037

<b>Product Type</b>	-	N/A	<b>Surface Treatment</b>	-	N/A
<b>Asbestos Type</b>	-	No Asbestos Detected	<b>Damage Extent</b>	-	N/A
<b>Material Risk Score</b>	-	<b>0</b>	<b>Material Risk Band</b>	-	N/A

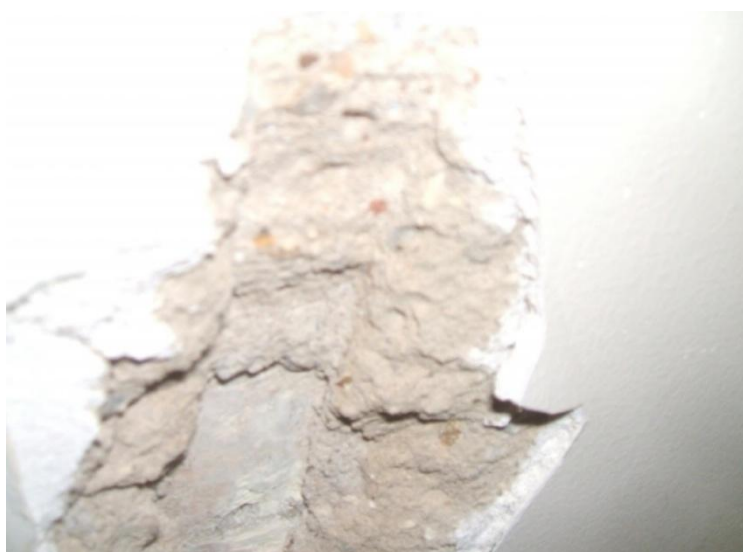
<b>Site Code/UPRN</b>	SD724P/86213	<b>Building</b>	Whitehall
<b>Address</b>	The Old War Office Horse Guards Avenue Whitehall London	<b>Floor</b>	Fourth Floor
	SW1A 2HB	<b>Room</b>	Room 466
<b>Description</b>	Plaster & render to walls.	<b>Quantity</b>	N/A
		<b>Asbestos Suspected</b>	<b>No</b>

<b>Last Inspection Date</b>	-	03 Sep 2012	<b>Certificate N°</b>	-	BK30669
<b>Next Inspection Date</b>	-	03 Sep 2013	<b>Sample N°</b>	-	97
<b>Survey Type</b>	-	Refurbishment & Demolition Survey	<b>Photograph N°</b>	-	4815
<b>Position</b>	-	Sample Taken	<b>Location ID</b>	-	Loc20038

<b>Product Type</b>	-	N/A	<b>Surface Treatment</b>	-	N/A
<b>Asbestos Type</b>	-	No Asbestos Detected	<b>Damage Extent</b>	-	N/A
<b>Material Risk Score</b>	-	<b>0</b>	<b>Material Risk Band</b>	-	N/A

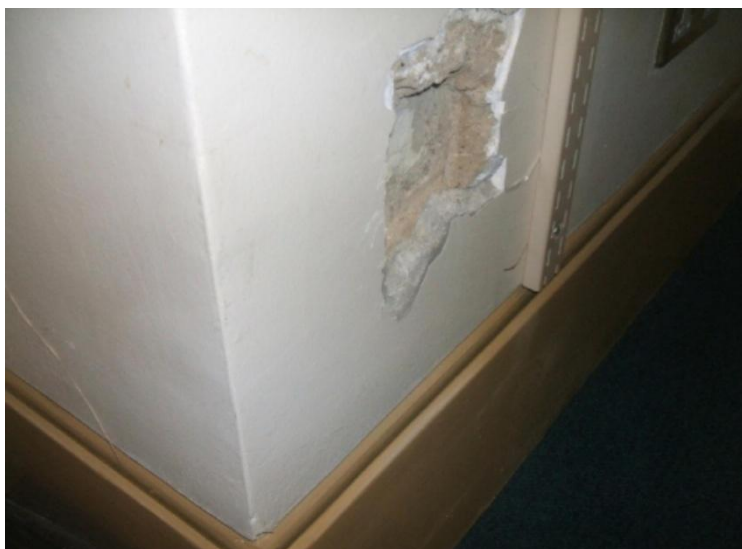
<b>Site Code/UPRN</b>	SD724P/86213	<b>Building</b>	Whitehall
<b>Address</b>	The Old War Office Horse Guards Avenue Whitehall London	<b>Floor</b>	Fourth Floor
	SW1A 2HB	<b>Room</b>	Room 466
<b>Description</b>	Plaster & render to walls adjacent to plug socket.	<b>Quantity</b>	N/A
		<b>Asbestos Suspected</b>	<b>No</b>

<b>Last Inspection Date</b>	-	03 Sep 2012	<b>Certificate N<sup>o</sup></b>	-	BK30669
<b>Next Inspection Date</b>	-	03 Sep 2013	<b>Sample N<sup>o</sup></b>	-	93
<b>Survey Type</b>	-	Refurbishment & Demolition Survey	<b>Photograph N<sup>o</sup></b>	-	4811
<b>Position</b>	-	Sample Taken	<b>Location ID</b>	-	Loc20034

<b>Product Type</b>	-	N/A	<b>Surface Treatment</b>	-	N/A
<b>Asbestos Type</b>	-	No Asbestos Detected	<b>Damage Extent</b>	-	N/A
<b>Material Risk Score</b>	-	<b>0</b>	<b>Material Risk Band</b>	-	N/A

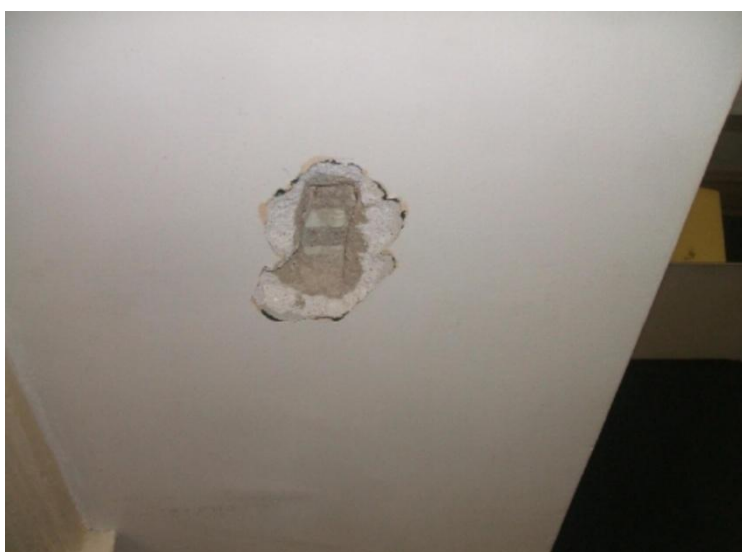
<b>Site Code/UPRN</b>	SD724P/86213	<b>Building</b>	Whitehall
<b>Address</b>	The Old War Office Horse Guards Avenue Whitehall London	<b>Floor</b>	Fourth Floor
	SW1A 2HB	<b>Room</b>	Room 466
<b>Description</b>	Plaster & render to walls adjacent to light socket.	<b>Quantity</b>	N/A
		<b>Asbestos Suspected</b>	<b>No</b>

<b>Last Inspection Date</b>	-	03 Sep 2012	<b>Certificate N°</b>	-	BK30669
<b>Next Inspection Date</b>	-	03 Sep 2013	<b>Sample N°</b>	-	91
<b>Survey Type</b>	-	Refurbishment & Demolition Survey	<b>Photograph N°</b>	-	4809
<b>Position</b>	-	Sample Taken	<b>Location ID</b>	-	Loc20032

<b>Product Type</b>	-	N/A	<b>Surface Treatment</b>	-	N/A
<b>Asbestos Type</b>	-	No Asbestos Detected	<b>Damage Extent</b>	-	N/A
<b>Material Risk Score</b>	-	<b>0</b>	<b>Material Risk Band</b>	-	N/A

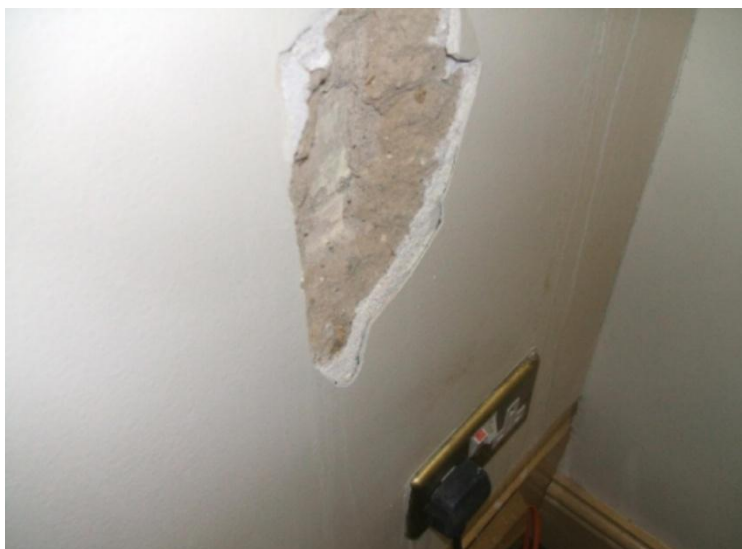
<b>Site Code/UPRN</b>	SD724P/86213	<b>Building</b>	Whitehall
<b>Address</b>	The Old War Office Horse Guards Avenue Whitehall London	<b>Floor</b>	Fourth Floor
	SW1A 2HB	<b>Room</b>	Room 466
<b>Description</b>	Plaster & render adjacent to BT switch & wall socket.	<b>Quantity</b>	N/A
		<b>Asbestos Suspected</b>	<b>No</b>

<b>Last Inspection Date</b>	-	03 Sep 2012	<b>Certificate N<sup>o</sup></b>	-	BK30669
<b>Next Inspection Date</b>	-	03 Sep 2013	<b>Sample N<sup>o</sup></b>	-	95
<b>Survey Type</b>	-	Refurbishment & Demolition Survey	<b>Photograph N<sup>o</sup></b>	-	4813
<b>Position</b>	-	Sample Taken	<b>Location ID</b>	-	Loc20036

<b>Product Type</b>	-	N/A	<b>Surface Treatment</b>	-	N/A
<b>Asbestos Type</b>	-	No Asbestos Detected	<b>Damage Extent</b>	-	N/A
<b>Material Risk Score</b>	-	<b>0</b>	<b>Material Risk Band</b>	-	N/A

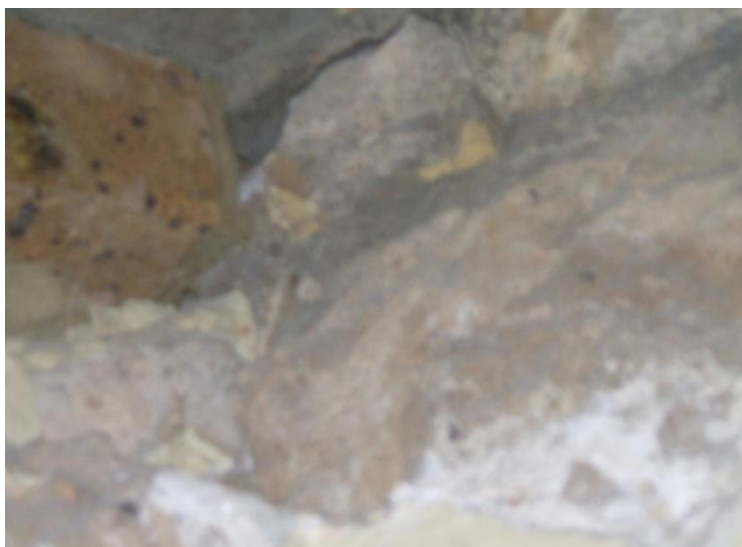
<b>Site Code/UPRN</b>	SD724P/86213	<b>Building</b>	Whitehall
<b>Address</b>	The Old War Office Horse Guards Avenue Whitehall London	<b>Floor</b>	Fourth Floor
	SW1A 2HB	<b>Room</b>	Room 466
<b>Description</b>	Mortar line below ceiling over top course of brickwork.	<b>Quantity</b>	N/A
		<b>Asbestos Suspected</b>	<b>No</b>

<b>Last Inspection Date</b>	-	03 Sep 2012	<b>Certificate N°</b>	-	BK30669
<b>Next Inspection Date</b>	-	03 Sep 2013	<b>Sample N°</b>	-	100
<b>Survey Type</b>	-	Refurbishment & Demolition Survey	<b>Photograph N°</b>	-	4818
<b>Position</b>	-	Sample Taken	<b>Location ID</b>	-	Loc20041

<b>Product Type</b>	-	N/A	<b>Surface Treatment</b>	-	N/A
<b>Asbestos Type</b>	-	No Asbestos Detected	<b>Damage Extent</b>	-	N/A
<b>Material Risk Score</b>	-	<b>0</b>	<b>Material Risk Band</b>	-	N/A

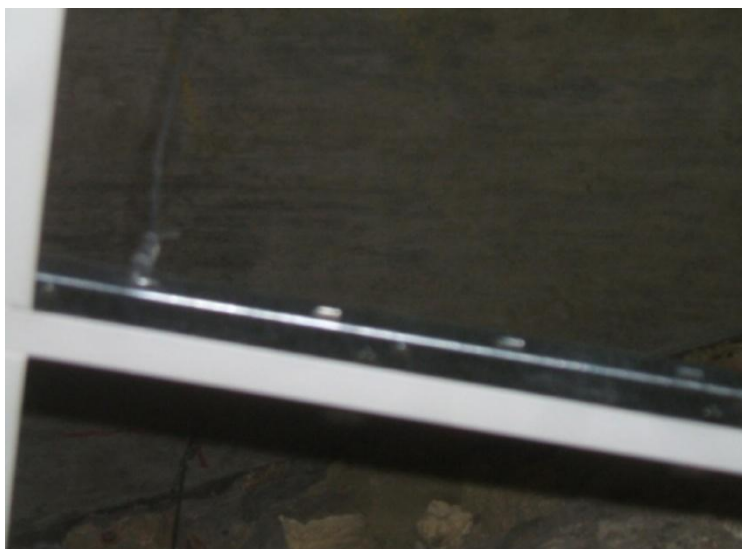
<b>Site Code/UPRN</b>	SD724P/86213	<b>Building</b>	Whitehall
<b>Address</b>	The Old War Office Horse Guards Avenue Whitehall London	<b>Floor</b>	Fourth Floor
	SW1A 2HB	<b>Room</b>	Room 466
		<b>Quantity</b>	N/A
<b>Description</b>	Concrete slab ceiling.	<b>Asbestos Suspected</b>	<b>No</b>

<b>Last Inspection Date</b>	-	03 Sep 2012	<b>Certificate N<sup>o</sup></b>	-	BK30669
<b>Next Inspection Date</b>	-	03 Sep 2013	<b>Sample N<sup>o</sup></b>	-	99
<b>Survey Type</b>	-	Refurbishment & Demolition Survey	<b>Photograph N<sup>o</sup></b>	-	4817
<b>Position</b>	-	Sample Taken	<b>Location ID</b>	-	Loc20040

<b>Product Type</b>	-	N/A	<b>Surface Treatment</b>	-	N/A
<b>Asbestos Type</b>	-	No Asbestos Detected	<b>Damage Extent</b>	-	N/A
<b>Material Risk Score</b>	-	<b>0</b>	<b>Material Risk Band</b>	-	N/A

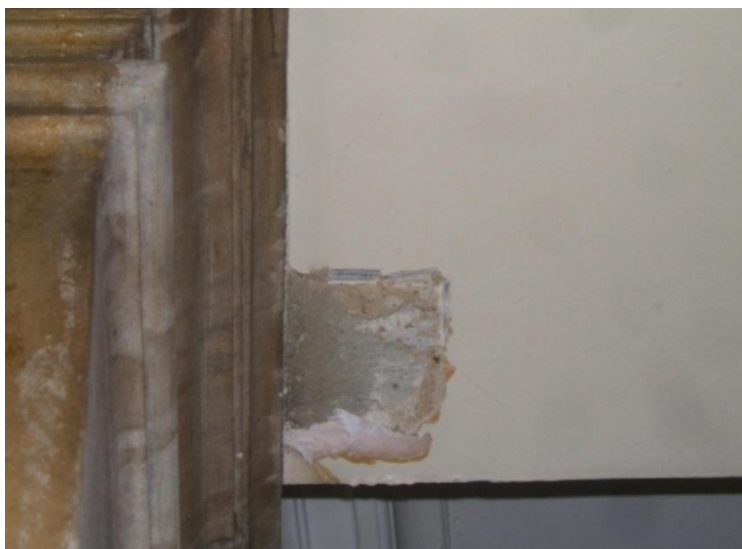
<b>Site Code/UPRN</b>	SD724P/86213	<b>Building</b>	Whitehall
<b>Address</b>	The Old War Office Horse Guards Avenue Whitehall London	<b>Floor</b>	Fourth Floor
	SW1A 2HB	<b>Room</b>	Stairwell (1)
<b>Description</b>	Render behind plaster finish.	<b>Quantity</b>	N/A
		<b>Asbestos Suspected</b>	<b>No</b>

<b>Last Inspection Date</b>	-	03 Sep 2012	<b>Certificate N°</b>	-	BK30669
<b>Next Inspection Date</b>	-	03 Sep 2013	<b>Sample N°</b>	-	68
<b>Survey Type</b>	-	Refurbishment & Demolition Survey	<b>Photograph N°</b>	-	4786
<b>Position</b>	-	Sample Taken	<b>Location ID</b>	-	Loc20009

<b>Product Type</b>	-	N/A	<b>Surface Treatment</b>	-	N/A
<b>Asbestos Type</b>	-	No Asbestos Detected	<b>Damage Extent</b>	-	N/A
<b>Material Risk Score</b>	-	<b>0</b>	<b>Material Risk Band</b>	-	N/A

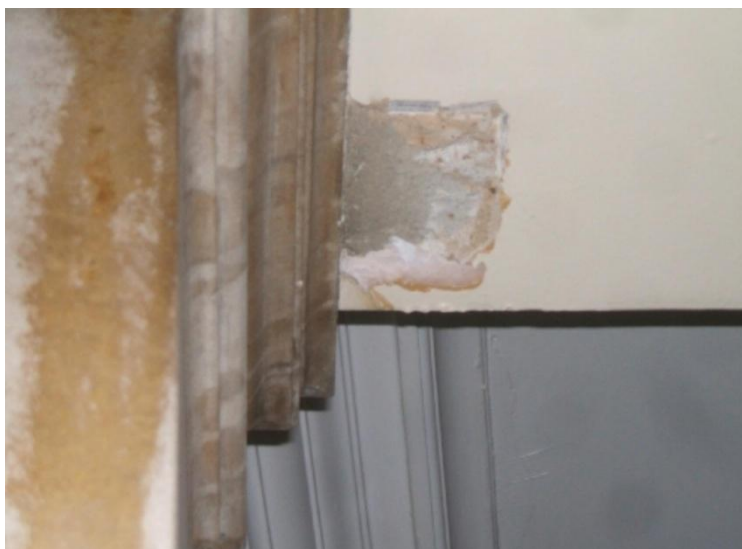
<b>Site Code/UPRN</b>	SD724P/86213	<b>Building</b>	Whitehall
<b>Address</b>	The Old War Office Horse Guards Avenue Whitehall London	<b>Floor</b>	Fourth Floor
	SW1A 2HB	<b>Room</b>	Stairwell (1)
<b>Description</b>	Plaster finish to be an access stairwell.	<b>Quantity</b>	N/A
		<b>Asbestos Suspected</b>	<b>No</b>

<b>Last Inspection Date</b>	-	03 Sep 2012	<b>Certificate N°</b>	-	BK30669
<b>Next Inspection Date</b>	-	03 Sep 2013	<b>Sample N°</b>	-	67
<b>Survey Type</b>	-	Refurbishment & Demolition Survey	<b>Photograph N°</b>	-	4785
<b>Position</b>	-	Sample Taken	<b>Location ID</b>	-	Loc20008

<b>Product Type</b>	-	N/A	<b>Surface Treatment</b>	-	N/A
<b>Asbestos Type</b>	-	No Asbestos Detected	<b>Damage Extent</b>	-	N/A
<b>Material Risk Score</b>	-	<b>0</b>	<b>Material Risk Band</b>	-	N/A

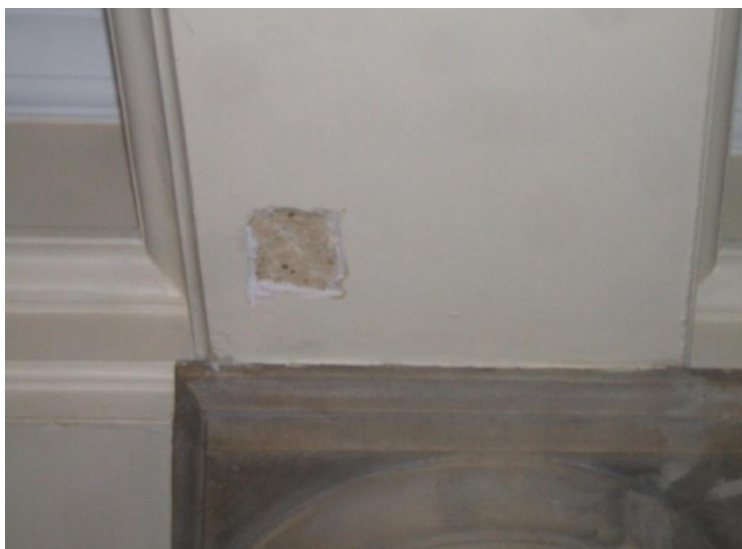
<b>Site Code/UPRN</b>	SD724P/86213	<b>Building</b>	Whitehall
<b>Address</b>	The Old War Office Horse Guards Avenue Whitehall London	<b>Floor</b>	Fourth Floor
	SW1A 2HB	<b>Room</b>	WES 371 Lifts
<b>Description</b>	Plaster finish to beam adjacent to lifts.	<b>Quantity</b>	N/A
		<b>Asbestos Suspected</b>	<b>No</b>

<b>Last Inspection Date</b>	-	03 Sep 2012	<b>Certificate N<sup>o</sup></b>	-	BK30669
<b>Next Inspection Date</b>	-	03 Sep 2013	<b>Sample N<sup>o</sup></b>	-	69
<b>Survey Type</b>	-	Refurbishment & Demolition Survey	<b>Photograph N<sup>o</sup></b>	-	4787
<b>Position</b>	-	Sample Taken	<b>Location ID</b>	-	Loc20010

<b>Product Type</b>	-	N/A	<b>Surface Treatment</b>	-	N/A
<b>Asbestos Type</b>	-	No Asbestos Detected	<b>Damage Extent</b>	-	N/A
<b>Material Risk Score</b>	-	<b>0</b>	<b>Material Risk Band</b>	-	N/A

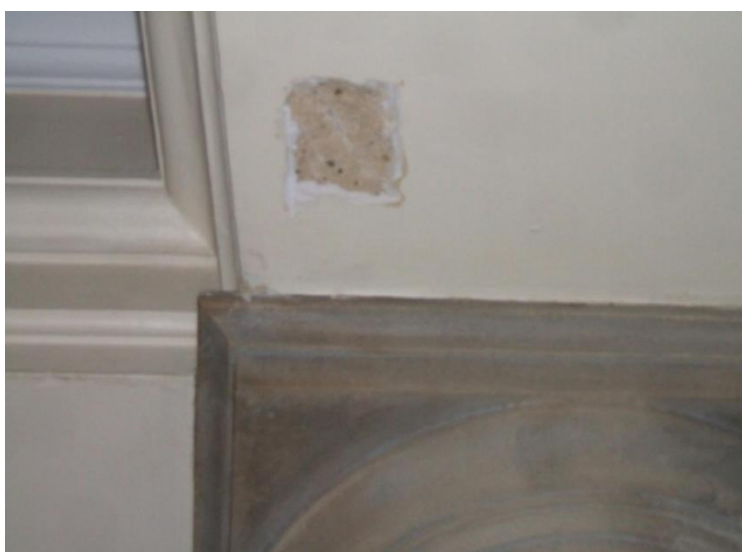
<b>Site Code/UPRN</b>	SD724P/86213	<b>Building</b>	Whitehall
<b>Address</b>	The Old War Office Horse Guards Avenue Whitehall London	<b>Floor</b>	Fourth Floor
	SW1A 2HB	<b>Room</b>	WES 371 Lifts
<b>Description</b>	Render to beam adjacent to lifts.	<b>Quantity</b>	N/A
		<b>Asbestos Suspected</b>	<b>No</b>

<b>Last Inspection Date</b>	-	03 Sep 2012	<b>Certificate N<sup>o</sup></b>	-	BK30669
<b>Next Inspection Date</b>	-	03 Sep 2013	<b>Sample N<sup>o</sup></b>	-	70
<b>Survey Type</b>	-	Refurbishment & Demolition Survey	<b>Photograph N<sup>o</sup></b>	-	4788
<b>Position</b>	-	Sample Taken	<b>Location ID</b>	-	Loc20011

<b>Product Type</b>	-	N/A	<b>Surface Treatment</b>	-	N/A
<b>Asbestos Type</b>	-	No Asbestos Detected	<b>Damage Extent</b>	-	N/A
<b>Material Risk Score</b>	-	<b>0</b>	<b>Material Risk Band</b>	-	N/A

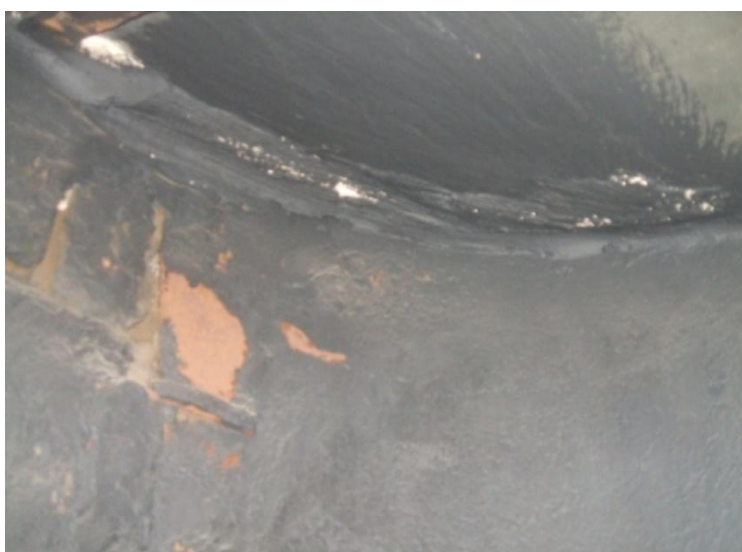
<b>Site Code/UPRN</b>	SD724P/86213	<b>Building</b>	Whitehall
<b>Address</b>	The Old War Office Horse Guards Avenue Whitehall London	<b>Floor</b>	Ground (0)
	SW1A 2HB	<b>Room</b>	Main Entrance Area
<b>Description</b>	Firebrick & mortar.	<b>Quantity</b>	N/A
		<b>Asbestos Suspected</b>	<b>No</b>

<b>Last Inspection Date</b>	-	03 Sep 2012	<b>Certificate N<sup>o</sup></b>	-	BK30786
<b>Next Inspection Date</b>	-	03 Sep 2013	<b>Sample N<sup>o</sup></b>	-	243
<b>Survey Type</b>	-	Refurbishment & Demolition Survey	<b>Photograph N<sup>o</sup></b>	-	4964
<b>Position</b>	-	Sample Taken	<b>Location ID</b>	-	Loc20192

<b>Product Type</b>	-	N/A	<b>Surface Treatment</b>	-	N/A
<b>Asbestos Type</b>	-	No Asbestos Detected	<b>Damage Extent</b>	-	N/A
<b>Material Risk Score</b>	-	<b>0</b>	<b>Material Risk Band</b>	-	N/A

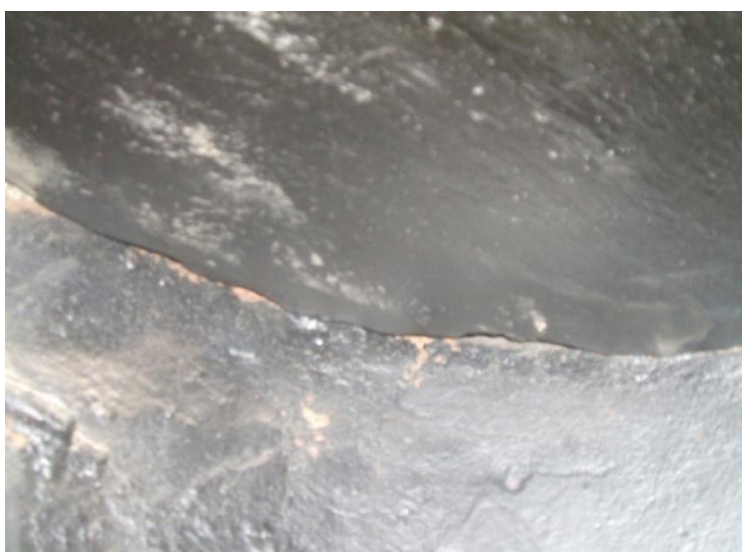
<b>Site Code/UPRN</b>	SD724P/86213	<b>Building</b>	Whitehall
<b>Address</b>	The Old War Office Horse Guards Avenue Whitehall London	<b>Floor</b>	Ground (0)
	SW1A 2HB	<b>Room</b>	Main Entrance Area
<b>Description</b>	Fireplace (01)- Firebrick.	<b>Quantity</b>	N/A
		<b>Asbestos Suspected</b>	<b>No</b>

<b>Last Inspection Date</b>	-	03 Sep 2012	<b>Certificate N<sup>o</sup></b>	-	BK30786
<b>Next Inspection Date</b>	-	03 Sep 2013	<b>Sample N<sup>o</sup></b>	-	241
<b>Survey Type</b>	-	Refurbishment & Demolition Survey	<b>Photograph N<sup>o</sup></b>	-	4963
<b>Position</b>	-	Sample Taken	<b>Location ID</b>	-	Loc20190

<b>Product Type</b>	-	N/A	<b>Surface Treatment</b>	-	N/A
<b>Asbestos Type</b>	-	No Asbestos Detected	<b>Damage Extent</b>	-	N/A
<b>Material Risk Score</b>	-	<b>0</b>	<b>Material Risk Band</b>	-	N/A

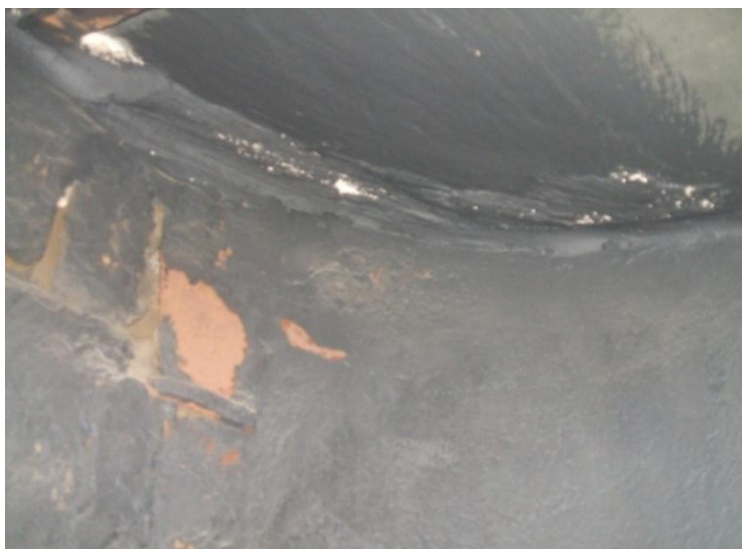
<b>Site Code/UPRN</b>	SD724P/86213	<b>Building</b>	Whitehall
<b>Address</b>	The Old War Office Horse Guards Avenue Whitehall London	<b>Floor</b>	Ground (0)
	SW1A 2HB	<b>Room</b>	Main Entrance Area
<b>Description</b>	Mortar.	<b>Quantity</b>	N/A
		<b>Asbestos Suspected</b>	<b>No</b>

<b>Product Type</b>	-	N/A	<b>Surface Treatment</b>	-	N/A
<b>Asbestos Type</b>	-	No Asbestos Detected	<b>Damage Extent</b>	-	N/A
<b>Material Risk Score</b>	-	<b>0</b>	<b>Material Risk Band</b>	-	N/A

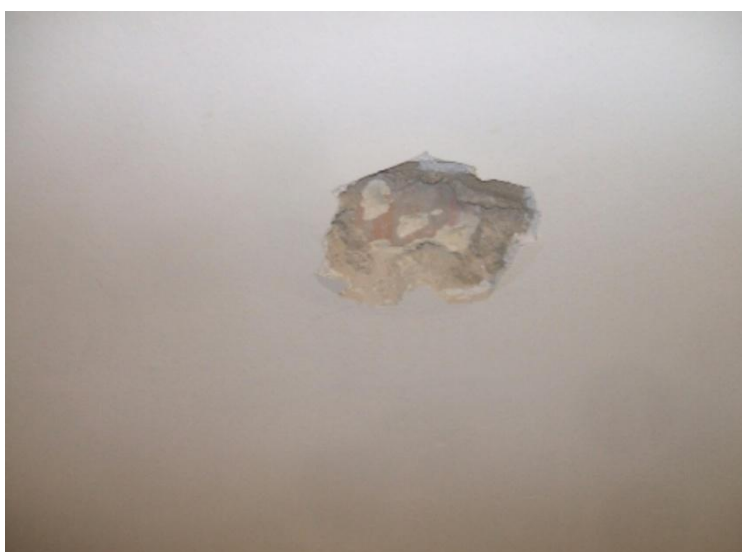
<b>Site Code/UPRN</b>	SD724P/86213	<b>Building</b>	Whitehall
<b>Address</b>	The Old War Office Horse Guards Avenue Whitehall London	<b>Floor</b>	Ground (0)
	SW1A 2HB	<b>Room</b>	Room 019
<b>Description</b>	Plaster & render to walls adjacent to socket.	<b>Quantity</b>	N/A
		<b>Asbestos Suspected</b>	<b>No</b>

<b>Product Type</b>	-	N/A	<b>Surface Treatment</b>	-	N/A
<b>Asbestos Type</b>	-	No Asbestos Detected	<b>Damage Extent</b>	-	N/A
<b>Material Risk Score</b>	-	<b>0</b>	<b>Material Risk Band</b>	-	N/A

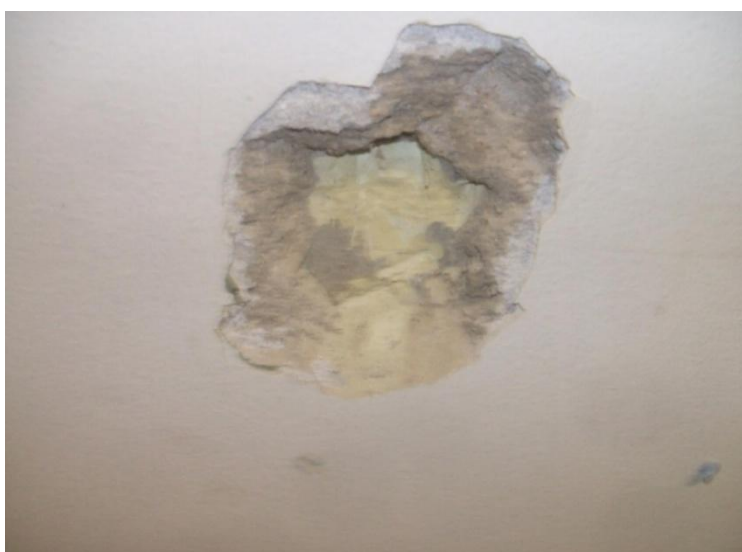
<b>Site Code/UPRN</b>	SD724P/86213	<b>Building</b>	Whitehall
<b>Address</b>	The Old War Office Horse Guards Avenue Whitehall London	<b>Floor</b>	Ground (0)
	SW1A 2HB	<b>Room</b>	Room 019
<b>Description</b>	Plaster & render to walls.	<b>Quantity</b>	N/A
		<b>Asbestos Suspected</b>	<b>No</b>

<b>Product Type</b>	-	N/A	<b>Surface Treatment</b>	-	N/A
<b>Asbestos Type</b>	-	No Asbestos Detected	<b>Damage Extent</b>	-	N/A
<b>Material Risk Score</b>	-	<b>0</b>	<b>Material Risk Band</b>	-	N/A

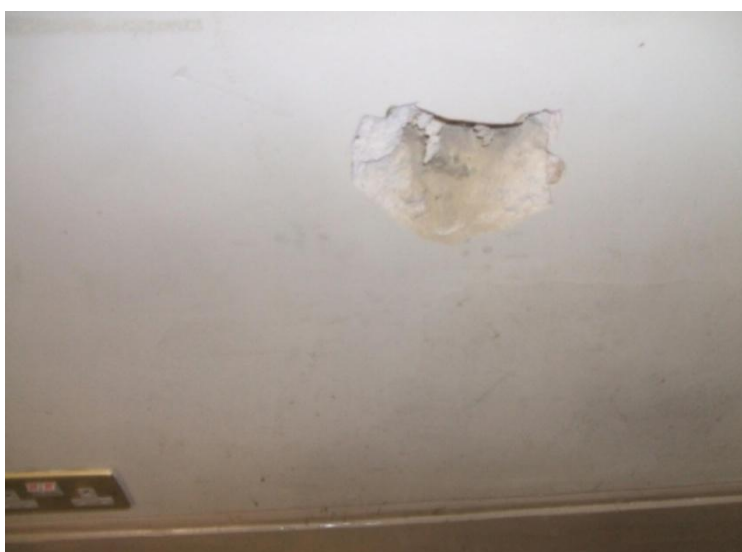
<b>Site Code/UPRN</b>	SD724P/86213	<b>Building</b>	Whitehall
<b>Address</b>	The Old War Office Horse Guards Avenue Whitehall London	<b>Floor</b>	Ground (0)
	SW1A 2HB	<b>Room</b>	Room 019
<b>Description</b>	Plaster & render to walls adjacent to socket.	<b>Quantity</b>	N/A
		<b>Asbestos Suspected</b>	<b>No</b>

<b>Product Type</b>	-	N/A	<b>Surface Treatment</b>	-	N/A
<b>Asbestos Type</b>	-	No Asbestos Detected	<b>Damage Extent</b>	-	N/A
<b>Material Risk Score</b>	-	<b>0</b>	<b>Material Risk Band</b>	-	N/A

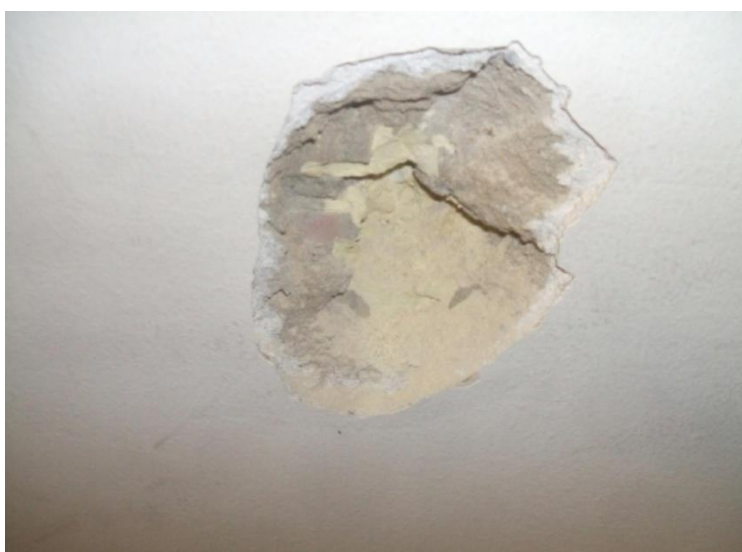
<b>Site Code/UPRN</b>	SD724P/86213	<b>Building</b>	Whitehall
<b>Address</b>	The Old War Office Horse Guards Avenue Whitehall London	<b>Floor</b>	Ground (0)
	SW1A 2HB	<b>Room</b>	Room 019
<b>Description</b>	Mortar line to walls adjacent to socket.	<b>Quantity</b>	N/A
		<b>Asbestos Suspected</b>	<b>No</b>

<b>Product Type</b>	-	N/A	<b>Surface Treatment</b>	-	N/A
<b>Asbestos Type</b>	-	No Asbestos Detected	<b>Damage Extent</b>	-	N/A
<b>Material Risk Score</b>	-	<b>0</b>	<b>Material Risk Band</b>	-	N/A

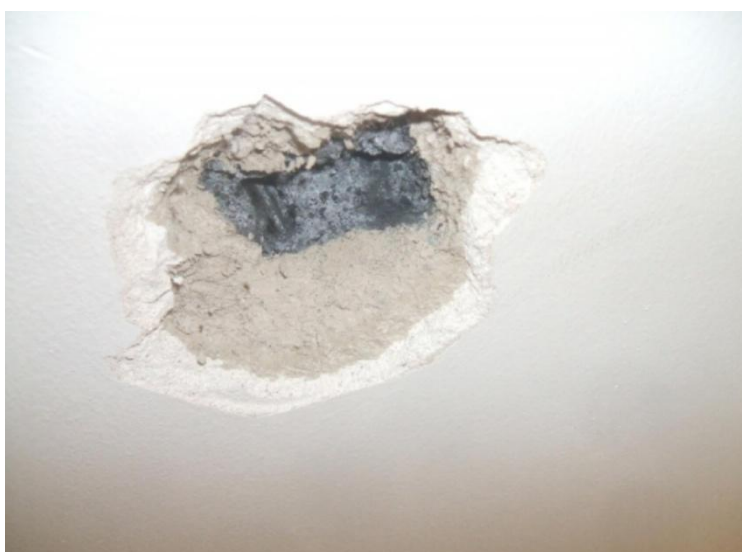
<b>Site Code/UPRN</b>	SD724P/86213	<b>Building</b>	Whitehall
<b>Address</b>	The Old War Office Horse Guards Avenue Whitehall London	<b>Floor</b>	Ground (0)
	SW1A 2HB	<b>Room</b>	Room 019
<b>Description</b>	Ceiling plaster & finish.	<b>Quantity</b>	N/A
		<b>Asbestos Suspected</b>	<b>No</b>

<b>Product Type</b>	-	N/A	<b>Surface Treatment</b>	-	N/A
<b>Asbestos Type</b>	-	No Asbestos Detected	<b>Damage Extent</b>	-	N/A
<b>Material Risk Score</b>	-	<b>0</b>	<b>Material Risk Band</b>	-	N/A

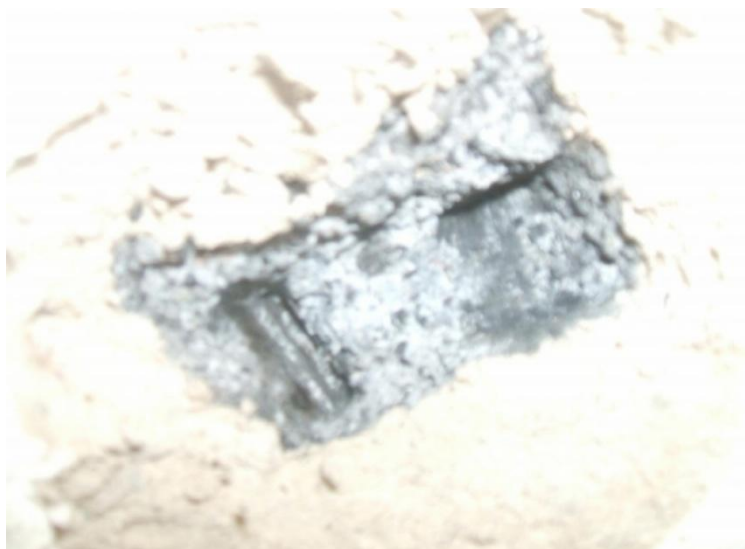
<b>Site Code/UPRN</b>	SD724P/86213	<b>Building</b>	Whitehall
<b>Address</b>	The Old War Office Horse Guards Avenue Whitehall London	<b>Floor</b>	Ground (0)
	SW1A 2HB	<b>Room</b>	Room 019
<b>Description</b>	Asphalt/ concrete overfil to ceiling.	<b>Quantity</b>	N/A
		<b>Asbestos Suspected</b>	<b>No</b>

<b>Product Type</b>	-	N/A	<b>Surface Treatment</b>	-	N/A
<b>Asbestos Type</b>	-	No Asbestos Detected	<b>Damage Extent</b>	-	N/A
<b>Material Risk Score</b>	-	<b>0</b>	<b>Material Risk Band</b>	-	N/A

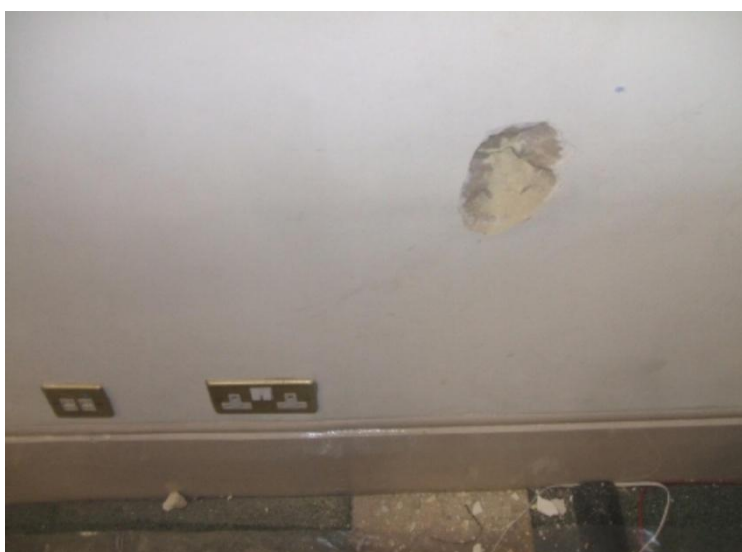
<b>Site Code/UPRN</b>	SD724P/86213	<b>Building</b>	Whitehall
<b>Address</b>	The Old War Office Horse Guards Avenue Whitehall London	<b>Floor</b>	Ground (0)
	SW1A 2HB	<b>Room</b>	Room 019
<b>Description</b>	Plaster & render to walls adjacent to socket.	<b>Quantity</b>	N/A
		<b>Asbestos Suspected</b>	<b>No</b>

<b>Product Type</b>	-	N/A	<b>Surface Treatment</b>	-	N/A
<b>Asbestos Type</b>	-	No Asbestos Detected	<b>Damage Extent</b>	-	N/A
<b>Material Risk Score</b>	-	<b>0</b>	<b>Material Risk Band</b>	-	N/A

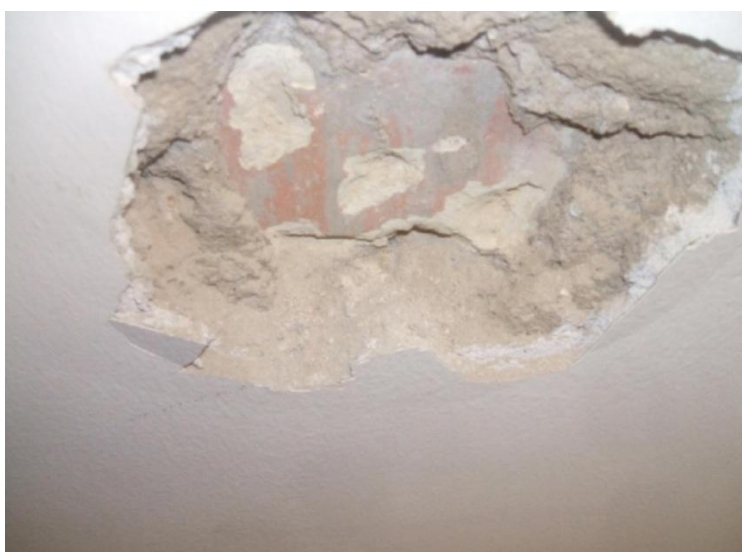
<b>Site Code/UPRN</b>	SD724P/86213	<b>Building</b>	Whitehall
<b>Address</b>	The Old War Office Horse Guards Avenue Whitehall London	<b>Floor</b>	Ground (0)
	SW1A 2HB	<b>Room</b>	Room 019
<b>Description</b>	Mortar line to walls adjacent to socket.	<b>Quantity</b>	N/A
		<b>Asbestos Suspected</b>	<b>No</b>

<b>Product Type</b>	-	N/A	<b>Surface Treatment</b>	-	N/A
<b>Asbestos Type</b>	-	No Asbestos Detected	<b>Damage Extent</b>	-	N/A
<b>Material Risk Score</b>	-	<b>0</b>	<b>Material Risk Band</b>	-	N/A

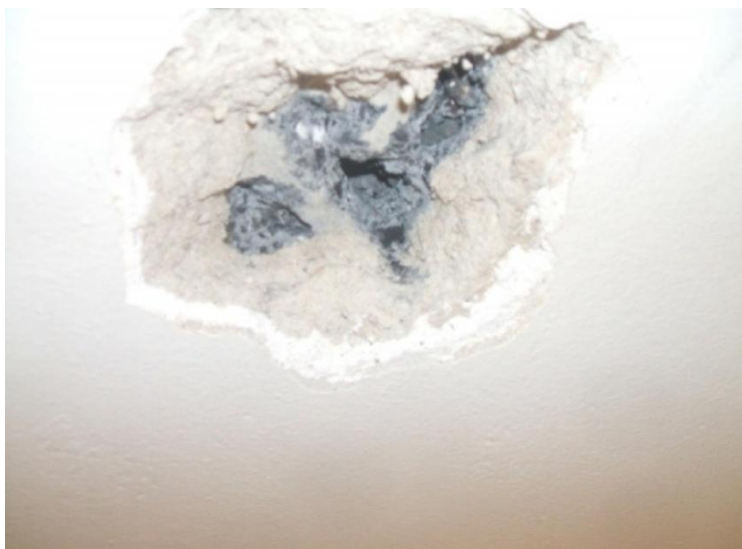
<b>Site Code/UPRN</b>	SD724P/86213	<b>Building</b>	Whitehall
<b>Address</b>	The Old War Office Horse Guards Avenue Whitehall London	<b>Floor</b>	Ground (0)
	SW1A 2HB	<b>Room</b>	Room 024
<b>Description</b>	Ceiling plaster & finish.	<b>Quantity</b>	N/A
		<b>Asbestos Suspected</b>	<b>No</b>

<b>Product Type</b>	-	N/A	<b>Surface Treatment</b>	-	N/A
<b>Asbestos Type</b>	-	No Asbestos Detected	<b>Damage Extent</b>	-	N/A
<b>Material Risk Score</b>	-	<b>0</b>	<b>Material Risk Band</b>	-	N/A

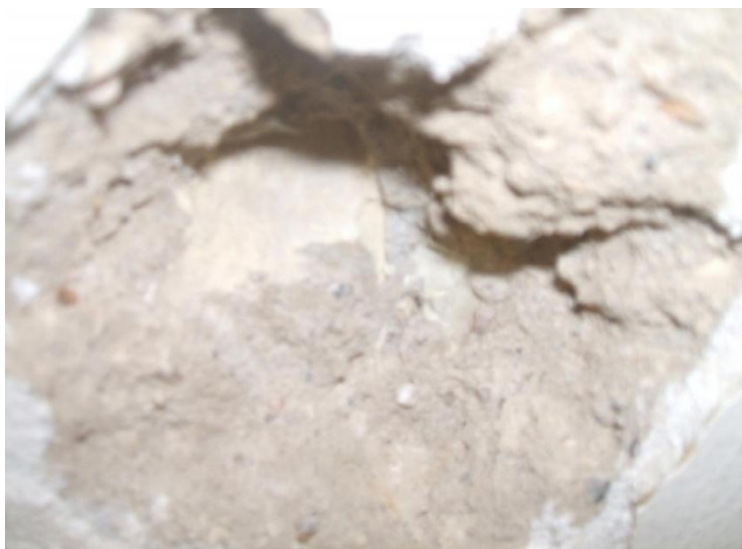
<b>Site Code/UPRN</b>	SD724P/86213	<b>Building</b>	Whitehall
<b>Address</b>	The Old War Office Horse Guards Avenue Whitehall London	<b>Floor</b>	Ground (0)
	SW1A 2HB	<b>Room</b>	Room 024
<b>Description</b>	Mortar line to walls adjacent to socket.	<b>Quantity</b>	N/A
		<b>Asbestos Suspected</b>	<b>No</b>

<b>Product Type</b>	-	N/A	<b>Surface Treatment</b>	-	N/A
<b>Asbestos Type</b>	-	No Asbestos Detected	<b>Damage Extent</b>	-	N/A
<b>Material Risk Score</b>	-	<b>0</b>	<b>Material Risk Band</b>	-	N/A

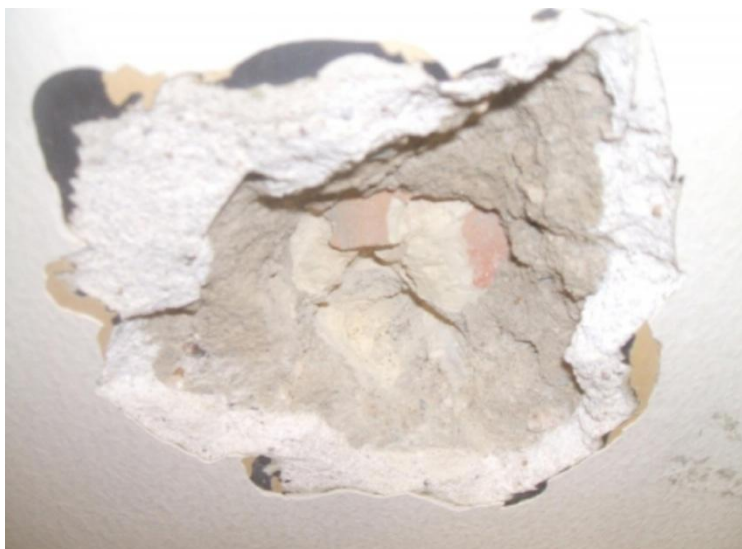
<b>Site Code/UPRN</b>	SD724P/86213	<b>Building</b>	Whitehall
<b>Address</b>	The Old War Office Horse Guards Avenue Whitehall London	<b>Floor</b>	Ground (0)
	SW1A 2HB	<b>Room</b>	Room 024
<b>Description</b>	Mortar line to walls adjacent to socket.	<b>Quantity</b>	N/A
		<b>Asbestos Suspected</b>	<b>No</b>

<b>Product Type</b>	-	N/A	<b>Surface Treatment</b>	-	N/A
<b>Asbestos Type</b>	-	No Asbestos Detected	<b>Damage Extent</b>	-	N/A
<b>Material Risk Score</b>	-	<b>0</b>	<b>Material Risk Band</b>	-	N/A

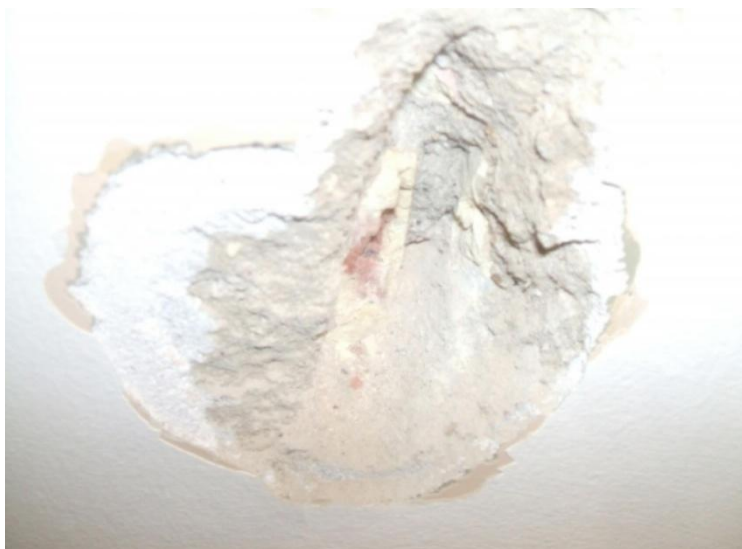
<b>Site Code/UPRN</b>	SD724P/86213	<b>Building</b>	Whitehall
<b>Address</b>	The Old War Office Horse Guards Avenue Whitehall London	<b>Floor</b>	Ground (0)
	SW1A 2HB	<b>Room</b>	Room 024
<b>Description</b>	Mortar line to walls adjacent to socket.	<b>Quantity</b>	N/A
		<b>Asbestos Suspected</b>	<b>No</b>

<b>Product Type</b>	-	N/A	<b>Surface Treatment</b>	-	N/A
<b>Asbestos Type</b>	-	No Asbestos Detected	<b>Damage Extent</b>	-	N/A
<b>Material Risk Score</b>	-	<b>0</b>	<b>Material Risk Band</b>	-	N/A

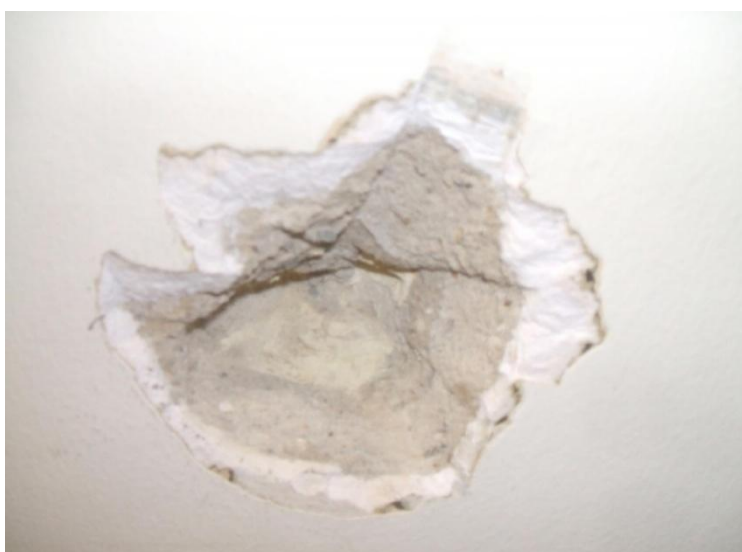
<b>Site Code/UPRN</b>	SD724P/86213	<b>Building</b>	Whitehall
<b>Address</b>	The Old War Office Horse Guards Avenue Whitehall London	<b>Floor</b>	Ground (0)
	SW1A 2HB	<b>Room</b>	Room 024
<b>Description</b>	Mortar line to walls.	<b>Quantity</b>	N/A
		<b>Asbestos Suspected</b>	<b>No</b>

<b>Product Type</b>	-	N/A	<b>Surface Treatment</b>	-	N/A
<b>Asbestos Type</b>	-	No Asbestos Detected	<b>Damage Extent</b>	-	N/A
<b>Material Risk Score</b>	-	<b>0</b>	<b>Material Risk Band</b>	-	N/A

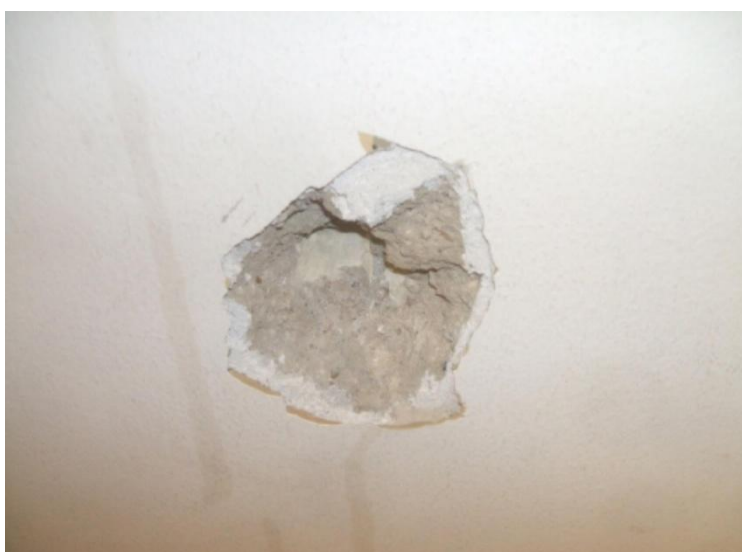
<b>Site Code/UPRN</b>	SD724P/86213	<b>Building</b>	Whitehall
<b>Address</b>	The Old War Office Horse Guards Avenue Whitehall London	<b>Floor</b>	Ground (0)
	SW1A 2HB	<b>Room</b>	Room 024
<b>Description</b>	Plaster & render to walls adjacent to socket.	<b>Quantity</b>	N/A
		<b>Asbestos Suspected</b>	<b>No</b>

<b>Product Type</b>	-	N/A	<b>Surface Treatment</b>	-	N/A
<b>Asbestos Type</b>	-	No Asbestos Detected	<b>Damage Extent</b>	-	N/A
<b>Material Risk Score</b>	-	<b>0</b>	<b>Material Risk Band</b>	-	N/A

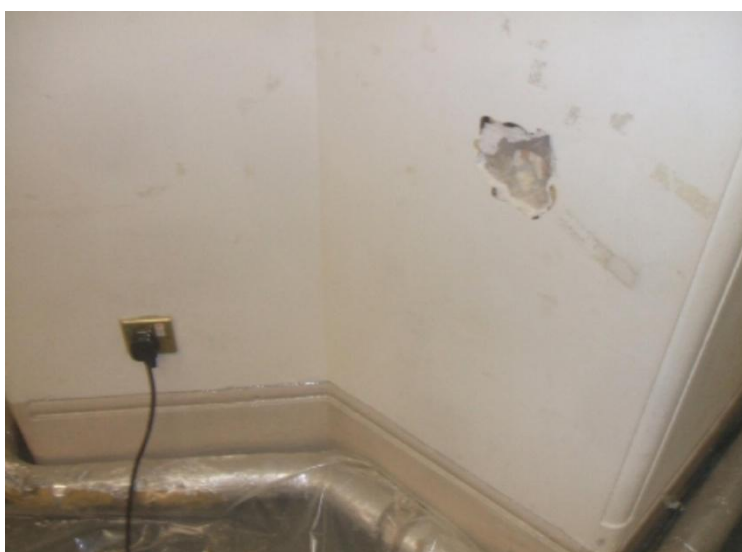
<b>Last Inspection Date</b>	-	03 Sep 2012	<b>Certificate N°</b>	-	BK30786
<b>Next Inspection Date</b>	-	03 Sep 2013	<b>Sample N°</b>	-	217
<b>Survey Type</b>	-	Refurbishment & Demolition Survey	<b>Photograph N°</b>	-	4939
<b>Position</b>	-	Sample Taken	<b>Location ID</b>	-	Loc20165

<b>Site Code/UPRN</b>	SD724P/86213	<b>Building</b>	Whitehall
<b>Address</b>	The Old War Office Horse Guards Avenue Whitehall London	<b>Floor</b>	Ground (0)
	SW1A 2HB	<b>Room</b>	Room 024
<b>Description</b>	Plaster & render to walls adjacent to socket.	<b>Quantity</b>	N/A
		<b>Asbestos Suspected</b>	<b>No</b>

<b>Product Type</b>	-	N/A	<b>Surface Treatment</b>	-	N/A
<b>Asbestos Type</b>	-	No Asbestos Detected	<b>Damage Extent</b>	-	N/A
<b>Material Risk Score</b>	-	<b>0</b>	<b>Material Risk Band</b>	-	N/A

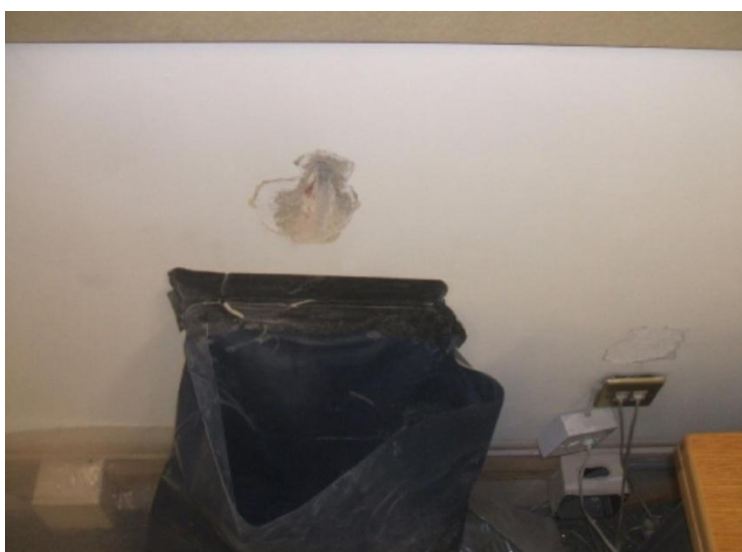
<b>Site Code/UPRN</b>	SD724P/86213	<b>Building</b>	Whitehall
<b>Address</b>	The Old War Office Horse Guards Avenue Whitehall London	<b>Floor</b>	Ground (0)
	SW1A 2HB	<b>Room</b>	Room 024
<b>Description</b>	Plaster & render to walls adjacent to socket.	<b>Quantity</b>	N/A
		<b>Asbestos Suspected</b>	<b>No</b>

<b>Product Type</b>	-	N/A	<b>Surface Treatment</b>	-	N/A
<b>Asbestos Type</b>	-	No Asbestos Detected	<b>Damage Extent</b>	-	N/A
<b>Material Risk Score</b>	-	<b>0</b>	<b>Material Risk Band</b>	-	N/A

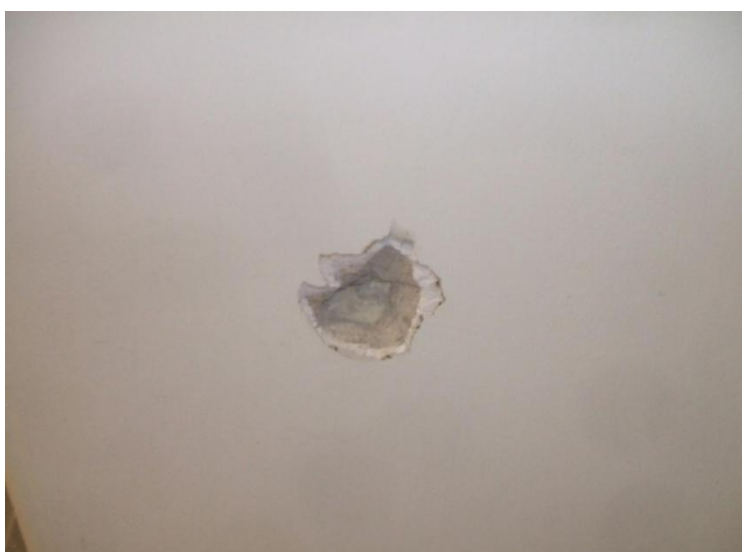
<b>Last Inspection Date</b>	-	03 Sep 2012	<b>Certificate N°</b>	-	BK30786
<b>Next Inspection Date</b>	-	03 Sep 2013	<b>Sample N°</b>	-	213
<b>Survey Type</b>	-	Refurbishment & Demolition Survey	<b>Photograph N°</b>	-	4935
<b>Position</b>	-	Sample Taken	<b>Location ID</b>	-	Loc20161

<b>Site Code/UPRN</b>	SD724P/86213	<b>Building</b>	Whitehall
<b>Address</b>	The Old War Office Horse Guards Avenue Whitehall London	<b>Floor</b>	Ground (0)
	SW1A 2HB	<b>Room</b>	Room 024
<b>Description</b>	Plaster & render to walls.	<b>Quantity</b>	N/A
		<b>Asbestos Suspected</b>	<b>No</b>

<b>Product Type</b>	-	N/A	<b>Surface Treatment</b>	-	N/A
<b>Asbestos Type</b>	-	No Asbestos Detected	<b>Damage Extent</b>	-	N/A
<b>Material Risk Score</b>	-	<b>0</b>	<b>Material Risk Band</b>	-	N/A

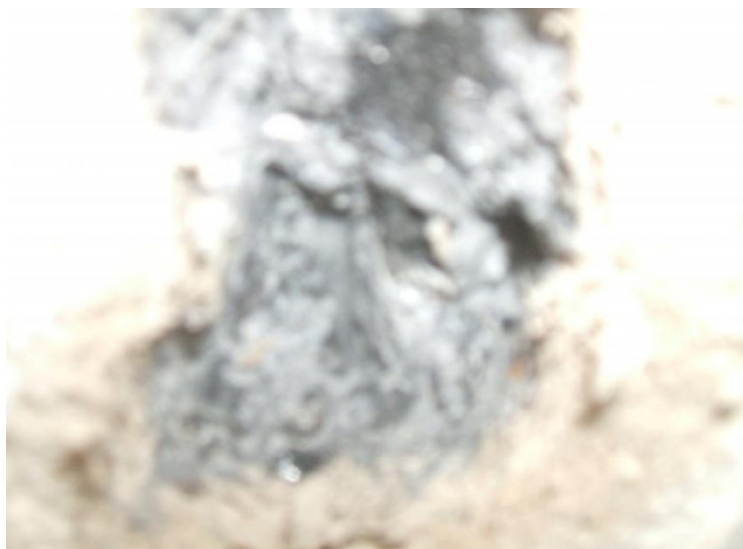
<b>Last Inspection Date</b>	-	03 Sep 2012	<b>Certificate N°</b>	-	BK30786
<b>Next Inspection Date</b>	-	03 Sep 2013	<b>Sample N°</b>	-	222
<b>Survey Type</b>	-	Refurbishment & Demolition Survey	<b>Photograph N°</b>	-	4944
<b>Position</b>	-	Sample Taken	<b>Location ID</b>	-	Loc20171

<b>Site Code/UPRN</b>	SD724P/86213	<b>Building</b>	Whitehall
<b>Address</b>	The Old War Office Horse Guards Avenue Whitehall London	<b>Floor</b>	Ground (0)
	SW1A 2HB	<b>Room</b>	Room 027
<b>Description</b>	Asphalt/ concrete overfil to ceiling.	<b>Quantity</b>	N/A
		<b>Asbestos Suspected</b>	<b>No</b>

<b>Product Type</b>	-	N/A	<b>Surface Treatment</b>	-	N/A
<b>Asbestos Type</b>	-	No Asbestos Detected	<b>Damage Extent</b>	-	N/A
<b>Material Risk Score</b>	-	<b>0</b>	<b>Material Risk Band</b>	-	N/A

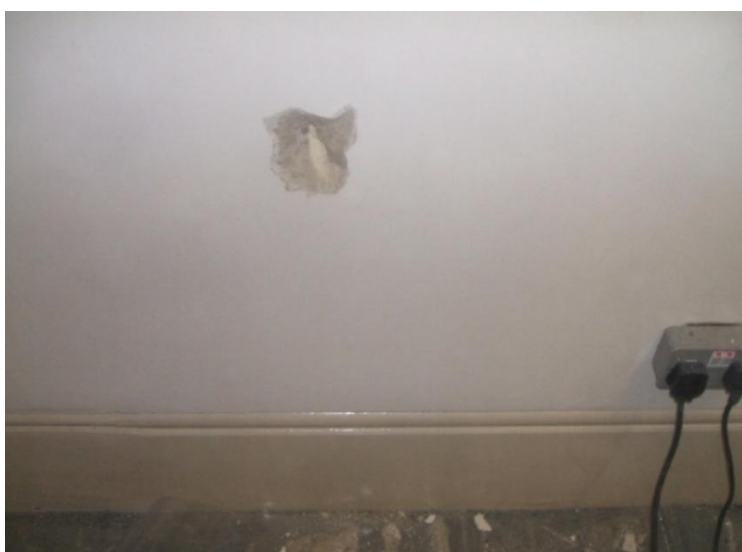
<b>Site Code/UPRN</b>	SD724P/86213	<b>Building</b>	Whitehall
<b>Address</b>	The Old War Office Horse Guards Avenue Whitehall London	<b>Floor</b>	Ground (0)
	SW1A 2HB	<b>Room</b>	Room 027
<b>Description</b>	Plaster & render to walls.	<b>Quantity</b>	N/A
		<b>Asbestos Suspected</b>	<b>No</b>

<b>Product Type</b>	-	N/A	<b>Surface Treatment</b>	-	N/A
<b>Asbestos Type</b>	-	No Asbestos Detected	<b>Damage Extent</b>	-	N/A
<b>Material Risk Score</b>	-	<b>0</b>	<b>Material Risk Band</b>	-	N/A

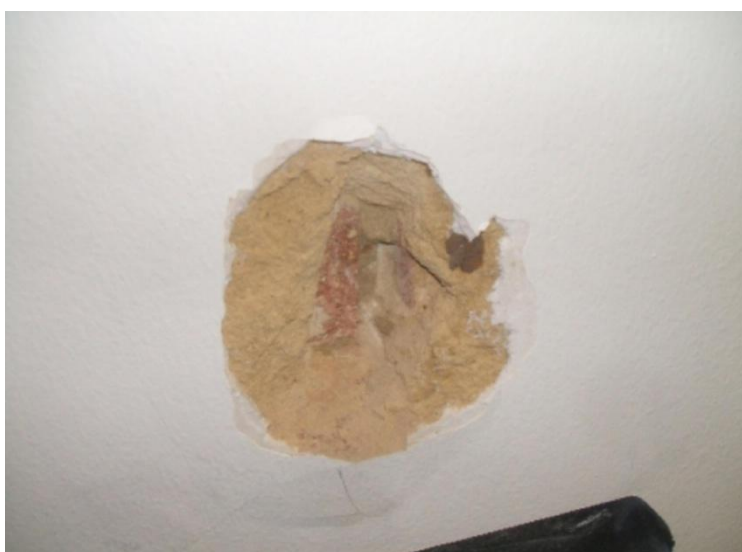
<b>Site Code/UPRN</b>	SD724P/86213	<b>Building</b>	Whitehall
<b>Address</b>	The Old War Office Horse Guards Avenue Whitehall London	<b>Floor</b>	Ground (0)
	SW1A 2HB	<b>Room</b>	Room 027
<b>Description</b>	Plaster & render to walls adjacent to socket.	<b>Quantity</b>	N/A
		<b>Asbestos Suspected</b>	<b>No</b>

<b>Product Type</b>	-	N/A	<b>Surface Treatment</b>	-	N/A
<b>Asbestos Type</b>	-	No Asbestos Detected	<b>Damage Extent</b>	-	N/A
<b>Material Risk Score</b>	-	<b>0</b>	<b>Material Risk Band</b>	-	N/A

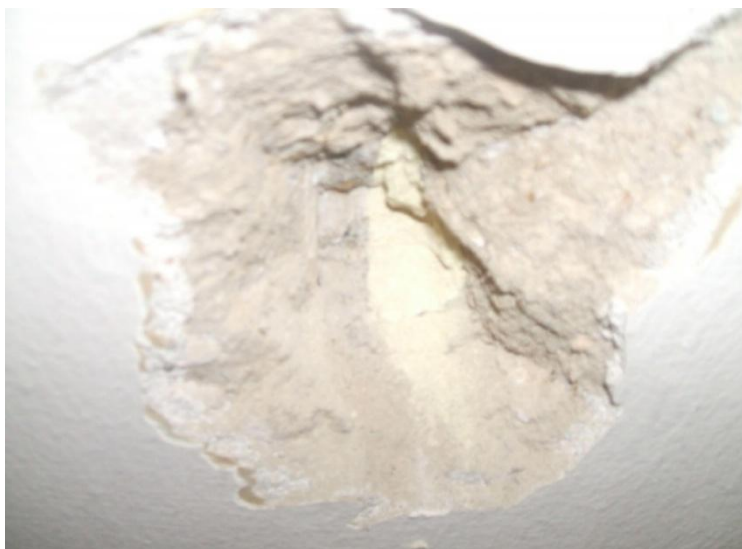
<b>Site Code/UPRN</b>	SD724P/86213	<b>Building</b>	Whitehall
<b>Address</b>	The Old War Office Horse Guards Avenue Whitehall London	<b>Floor</b>	Ground (0)
	SW1A 2HB	<b>Room</b>	Room 027
<b>Description</b>	Mortar line to walls.	<b>Quantity</b>	N/A
		<b>Asbestos Suspected</b>	<b>No</b>

<b>Product Type</b>	-	N/A	<b>Surface Treatment</b>	-	N/A
<b>Asbestos Type</b>	-	No Asbestos Detected	<b>Damage Extent</b>	-	N/A
<b>Material Risk Score</b>	-	<b>0</b>	<b>Material Risk Band</b>	-	N/A

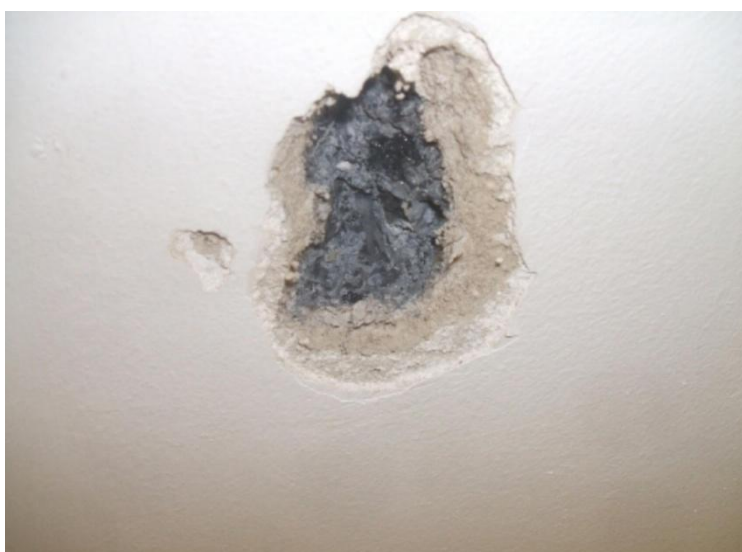
<b>Last Inspection Date</b>	-	03 Sep 2012	<b>Certificate N°</b>	-	BK30786
<b>Next Inspection Date</b>	-	03 Sep 2013	<b>Sample N°</b>	-	221
<b>Survey Type</b>	-	Refurbishment & Demolition Survey	<b>Photograph N°</b>	-	4943
<b>Position</b>	-	Sample Taken	<b>Location ID</b>	-	Loc20169

<b>Site Code/UPRN</b>	SD724P/86213	<b>Building</b>	Whitehall
<b>Address</b>	The Old War Office Horse Guards Avenue Whitehall London	<b>Floor</b>	Ground (0)
	SW1A 2HB	<b>Room</b>	Room 027
<b>Description</b>	Ceiling plaster & finish.	<b>Quantity</b>	N/A
		<b>Asbestos Suspected</b>	<b>No</b>

<b>Product Type</b>	-	N/A	<b>Surface Treatment</b>	-	N/A
<b>Asbestos Type</b>	-	No Asbestos Detected	<b>Damage Extent</b>	-	N/A
<b>Material Risk Score</b>	-	<b>0</b>	<b>Material Risk Band</b>	-	N/A

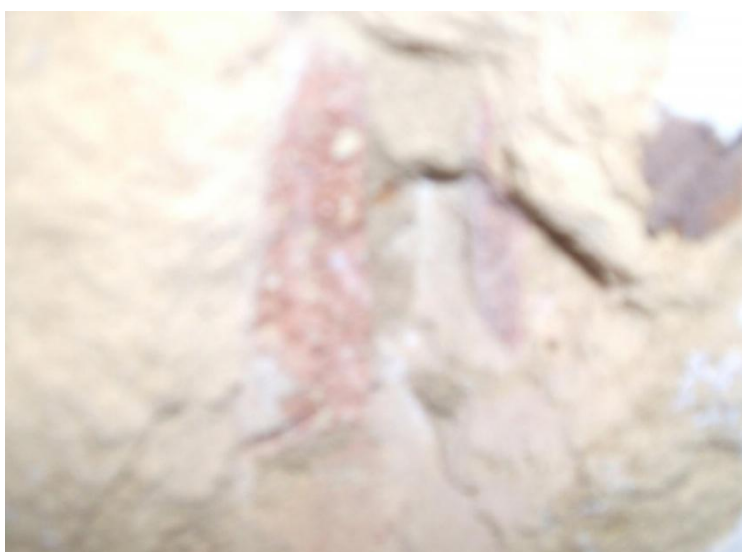
<b>Last Inspection Date</b>	-	03 Sep 2012	<b>Certificate N°</b>	-	BK30786
<b>Next Inspection Date</b>	-	03 Sep 2013	<b>Sample N°</b>	-	226
<b>Survey Type</b>	-	Refurbishment & Demolition Survey	<b>Photograph N°</b>	-	4948
<b>Position</b>	-	Sample Taken	<b>Location ID</b>	-	Loc20175

<b>Site Code/UPRN</b>	SD724P/86213	<b>Building</b>	Whitehall
<b>Address</b>	The Old War Office Horse Guards Avenue Whitehall London	<b>Floor</b>	Ground (0)
	SW1A 2HB	<b>Room</b>	Room 027
<b>Description</b>	Mortar line to wall adjacent to socket.	<b>Quantity</b>	N/A
		<b>Asbestos Suspected</b>	<b>No</b>

<b>Product Type</b>	-	N/A	<b>Surface Treatment</b>	-	N/A
<b>Asbestos Type</b>	-	No Asbestos Detected	<b>Damage Extent</b>	-	N/A
<b>Material Risk Score</b>	-	<b>0</b>	<b>Material Risk Band</b>	-	N/A
