Ministry  
of Defence

## Defence Infrastructure Organisation

Ref: EIR/2017/13719

September 2014

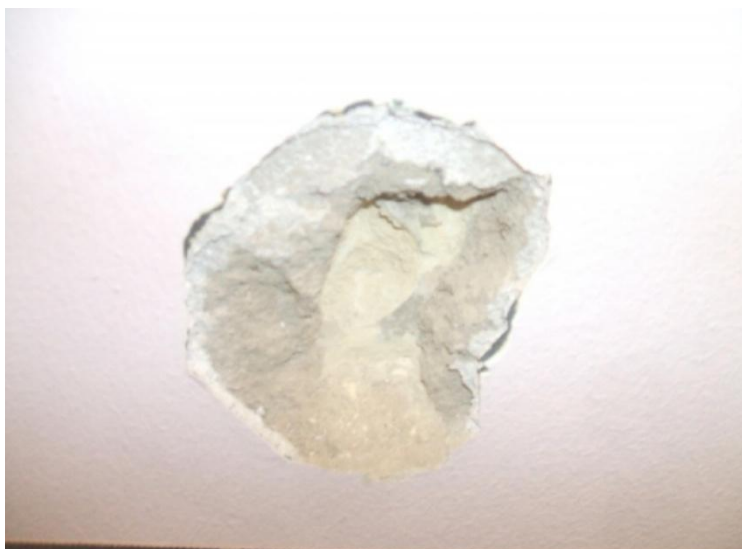
<b>Last Inspection Date</b>	-	03 Sep 2012	<b>Certificate N°</b>	-	BK30786
<b>Next Inspection Date</b>	-	03 Sep 2013	<b>Sample N°</b>	-	231
<b>Survey Type</b>	-	Refurbishment & Demolition Survey	<b>Photograph N°</b>	-	4953
<b>Position</b>	-	Sample Taken	<b>Location ID</b>	-	Loc20180

<b>Site Code/UPRN</b>	SD724P/86213	<b>Building</b>	Whitehall
<b>Address</b>	The Old War Office Horse Guards Avenue Whitehall London	<b>Floor</b>	Ground (0)
	SW1A 2HB	<b>Room</b>	Room 030
<b>Description</b>	Plaster & render to walls.	<b>Quantity</b>	N/A
		<b>Asbestos Suspected</b>	<b>No</b>

<b>Product Type</b>	-	N/A	<b>Surface Treatment</b>	-	N/A
<b>Asbestos Type</b>	-	No Asbestos Detected	<b>Damage Extent</b>	-	N/A
<b>Material Risk Score</b>	-	<b>0</b>	<b>Material Risk Band</b>	-	N/A

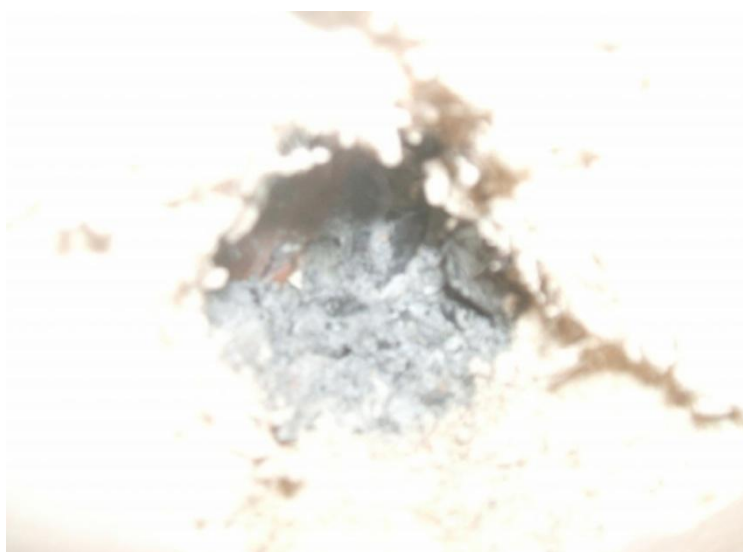
<b>Last Inspection Date</b>	-	03 Sep 2012	<b>Certificate N°</b>	-	BK30786
<b>Next Inspection Date</b>	-	03 Sep 2013	<b>Sample N°</b>	-	228
<b>Survey Type</b>	-	Refurbishment & Demolition Survey	<b>Photograph N°</b>	-	4950
<b>Position</b>	-	Sample Taken	<b>Location ID</b>	-	Loc20177

<b>Site Code/UPRN</b>	SD724P/86213	<b>Building</b>	Whitehall
<b>Address</b>	The Old War Office Horse Guards Avenue Whitehall London	<b>Floor</b>	Ground (0)
	SW1A 2HB	<b>Room</b>	Room 030
<b>Description</b>	Asphalt/ concrete overfil.	<b>Quantity</b>	N/A
		<b>Asbestos Suspected</b>	<b>No</b>

<b>Product Type</b>	-	N/A	<b>Surface Treatment</b>	-	N/A
<b>Asbestos Type</b>	-	No Asbestos Detected	<b>Damage Extent</b>	-	N/A
<b>Material Risk Score</b>	-	<b>0</b>	<b>Material Risk Band</b>	-	N/A

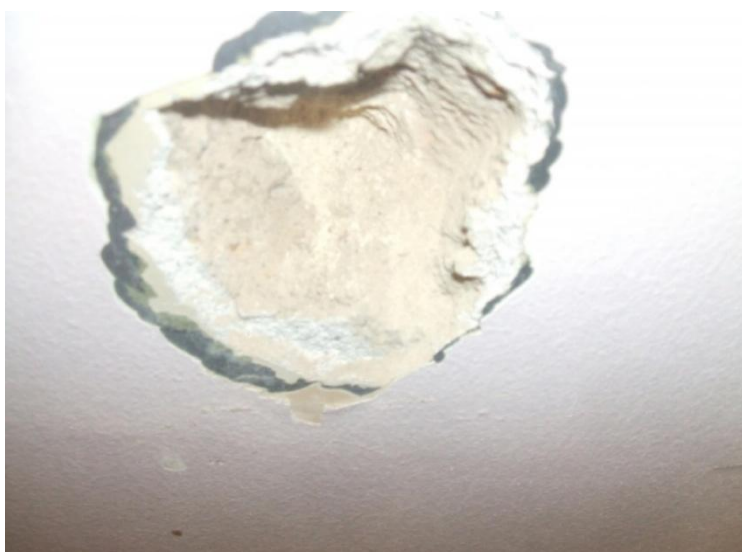
<b>Site Code/UPRN</b>	SD724P/86213	<b>Building</b>	Whitehall
<b>Address</b>	The Old War Office Horse Guards Avenue Whitehall London	<b>Floor</b>	Ground (0)
	SW1A 2HB	<b>Room</b>	Room 030
<b>Description</b>	Mortar line to wall.	<b>Quantity</b>	N/A
		<b>Asbestos Suspected</b>	<b>No</b>

<b>Product Type</b>	-	N/A	<b>Surface Treatment</b>	-	N/A
<b>Asbestos Type</b>	-	No Asbestos Detected	<b>Damage Extent</b>	-	N/A
<b>Material Risk Score</b>	-	<b>0</b>	<b>Material Risk Band</b>	-	N/A

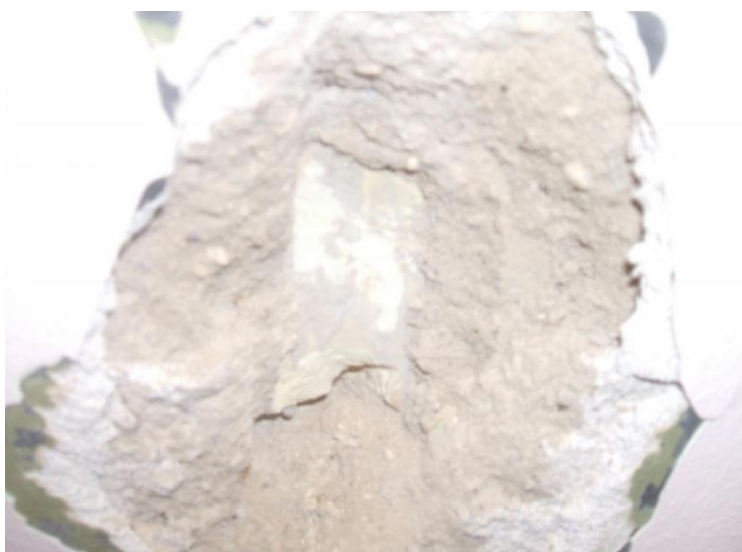
<b>Site Code/UPRN</b>	SD724P/86213	<b>Building</b>	Whitehall
<b>Address</b>	The Old War Office Horse Guards Avenue Whitehall London	<b>Floor</b>	Ground (0)
	SW1A 2HB	<b>Room</b>	Room 030
		<b>Quantity</b>	N/A
<b>Description</b>	Mortar line to walls.	<b>Asbestos Suspected</b>	<b>No</b>

<b>Product Type</b>	-	N/A	<b>Surface Treatment</b>	-	N/A
<b>Asbestos Type</b>	-	No Asbestos Detected	<b>Damage Extent</b>	-	N/A
<b>Material Risk Score</b>	-	<b>0</b>	<b>Material Risk Band</b>	-	N/A

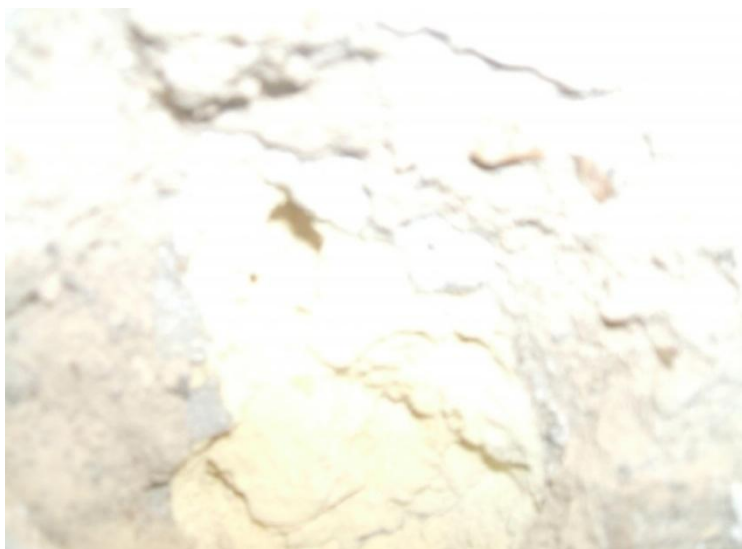
<b>Site Code/UPRN</b>	SD724P/86213	<b>Building</b>	Whitehall
<b>Address</b>	The Old War Office Horse Guards Avenue Whitehall London	<b>Floor</b>	Ground (0)
	SW1A 2HB	<b>Room</b>	Room 030
<b>Description</b>	Mortar line to walls.	<b>Quantity</b>	N/A
		<b>Asbestos Suspected</b>	<b>No</b>

<b>Last Inspection Date</b>	-	03 Sep 2012	<b>Certificate N<sup>o</sup></b>	-	BK30786
<b>Next Inspection Date</b>	-	03 Sep 2013	<b>Sample N<sup>o</sup></b>	-	236
<b>Survey Type</b>	-	Refurbishment & Demolition Survey	<b>Photograph N<sup>o</sup></b>	-	4958
<b>Position</b>	-	Sample Taken	<b>Location ID</b>	-	Loc20185

<b>Product Type</b>	-	N/A	<b>Surface Treatment</b>	-	N/A
<b>Asbestos Type</b>	-	No Asbestos Detected	<b>Damage Extent</b>	-	N/A
<b>Material Risk Score</b>	-	<b>0</b>	<b>Material Risk Band</b>	-	N/A

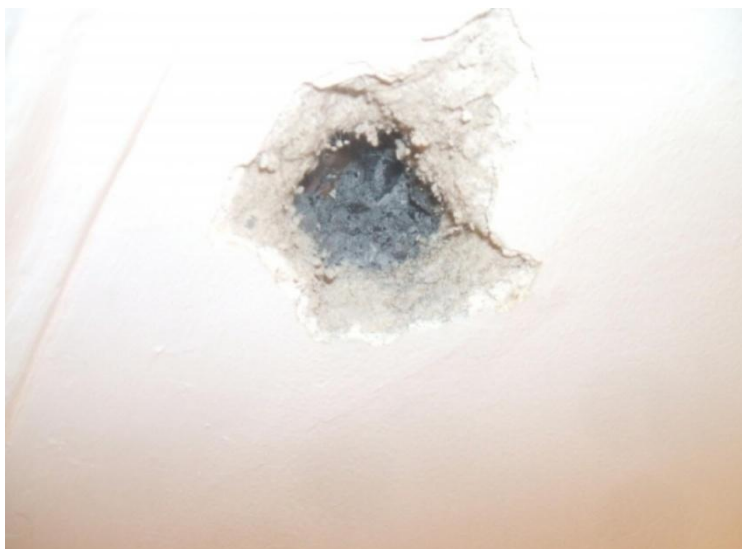
<b>Site Code/UPRN</b>	SD724P/86213	<b>Building</b>	Whitehall
<b>Address</b>	The Old War Office Horse Guards Avenue Whitehall London	<b>Floor</b>	Ground (0)
	SW1A 2HB	<b>Room</b>	Room 030
<b>Description</b>	Plaster & finish to ceiling.	<b>Quantity</b>	N/A
		<b>Asbestos Suspected</b>	<b>No</b>

<b>Last Inspection Date</b>	-	03 Sep 2012	<b>Certificate N<sup>o</sup></b>	-	BK30786
<b>Next Inspection Date</b>	-	03 Sep 2013	<b>Sample N<sup>o</sup></b>	-	227
<b>Survey Type</b>	-	Refurbishment & Demolition Survey	<b>Photograph N<sup>o</sup></b>	-	4949
<b>Position</b>	-	Sample Taken	<b>Location ID</b>	-	Loc20176

<b>Product Type</b>	-	N/A	<b>Surface Treatment</b>	-	N/A
<b>Asbestos Type</b>	-	No Asbestos Detected	<b>Damage Extent</b>	-	N/A
<b>Material Risk Score</b>	-	<b>0</b>	<b>Material Risk Band</b>	-	N/A

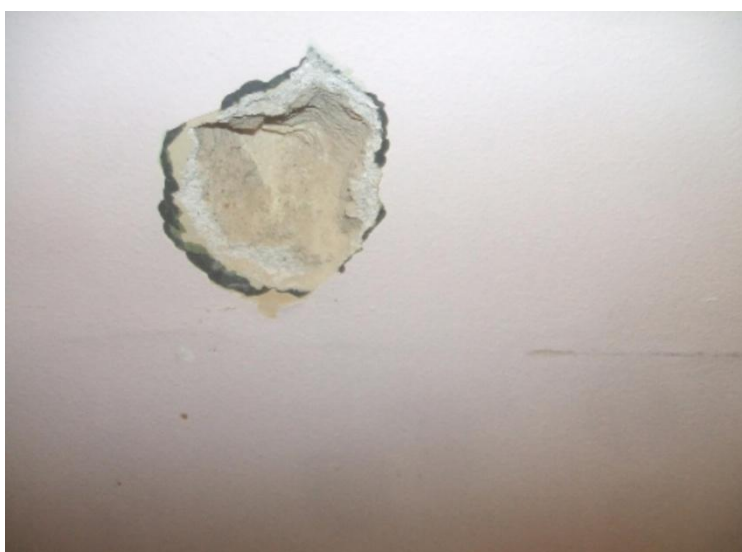
<b>Site Code/UPRN</b>	SD724P/86213	<b>Building</b>	Whitehall
<b>Address</b>	The Old War Office Horse Guards Avenue Whitehall London	<b>Floor</b>	Ground (0)
	SW1A 2HB	<b>Room</b>	Room 030
<b>Description</b>	Plaster & render to walls.	<b>Quantity</b>	N/A
		<b>Asbestos Suspected</b>	<b>No</b>

<b>Last Inspection Date</b>	-	03 Sep 2012	<b>Certificate N<sup>o</sup></b>	-	BK30786
<b>Next Inspection Date</b>	-	03 Sep 2013	<b>Sample N<sup>o</sup></b>	-	233
<b>Survey Type</b>	-	Refurbishment & Demolition Survey	<b>Photograph N<sup>o</sup></b>	-	4955
<b>Position</b>	-	Sample Taken	<b>Location ID</b>	-	Loc20182

<b>Product Type</b>	-	N/A	<b>Surface Treatment</b>	-	N/A
<b>Asbestos Type</b>	-	No Asbestos Detected	<b>Damage Extent</b>	-	N/A
<b>Material Risk Score</b>	-	<b>0</b>	<b>Material Risk Band</b>	-	N/A

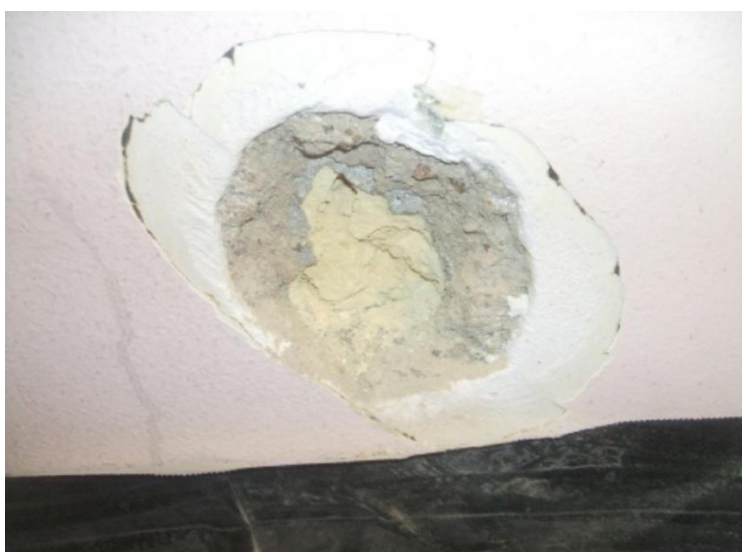
<b>Site Code/UPRN</b>	SD724P/86213	<b>Building</b>	Whitehall
<b>Address</b>	The Old War Office Horse Guards Avenue Whitehall London	<b>Floor</b>	Ground (0)
	SW1A 2HB	<b>Room</b>	Room 030
<b>Description</b>	Plaster & render to walls.	<b>Quantity</b>	N/A
		<b>Asbestos Suspected</b>	<b>No</b>

<b>Last Inspection Date</b>	-	03 Sep 2012	<b>Certificate N°</b>	-	BK30786
<b>Next Inspection Date</b>	-	03 Sep 2013	<b>Sample N°</b>	-	235
<b>Survey Type</b>	-	Refurbishment & Demolition Survey	<b>Photograph N°</b>	-	4957
<b>Position</b>	-	Sample Taken	<b>Location ID</b>	-	Loc20184

<b>Product Type</b>	-	N/A	<b>Surface Treatment</b>	-	N/A
<b>Asbestos Type</b>	-	No Asbestos Detected	<b>Damage Extent</b>	-	N/A
<b>Material Risk Score</b>	-	<b>0</b>	<b>Material Risk Band</b>	-	N/A

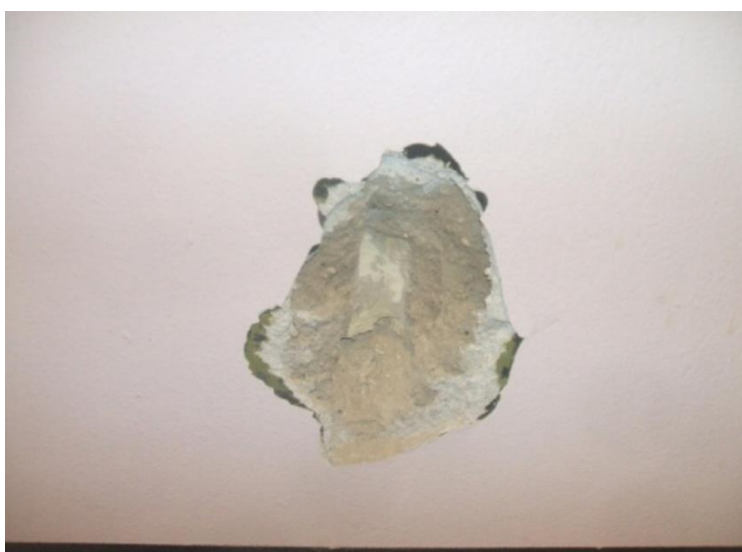
<b>Site Code/UPRN</b>	SD724P/86213	<b>Building</b>	Whitehall
<b>Address</b>	The Old War Office Horse Guards Avenue Whitehall London	<b>Floor</b>	Ground (0)
	SW1A 2HB	<b>Room</b>	Room 030
<b>Description</b>	Plaster & render to walls.	<b>Quantity</b>	N/A
		<b>Asbestos Suspected</b>	<b>No</b>

<b>Last Inspection Date</b>	-	03 Sep 2012	<b>Certificate N°</b>	-	BK30786
<b>Next Inspection Date</b>	-	03 Sep 2013	<b>Sample N°</b>	-	229
<b>Survey Type</b>	-	Refurbishment & Demolition Survey	<b>Photograph N°</b>	-	4951
<b>Position</b>	-	Sample Taken	<b>Location ID</b>	-	Loc20178

<b>Product Type</b>	-	N/A	<b>Surface Treatment</b>	-	N/A
<b>Asbestos Type</b>	-	No Asbestos Detected	<b>Damage Extent</b>	-	N/A
<b>Material Risk Score</b>	-	<b>0</b>	<b>Material Risk Band</b>	-	N/A

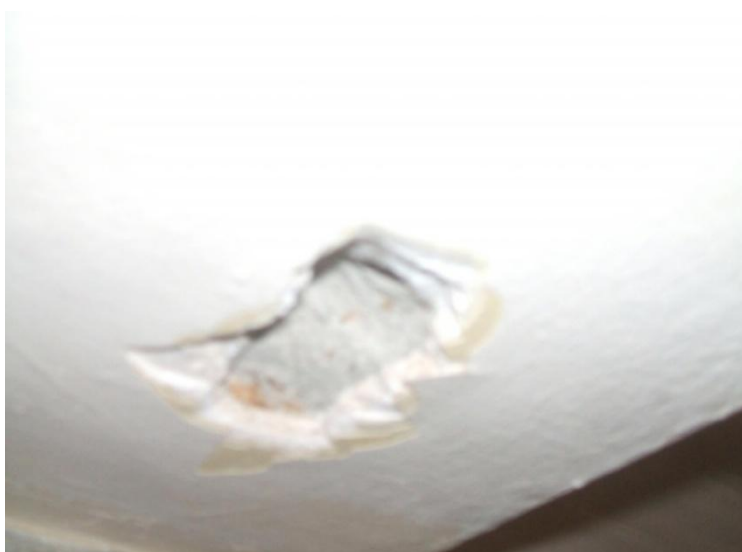
<b>Site Code/UPRN</b>	SD724P/86213	<b>Building</b>	Whitehall
<b>Address</b>	The Old War Office Horse Guards Avenue Whitehall London	<b>Floor</b>	Ground (0)
	SW1A 2HB	<b>Room</b>	Room- Stairwell 4
<b>Description</b>	High level beam- plaster finish.	<b>Quantity</b>	N/A
		<b>Asbestos Suspected</b>	<b>No</b>

<b>Last Inspection Date</b>	-	03 Sep 2012	<b>Certificate N<sup>o</sup></b>	-	BK30786
<b>Next Inspection Date</b>	-	03 Sep 2013	<b>Sample N<sup>o</sup></b>	-	239
<b>Survey Type</b>	-	Refurbishment & Demolition Survey	<b>Photograph N<sup>o</sup></b>	-	4961
<b>Position</b>	-	Sample Taken	<b>Location ID</b>	-	Loc20188

<b>Product Type</b>	-	N/A	<b>Surface Treatment</b>	-	N/A
<b>Asbestos Type</b>	-	No Asbestos Detected	<b>Damage Extent</b>	-	N/A
<b>Material Risk Score</b>	-	<b>0</b>	<b>Material Risk Band</b>	-	N/A

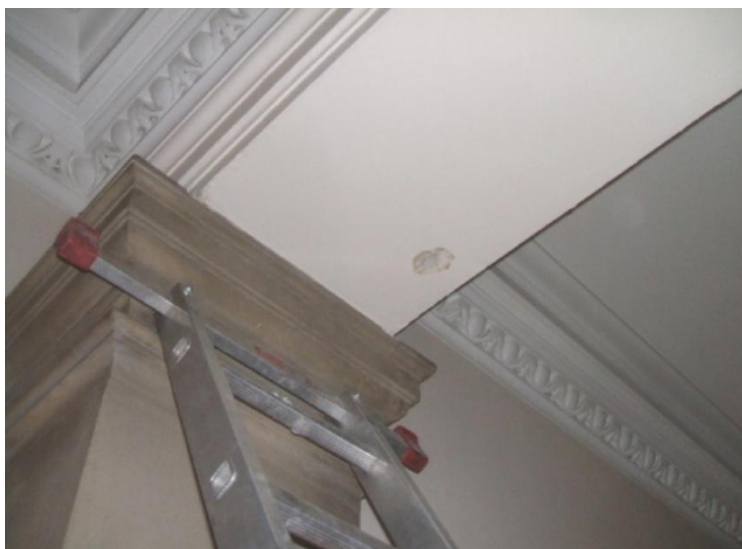
<b>Site Code/UPRN</b>	SD724P/86213	<b>Building</b>	Whitehall
<b>Address</b>	The Old War Office Horse Guards Avenue Whitehall London	<b>Floor</b>	Ground (0)
	SW1A 2HB	<b>Room</b>	Room WES 368
<b>Description</b>	Plaster finish to beam.	<b>Quantity</b>	N/A
		<b>Asbestos Suspected</b>	<b>No</b>

<b>Last Inspection Date</b>	-	03 Sep 2012	<b>Certificate N<sup>o</sup></b>	-	BK30786
<b>Next Inspection Date</b>	-	03 Sep 2013	<b>Sample N<sup>o</sup></b>	-	237
<b>Survey Type</b>	-	Refurbishment & Demolition Survey	<b>Photograph N<sup>o</sup></b>	-	4959
<b>Position</b>	-	Sample Taken	<b>Location ID</b>	-	Loc20186

<b>Product Type</b>	-	N/A	<b>Surface Treatment</b>	-	N/A
<b>Asbestos Type</b>	-	No Asbestos Detected	<b>Damage Extent</b>	-	N/A
<b>Material Risk Score</b>	-	<b>0</b>	<b>Material Risk Band</b>	-	N/A

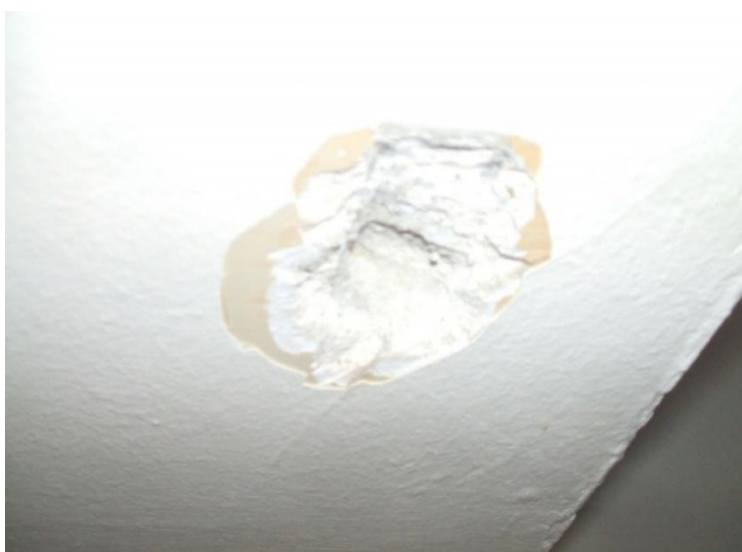
<b>Site Code/UPRN</b>	SD724P/86213	<b>Building</b>	Whitehall
<b>Address</b>	The Old War Office Horse Guards Avenue Whitehall London	<b>Floor</b>	Ground (0)
	SW1A 2HB	<b>Room</b>	Room WES 368
<b>Description</b>	Concrete beam structure.	<b>Quantity</b>	N/A
		<b>Asbestos Suspected</b>	<b>No</b>

<b>Last Inspection Date</b>	-	03 Sep 2012	<b>Certificate N°</b>	-	BK30786
<b>Next Inspection Date</b>	-	03 Sep 2013	<b>Sample N°</b>	-	238
<b>Survey Type</b>	-	Refurbishment & Demolition Survey	<b>Photograph N°</b>	-	4960
<b>Position</b>	-	Internal	<b>Location ID</b>	-	Loc20187

<b>Product Type</b>	-	N/A	<b>Surface Treatment</b>	-	N/A
<b>Asbestos Type</b>	-	No Asbestos Detected	<b>Damage Extent</b>	-	N/A
<b>Material Risk Score</b>	-	<b>0</b>	<b>Material Risk Band</b>	-	N/A

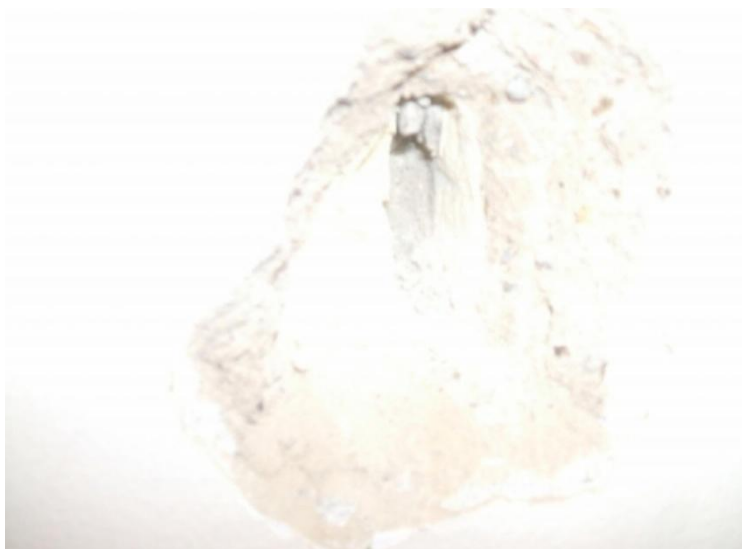
<b>Site Code/UPRN</b>	SD724P/86213	<b>Building</b>	Whitehall
<b>Address</b>	The Old War Office Horse Guards Avenue Whitehall London	<b>Floor</b>	Second Floor
	SW1A 2HB	<b>Room</b>	Room 220
<b>Description</b>	Mortar line to ride hand side wall.	<b>Quantity</b>	N/A
		<b>Asbestos Suspected</b>	<b>No</b>

<b>Last Inspection Date</b>	-	03 Sep 2012	<b>Certificate N<sup>o</sup></b>	-	BK30669
<b>Next Inspection Date</b>	-	03 Sep 2013	<b>Sample N<sup>o</sup></b>	-	156
<b>Survey Type</b>	-	Refurbishment & Demolition Survey	<b>Photograph N<sup>o</sup></b>	-	4872
<b>Position</b>	-	Sample Taken	<b>Location ID</b>	-	Loc20100

<b>Product Type</b>	-	N/A	<b>Surface Treatment</b>	-	N/A
<b>Asbestos Type</b>	-	No Asbestos Detected	<b>Damage Extent</b>	-	N/A
<b>Material Risk Score</b>	-	<b>0</b>	<b>Material Risk Band</b>	-	N/A

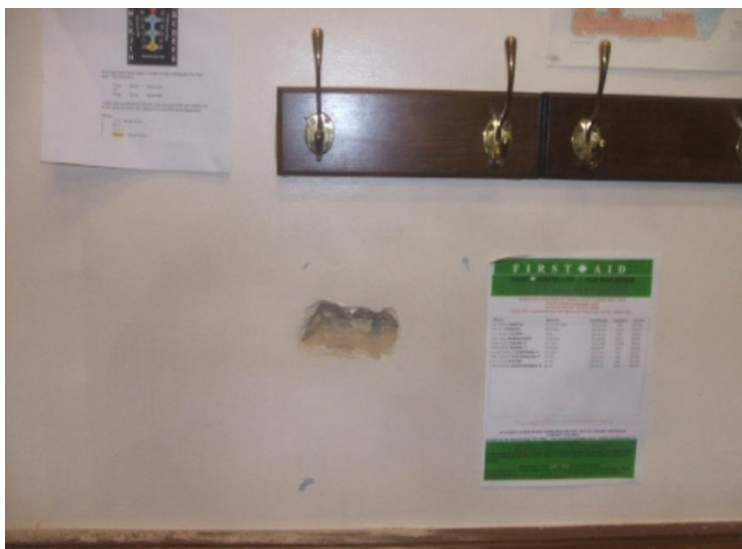
<b>Site Code/UPRN</b>	SD724P/86213	<b>Building</b>	Whitehall
<b>Address</b>	The Old War Office Horse Guards Avenue Whitehall London	<b>Floor</b>	Second Floor
	SW1A 2HB	<b>Room</b>	Room 220
<b>Description</b>	Plaster & render to walls adjacent light switch.	<b>Quantity</b>	N/A
		<b>Asbestos Suspected</b>	<b>No</b>

<b>Last Inspection Date</b>	-	03 Sep 2012	<b>Certificate N<sup>o</sup></b>	-	BK30669
<b>Next Inspection Date</b>	-	03 Sep 2013	<b>Sample N<sup>o</sup></b>	-	157
<b>Survey Type</b>	-	Refurbishment & Demolition Survey	<b>Photograph N<sup>o</sup></b>	-	4873
<b>Position</b>	-	Sample Taken	<b>Location ID</b>	-	Loc20101

<b>Product Type</b>	-	N/A	<b>Surface Treatment</b>	-	N/A
<b>Asbestos Type</b>	-	No Asbestos Detected	<b>Damage Extent</b>	-	N/A
<b>Material Risk Score</b>	-	<b>0</b>	<b>Material Risk Band</b>	-	N/A

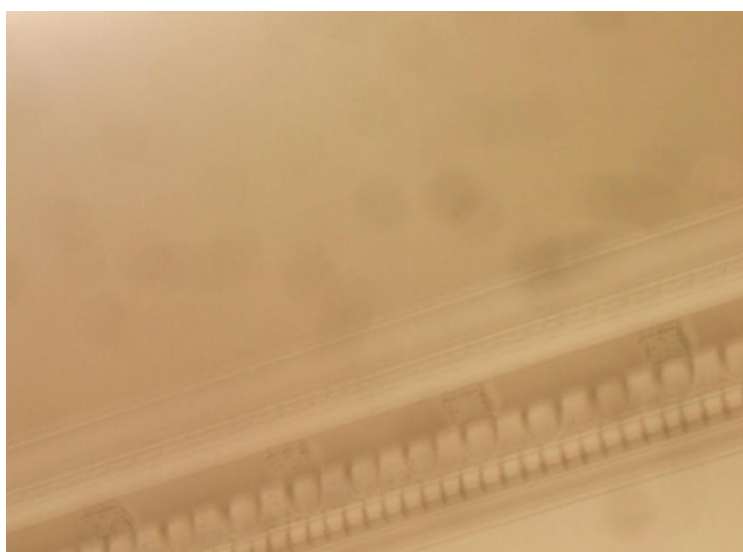
<b>Site Code/UPRN</b>	SD724P/86213	<b>Building</b>	Whitehall
<b>Address</b>	The Old War Office Horse Guards Avenue Whitehall London	<b>Floor</b>	Second Floor
	SW1A 2HB	<b>Room</b>	Room 220
<b>Description</b>	Plaster & render ceiling.	<b>Quantity</b>	N/A
		<b>Asbestos Suspected</b>	<b>No</b>

<b>Last Inspection Date</b>	-	03 Sep 2012	<b>Certificate N<sup>o</sup></b>	-	BK30669
<b>Next Inspection Date</b>	-	03 Sep 2013	<b>Sample N<sup>o</sup></b>	-	153
<b>Survey Type</b>	-	Refurbishment & Demolition Survey	<b>Photograph N<sup>o</sup></b>	-	4878
<b>Position</b>	-	Sample Taken	<b>Location ID</b>	-	Loc20097

<b>Product Type</b>	-	N/A	<b>Surface Treatment</b>	-	N/A
<b>Asbestos Type</b>	-	No Asbestos Detected	<b>Damage Extent</b>	-	N/A
<b>Material Risk Score</b>	-	<b>0</b>	<b>Material Risk Band</b>	-	N/A

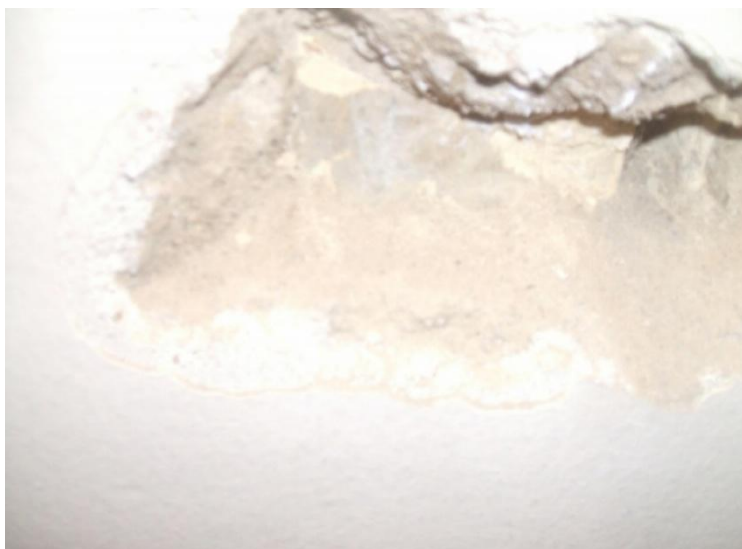
<b>Site Code/UPRN</b>	SD724P/86213	<b>Building</b>	Whitehall
<b>Address</b>	The Old War Office Horse Guards Avenue Whitehall London	<b>Floor</b>	Second Floor
	SW1A 2HB	<b>Room</b>	Room 220
<b>Description</b>	Mortar line to wall adjacent light switch.	<b>Quantity</b>	N/A
		<b>Asbestos Suspected</b>	<b>No</b>

<b>Last Inspection Date</b>	-	03 Sep 2012	<b>Certificate N<sup>o</sup></b>	-	BK30669
<b>Next Inspection Date</b>	-	03 Sep 2013	<b>Sample N<sup>o</sup></b>	-	158
<b>Survey Type</b>	-	Refurbishment & Demolition Survey	<b>Photograph N<sup>o</sup></b>	-	4874
<b>Position</b>	-	Sample Taken	<b>Location ID</b>	-	Loc20102

<b>Product Type</b>	-	N/A	<b>Surface Treatment</b>	-	N/A
<b>Asbestos Type</b>	-	No Asbestos Detected	<b>Damage Extent</b>	-	N/A
<b>Material Risk Score</b>	-	<b>0</b>	<b>Material Risk Band</b>	-	N/A

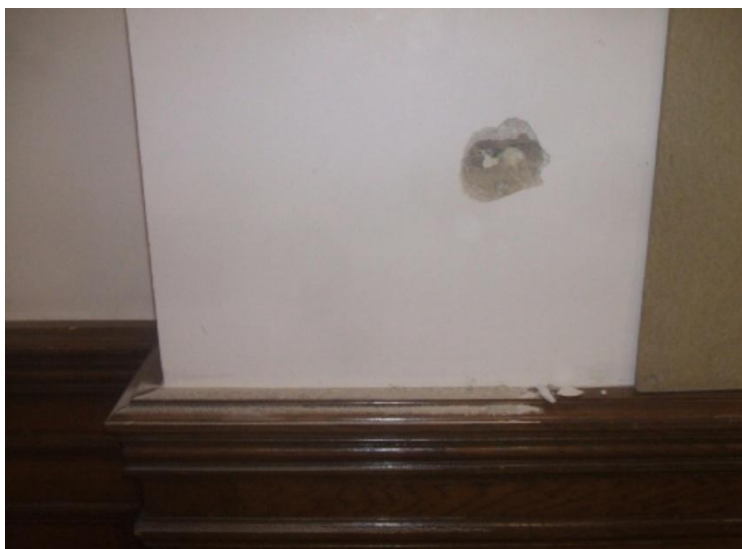
<b>Site Code/UPRN</b>	SD724P/86213	<b>Building</b>	Whitehall
<b>Address</b>	The Old War Office Horse Guards Avenue Whitehall London	<b>Floor</b>	Second Floor
	SW1A 2HB	<b>Room</b>	Room 220
<b>Description</b>	Plaster & render walls. (chimney breasts)	<b>Quantity</b>	N/A
		<b>Asbestos Suspected</b>	<b>No</b>

<b>Last Inspection Date</b>	-	03 Sep 2012	<b>Certificate N°</b>	-	BK30669
<b>Next Inspection Date</b>	-	03 Sep 2013	<b>Sample N°</b>	-	159
<b>Survey Type</b>	-	Refurbishment & Demolition Survey	<b>Photograph N°</b>	-	4875
<b>Position</b>	-	Sample Taken	<b>Location ID</b>	-	Loc20103

<b>Product Type</b>	-	N/A	<b>Surface Treatment</b>	-	N/A
<b>Asbestos Type</b>	-	No Asbestos Detected	<b>Damage Extent</b>	-	N/A
<b>Material Risk Score</b>	-	<b>0</b>	<b>Material Risk Band</b>	-	N/A

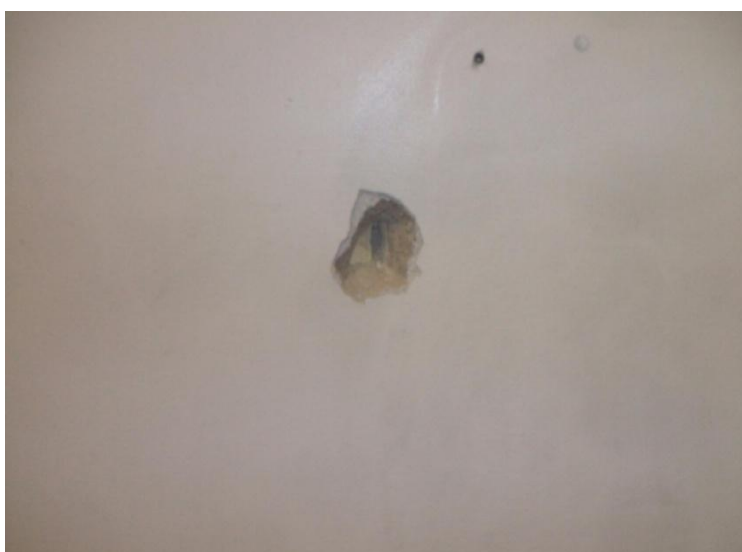
<b>Site Code/UPRN</b>	SD724P/86213	<b>Building</b>	Whitehall
<b>Address</b>	The Old War Office Horse Guards Avenue Whitehall London	<b>Floor</b>	Second Floor
	SW1A 2HB	<b>Room</b>	Room 220
<b>Description</b>	Plaster & render on right hand side wall.	<b>Quantity</b>	N/A
		<b>Asbestos Suspected</b>	<b>No</b>

<b>Last Inspection Date</b>	-	03 Sep 2012	<b>Certificate N<sup>o</sup></b>	-	BK30669
<b>Next Inspection Date</b>	-	03 Sep 2013	<b>Sample N<sup>o</sup></b>	-	155
<b>Survey Type</b>	-	Refurbishment & Demolition Survey	<b>Photograph N<sup>o</sup></b>	-	4871
<b>Position</b>	-	Sample Taken	<b>Location ID</b>	-	Loc20099

<b>Product Type</b>	-	N/A	<b>Surface Treatment</b>	-	N/A
<b>Asbestos Type</b>	-	No Asbestos Detected	<b>Damage Extent</b>	-	N/A
<b>Material Risk Score</b>	-	<b>0</b>	<b>Material Risk Band</b>	-	N/A

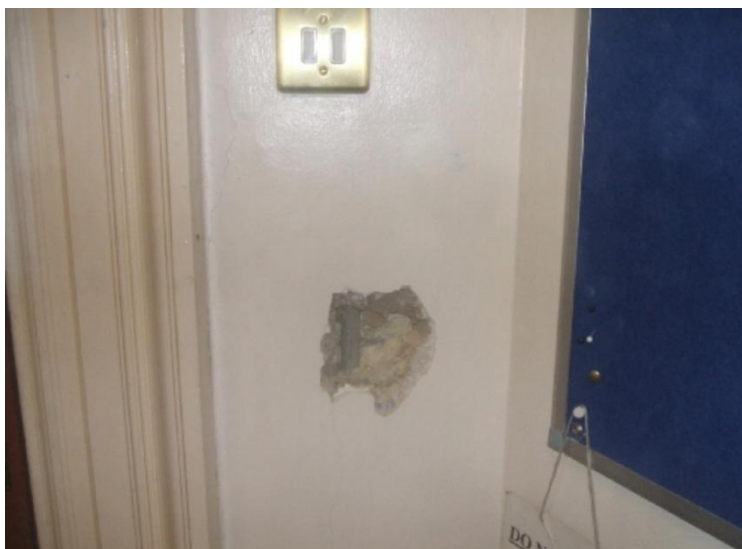
<b>Site Code/UPRN</b>	SD724P/86213	<b>Building</b>	Whitehall
<b>Address</b>	The Old War Office Horse Guards Avenue Whitehall London	<b>Floor</b>	Second Floor
	SW1A 2HB	<b>Room</b>	Room 230
<b>Description</b>	Mortar line walls adjacent to light switch.	<b>Quantity</b>	N/A
		<b>Asbestos Suspected</b>	<b>No</b>

<b>Last Inspection Date</b>	-	03 Sep 2012	<b>Certificate N<sup>o</sup></b>	-	BK30669
<b>Next Inspection Date</b>	-	03 Sep 2013	<b>Sample N<sup>o</sup></b>	-	128
<b>Survey Type</b>	-	Refurbishment & Demolition Survey	<b>Photograph N<sup>o</sup></b>	-	4847
<b>Position</b>	-	Sample Taken	<b>Location ID</b>	-	Loc20070

<b>Product Type</b>	-	N/A	<b>Surface Treatment</b>	-	N/A
<b>Asbestos Type</b>	-	No Asbestos Detected	<b>Damage Extent</b>	-	N/A
<b>Material Risk Score</b>	-	<b>0</b>	<b>Material Risk Band</b>	-	N/A

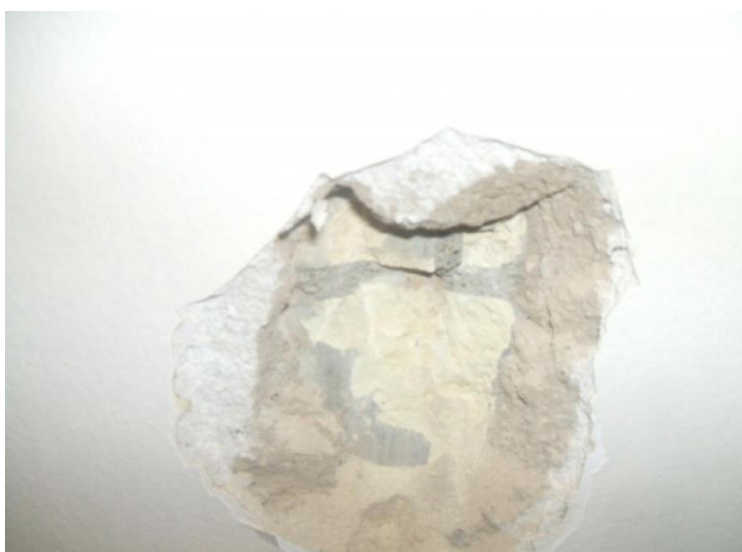
<b>Site Code/UPRN</b>	SD724P/86213	<b>Building</b>	Whitehall
<b>Address</b>	The Old War Office Horse Guards Avenue Whitehall London	<b>Floor</b>	Second Floor
	SW1A 2HB	<b>Room</b>	Room 230
<b>Description</b>	Mortar line wall.	<b>Quantity</b>	N/A
		<b>Asbestos Suspected</b>	<b>No</b>

<b>Last Inspection Date</b>	-	03 Sep 2012	<b>Certificate N°</b>	-	BK30669
<b>Next Inspection Date</b>	-	03 Sep 2013	<b>Sample N°</b>	-	130
<b>Survey Type</b>	-	Refurbishment & Demolition Survey	<b>Photograph N°</b>	-	4849
<b>Position</b>	-	Sample Taken	<b>Location ID</b>	-	Loc20072

<b>Product Type</b>	-	N/A	<b>Surface Treatment</b>	-	N/A
<b>Asbestos Type</b>	-	No Asbestos Detected	<b>Damage Extent</b>	-	N/A
<b>Material Risk Score</b>	-	<b>0</b>	<b>Material Risk Band</b>	-	N/A

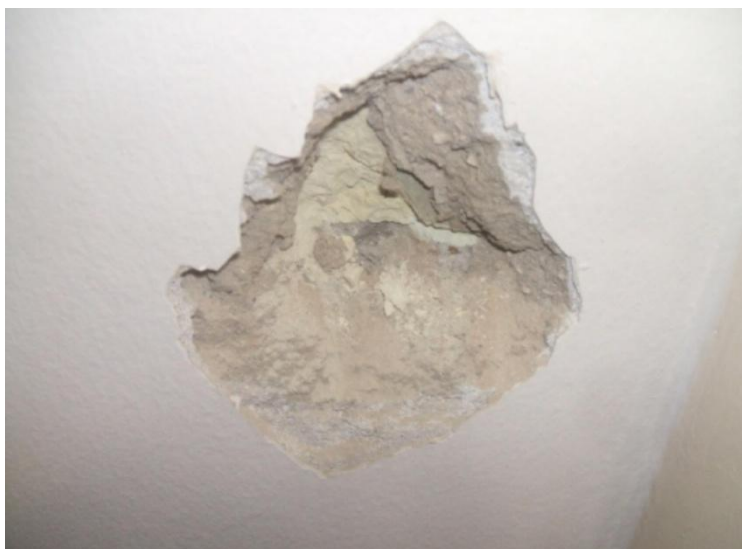
<b>Site Code/UPRN</b>	SD724P/86213	<b>Building</b>	Whitehall
<b>Address</b>	The Old War Office Horse Guards Avenue Whitehall London	<b>Floor</b>	Second Floor
	SW1A 2HB	<b>Room</b>	Room 230
<b>Description</b>	Mortar line wall.	<b>Quantity</b>	N/A
		<b>Asbestos Suspected</b>	<b>No</b>

<b>Last Inspection Date</b>	-	03 Sep 2012	<b>Certificate N<sup>o</sup></b>	-	BK30669
<b>Next Inspection Date</b>	-	03 Sep 2013	<b>Sample N<sup>o</sup></b>	-	132
<b>Survey Type</b>	-	Refurbishment & Demolition Survey	<b>Photograph N<sup>o</sup></b>	-	4851
<b>Position</b>	-	Sample Taken	<b>Location ID</b>	-	Loc20074

<b>Product Type</b>	-	N/A	<b>Surface Treatment</b>	-	N/A
<b>Asbestos Type</b>	-	No Asbestos Detected	<b>Damage Extent</b>	-	N/A
<b>Material Risk Score</b>	-	<b>0</b>	<b>Material Risk Band</b>	-	N/A

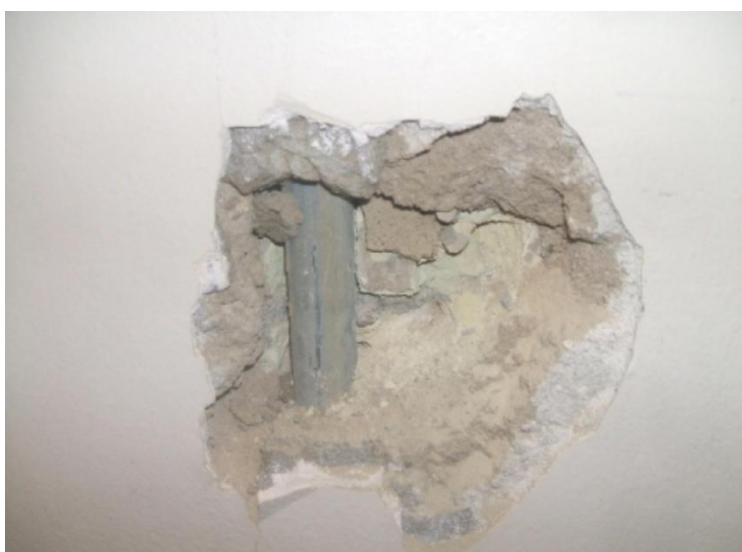
<b>Site Code/UPRN</b>	SD724P/86213	<b>Building</b>	Whitehall
<b>Address</b>	The Old War Office Horse Guards Avenue Whitehall London	<b>Floor</b>	Second Floor
	SW1A 2HB	<b>Room</b>	Room 230
<b>Description</b>	Plaster & render walls adjacent to light switch.	<b>Quantity</b>	N/A
		<b>Asbestos Suspected</b>	<b>No</b>

<b>Last Inspection Date</b>	-	03 Sep 2012	<b>Certificate N<sup>o</sup></b>	-	BK30669
<b>Next Inspection Date</b>	-	03 Sep 2013	<b>Sample N<sup>o</sup></b>	-	127
<b>Survey Type</b>	-	Refurbishment & Demolition Survey	<b>Photograph N<sup>o</sup></b>	-	4846
<b>Position</b>	-	Sample Taken	<b>Location ID</b>	-	Loc20069

<b>Product Type</b>	-	N/A	<b>Surface Treatment</b>	-	N/A
<b>Asbestos Type</b>	-	No Asbestos Detected	<b>Damage Extent</b>	-	N/A
<b>Material Risk Score</b>	-	<b>0</b>	<b>Material Risk Band</b>	-	N/A

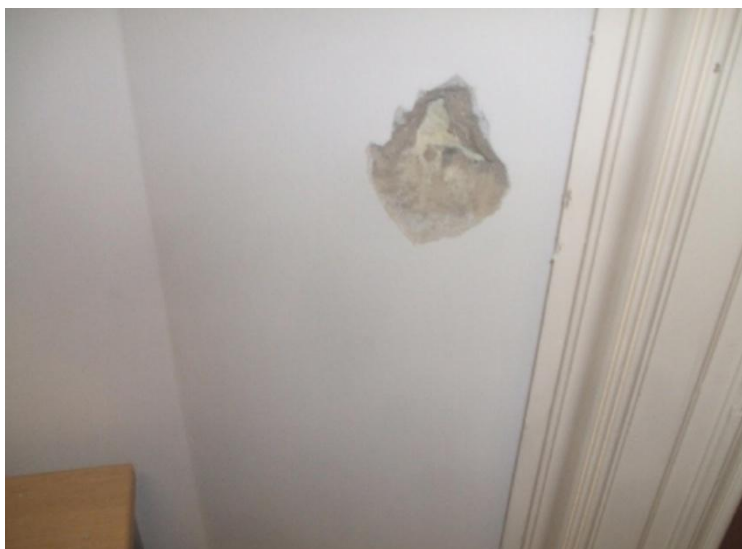
<b>Site Code/UPRN</b>	SD724P/86213	<b>Building</b>	Whitehall
<b>Address</b>	The Old War Office Horse Guards Avenue Whitehall London	<b>Floor</b>	Second Floor
	SW1A 2HB	<b>Room</b>	Room 230
<b>Description</b>	Plaster & render walls corridor way.	<b>Quantity</b>	N/A
		<b>Asbestos Suspected</b>	<b>No</b>

<b>Last Inspection Date</b>	-	03 Sep 2012	<b>Certificate N<sup>o</sup></b>	-	BK30669
<b>Next Inspection Date</b>	-	03 Sep 2013	<b>Sample N<sup>o</sup></b>	-	131
<b>Survey Type</b>	-	Refurbishment & Demolition Survey	<b>Photograph N<sup>o</sup></b>	-	4850
<b>Position</b>	-	Sample Taken	<b>Location ID</b>	-	Loc20073

<b>Product Type</b>	-	N/A	<b>Surface Treatment</b>	-	N/A
<b>Asbestos Type</b>	-	No Asbestos Detected	<b>Damage Extent</b>	-	N/A
<b>Material Risk Score</b>	-	<b>0</b>	<b>Material Risk Band</b>	-	N/A

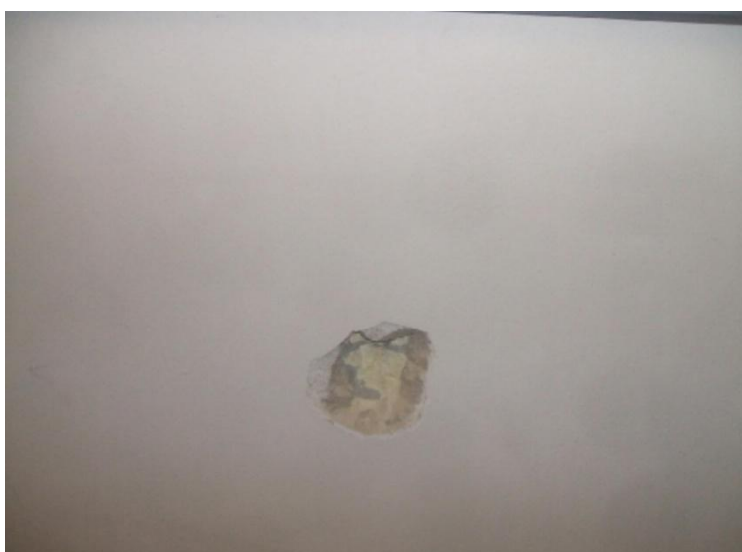
<b>Site Code/UPRN</b>	SD724P/86213	<b>Building</b>	Whitehall
<b>Address</b>	The Old War Office Horse Guards Avenue Whitehall London	<b>Floor</b>	Second Floor
	SW1A 2HB	<b>Room</b>	Room 230
<b>Description</b>	Plaster & render walls adjacent to socket.	<b>Quantity</b>	N/A
		<b>Asbestos Suspected</b>	<b>No</b>

<b>Last Inspection Date</b>	-	03 Sep 2012	<b>Certificate N<sup>o</sup></b>	-	BK30669
<b>Next Inspection Date</b>	-	03 Sep 2013	<b>Sample N<sup>o</sup></b>	-	129
<b>Survey Type</b>	-	Refurbishment & Demolition Survey	<b>Photograph N<sup>o</sup></b>	-	4848
<b>Position</b>	-	Sample Taken	<b>Location ID</b>	-	Loc20071

<b>Product Type</b>	-	N/A	<b>Surface Treatment</b>	-	N/A
<b>Asbestos Type</b>	-	No Asbestos Detected	<b>Damage Extent</b>	-	N/A
<b>Material Risk Score</b>	-	<b>0</b>	<b>Material Risk Band</b>	-	N/A

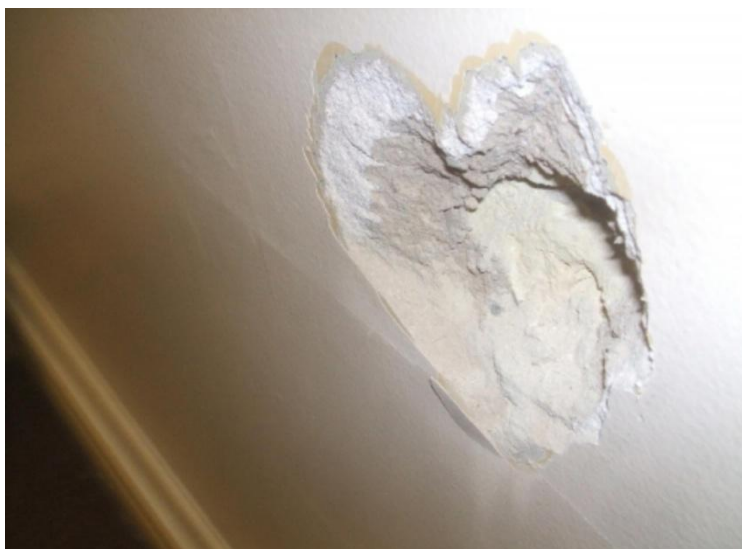
<b>Site Code/UPRN</b>	SD724P/86213	<b>Building</b>	Whitehall
<b>Address</b>	The Old War Office Horse Guards Avenue Whitehall London	<b>Floor</b>	Second Floor
	SW1A 2HB	<b>Room</b>	Room 244
<b>Description</b>	Plaster & render walls.	<b>Quantity</b>	N/A
		<b>Asbestos Suspected</b>	<b>No</b>

<b>Last Inspection Date</b>	-	03 Sep 2012	<b>Certificate N°</b>	-	BK30669
<b>Next Inspection Date</b>	-	03 Sep 2013	<b>Sample N°</b>	-	149
<b>Survey Type</b>	-	Refurbishment & Demolition Survey	<b>Photograph N°</b>	-	4866
<b>Position</b>	-	Sample Taken	<b>Location ID</b>	-	Loc20090

<b>Product Type</b>	-	N/A	<b>Surface Treatment</b>	-	N/A
<b>Asbestos Type</b>	-	No Asbestos Detected	<b>Damage Extent</b>	-	N/A
<b>Material Risk Score</b>	-	<b>0</b>	<b>Material Risk Band</b>	-	N/A

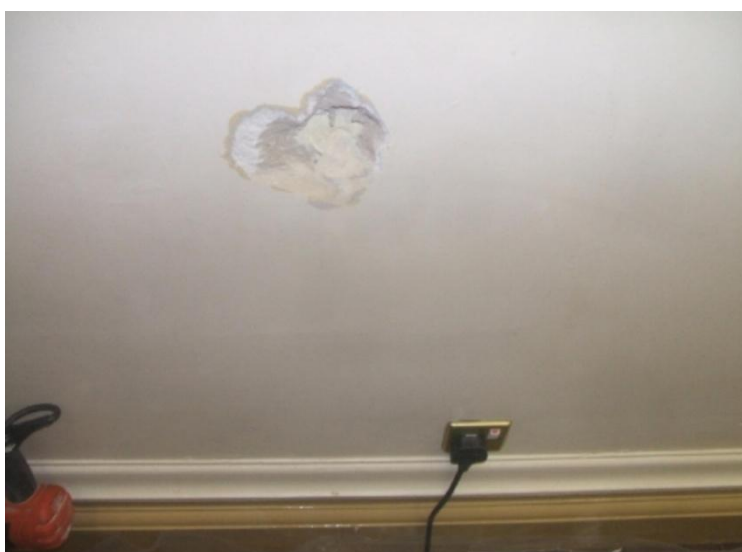
<b>Site Code/UPRN</b>	SD724P/86213	<b>Building</b>	Whitehall
<b>Address</b>	The Old War Office Horse Guards Avenue Whitehall London	<b>Floor</b>	Second Floor
	SW1A 2HB	<b>Room</b>	Room 244
<b>Description</b>	Plaster & render walls adjacent to socket.	<b>Quantity</b>	N/A
		<b>Asbestos Suspected</b>	<b>No</b>

<b>Last Inspection Date</b>	-	03 Sep 2012	<b>Certificate N<sup>o</sup></b>	-	BK30669
<b>Next Inspection Date</b>	-	03 Sep 2013	<b>Sample N<sup>o</sup></b>	-	147
<b>Survey Type</b>	-	Refurbishment & Demolition Survey	<b>Photograph N<sup>o</sup></b>	-	4864
<b>Position</b>	-	Sample Taken	<b>Location ID</b>	-	Loc20088

<b>Product Type</b>	-	N/A	<b>Surface Treatment</b>	-	N/A
<b>Asbestos Type</b>	-	No Asbestos Detected	<b>Damage Extent</b>	-	N/A
<b>Material Risk Score</b>	-	<b>0</b>	<b>Material Risk Band</b>	-	N/A

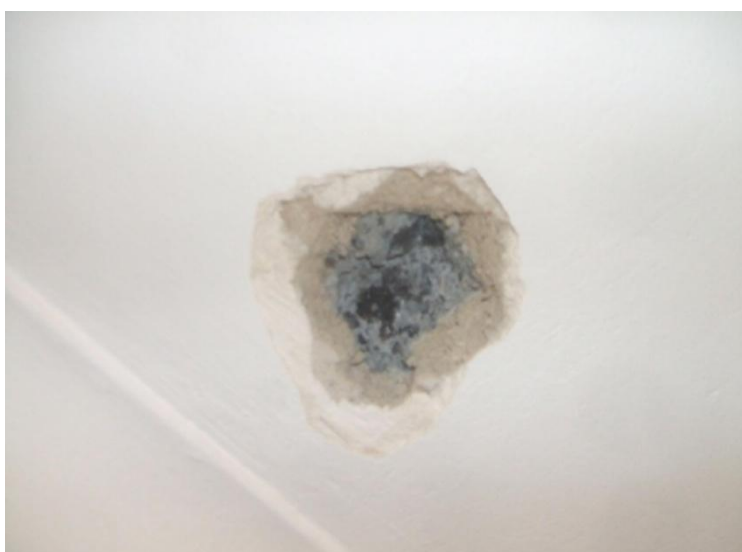
<b>Site Code/UPRN</b>	SD724P/86213	<b>Building</b>	Whitehall
<b>Address</b>	The Old War Office Horse Guards Avenue Whitehall London	<b>Floor</b>	Second Floor
	SW1A 2HB	<b>Room</b>	Room 244
<b>Description</b>	Plaster & mortar walls.	<b>Quantity</b>	N/A
		<b>Asbestos Suspected</b>	<b>No</b>

<b>Last Inspection Date</b>	-	03 Sep 2012	<b>Certificate N°</b>	-	BK30669
<b>Next Inspection Date</b>	-	03 Sep 2013	<b>Sample N°</b>	-	151
<b>Survey Type</b>	-	Refurbishment & Demolition Survey	<b>Photograph N°</b>	-	4868
<b>Position</b>	-	Sample Taken	<b>Location ID</b>	-	Loc20092

<b>Product Type</b>	-	N/A	<b>Surface Treatment</b>	-	N/A
<b>Asbestos Type</b>	-	No Asbestos Detected	<b>Damage Extent</b>	-	N/A
<b>Material Risk Score</b>	-	<b>0</b>	<b>Material Risk Band</b>	-	N/A

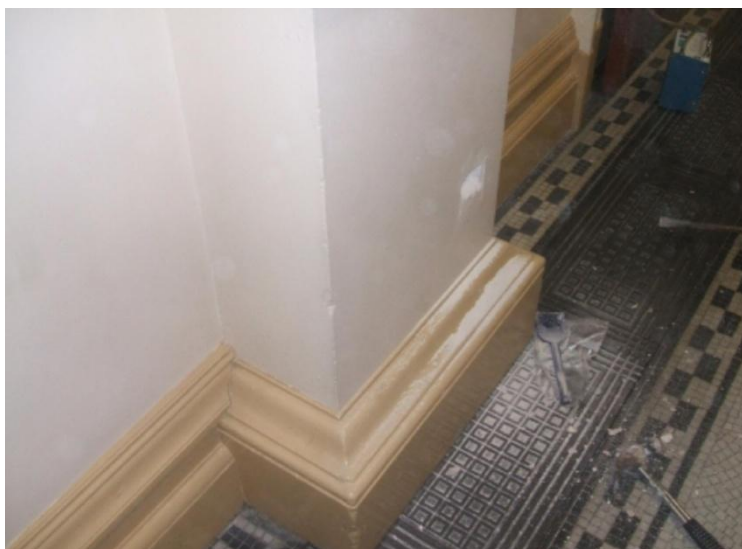
<b>Site Code/UPRN</b>	SD724P/86213	<b>Building</b>	Whitehall
<b>Address</b>	The Old War Office Horse Guards Avenue Whitehall London	<b>Floor</b>	Second Floor
	SW1A 2HB	<b>Room</b>	Room 244
<b>Description</b>	Plaster & render ceiling.	<b>Quantity</b>	N/A
		<b>Asbestos Suspected</b>	<b>No</b>

<b>Last Inspection Date</b>	-	03 Sep 2012	<b>Certificate N<sup>o</sup></b>	-	BK30669
<b>Next Inspection Date</b>	-	03 Sep 2013	<b>Sample N<sup>o</sup></b>	-	145
<b>Survey Type</b>	-	Refurbishment & Demolition Survey	<b>Photograph N<sup>o</sup></b>	-	4862
<b>Position</b>	-	Sample Taken	<b>Location ID</b>	-	Loc20086

<b>Product Type</b>	-	N/A	<b>Surface Treatment</b>	-	N/A
<b>Asbestos Type</b>	-	No Asbestos Detected	<b>Damage Extent</b>	-	N/A
<b>Material Risk Score</b>	-	<b>0</b>	<b>Material Risk Band</b>	-	N/A

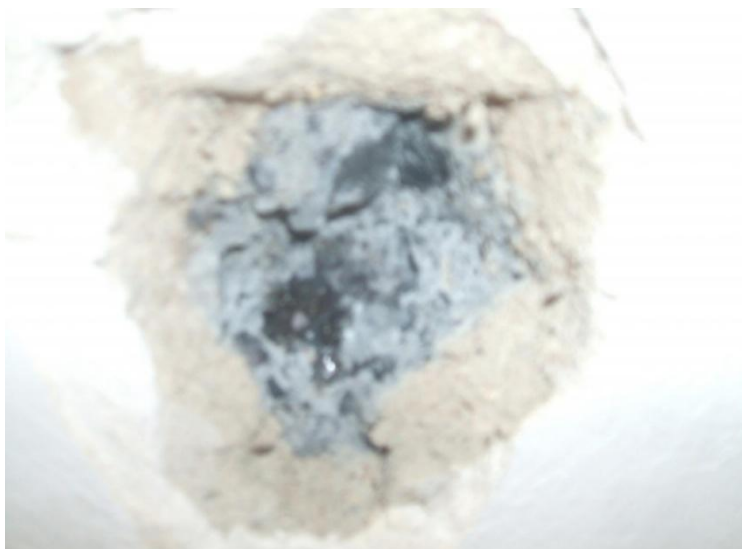
<b>Site Code/UPRN</b>	SD724P/86213	<b>Building</b>	Whitehall
<b>Address</b>	The Old War Office Horse Guards Avenue Whitehall London	<b>Floor</b>	Second Floor
	SW1A 2HB	<b>Room</b>	Room 244
<b>Description</b>	Mortar line walls.	<b>Quantity</b>	N/A
		<b>Asbestos Suspected</b>	<b>No</b>

<b>Last Inspection Date</b>	-	03 Sep 2012	<b>Certificate N°</b>	-	BK30669
<b>Next Inspection Date</b>	-	03 Sep 2013	<b>Sample N°</b>	-	152
<b>Survey Type</b>	-	Refurbishment & Demolition Survey	<b>Photograph N°</b>	-	4869
<b>Position</b>	-	Sample Taken	<b>Location ID</b>	-	Loc20093

<b>Product Type</b>	-	N/A	<b>Surface Treatment</b>	-	N/A
<b>Asbestos Type</b>	-	No Asbestos Detected	<b>Damage Extent</b>	-	N/A
<b>Material Risk Score</b>	-	<b>0</b>	<b>Material Risk Band</b>	-	N/A

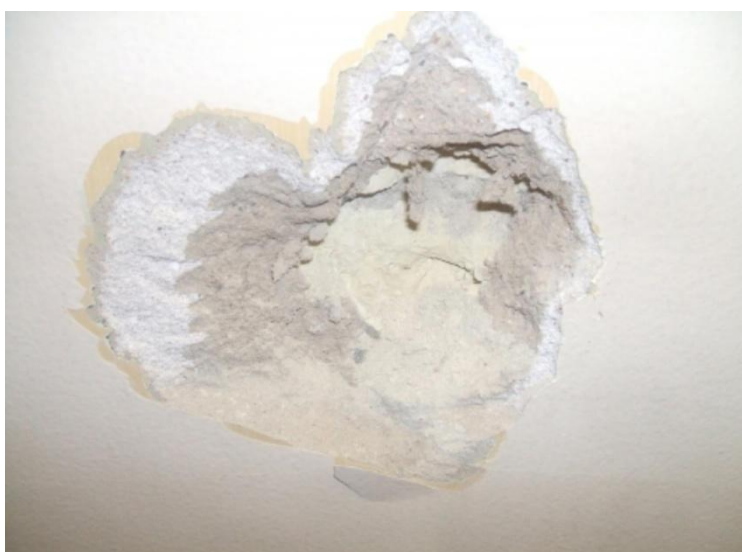
<b>Site Code/UPRN</b>	SD724P/86213	<b>Building</b>	Whitehall
<b>Address</b>	The Old War Office Horse Guards Avenue Whitehall London	<b>Floor</b>	Second Floor
	SW1A 2HB	<b>Room</b>	Room 244
<b>Description</b>	Mortar line walls.	<b>Quantity</b>	N/A
		<b>Asbestos Suspected</b>	<b>No</b>

<b>Last Inspection Date</b>	-	03 Sep 2012	<b>Certificate N<sup>o</sup></b>	-	BK30669
<b>Next Inspection Date</b>	-	03 Sep 2013	<b>Sample N<sup>o</sup></b>	-	148
<b>Survey Type</b>	-	Refurbishment & Demolition Survey	<b>Photograph N<sup>o</sup></b>	-	4865
<b>Position</b>	-	Sample Taken	<b>Location ID</b>	-	Loc20089

<b>Product Type</b>	-	N/A	<b>Surface Treatment</b>	-	N/A
<b>Asbestos Type</b>	-	No Asbestos Detected	<b>Damage Extent</b>	-	N/A
<b>Material Risk Score</b>	-	<b>0</b>	<b>Material Risk Band</b>	-	N/A

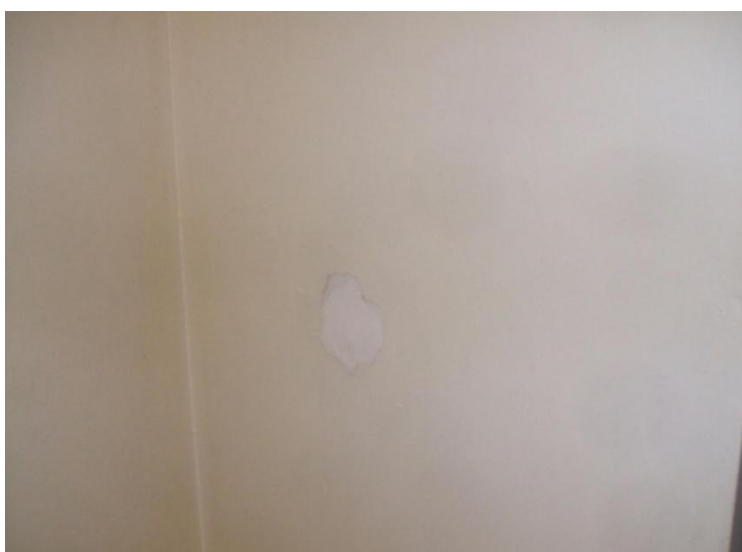
<b>Site Code/UPRN</b>	SD724P/86213	<b>Building</b>	Whitehall
<b>Address</b>	The Old War Office Horse Guards Avenue Whitehall London	<b>Floor</b>	Second Floor
	SW1A 2HB	<b>Room</b>	Room 284
		<b>Quantity</b>	N/A
<b>Description</b>	Plaster & render to walls adjacent to light switch.	<b>Asbestos Suspected</b>	<b>No</b>

<b>Last Inspection Date</b>	-	03 Sep 2012	<b>Certificate N°</b>	-	BK30669
<b>Next Inspection Date</b>	-	03 Sep 2013	<b>Sample N°</b>	-	139
<b>Survey Type</b>	-	Refurbishment & Demolition Survey	<b>Photograph N°</b>	-	4858
<b>Position</b>	-	Sample Taken	<b>Location ID</b>	-	Loc20082

<b>Product Type</b>	-	N/A	<b>Surface Treatment</b>	-	N/A
<b>Asbestos Type</b>	-	No Asbestos Detected	<b>Damage Extent</b>	-	N/A
<b>Material Risk Score</b>	-	<b>0</b>	<b>Material Risk Band</b>	-	N/A

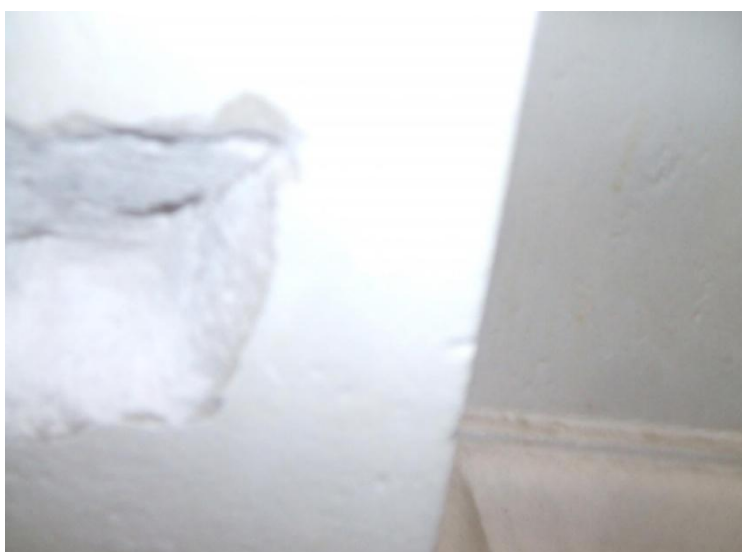
<b>Site Code/UPRN</b>	SD724P/86213	<b>Building</b>	Whitehall
<b>Address</b>	The Old War Office Horse Guards Avenue Whitehall London	<b>Floor</b>	Second Floor
	SW1A 2HB	<b>Room</b>	Room 284
<b>Description</b>	Plaster & render structural pillar.	<b>Quantity</b>	N/A
		<b>Asbestos Suspected</b>	<b>No</b>

<b>Product Type</b>	-	N/A	<b>Surface Treatment</b>	-	N/A
<b>Asbestos Type</b>	-	No Asbestos Detected	<b>Damage Extent</b>	-	N/A
<b>Material Risk Score</b>	-	<b>0</b>	<b>Material Risk Band</b>	-	N/A

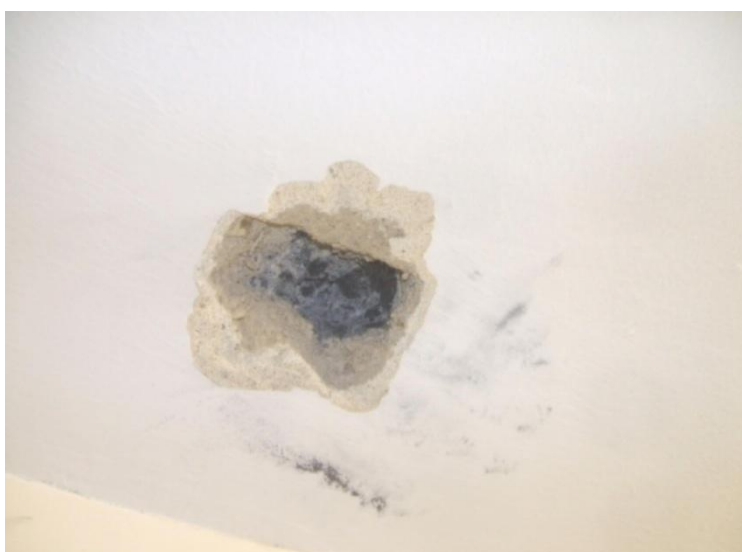
<b>Site Code/UPRN</b>	SD724P/86213	<b>Building</b>	Whitehall
<b>Address</b>	The Old War Office Horse Guards Avenue Whitehall London	<b>Floor</b>	Second Floor
	SW1A 2HB	<b>Room</b>	Room 284
<b>Description</b>	Plaster & render ceiling.	<b>Quantity</b>	N/A
		<b>Asbestos Suspected</b>	<b>No</b>

<b>Product Type</b>	-	N/A	<b>Surface Treatment</b>	-	N/A
<b>Asbestos Type</b>	-	No Asbestos Detected	<b>Damage Extent</b>	-	N/A
<b>Material Risk Score</b>	-	<b>0</b>	<b>Material Risk Band</b>	-	N/A

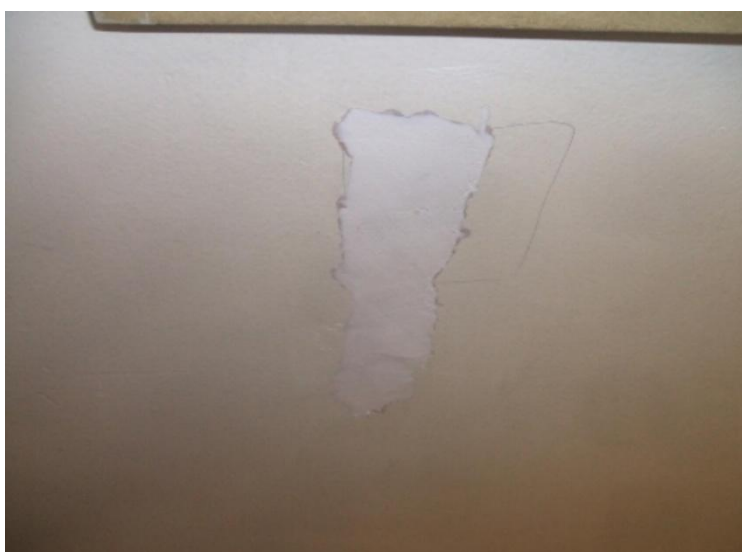
<b>Site Code/UPRN</b>	SD724P/86213	<b>Building</b>	Whitehall
<b>Address</b>	The Old War Office Horse Guards Avenue Whitehall London	<b>Floor</b>	Second Floor
	SW1A 2HB	<b>Room</b>	Room 284
<b>Description</b>	Mortar line.	<b>Quantity</b>	N/A
		<b>Asbestos Suspected</b>	<b>No</b>

<b>Product Type</b>	-	N/A	<b>Surface Treatment</b>	-	N/A
<b>Asbestos Type</b>	-	No Asbestos Detected	<b>Damage Extent</b>	-	N/A
<b>Material Risk Score</b>	-	<b>0</b>	<b>Material Risk Band</b>	-	N/A

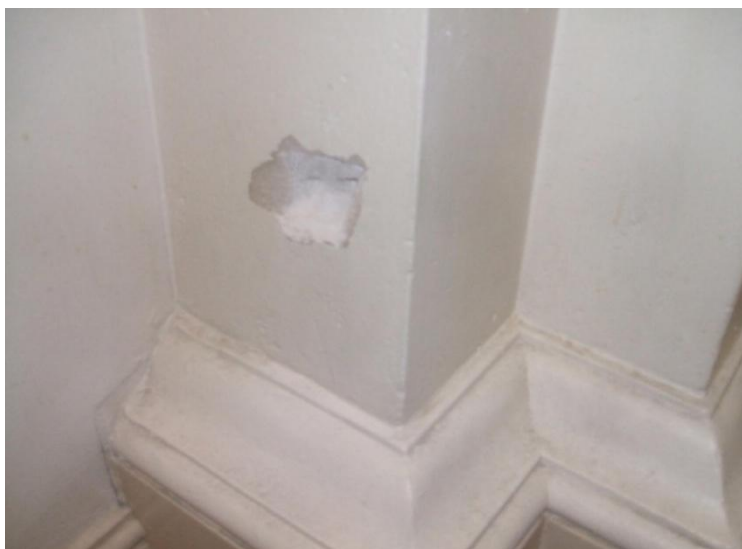
<b>Site Code/UPRN</b>	SD724P/86213	<b>Building</b>	Whitehall
<b>Address</b>	The Old War Office Horse Guards Avenue Whitehall London	<b>Floor</b>	Second Floor
	SW1A 2HB	<b>Room</b>	Room 284
<b>Description</b>	Concrete vertical pillar/column.	<b>Quantity</b>	N/A
		<b>Asbestos Suspected</b>	<b>No</b>

<b>Product Type</b>	-	N/A	<b>Surface Treatment</b>	-	N/A
<b>Asbestos Type</b>	-	No Asbestos Detected	<b>Damage Extent</b>	-	N/A
<b>Material Risk Score</b>	-	<b>0</b>	<b>Material Risk Band</b>	-	N/A

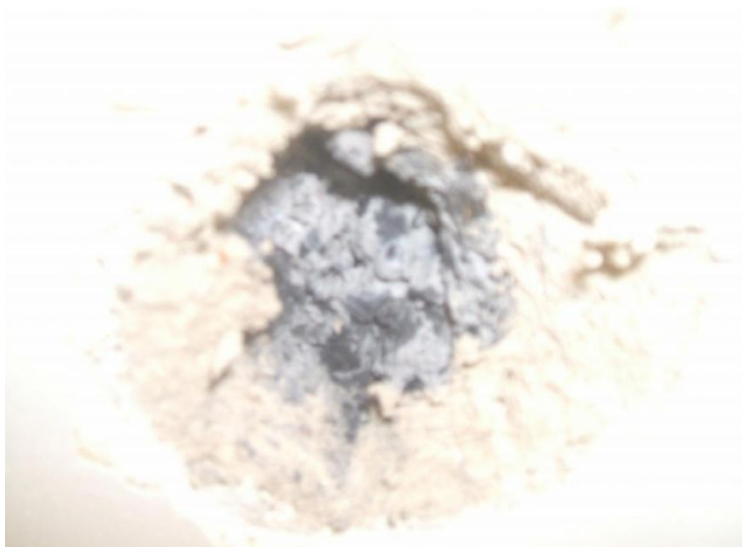
<b>Site Code/UPRN</b>	SD724P/86213	<b>Building</b>	Whitehall
<b>Address</b>	The Old War Office Horse Guards Avenue Whitehall London	<b>Floor</b>	Second Floor
	SW1A 2HB	<b>Room</b>	Room 284
<b>Description</b>	Mortar line walls adjacent to light switch.	<b>Quantity</b>	N/A
		<b>Asbestos Suspected</b>	<b>No</b>

<b>Product Type</b>	-	N/A	<b>Surface Treatment</b>	-	N/A
<b>Asbestos Type</b>	-	No Asbestos Detected	<b>Damage Extent</b>	-	N/A
<b>Material Risk Score</b>	-	<b>0</b>	<b>Material Risk Band</b>	-	N/A
