Ministry  
of Defence

## Defence Infrastructure Organisation

Ref: EIR/2017/13719

September 2014

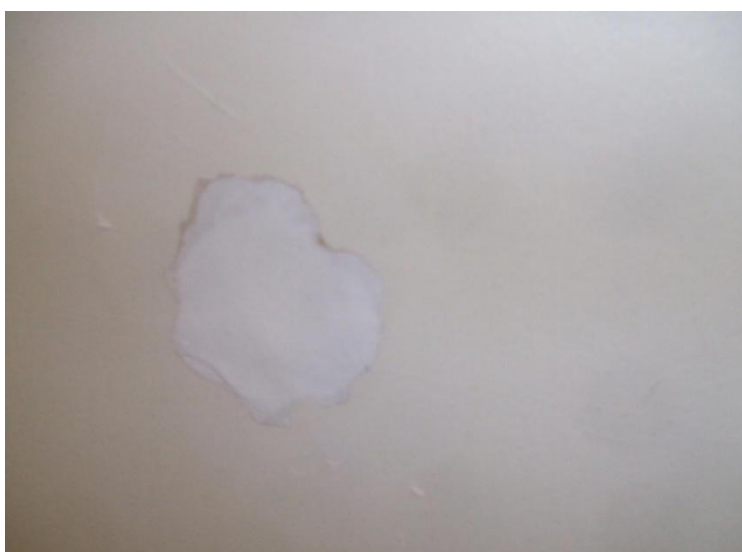
<b>Site Code/UPRN</b>	SD724P/86213	<b>Building</b>	Whitehall
<b>Address</b>	The Old War Office Horse Guards Avenue Whitehall London	<b>Floor</b>	Second Floor
	SW1A 2HB	<b>Room</b>	Room 284
<b>Description</b>	Mortar line.	<b>Quantity</b>	N/A
		<b>Asbestos Suspected</b>	<b>No</b>

<b>Product Type</b>	-	N/A	<b>Surface Treatment</b>	-	N/A
<b>Asbestos Type</b>	-	No Asbestos Detected	<b>Damage Extent</b>	-	N/A
<b>Material Risk Score</b>	-	<b>0</b>	<b>Material Risk Band</b>	-	N/A

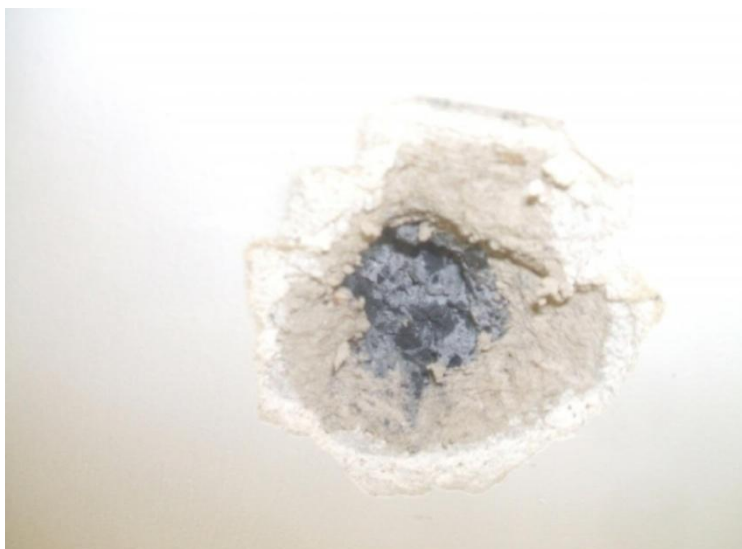
<b>Site Code/UPRN</b>	SD724P/86213	<b>Building</b>	Whitehall
<b>Address</b>	The Old War Office Horse Guards Avenue Whitehall London	<b>Floor</b>	Second Floor
	SW1A 2HB	<b>Room</b>	Room 284
<b>Description</b>	Plaster & render walls adjacent to wall socket.	<b>Quantity</b>	N/A
		<b>Asbestos Suspected</b>	<b>No</b>

<b>Product Type</b>	-	N/A	<b>Surface Treatment</b>	-	N/A
<b>Asbestos Type</b>	-	No Asbestos Detected	<b>Damage Extent</b>	-	N/A
<b>Material Risk Score</b>	-	<b>0</b>	<b>Material Risk Band</b>	-	N/A

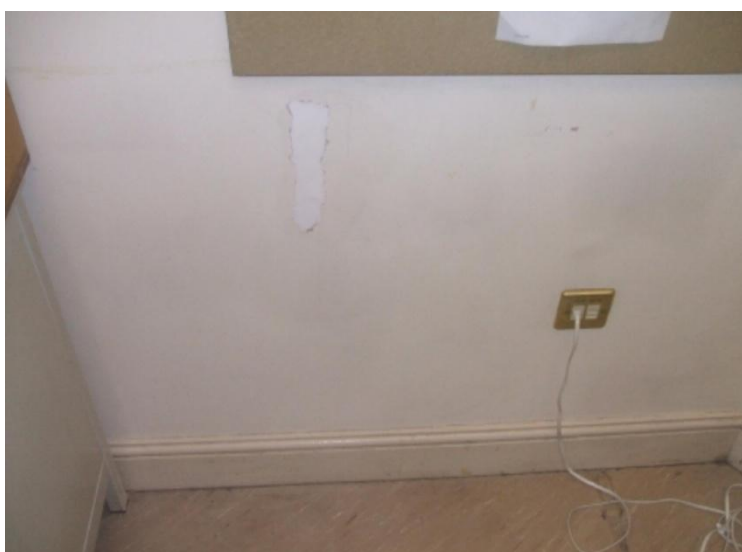
<b>Site Code/UPRN</b>	SD724P/86213	<b>Building</b>	Whitehall
<b>Address</b>	The Old War Office Horse Guards Avenue Whitehall London	<b>Floor</b>	Second Floor
	SW1A 2HB	<b>Room</b>	Room 284
<b>Description</b>	Plaster & render.	<b>Quantity</b>	N/A
		<b>Asbestos Suspected</b>	<b>No</b>

<b>Product Type</b>	-	N/A	<b>Surface Treatment</b>	-	N/A
<b>Asbestos Type</b>	-	No Asbestos Detected	<b>Damage Extent</b>	-	N/A
<b>Material Risk Score</b>	-	<b>0</b>	<b>Material Risk Band</b>	-	N/A

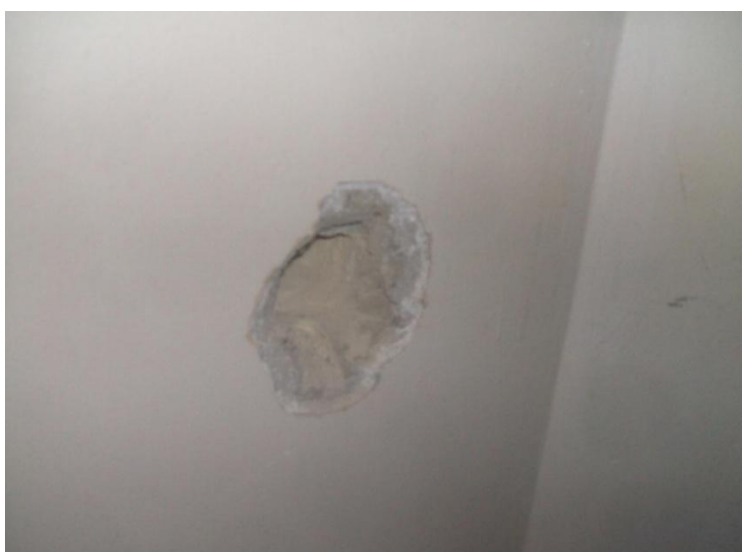
<b>Site Code/UPRN</b>	SD724P/86213	<b>Building</b>	Whitehall
<b>Address</b>	The Old War Office Horse Guards Avenue Whitehall London	<b>Floor</b>	Third Floor
	SW1A 2HB	<b>Room</b>	Cleaners Cupboard (opposite 326)
<b>Description</b>	Plaster & render to walls.	<b>Quantity</b>	N/A
		<b>Asbestos Suspected</b>	<b>No</b>

<b>Product Type</b>	-	N/A	<b>Surface Treatment</b>	-	N/A
<b>Asbestos Type</b>	-	No Asbestos Detected	<b>Damage Extent</b>	-	N/A
<b>Material Risk Score</b>	-	<b>0</b>	<b>Material Risk Band</b>	-	N/A

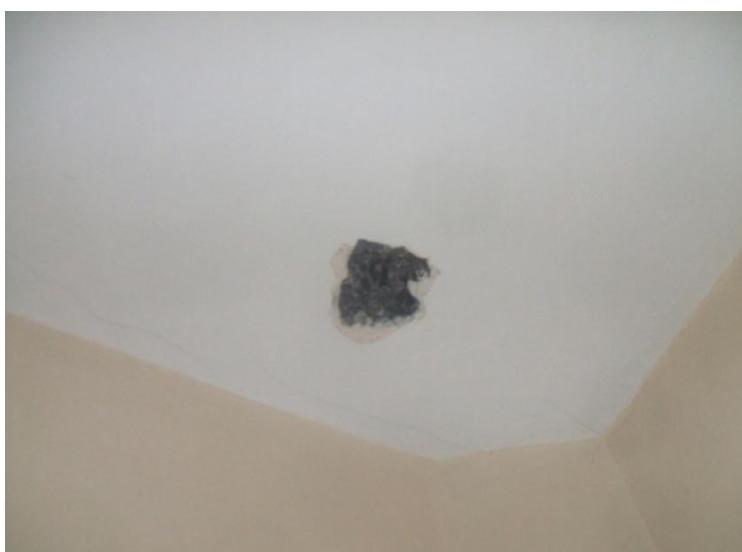
<b>Site Code/UPRN</b>	SD724P/86213	<b>Building</b>	Whitehall
<b>Address</b>	The Old War Office Horse Guards Avenue Whitehall London	<b>Floor</b>	Third Floor
	SW1A 2HB	<b>Room</b>	Cleaners Cupboard (opposite 326)
<b>Description</b>	Plaster & render ceiling.	<b>Quantity</b>	N/A
		<b>Asbestos Suspected</b>	<b>No</b>

<b>Product Type</b>	-	N/A	<b>Surface Treatment</b>	-	N/A
<b>Asbestos Type</b>	-	No Asbestos Detected	<b>Damage Extent</b>	-	N/A
<b>Material Risk Score</b>	-	<b>0</b>	<b>Material Risk Band</b>	-	N/A

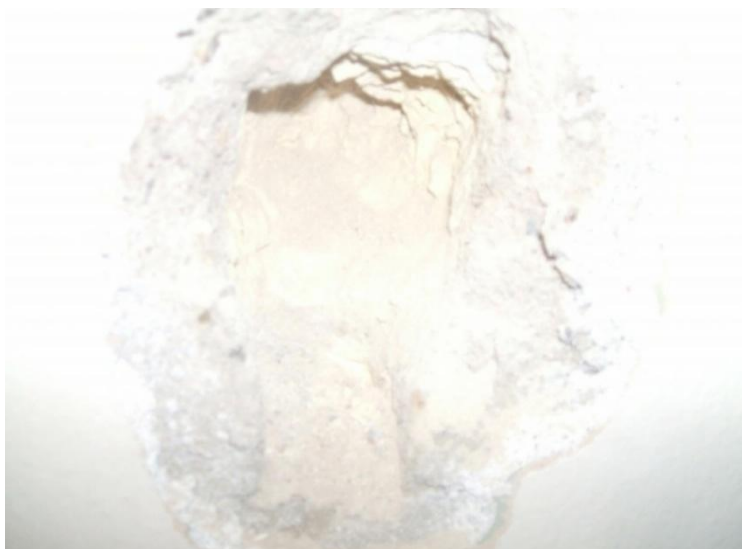
<b>Site Code/UPRN</b>	SD724P/86213	<b>Building</b>	Whitehall
<b>Address</b>	The Old War Office Horse Guards Avenue Whitehall London	<b>Floor</b>	Third Floor
	SW1A 2HB	<b>Room</b>	Cleaners Cupboard (opposite 326)
<b>Description</b>	Mortar line to brickwork walls.	<b>Quantity</b>	N/A
		<b>Asbestos Suspected</b>	<b>No</b>

<b>Product Type</b>	-	N/A	<b>Surface Treatment</b>	-	N/A
<b>Asbestos Type</b>	-	No Asbestos Detected	<b>Damage Extent</b>	-	N/A
<b>Material Risk Score</b>	-	<b>0</b>	<b>Material Risk Band</b>	-	N/A

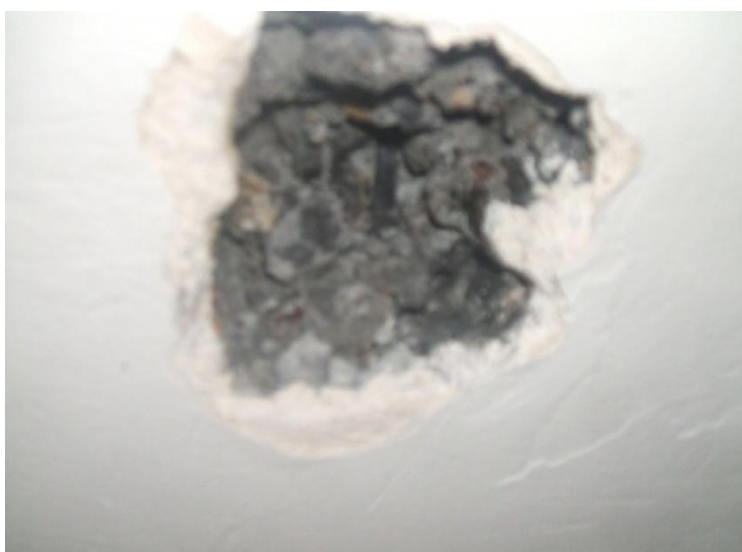
<b>Site Code/UPRN</b>	SD724P/86213	<b>Building</b>	Whitehall
<b>Address</b>	The Old War Office Horse Guards Avenue Whitehall London	<b>Floor</b>	Third Floor
	SW1A 2HB	<b>Room</b>	Cleaners Cupboard (opposite 326)
<b>Description</b>	Asphalt/ concrete ceiling.	<b>Quantity</b>	N/A
		<b>Asbestos Suspected</b>	<b>No</b>

<b>Product Type</b>	-	N/A	<b>Surface Treatment</b>	-	N/A
<b>Asbestos Type</b>	-	No Asbestos Detected	<b>Damage Extent</b>	-	N/A
<b>Material Risk Score</b>	-	<b>0</b>	<b>Material Risk Band</b>	-	N/A

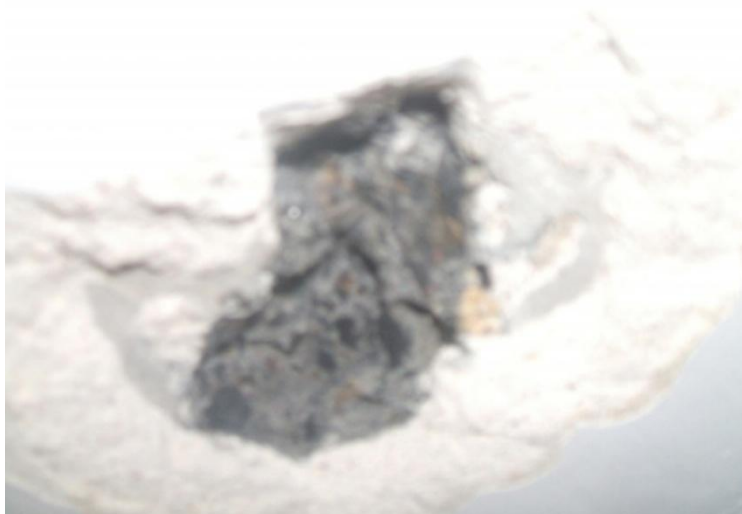
<b>Site Code/UPRN</b>	SD724P/86213	<b>Building</b>	Whitehall
<b>Address</b>	The Old War Office Horse Guards Avenue Whitehall London	<b>Floor</b>	Third Floor
	SW1A 2HB	<b>Room</b>	Cleaners Cupboard (opposite 336)
<b>Description</b>	Asphalt/concrete ceiling.	<b>Quantity</b>	N/A
		<b>Asbestos Suspected</b>	<b>No</b>

<b>Product Type</b>	-	N/A	<b>Surface Treatment</b>	-	N/A
<b>Asbestos Type</b>	-	No Asbestos Detected	<b>Damage Extent</b>	-	N/A
<b>Material Risk Score</b>	-	<b>0</b>	<b>Material Risk Band</b>	-	N/A

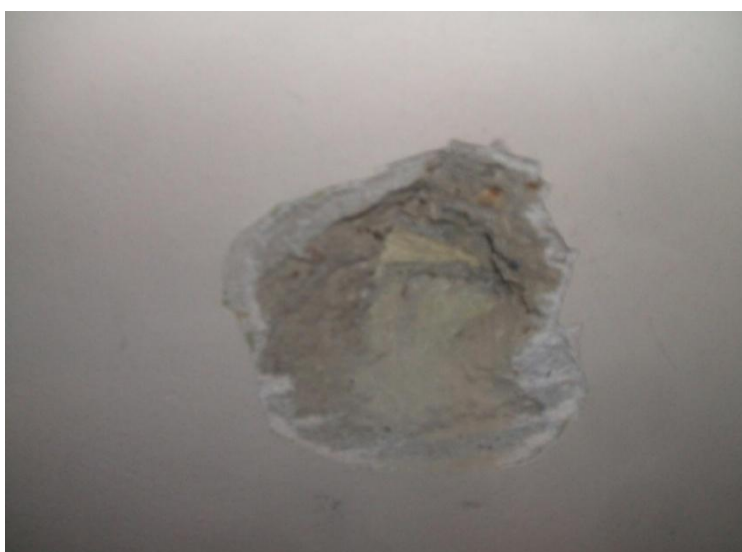
<b>Site Code/UPRN</b>	SD724P/86213	<b>Building</b>	Whitehall
<b>Address</b>	The Old War Office Horse Guards Avenue Whitehall London	<b>Floor</b>	Third Floor
	SW1A 2HB	<b>Room</b>	Cleaners Cupboard (opposite 336)
<b>Description</b>	Mortar line to brickwork.	<b>Quantity</b>	N/A
		<b>Asbestos Suspected</b>	<b>No</b>

<b>Product Type</b>	-	N/A	<b>Surface Treatment</b>	-	N/A
<b>Asbestos Type</b>	-	No Asbestos Detected	<b>Damage Extent</b>	-	N/A
<b>Material Risk Score</b>	-	<b>0</b>	<b>Material Risk Band</b>	-	N/A

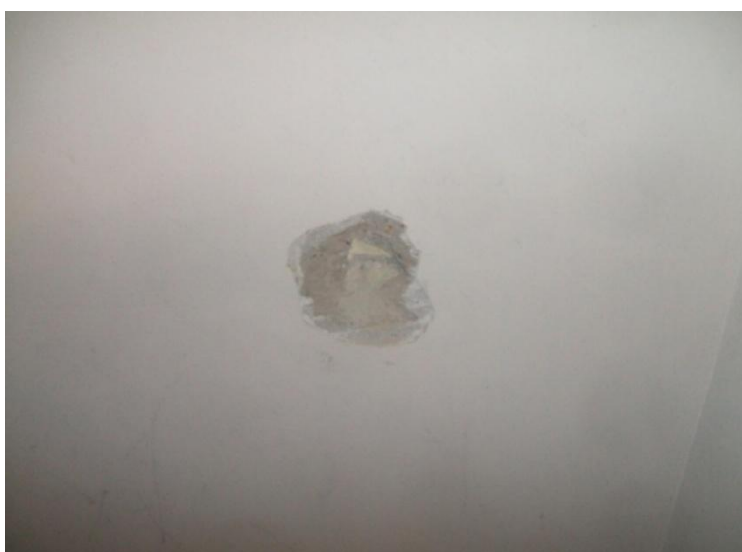
<b>Site Code/UPRN</b>	SD724P/86213	<b>Building</b>	Whitehall
<b>Address</b>	The Old War Office Horse Guards Avenue Whitehall London	<b>Floor</b>	Third Floor
	SW1A 2HB	<b>Room</b>	Cleaners Cupboard (opposite 336)
<b>Description</b>	Plaster & render walls.	<b>Quantity</b>	N/A
		<b>Asbestos Suspected</b>	<b>No</b>

<b>Last Inspection Date</b>	-	03 Sep 2012	<b>Certificate N<sup>o</sup></b>	-	BK30669
<b>Next Inspection Date</b>	-	03 Sep 2013	<b>Sample N<sup>o</sup></b>	-	119
<b>Survey Type</b>	-	Refurbishment & Demolition Survey	<b>Photograph N<sup>o</sup></b>	-	4837
<b>Position</b>	-	Sample Taken	<b>Location ID</b>	-	Loc20060

<b>Product Type</b>	-	N/A	<b>Surface Treatment</b>	-	N/A
<b>Asbestos Type</b>	-	No Asbestos Detected	<b>Damage Extent</b>	-	N/A
<b>Material Risk Score</b>	-	<b>0</b>	<b>Material Risk Band</b>	-	N/A

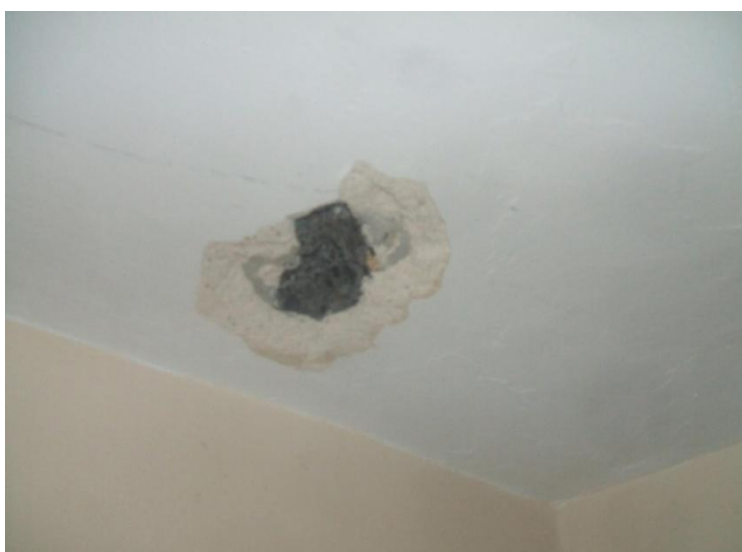
<b>Site Code/UPRN</b>	SD724P/86213	<b>Building</b>	Whitehall
<b>Address</b>	The Old War Office Horse Guards Avenue Whitehall London	<b>Floor</b>	Third Floor
	SW1A 2HB	<b>Room</b>	Cleaners Cupboard (opposite 336)
<b>Description</b>	Plaster & render ceiling.	<b>Quantity</b>	N/A
		<b>Asbestos Suspected</b>	<b>No</b>

<b>Last Inspection Date</b>	-	03 Sep 2012	<b>Certificate N<sup>o</sup></b>	-	BK30669
<b>Next Inspection Date</b>	-	03 Sep 2013	<b>Sample N<sup>o</sup></b>	-	117
<b>Survey Type</b>	-	Refurbishment & Demolition Survey	<b>Photograph N<sup>o</sup></b>	-	4835
<b>Position</b>	-	Sample Taken	<b>Location ID</b>	-	Loc20058

<b>Product Type</b>	-	N/A	<b>Surface Treatment</b>	-	N/A
<b>Asbestos Type</b>	-	No Asbestos Detected	<b>Damage Extent</b>	-	N/A
<b>Material Risk Score</b>	-	<b>0</b>	<b>Material Risk Band</b>	-	N/A

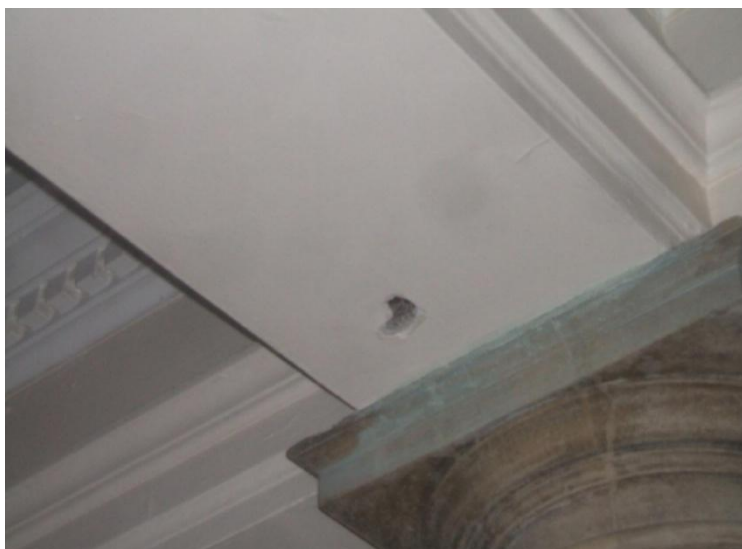
<b>Site Code/UPRN</b>	SD724P/86213	<b>Building</b>	Whitehall
<b>Address</b>	The Old War Office Horse Guards Avenue Whitehall London	<b>Floor</b>	Third Floor
	SW1A 2HB	<b>Room</b>	Corridor WES 368
<b>Description</b>	Lining to plasterboard to steel RSJ.	<b>Quantity</b>	N/A
		<b>Asbestos Suspected</b>	<b>No</b>

<b>Last Inspection Date</b>	-	03 Sep 2012	<b>Certificate N<sup>o</sup></b>	-	BK30669
<b>Next Inspection Date</b>	-	03 Sep 2013	<b>Sample N<sup>o</sup></b>	-	121
<b>Survey Type</b>	-	Refurbishment & Demolition Survey	<b>Photograph N<sup>o</sup></b>	-	4839
<b>Position</b>	-	Sample Taken	<b>Location ID</b>	-	Loc20062

<b>Product Type</b>	-	N/A	<b>Surface Treatment</b>	-	N/A
<b>Asbestos Type</b>	-	No Asbestos Detected	<b>Damage Extent</b>	-	N/A
<b>Material Risk Score</b>	-	<b>0</b>	<b>Material Risk Band</b>	-	N/A

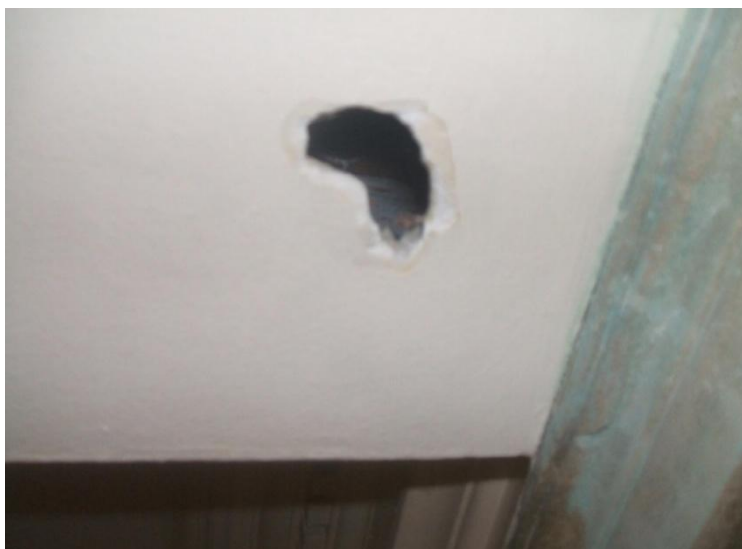
<b>Site Code/UPRN</b>	SD724P/86213	<b>Building</b>	Whitehall
<b>Address</b>	The Old War Office Horse Guards Avenue Whitehall London	<b>Floor</b>	Third Floor
	SW1A 2HB	<b>Room</b>	Corridor WES 368
<b>Description</b>	Plaster ceiling.	<b>Quantity</b>	N/A
		<b>Asbestos Suspected</b>	<b>No</b>

<b>Last Inspection Date</b>	-	03 Sep 2012	<b>Certificate N<sup>o</sup></b>	-	BK30669
<b>Next Inspection Date</b>	-	03 Sep 2013	<b>Sample N<sup>o</sup></b>	-	122
<b>Survey Type</b>	-	Refurbishment & Demolition Survey	<b>Photograph N<sup>o</sup></b>	-	4840
<b>Position</b>	-	Sample Taken	<b>Location ID</b>	-	Loc20063

<b>Product Type</b>	-	N/A	<b>Surface Treatment</b>	-	N/A
<b>Asbestos Type</b>	-	No Asbestos Detected	<b>Damage Extent</b>	-	N/A
<b>Material Risk Score</b>	-	<b>0</b>	<b>Material Risk Band</b>	-	N/A

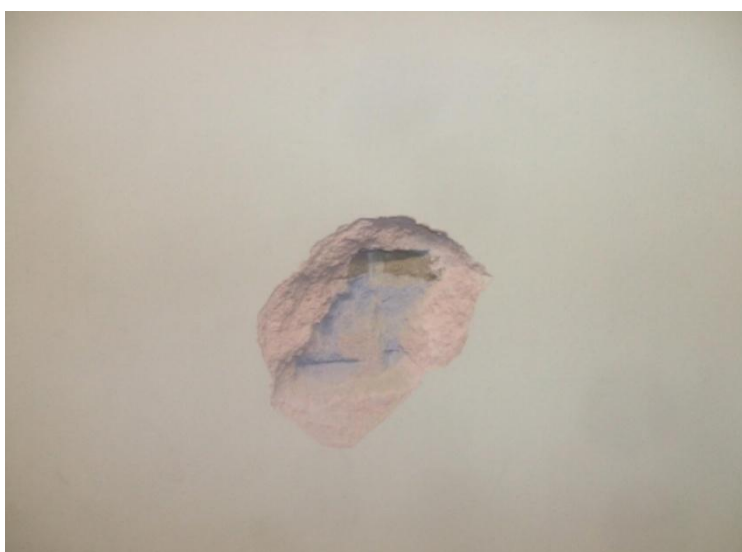
<b>Site Code/UPRN</b>	SD724P/86213	<b>Building</b>	Whitehall
<b>Address</b>	The Old War Office Horse Guards Avenue Whitehall London	<b>Floor</b>	Third Floor
	SW1A 2HB	<b>Room</b>	Electric Riser (c)
<b>Description</b>	Plaster & render to walls.	<b>Quantity</b>	N/A
		<b>Asbestos Suspected</b>	<b>No</b>

<b>Last Inspection Date</b>	-	03 Sep 2012	<b>Certificate N<sup>o</sup></b>	-	BK30669
<b>Next Inspection Date</b>	-	03 Sep 2013	<b>Sample N<sup>o</sup></b>	-	115
<b>Survey Type</b>	-	Refurbishment & Demolition Survey	<b>Photograph N<sup>o</sup></b>	-	4833
<b>Position</b>	-	Sample Taken	<b>Location ID</b>	-	Loc20056

<b>Product Type</b>	-	N/A	<b>Surface Treatment</b>	-	N/A
<b>Asbestos Type</b>	-	No Asbestos Detected	<b>Damage Extent</b>	-	N/A
<b>Material Risk Score</b>	-	<b>0</b>	<b>Material Risk Band</b>	-	N/A

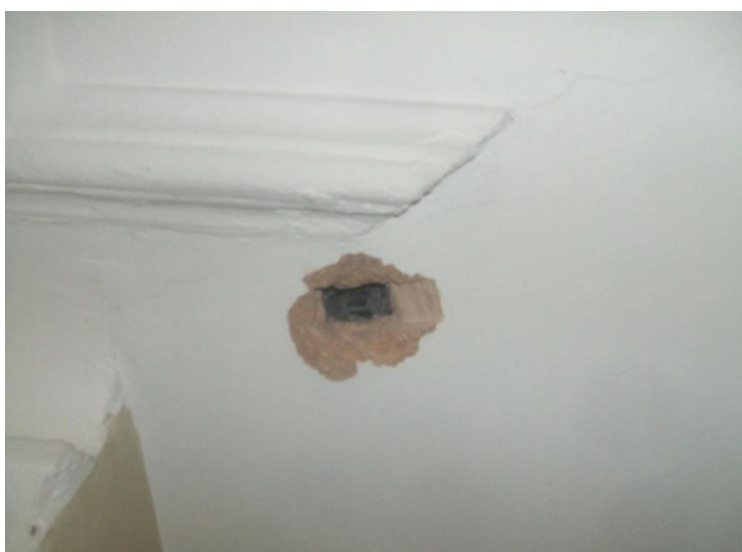
<b>Site Code/UPRN</b>	SD724P/86213	<b>Building</b>	Whitehall
<b>Address</b>	The Old War Office Horse Guards Avenue Whitehall London	<b>Floor</b>	Third Floor
	SW1A 2HB	<b>Room</b>	Electric Riser (c)
<b>Description</b>	Plaster & render ceiling.	<b>Quantity</b>	N/A
		<b>Asbestos Suspected</b>	<b>No</b>

<b>Last Inspection Date</b>	-	03 Sep 2012	<b>Certificate N<sup>o</sup></b>	-	BK30669
<b>Next Inspection Date</b>	-	03 Sep 2013	<b>Sample N<sup>o</sup></b>	-	113
<b>Survey Type</b>	-	Refurbishment & Demolition Survey	<b>Photograph N<sup>o</sup></b>	-	4831
<b>Position</b>	-	Sample Taken	<b>Location ID</b>	-	Loc20054

<b>Product Type</b>	-	N/A	<b>Surface Treatment</b>	-	N/A
<b>Asbestos Type</b>	-	No Asbestos Detected	<b>Damage Extent</b>	-	N/A
<b>Material Risk Score</b>	-	<b>0</b>	<b>Material Risk Band</b>	-	N/A

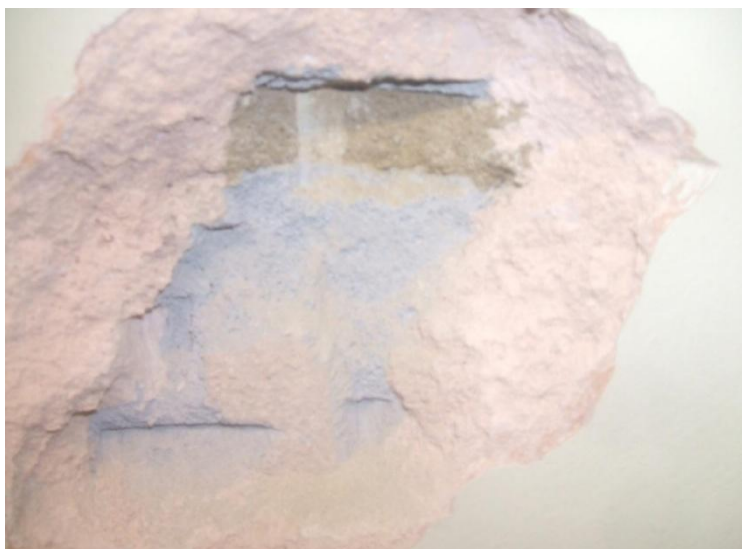
<b>Site Code/UPRN</b>	SD724P/86213	<b>Building</b>	Whitehall
<b>Address</b>	The Old War Office Horse Guards Avenue Whitehall London	<b>Floor</b>	Third Floor
	SW1A 2HB	<b>Room</b>	Electric Riser (c)
<b>Description</b>	Mortar line walls.	<b>Quantity</b>	N/A
		<b>Asbestos Suspected</b>	<b>No</b>

<b>Last Inspection Date</b>	-	03 Sep 2012	<b>Certificate N<sup>o</sup></b>	-	BK30669
<b>Next Inspection Date</b>	-	03 Sep 2013	<b>Sample N<sup>o</sup></b>	-	116
<b>Survey Type</b>	-	Refurbishment & Demolition Survey	<b>Photograph N<sup>o</sup></b>	-	4834
<b>Position</b>	-	Sample Taken	<b>Location ID</b>	-	Loc20057

<b>Product Type</b>	-	N/A	<b>Surface Treatment</b>	-	N/A
<b>Asbestos Type</b>	-	No Asbestos Detected	<b>Damage Extent</b>	-	N/A
<b>Material Risk Score</b>	-	<b>0</b>	<b>Material Risk Band</b>	-	N/A

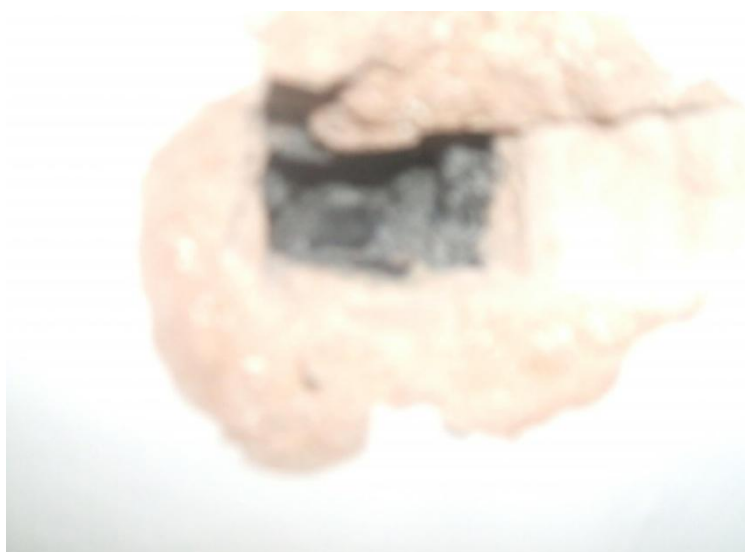
<b>Site Code/UPRN</b>	SD724P/86213	<b>Building</b>	Whitehall
<b>Address</b>	The Old War Office Horse Guards Avenue Whitehall London	<b>Floor</b>	Third Floor
	SW1A 2HB	<b>Room</b>	Electric Riser (c)
<b>Description</b>	Asphalt/ concrete to ceiling blockwork.	<b>Quantity</b>	N/A
		<b>Asbestos Suspected</b>	<b>No</b>

<b>Last Inspection Date</b>	-	03 Sep 2012	<b>Certificate N°</b>	-	BK30669
<b>Next Inspection Date</b>	-	03 Sep 2013	<b>Sample N°</b>	-	114
<b>Survey Type</b>	-	Refurbishment & Demolition Survey	<b>Photograph N°</b>	-	4832
<b>Position</b>	-	Sample Taken	<b>Location ID</b>	-	Loc20055

<b>Product Type</b>	-	N/A	<b>Surface Treatment</b>	-	N/A
<b>Asbestos Type</b>	-	No Asbestos Detected	<b>Damage Extent</b>	-	N/A
<b>Material Risk Score</b>	-	<b>0</b>	<b>Material Risk Band</b>	-	N/A

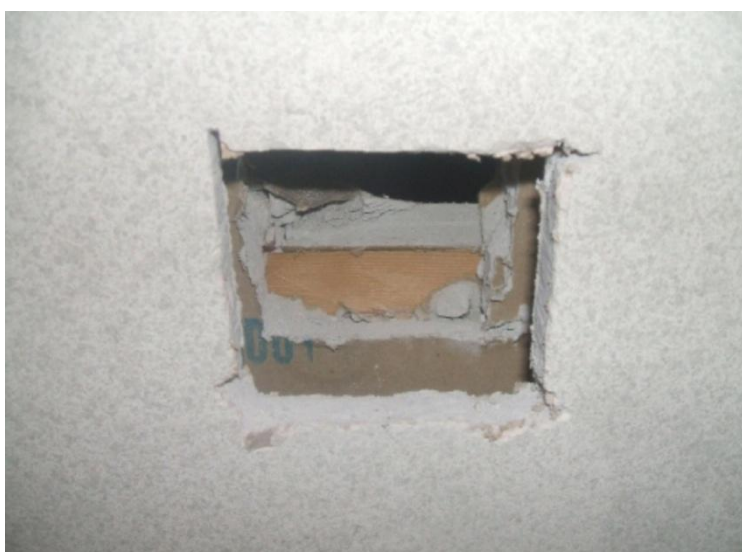
<b>Site Code/UPRN</b>	SD724P/86213	<b>Building</b>	Whitehall
<b>Address</b>	The Old War Office Horse Guards Avenue Whitehall London	<b>Floor</b>	Third Floor
	SW1A 2HB	<b>Room</b>	Lift Shaft- WES 367
<b>Description</b>	Inner board to wall. Rear wall.	<b>Quantity</b>	N/A
		<b>Asbestos Suspected</b>	<b>No</b>

<b>Last Inspection Date</b>	-	03 Sep 2012	<b>Certificate N°</b>	-	BK30669
<b>Next Inspection Date</b>	-	03 Sep 2013	<b>Sample N°</b>	-	124
<b>Survey Type</b>	-	Refurbishment & Demolition Survey	<b>Photograph N°</b>	-	4842
<b>Position</b>	-	Sample Taken	<b>Location ID</b>	-	Loc20066

<b>Product Type</b>	-	N/A	<b>Surface Treatment</b>	-	N/A
<b>Asbestos Type</b>	-	No Asbestos Detected	<b>Damage Extent</b>	-	N/A
<b>Material Risk Score</b>	-	<b>0</b>	<b>Material Risk Band</b>	-	N/A

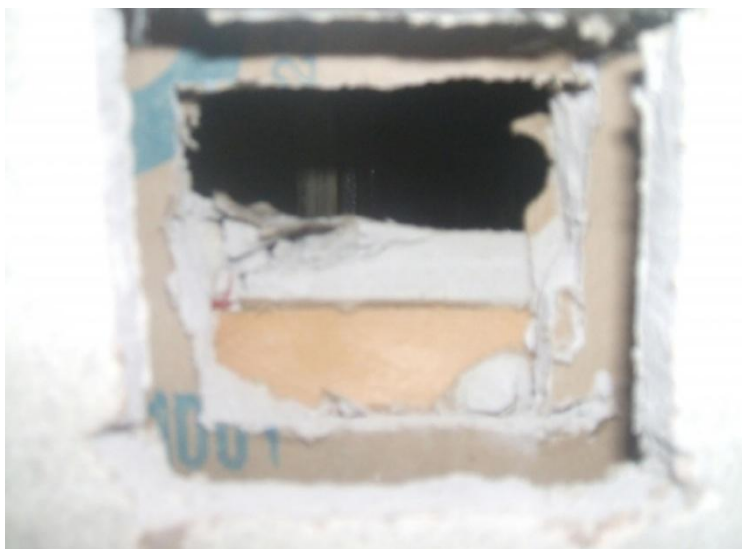
<b>Site Code/UPRN</b>	SD724P/86213	<b>Building</b>	Whitehall
<b>Address</b>	The Old War Office Horse Guards Avenue Whitehall London	<b>Floor</b>	Third Floor
	SW1A 2HB	<b>Room</b>	Lift Shaft- WES 367
<b>Description</b>	Outer board to walls. Rear way.	<b>Quantity</b>	N/A
		<b>Asbestos Suspected</b>	<b>No</b>

<b>Last Inspection Date</b>	-	03 Sep 2012	<b>Certificate N°</b>	-	BK30669
<b>Next Inspection Date</b>	-	03 Sep 2013	<b>Sample N°</b>	-	123
<b>Survey Type</b>	-	Refurbishment & Demolition Survey	<b>Photograph N°</b>	-	4841
<b>Position</b>	-	Sample Taken	<b>Location ID</b>	-	Loc20065

<b>Product Type</b>	-	N/A	<b>Surface Treatment</b>	-	N/A
<b>Asbestos Type</b>	-	No Asbestos Detected	<b>Damage Extent</b>	-	N/A
<b>Material Risk Score</b>	-	<b>0</b>	<b>Material Risk Band</b>	-	N/A

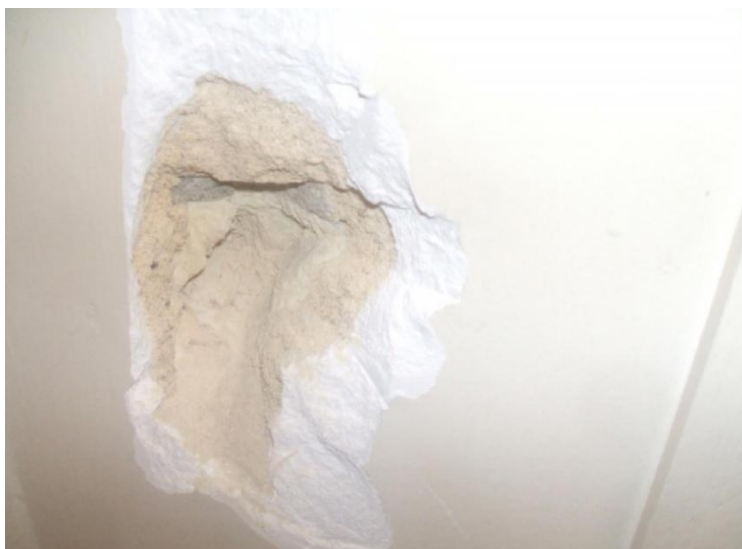
<b>Site Code/UPRN</b>	SD724P/86213	<b>Building</b>	Whitehall
<b>Address</b>	The Old War Office Horse Guards Avenue Whitehall London	<b>Floor</b>	Third Floor
	SW1A 2HB	<b>Room</b>	Room 313 (Porters)
<b>Description</b>	Mortar line to brickwork walls.	<b>Quantity</b>	N/A
		<b>Asbestos Suspected</b>	<b>No</b>

<b>Last Inspection Date</b>	-	03 Sep 2012	<b>Certificate N<sup>o</sup></b>	-	BK30669
<b>Next Inspection Date</b>	-	03 Sep 2013	<b>Sample N<sup>o</sup></b>	-	112
<b>Survey Type</b>	-	Refurbishment & Demolition Survey	<b>Photograph N<sup>o</sup></b>	-	4830
<b>Position</b>	-	Sample Taken	<b>Location ID</b>	-	Loc20049

<b>Product Type</b>	-	N/A	<b>Surface Treatment</b>	-	N/A
<b>Asbestos Type</b>	-	No Asbestos Detected	<b>Damage Extent</b>	-	N/A
<b>Material Risk Score</b>	-	<b>0</b>	<b>Material Risk Band</b>	-	N/A

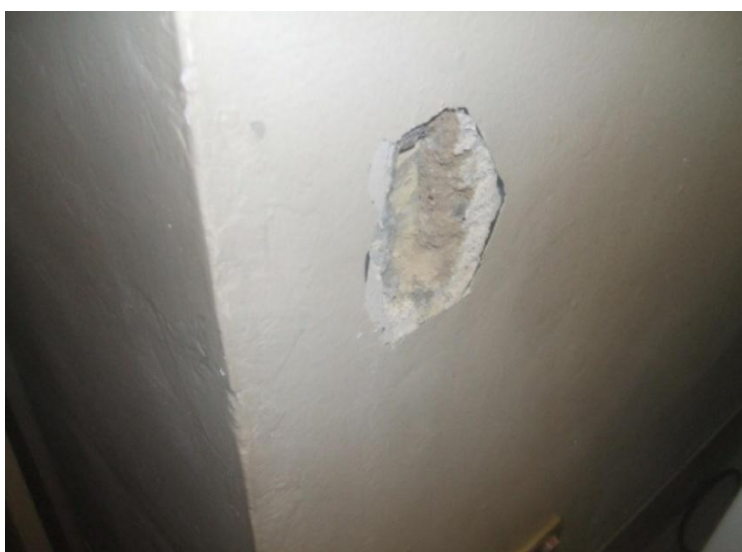
<b>Site Code/UPRN</b>	SD724P/86213	<b>Building</b>	Whitehall
<b>Address</b>	The Old War Office Horse Guards Avenue Whitehall London	<b>Floor</b>	Third Floor
	SW1A 2HB	<b>Room</b>	Room 313 (Porters)
<b>Description</b>	Mortar line to blockwork.	<b>Quantity</b>	N/A
		<b>Asbestos Suspected</b>	<b>No</b>

<b>Last Inspection Date</b>	-	03 Sep 2012	<b>Certificate N°</b>	-	BK30669
<b>Next Inspection Date</b>	-	03 Sep 2013	<b>Sample N°</b>	-	104
<b>Survey Type</b>	-	Refurbishment & Demolition Survey	<b>Photograph N°</b>	-	4822
<b>Position</b>	-	Sample Taken	<b>Location ID</b>	-	Loc20045

<b>Product Type</b>	-	N/A	<b>Surface Treatment</b>	-	N/A
<b>Asbestos Type</b>	-	No Asbestos Detected	<b>Damage Extent</b>	-	N/A
<b>Material Risk Score</b>	-	<b>0</b>	<b>Material Risk Band</b>	-	N/A

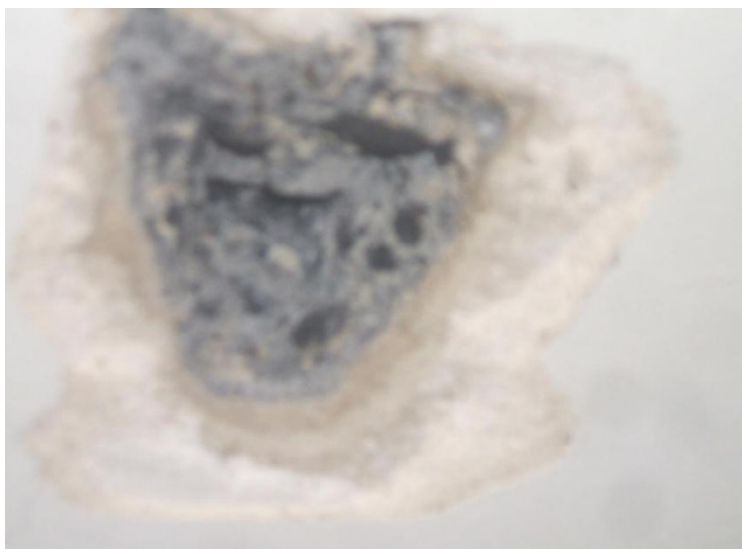
<b>Site Code/UPRN</b>	SD724P/86213	<b>Building</b>	Whitehall
<b>Address</b>	The Old War Office Horse Guards Avenue Whitehall London	<b>Floor</b>	Third Floor
	SW1A 2HB	<b>Room</b>	Room 313 (Porters)
<b>Description</b>	Asphalt overfil.	<b>Quantity</b>	N/A
		<b>Asbestos Suspected</b>	<b>No</b>

<b>Last Inspection Date</b>	-	03 Sep 2012	<b>Certificate N°</b>	-	BK30669
<b>Next Inspection Date</b>	-	03 Sep 2013	<b>Sample N°</b>	-	102
<b>Survey Type</b>	-	Refurbishment & Demolition Survey	<b>Photograph N°</b>	-	4820
<b>Position</b>	-	Sample Taken	<b>Location ID</b>	-	Loc20043

<b>Product Type</b>	-	N/A	<b>Surface Treatment</b>	-	N/A
<b>Asbestos Type</b>	-	No Asbestos Detected	<b>Damage Extent</b>	-	N/A
<b>Material Risk Score</b>	-	<b>0</b>	<b>Material Risk Band</b>	-	N/A

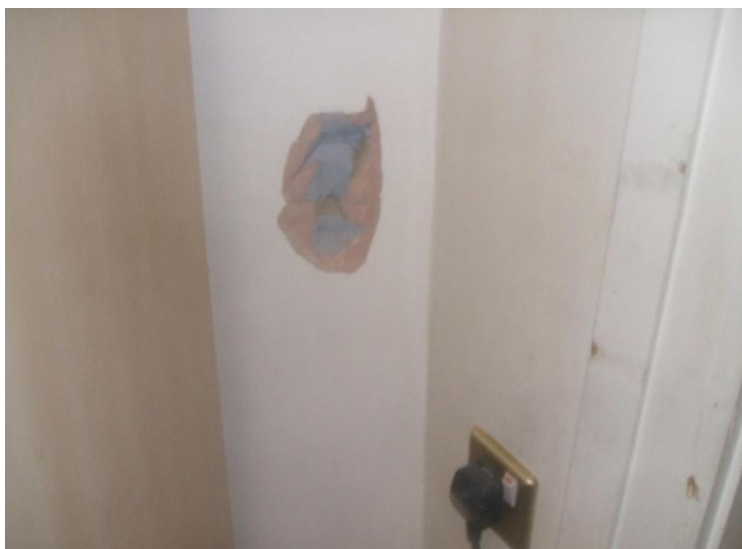
<b>Site Code/UPRN</b>	SD724P/86213	<b>Building</b>	Whitehall
<b>Address</b>	The Old War Office Horse Guards Avenue Whitehall London	<b>Floor</b>	Third Floor
	SW1A 2HB	<b>Room</b>	Room 313 (Porters)
<b>Description</b>	Plaster & render to walls adjacent to power socket.	<b>Quantity</b>	N/A
		<b>Asbestos Suspected</b>	<b>No</b>

<b>Last Inspection Date</b>	-	03 Sep 2012	<b>Certificate N°</b>	-	BK30669
<b>Next Inspection Date</b>	-	03 Sep 2013	<b>Sample N°</b>	-	103
<b>Survey Type</b>	-	Refurbishment & Demolition Survey	<b>Photograph N°</b>	-	4821
<b>Position</b>	-	Sample Taken	<b>Location ID</b>	-	Loc20044

<b>Product Type</b>	-	N/A	<b>Surface Treatment</b>	-	N/A
<b>Asbestos Type</b>	-	No Asbestos Detected	<b>Damage Extent</b>	-	N/A
<b>Material Risk Score</b>	-	<b>0</b>	<b>Material Risk Band</b>	-	N/A

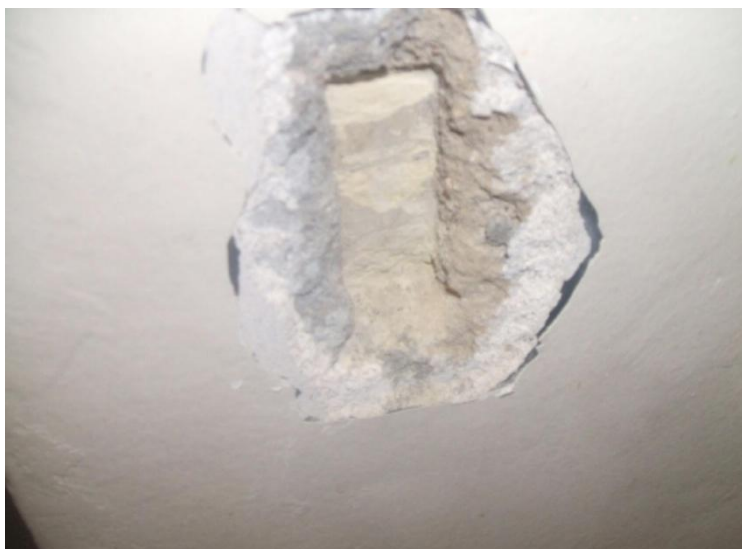
<b>Site Code/UPRN</b>	SD724P/86213	<b>Building</b>	Whitehall
<b>Address</b>	The Old War Office Horse Guards Avenue Whitehall London	<b>Floor</b>	Third Floor
	SW1A 2HB	<b>Room</b>	Room 313 (Porters)
<b>Description</b>	Plaster & render walls adjacent to power socket.	<b>Quantity</b>	N/A
		<b>Asbestos Suspected</b>	<b>No</b>

<b>Last Inspection Date</b>	-	03 Sep 2012	<b>Certificate N°</b>	-	BK30669
<b>Next Inspection Date</b>	-	03 Sep 2013	<b>Sample N°</b>	-	105
<b>Survey Type</b>	-	Refurbishment & Demolition Survey	<b>Photograph N°</b>	-	4823
<b>Position</b>	-	Sample Taken	<b>Location ID</b>	-	Loc20046

<b>Product Type</b>	-	N/A	<b>Surface Treatment</b>	-	N/A
<b>Asbestos Type</b>	-	No Asbestos Detected	<b>Damage Extent</b>	-	N/A
<b>Material Risk Score</b>	-	<b>0</b>	<b>Material Risk Band</b>	-	N/A

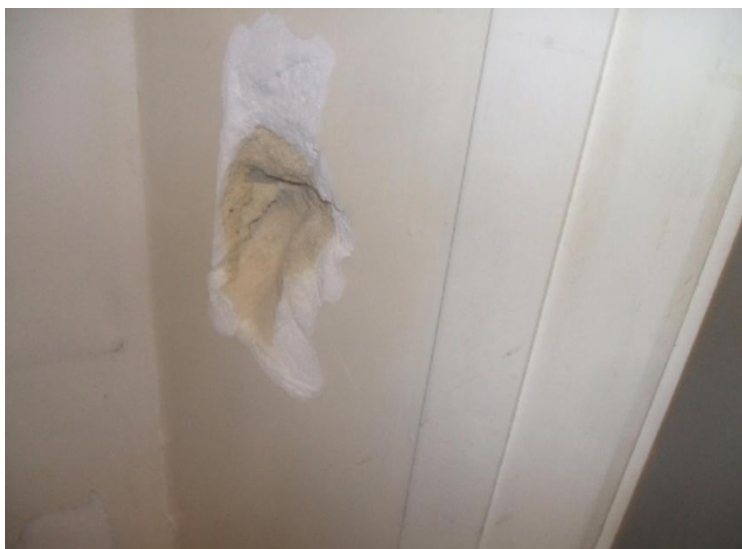
<b>Site Code/UPRN</b>	SD724P/86213	<b>Building</b>	Whitehall
<b>Address</b>	The Old War Office Horse Guards Avenue Whitehall London	<b>Floor</b>	Third Floor
	SW1A 2HB	<b>Room</b>	Room 313 (Porters)
<b>Description</b>	Plaster & render to brickwork walls.	<b>Quantity</b>	N/A
		<b>Asbestos Suspected</b>	<b>No</b>

<b>Last Inspection Date</b>	-	03 Sep 2012	<b>Certificate N°</b>	-	BK30669
<b>Next Inspection Date</b>	-	03 Sep 2013	<b>Sample N°</b>	-	111
<b>Survey Type</b>	-	Refurbishment & Demolition Survey	<b>Photograph N°</b>	-	4829
<b>Position</b>	-	Sample Taken	<b>Location ID</b>	-	Loc20048

<b>Product Type</b>	-	N/A	<b>Surface Treatment</b>	-	N/A
<b>Asbestos Type</b>	-	No Asbestos Detected	<b>Damage Extent</b>	-	N/A
<b>Material Risk Score</b>	-	<b>0</b>	<b>Material Risk Band</b>	-	N/A

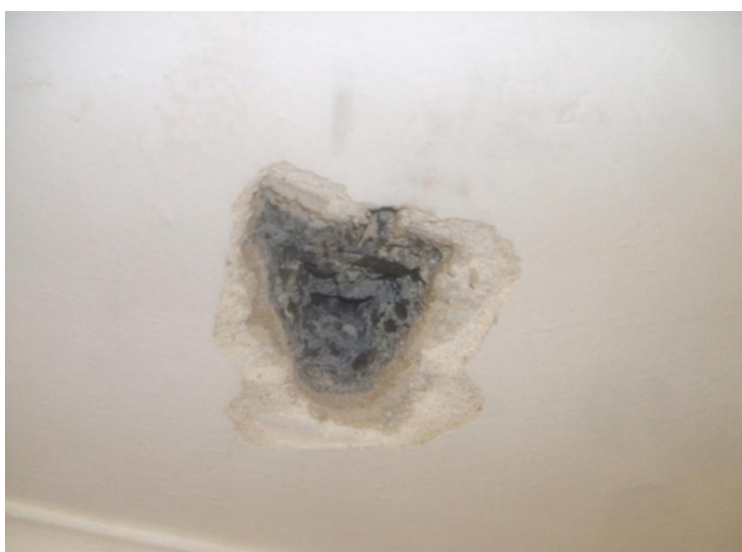
<b>Site Code/UPRN</b>	SD724P/86213	<b>Building</b>	Whitehall
<b>Address</b>	The Old War Office Horse Guards Avenue Whitehall London	<b>Floor</b>	Third Floor
	SW1A 2HB	<b>Room</b>	Room 313 (Porters)
<b>Description</b>	Plaster & render to ceiling.	<b>Quantity</b>	N/A
		<b>Asbestos Suspected</b>	<b>No</b>

<b>Product Type</b>	-	N/A	<b>Surface Treatment</b>	-	N/A
<b>Asbestos Type</b>	-	No Asbestos Detected	<b>Damage Extent</b>	-	N/A
<b>Material Risk Score</b>	-	<b>0</b>	<b>Material Risk Band</b>	-	N/A
