## Fire and Solar PV Systems – Investigations and Evidence

Prepared for: Malwina Gradecka and Yehuda Lethbridge, SICE, BEIS

Date: 11th May 2018

Report Number: P100874-1004 Issue 2.9

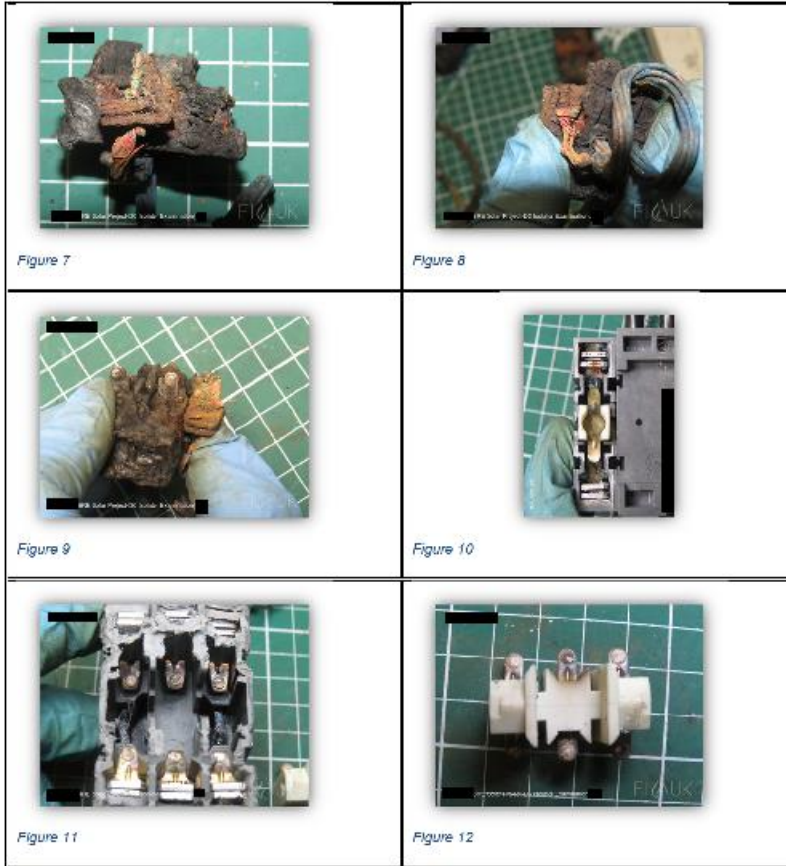
Figure 6

- 3.5. Within the enclosure 3-poles from the switch mechanism had been wired in series using two insulated link cables. The isolator had been wired so that 3-poles were used to switch the positive and 1-pole was used to switch the negative (see Figure 6). Both the fire damaged isolator (exhibit [REDACTED]) and the exemplar (exhibit [REDACTED]) were wired identically in terms of terminal configuration and gland position.
