## Collision between the ro-ro passenger ferry *Red Falcon* and the motor cruiser *Phoenix* Thorn Channel, Southampton, England 29 September 2018

### SUMMARY

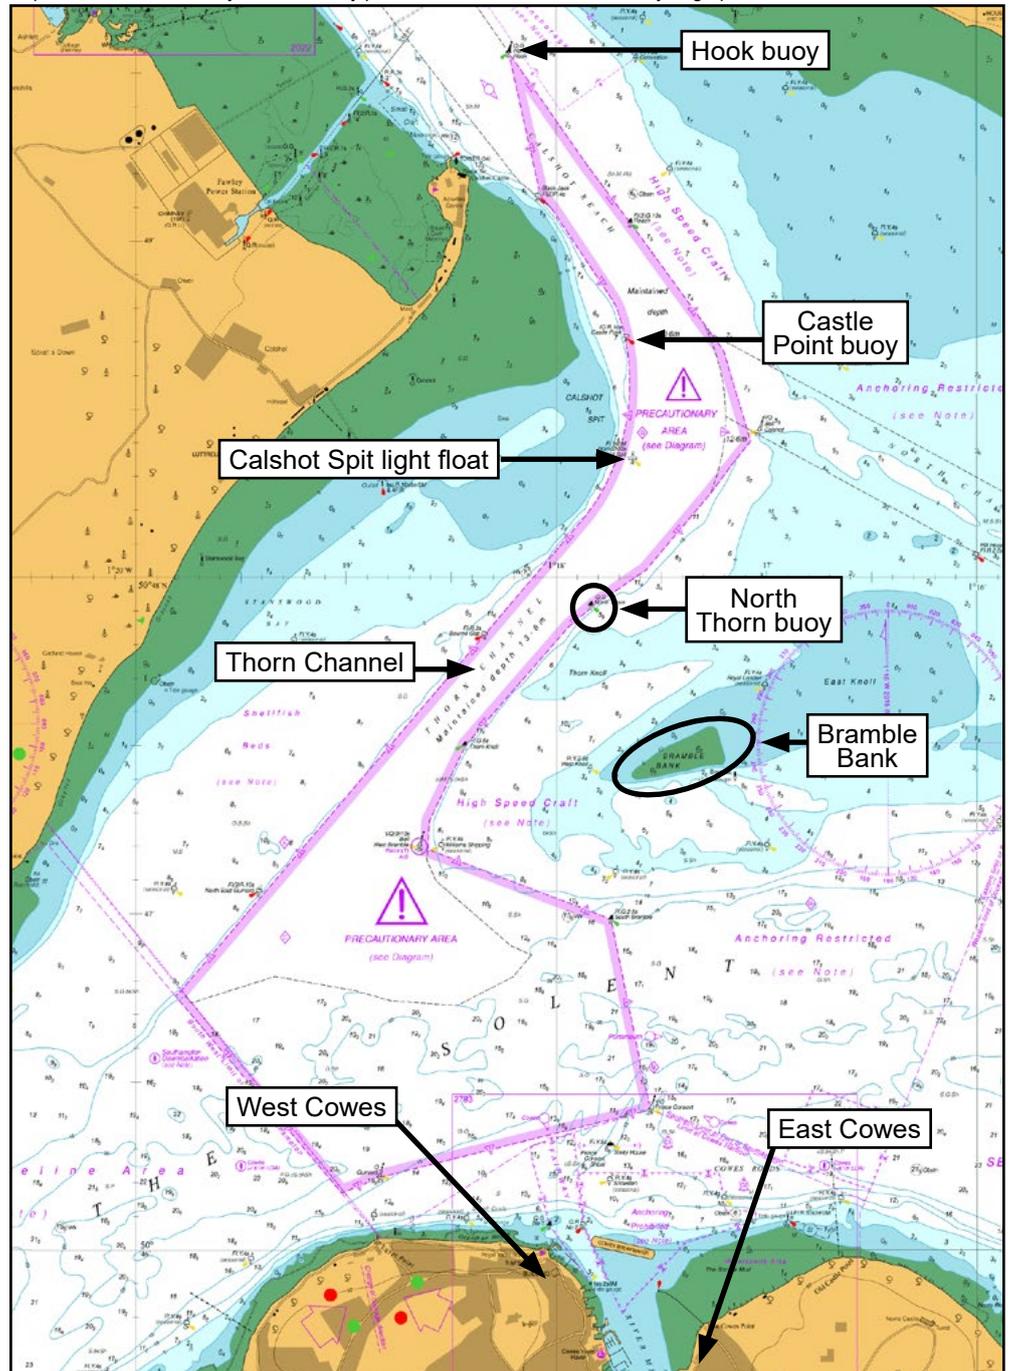
Figure 1: Extract of Admiralty chart 2038

At 1627, *Red Falcon*'s master called Southampton VTS<sup>2</sup> on VHF<sup>3</sup> channel 12 to advise that the ferry was passing the Hook buoy (**Figure 1**). The ferry was making good a course of 140° at 13.5 knots (kts)<sup>4</sup>. Meanwhile, the chief officer took over from the deckhand, and sat down behind the central propulsion control console. The master was seated on the starboard side of the bridge (**Figure 2**).

By that time, *Phoenix* had crossed the main channel at about 8kts and was southbound to the west of Castle Point buoy (**Figure 1**). Between 1627 and 1632, VTS radar tracking, which was intermittent, indicated that the motor cruiser's speed was briefly reduced at some point, resulting in an average speed of 6kts for the period.
