Collision between the ro-ro passenger ferry *Red Falcon* and the motor cruiser *Phoenix* Thorn Channel, Southampton, England 29 September 2018

SUMMARY

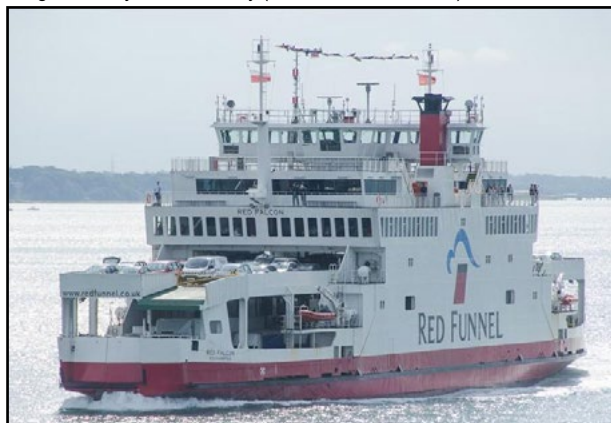
Red Falcon

On 29 September 2018, the UK registered roll-on roll-off passenger ferry *Red Falcon* and the privately-owned motor cruiser *Phoenix* collided in the Thorn Channel, Southampton, England. Both vessels were heading for Cowes on the Isle of Wight. The ferry was carrying 20 crew and 182 passengers, and the motor cruiser had four persons on board. *Phoenix* was pinned against the ferry's bow for 18 seconds and was seriously damaged. *Red Falcon* was not damaged. There were no injuries and no pollution.

Following the accident, an internal investigation by the Southampton Isle of Wight and South of England Royal Mail Steam Packet Company Limited, *Red Falcon*'s owner, identified several areas of navigational watchkeeping practice to be improved. In view of this action, no recommendations have been made.

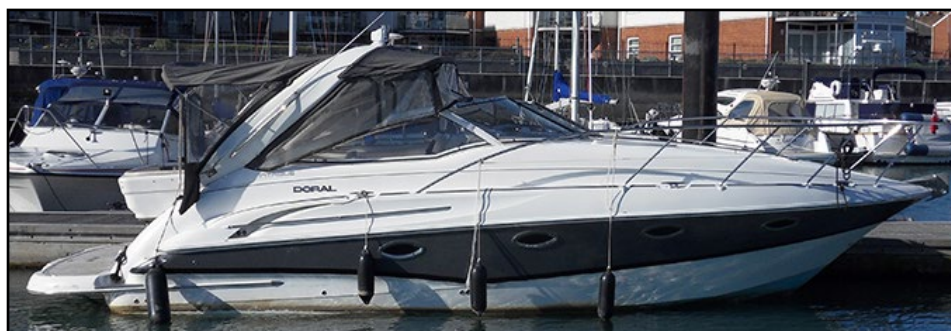
Phoenix

Damage to *Phoenix* included a 5m split in the hull to deck join, hull deformation, and detachment of sections of superstructure. The motor cruiser was declared a total constructive loss by its insurers. *Red Falcon* was not damaged.

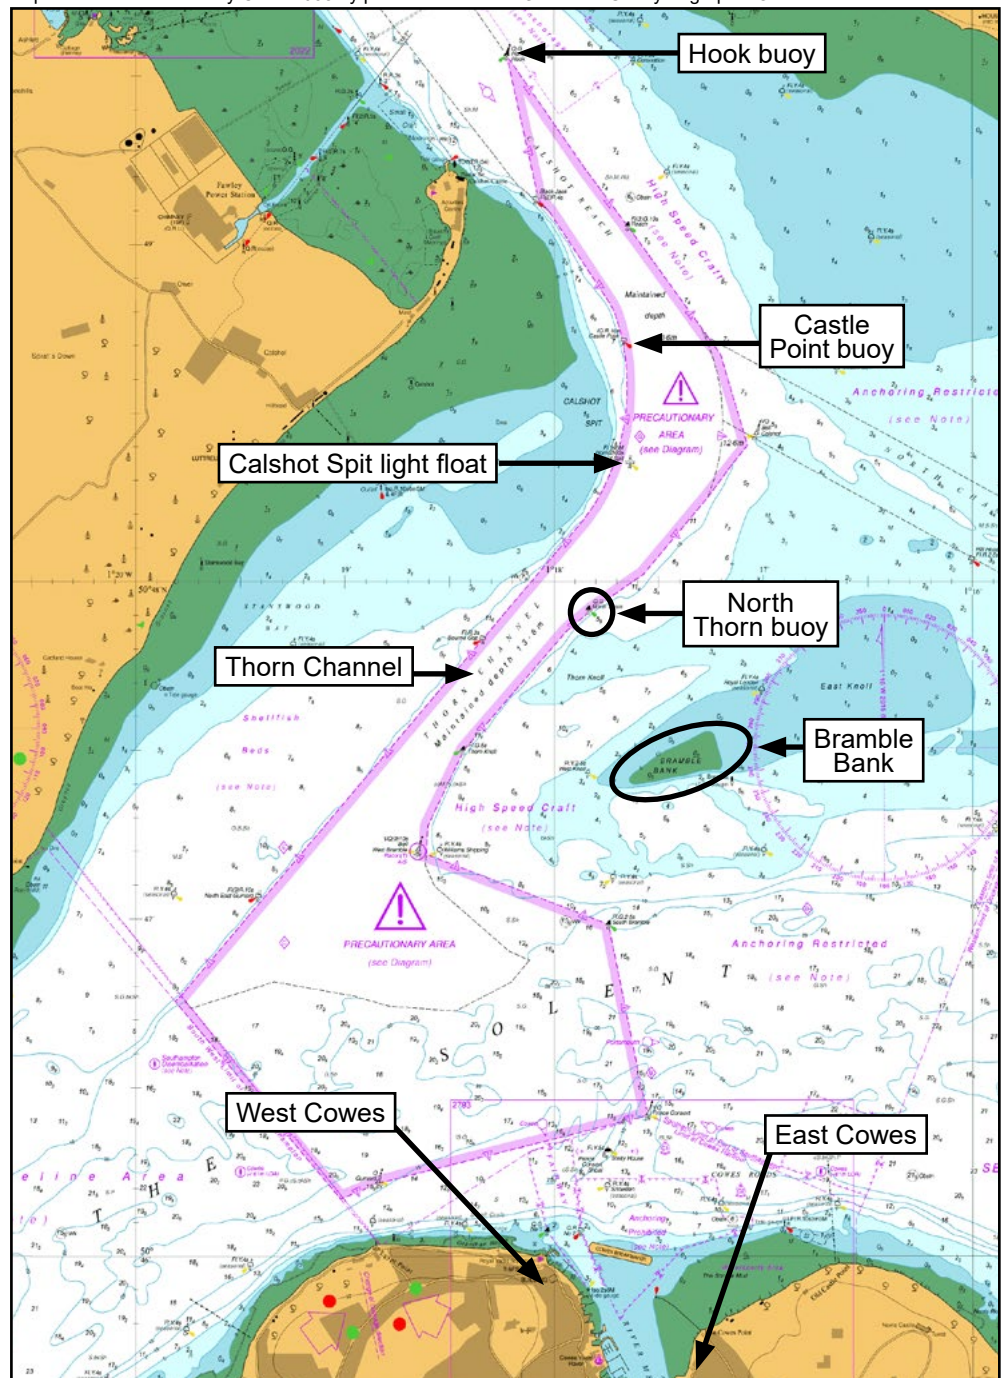
Figure 1: Extract of Admiralty chart 2038

At 1627, *Red Falcon*'s master called Southampton VTS² on VHF³ channel 12 to advise that the ferry was passing the Hook buoy (**Figure 1**). The ferry was making good a course of 140° at 13.5 knots (kts)⁴. Meanwhile, the chief officer took over from the deckhand, and sat down behind the central propulsion control console. The master was seated on the starboard side of the bridge (**Figure 2**).

By that time, *Phoenix* had crossed the main channel at about 8kts and was southbound to the west of Castle Point buoy (**Figure 1**). Between 1627 and 1632, VTS radar tracking, which was intermittent, indicated that the motor cruiser's speed was briefly reduced at some point, resulting in an average speed of 6kts for the period.
