Rail Accident Investigation Branch

Rail Accident Report

Passenger trapped and dragged at Notting Hill Gate station, 31 January 2018

Report 14/2018
September 2018

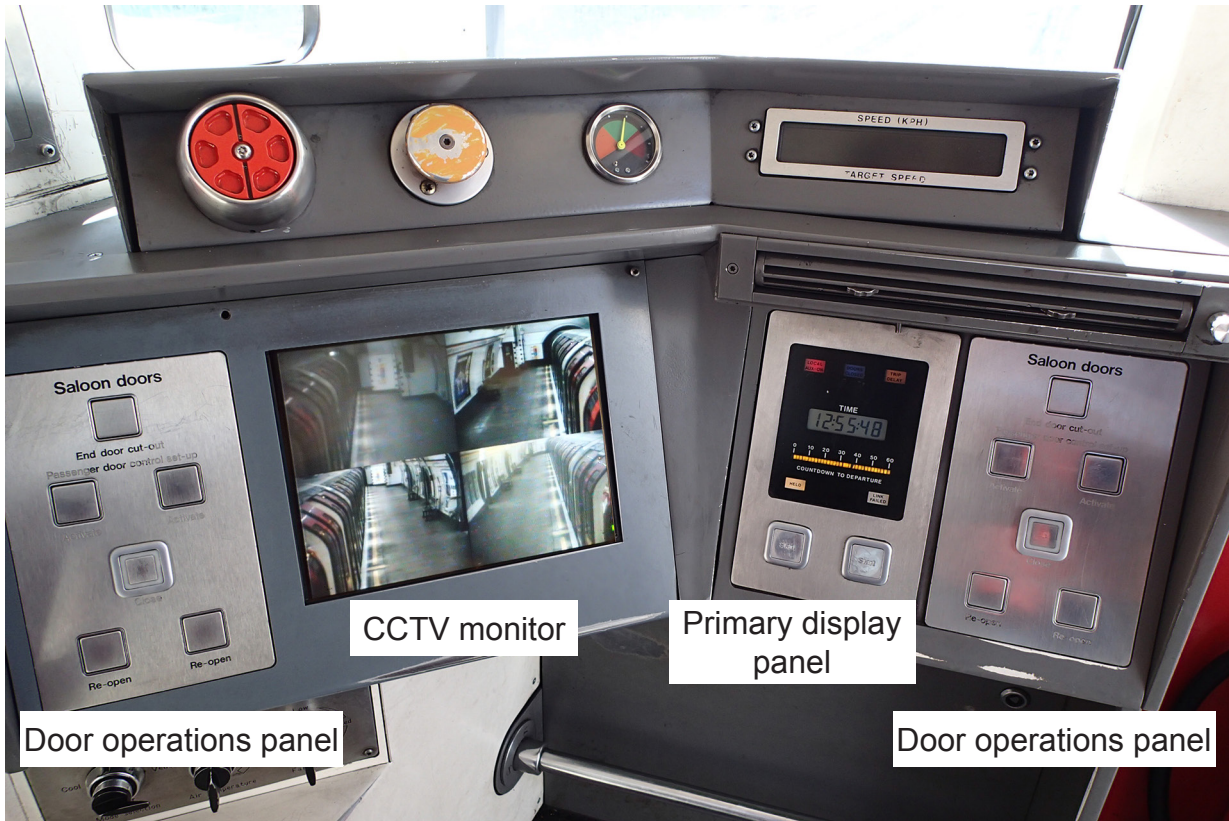
- f. *make a final check of the platform train interface*
 - g. *start your train*
 - h. *check the in-cab monitors as your train leaves the platform.*
- 38 The cab display and control panels on 1992 stock (figure 3) include buttons for opening and closing the doors on each side, a pair of buttons for starting the train, and a CCTV monitor to view images of the platform-train interface.

Figure 3: 1992 stock cab display and control panels. The panels to the left and right are for door operation on each side of the train, there is a 12.1 inch LCD monitor to display platform CCTV images, and a primary display panel. NB: For illustration, RAIB has superimposed a typical platform image on the CCTV monitor display, as the original photograph showed a blank display.

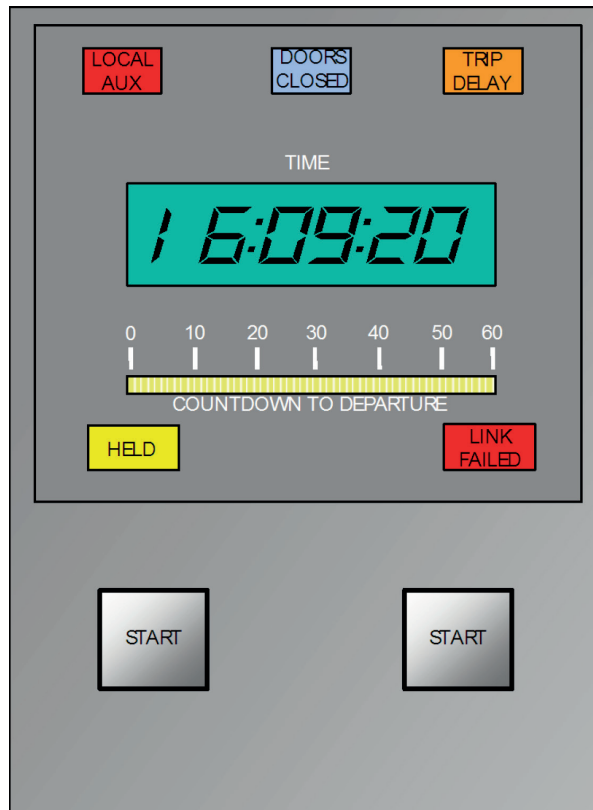
- 39 The primary display panel (figure 4) includes the following features:
- a. a 'doors closed' visual indicator (blue light, top centre), commonly known as a 'pilot light', which shows that a door interlock circuit has detected that all the doors are closed and, therefore, that the train can be moved (see paragraph 49);

- b. a countdown to departure display, which takes its input from the signalling control centre and is set automatically depending on prevailing service conditions (typically it starts at 20-30 seconds); and

- c. a pair of start buttons which must be simultaneously pressed and held for at least two seconds to start the train.
- 40 The train operator uses images on the CCTV monitor to check the platform-train interface during train despatch. The CCTV monitor displays images from station cameras, which are transmitted to the train from around the moment it enters the station until the last carriage has left the platform. At most stations, the screen is divided into four images to cover the full length of the train and the platform edge (as shown in figure 5). However, some stations require more images due to platform curvature (for instance, Bank and Stratford stations use eight images). At platform 4 at Notting Hill Gate, there are five images arranged as shown in figure 6. The three images on the left-hand side look towards the front of the train; the two images on the right look towards the rear.

Figure 4: Schematic representation of the primary display panel (courtesy of LUL)

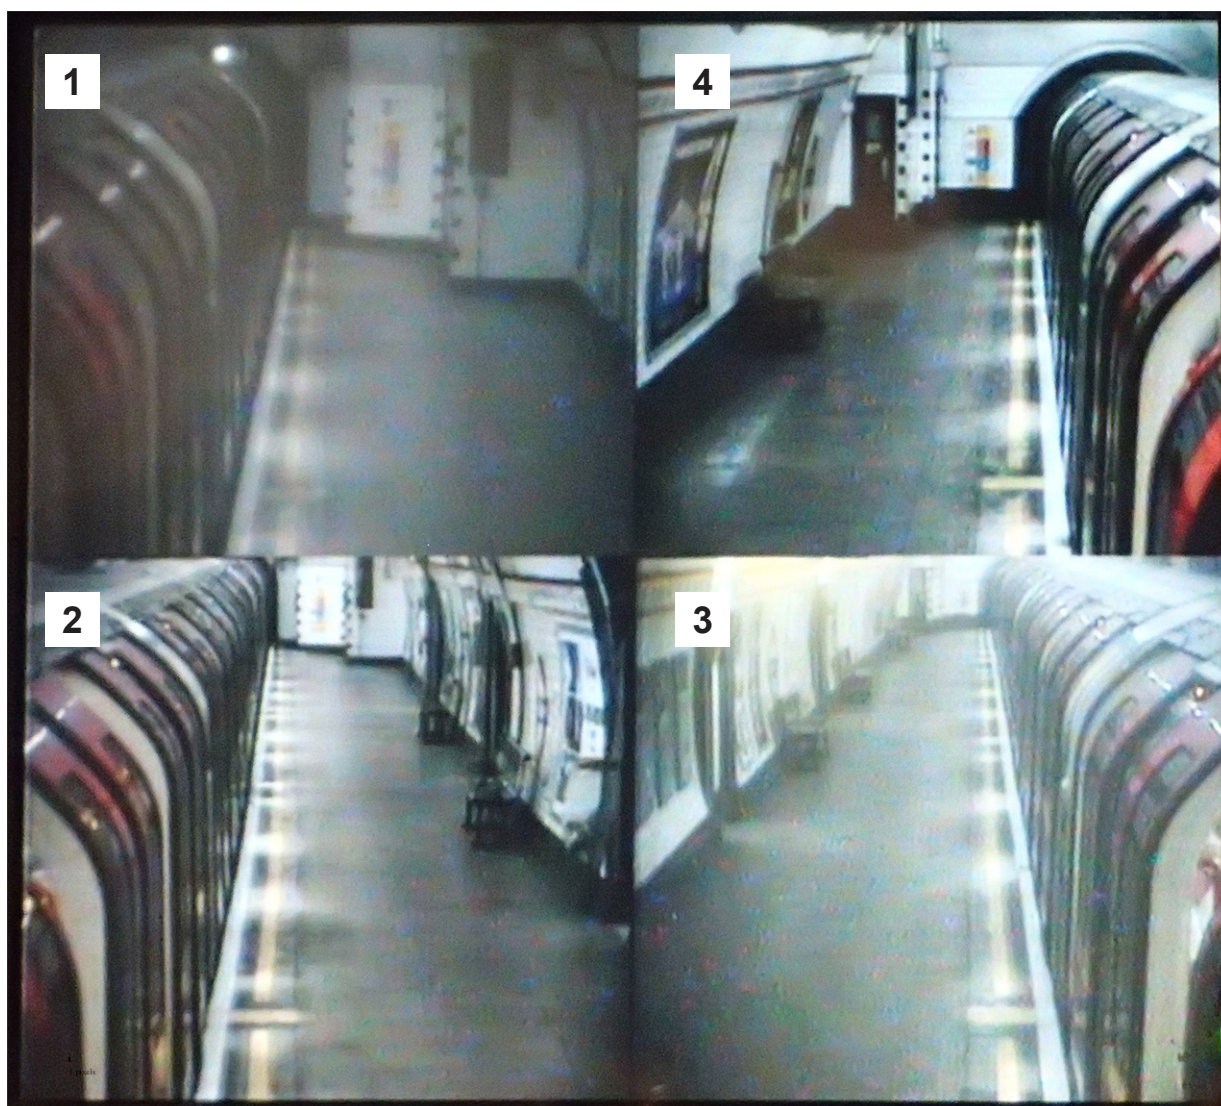
Figure 5: Typical arrangement of in-cab platform CCTV images on the Central line (numbers denote the ordering of images from front to rear of the train)

41 LUL's current standard⁶ for in-cab, platform CCTV monitors, sets out specific requirements for a clear view of the complete critical area of the platform-train interface under all conditions at all times. This includes the configuration of cameras, the arrangement of images on the monitor (with no more than four images per display screen) and visibility requirements for the displayed image. The specified optimum viewing angle for a target object shall be at least 54 minutes of arc⁷ at the driver's eye point, and shall never be less than 42 minutes of arc (the absolute limit of discernibility is defined in the standard as 20 minutes of arc). The same specified object should occupy at least 13.2% of the screen height for a four-way split screen. However, 1992 stock pre-dates this standard and the standard is not applicable retrospectively. LUL stated that the specification for the in-cab platform CCTV monitors on 1992 stock is no longer available.
