SS Richard Montgomery Survey Report 2016

Maritime and Coastguard Agency
January 2019

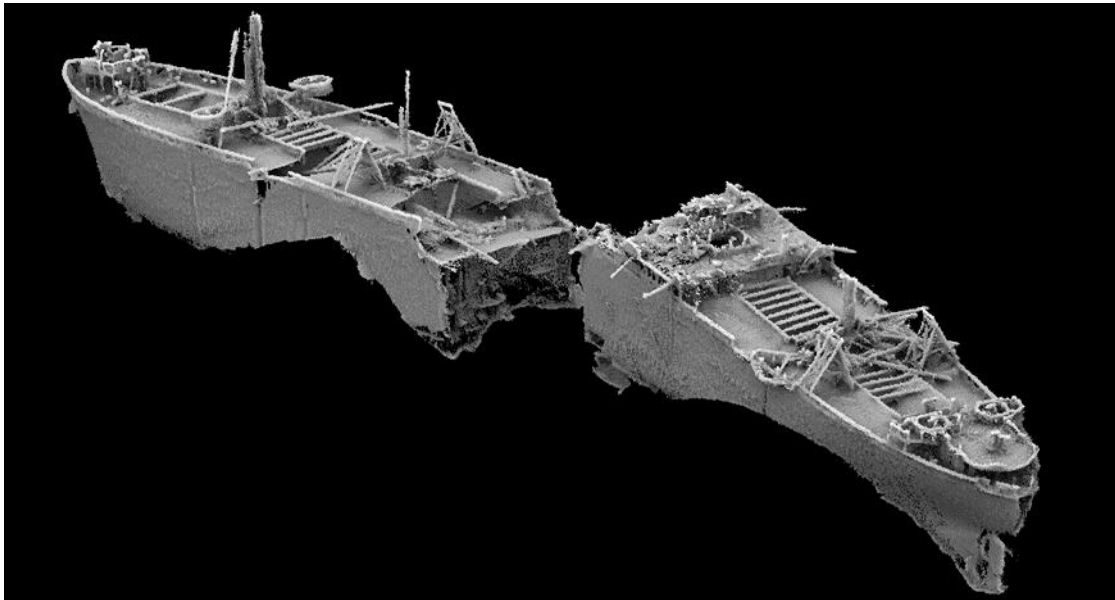
Fig. 2 Overview of the port side of the SSRM – 2016 data

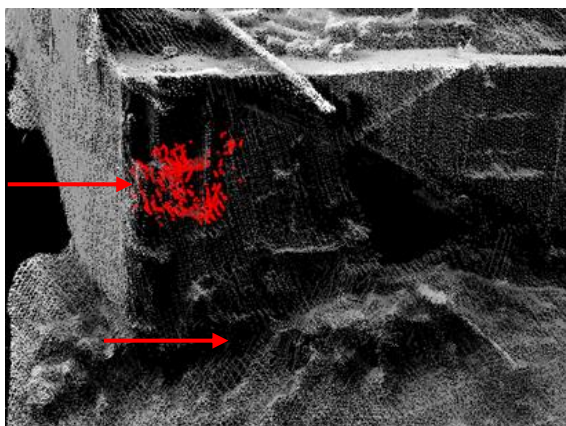
4.7.1 At the aft end of the forward section, the bulkhead between Hold 3 and the engine room is still in place and is providing containment for the contents of Hold 3. Although the bulkhead remains intact, apertures can be seen in successive survey data, in particular, an aperture on the port side. This aperture is clearly visible in the 2016 dataset. A CARIS profile shows very good correlation between the data sets. The dimensions of the aperture have remained consistent across the datasets from the previous three years, no changes have been noted.

4.7.2 Whilst the hold cargo can be seen through the aperture, the exact oblique sonar angle required for good internal ensonification was not achieved. This may be because of the state of tide or beam sector angle during that pass. The shoalest depth recorded of the internal cargo was 8m below CD compared to 7.04m in 2015. It is not possible to ascertain whether this represents a decrease in the amount of cargo visible or whether the area was not fully ensonified. No change was noted in the debris field at the foot of Hold 3, which suggests that this change is related to data collection rather than an actual change in the wreck.

Fig. 25 Bulkhead at Hold 3 showing data inside of the hold and debris pile

4.7.3 For future surveys, it is recommended that flex mode on the Reson 7125 should be used. This compresses all the beams into a very narrow sector and, by varying the distance from the hold 3 aperture to the sonar head, this should allow for better angles of acoustic signal propagation.

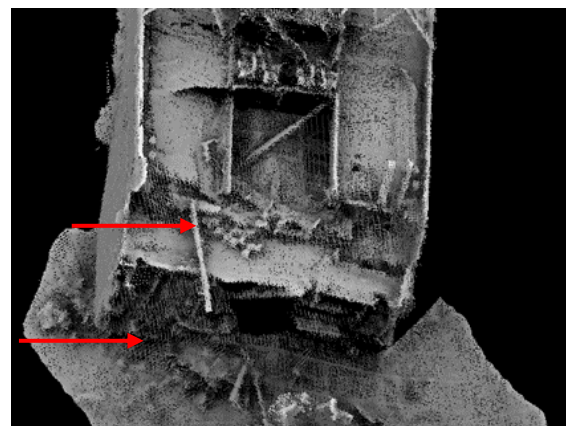
4.13.2 Holes in the deck plating at Hold 1 have facilitated the acquisition of MBES data points from the 'tween deck below. The surface here appears to be undulating, which suggests that there is sediment build-up over the cargo. Similarly, MBES data was acquired through the crack in the hull at Hold 2. The data points show good agreement with previous surveys, suggesting that no changes have occurred. In the debris pile at the foot of Hold 3 and the remains of the Hold 3 'tween deck area, no changes were noted in the cargo that is visible in the multibeam data.

Fig. 26 Aft end of bow section showing the remains of Hold 3 'tween deck and debris

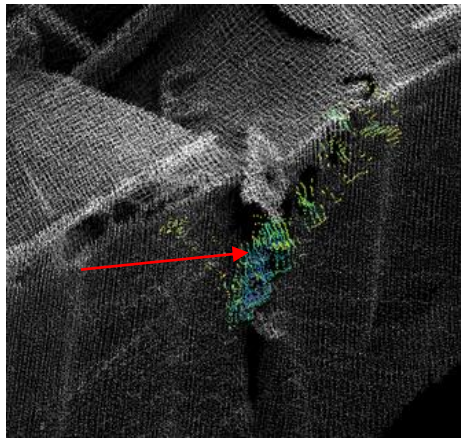
Fig. 27 MBES data inside of Hold 2

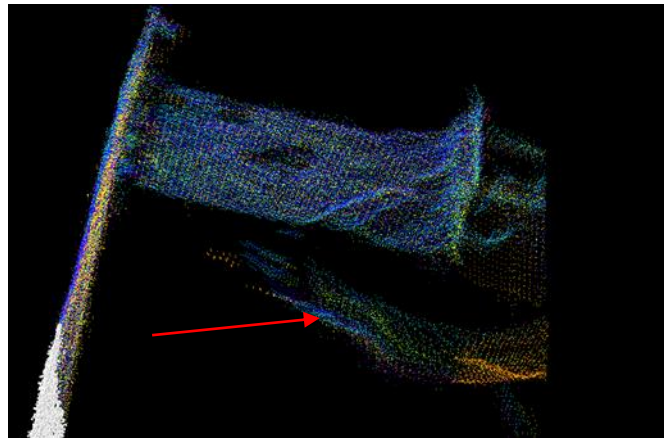
Fig. 28 Showing data inside the hull

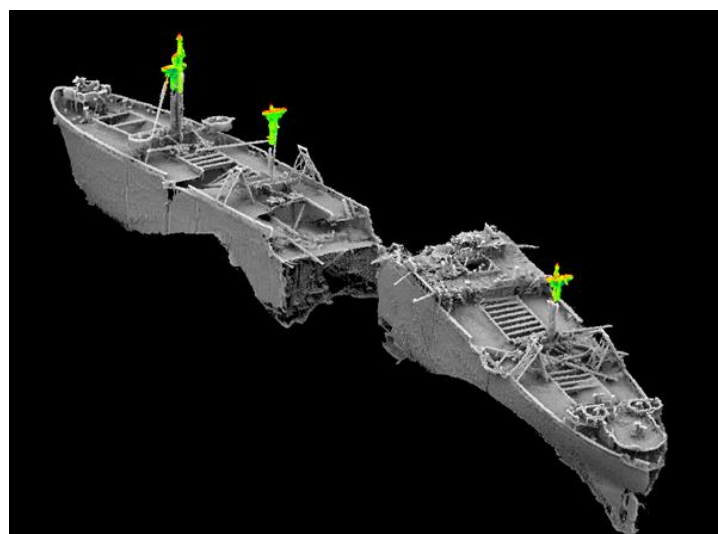
4.14.3 The main mast and cargo handling boom was well covered although slightly less coverage was achieved than in 2015 due to low spring tides coinciding with fading light. The data indications that the condition of the masts has not changed noticeably since 2015.

4.14.4 Data coverage of the mizzen mast was good in the 2016 survey although with small gap between the MBES and laser data. As with the fore and main masts, the mizzen mast has remained stable with no noticeable deterioration.

Fig. 29 Multibeam (grey) and laser data (green) combined

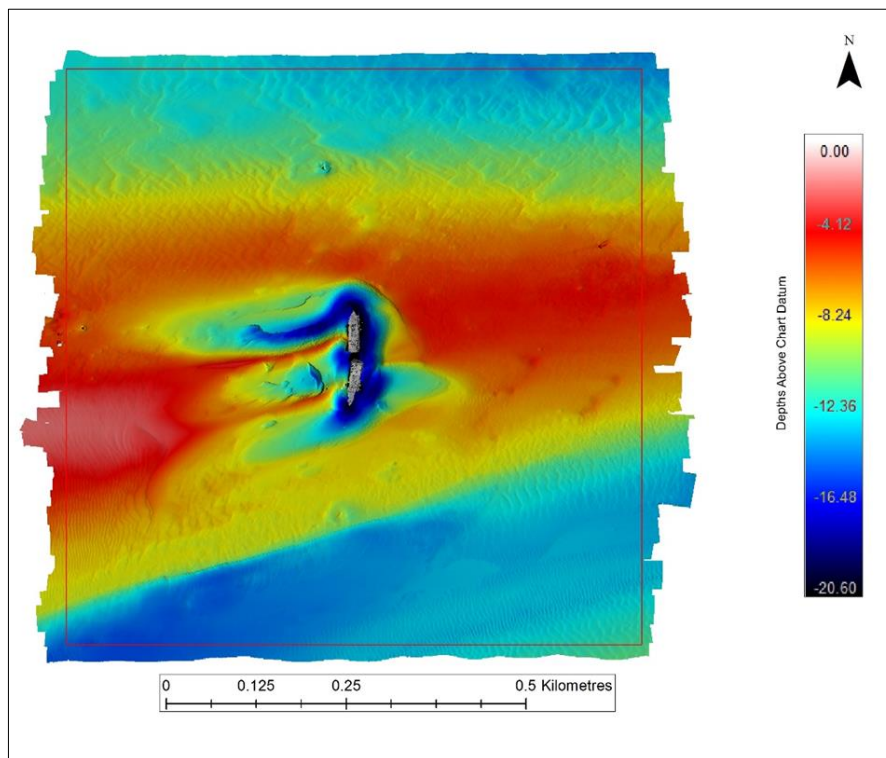
5.1.3 Across the site, water depths vary between 20.6m below LAT in the scour pit surrounding the wreck of the SSRM (off the starboard-bow quarter), and 2.2m below LAT on the top of the sandbank at the very west of the survey area. The scour pit is present on both sides of the wreck, though it extends further to the west, up to 330m from the structure. The edge of the dredged channel is clearly visible in the south of the survey area. Depths in this area are in the region of 16m CD.

Fig. 30 Bathymetry from the survey area, 2016

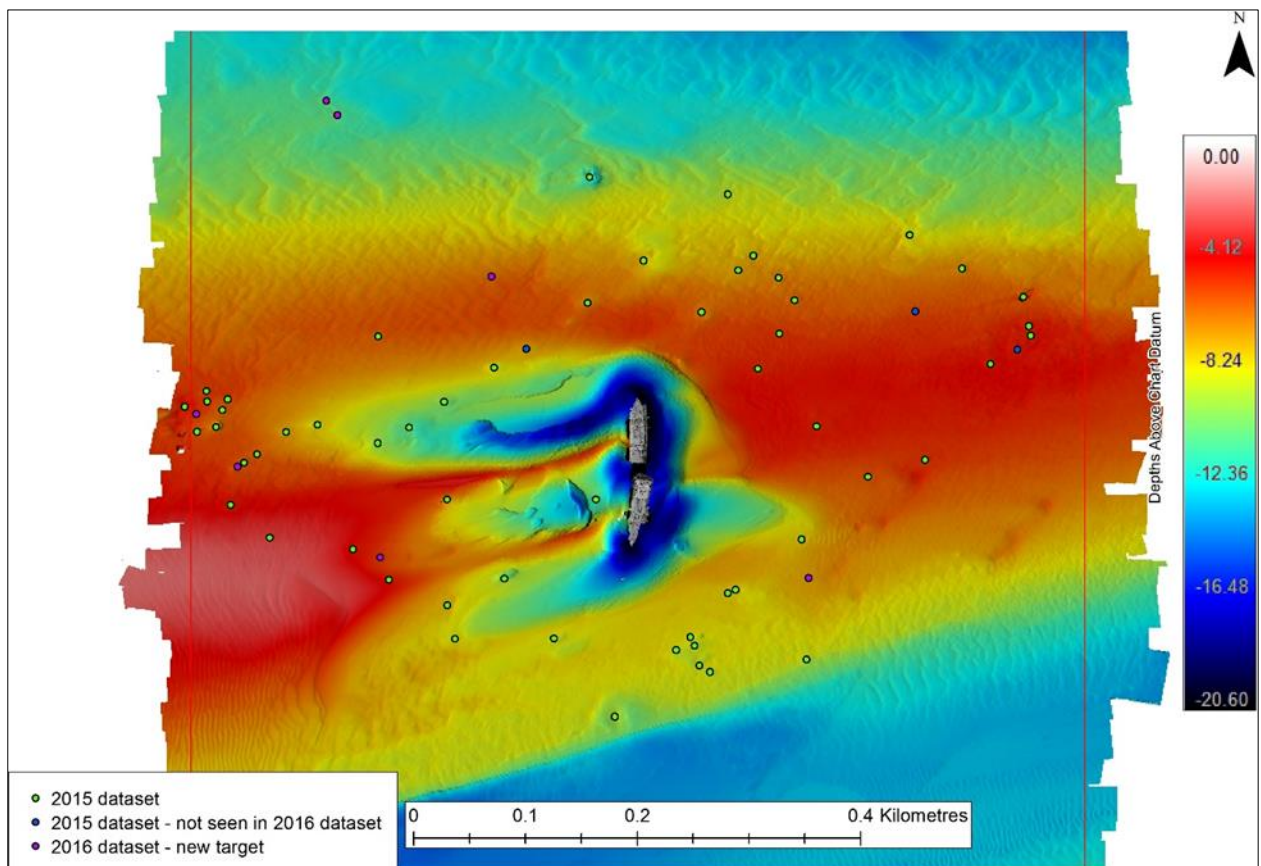
5.2.1 As outlined above, within the wider survey area a variety of other objects are known on the seabed. These are located and assessed in each survey. The seabed contact list from 2015, with a total of 59 contacts, was compared against the 2016 bathymetry and backscatter datasets. This careful analysis has added a further 7 targets to the contact list, while 3 items from the 2015 contact list are not apparent on the 2016 data. The image below shows the location of each of these objects.

Fig. 32 Seabed contacts, 2016
