Report on the investigation of the
fatal man overboard from the UK registered yacht
CV30
approximately 1500nm west of Fremantle, Australia
on 18 November 2017

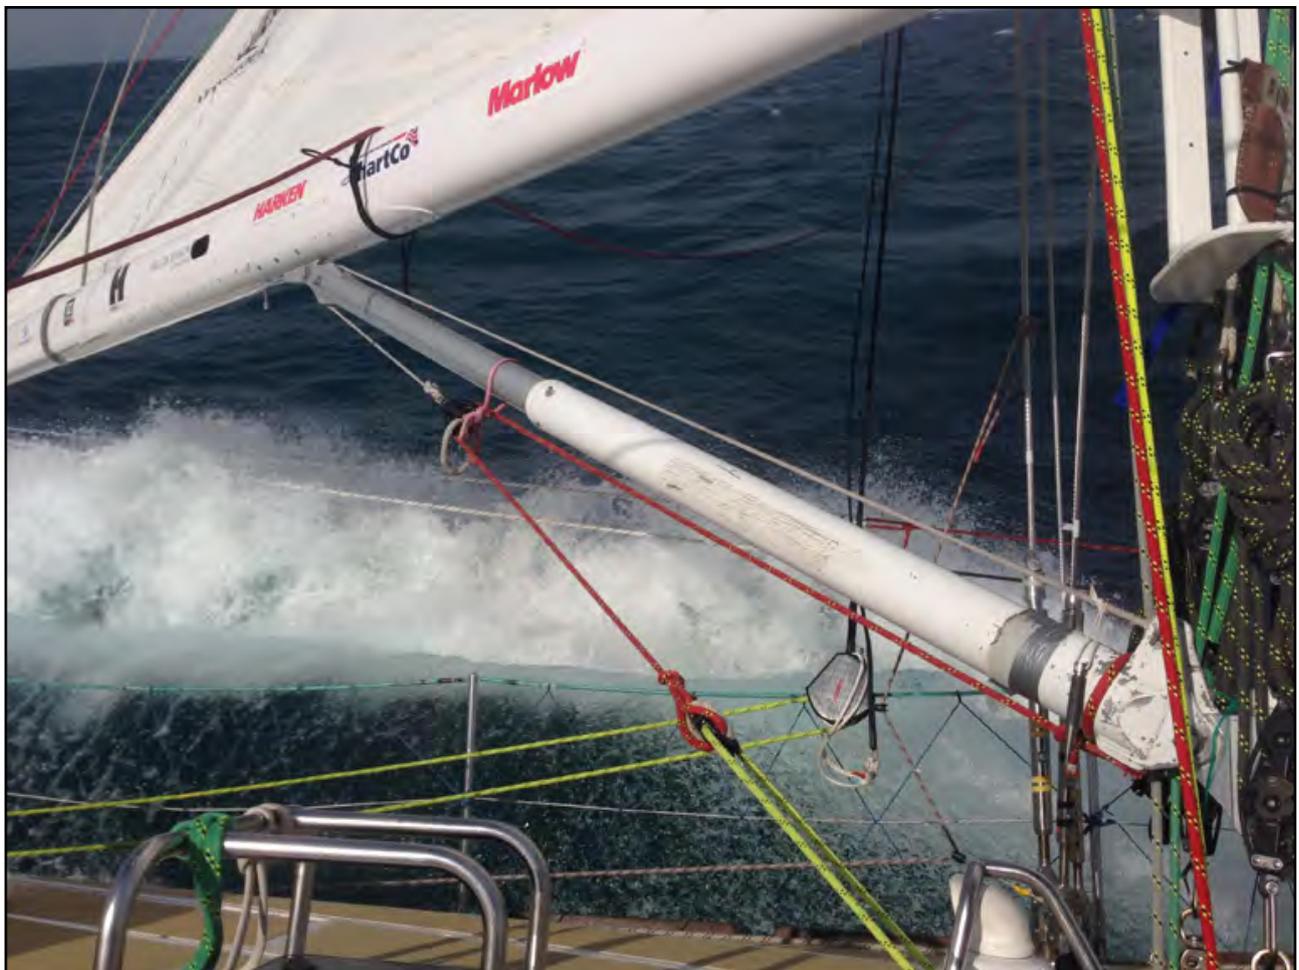
Figure 3: Vang before damage

On 8 November, CV30 suffered further damage, including the breaking of two mainsail battens and the vang strut (**Figure 3**). The latter occurred when a crew member mistakenly winched on the vang rather than the outhaul, compressing the vang strut and buckling it (**Figure 4**). The vang strut was removed and a kicker rigged to enable the mainsail leech tension to be controlled. On the same day, the watch leader for Jack watch fell from his bunk, injuring his hand, resulting in him being confined below deck on light duties. Simon Speirs therefore resumed his previous role of watch leader.

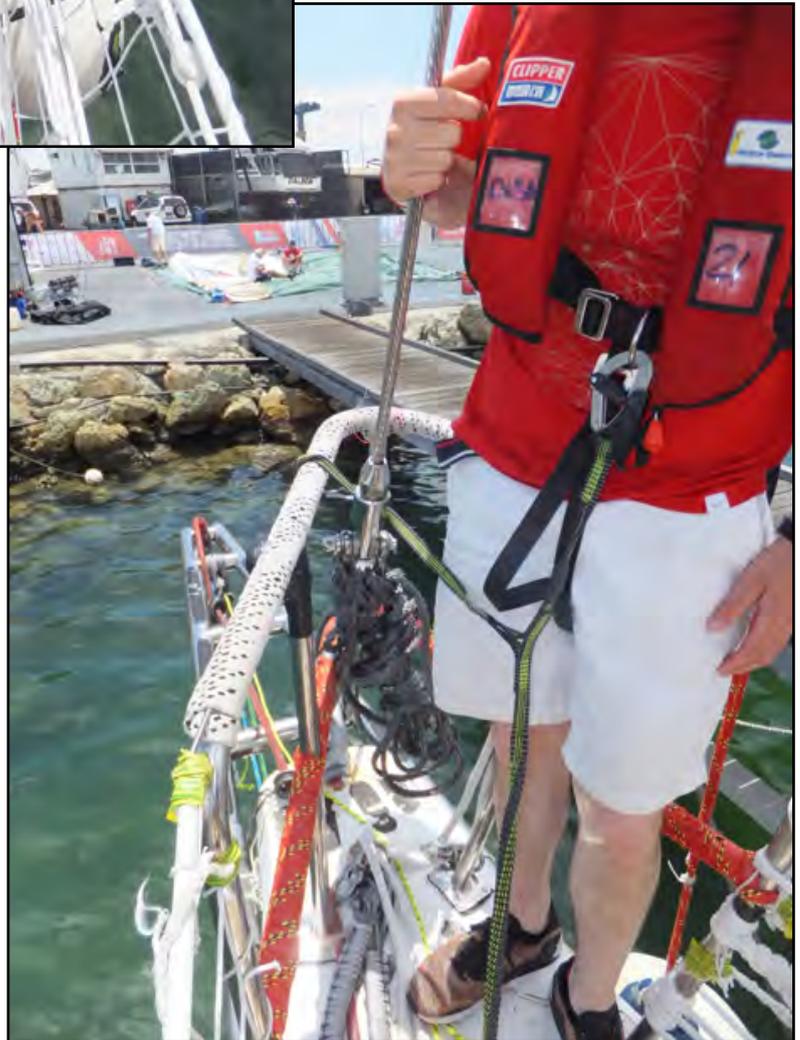
Figure 6: Bowman secured by short and long tether

All the crew on the foredeck were clipped on to the yacht via their safety tethers. Most were clipped to the starboard jackstay with their long tethers. The bowman was additionally clipped to the pulpit itself via his short tether (**Figure 6**). There is no clear evidence to indicate what Simon was clipped on to at this stage. However, in moving from the cockpit to the foredeck it was normal practice to be clipped with a long tether to the jackstay on the high side of the yacht (**Figure 7**).

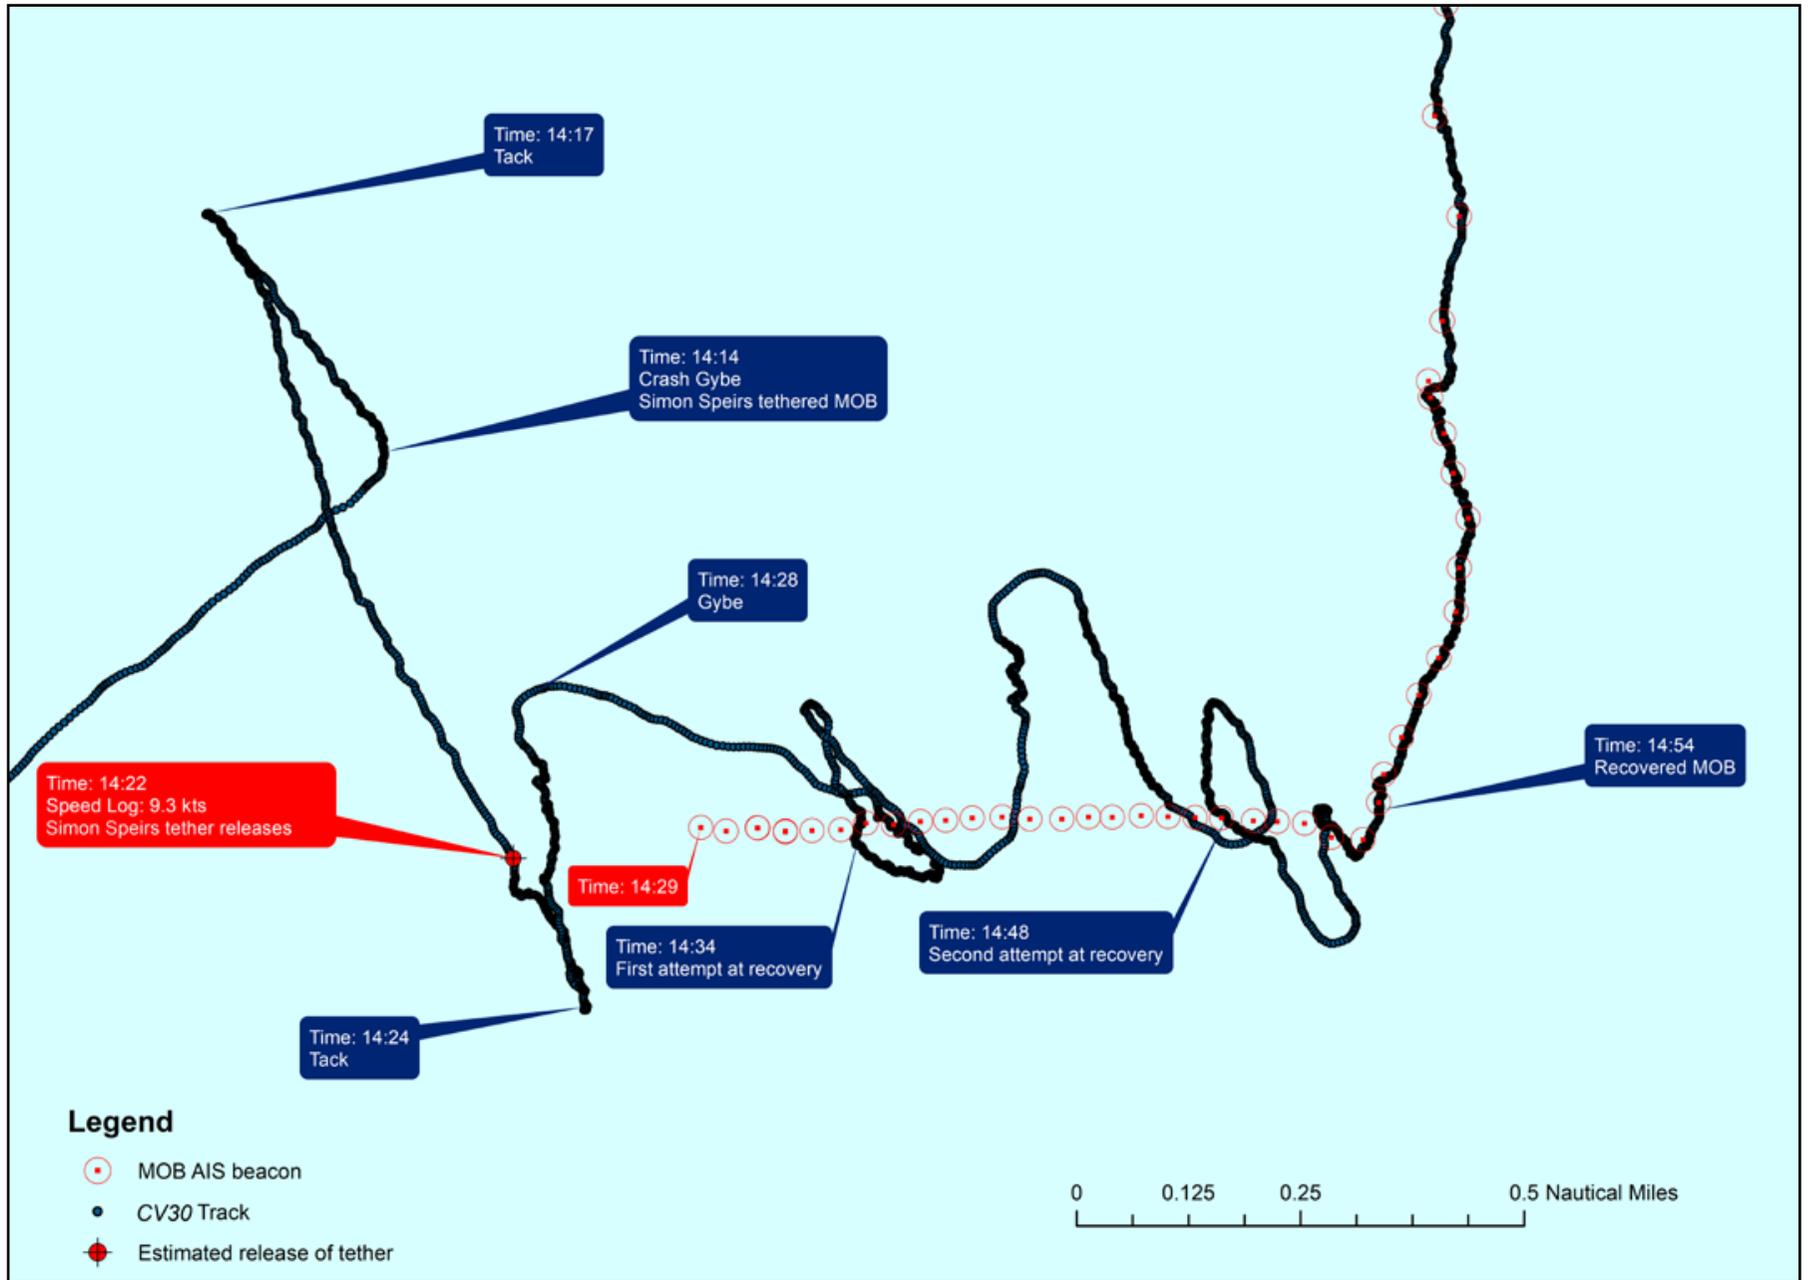
Figure 10: Tracks of CV30 and AIS MOB beacon

From 1414 until 1417, CV30's speed through the water increased to a maximum of 8.5kts. The skipper was aware of the tethered MOB and could see crew leaning over the starboard side. At 1417 (**Figure 10**), he tacked CV30 on to a starboard tack to ensure Simon was on the high side. He then tried to slow and stop CV30 in the water by heading the yacht up into the wind. However, this proved to be impossible in the sea conditions as both sails were unable to be controlled with the yankee 3 still partially hoisted and the main sheet having developed a riding turn on the winch, hampering it being eased.

The bowman passed the end of the halyard, with the snap shackle open, down to Simon (**Figure 11**), who was then seen trying to clip the halyard to his lifejacket harness. CV30 was moving through the water between 6 and 9kts, making it very difficult for Simon to clip on as the water buffeted and broke over him. Suddenly, at 1422, Simon's long tether released with a bang and he was separated from the yacht (**Figure 10**).

At 1424 the skipper managed to tack CV30 on to a port tack to head back towards Simon (**Figure 10**). A few minutes later he tried to tack back, but could not swing the yacht's bow through the wind in the strong wind and very rough sea conditions.

Instead, at 1428, he gybed the boat on to a starboard tack with some difficulty due to the lack of control of the mainsail and riding turns on the main sheet winch. At about that time, the AIS beacon on Simon's lifejacket started to be displayed on CV30's plotter (**Figure 10**).

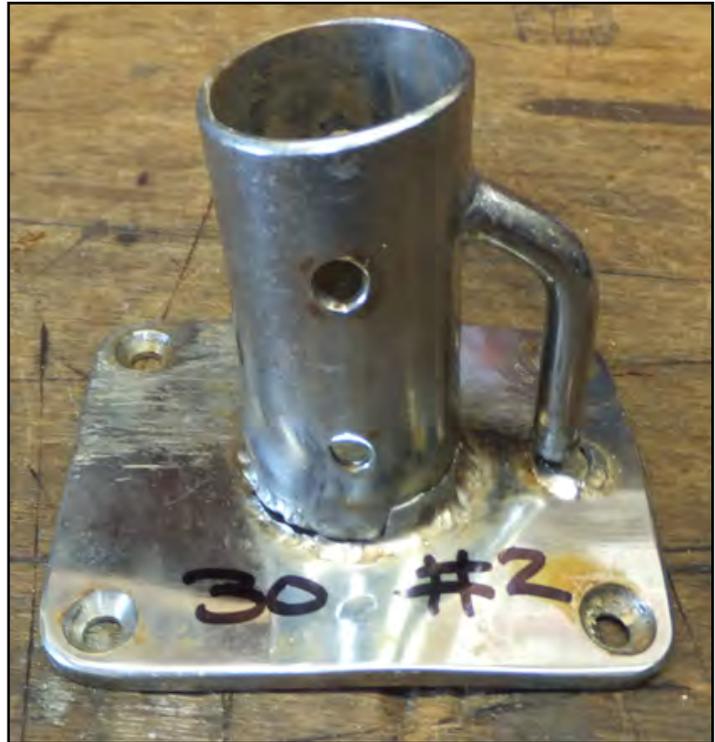
Figure 16: Stanchion base

The stanchion bases, which located the foot of the stanchion on to the deck, were made of stainless steel and comprised a base plate 95x80mm and a 60mm stainless steel tubing section welded perpendicular to the base plate (**Figure 16**). There was also a short section of stainless steel rod welded as a support on the inboard side of the tube.

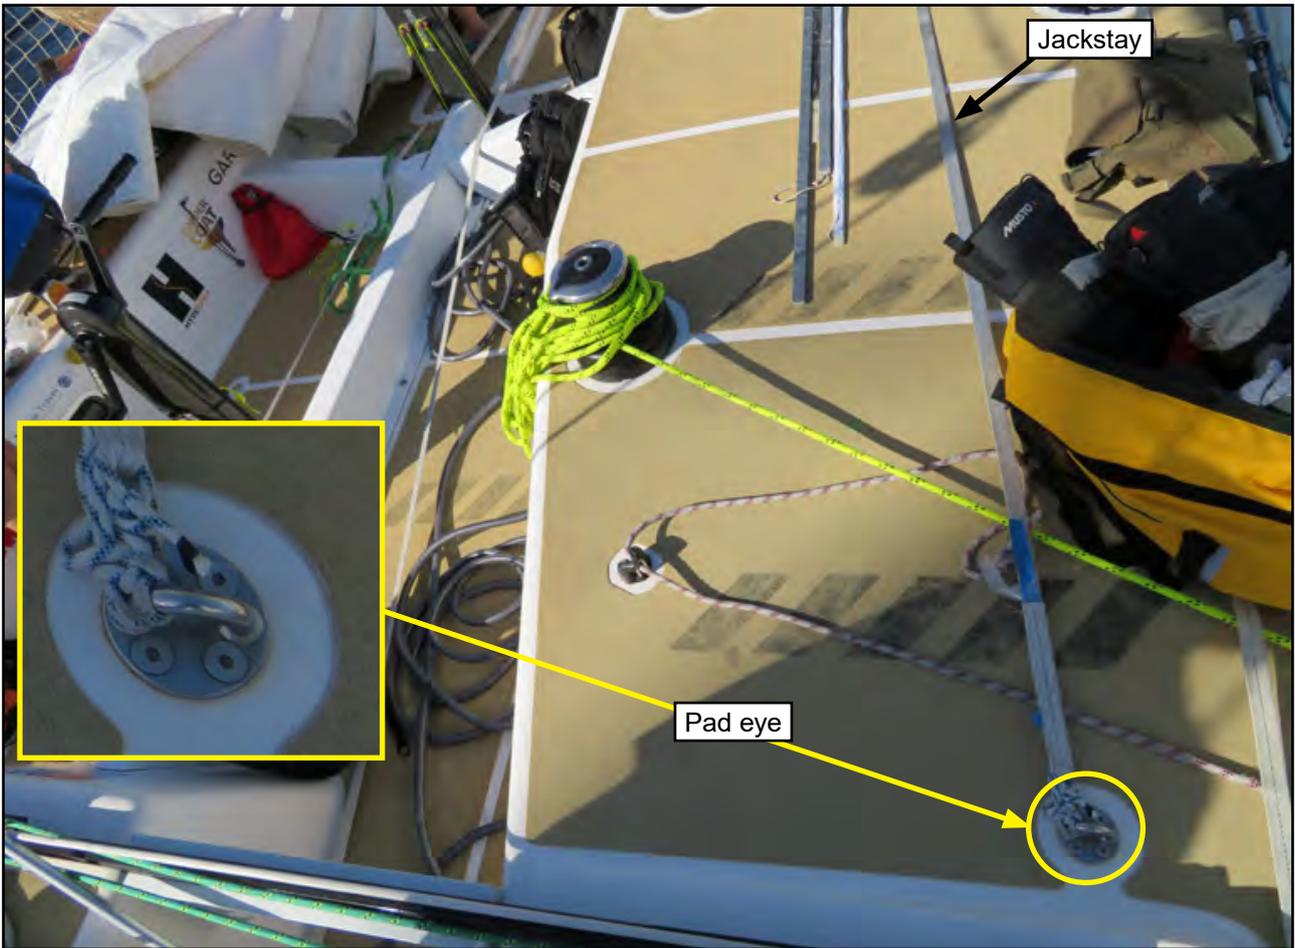
Figure 19: Jackstay termination at pad eye

The majority of jackstays were secured to the yacht via pad eyes (**Figure 19**); the only exceptions being the forward end of the bow jackstays (**Figure 20**) and the stern end of stern jackstays, which were attached with shackles to the port and starboard forward and aft mooring cleats.

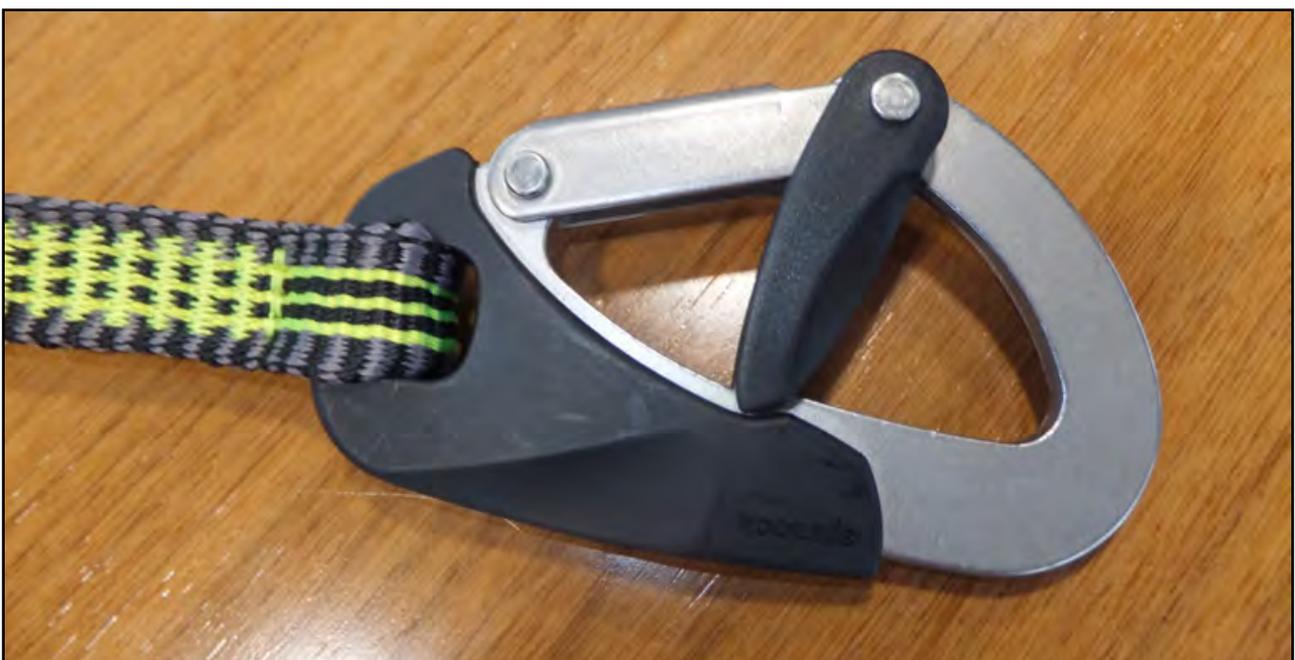
Figure 25: Spinlock tether hook

At the three ends of the tether were identical single-handed double action spring-loaded hooks (**Figure 25**). Although the precise design was Spinlock's, the basic hook design (Gibb hook) was commonly used by many tether manufacturers and had been in existence for 30 years. The main structural element of the hook was pressed from non-magnetic stainless steel.

Spinlock tested to destruction a sample tether from each batch that was produced to ensure they met approval requirements. During these tests the tether webbing and stitching always failed prior to the tether hooks themselves.

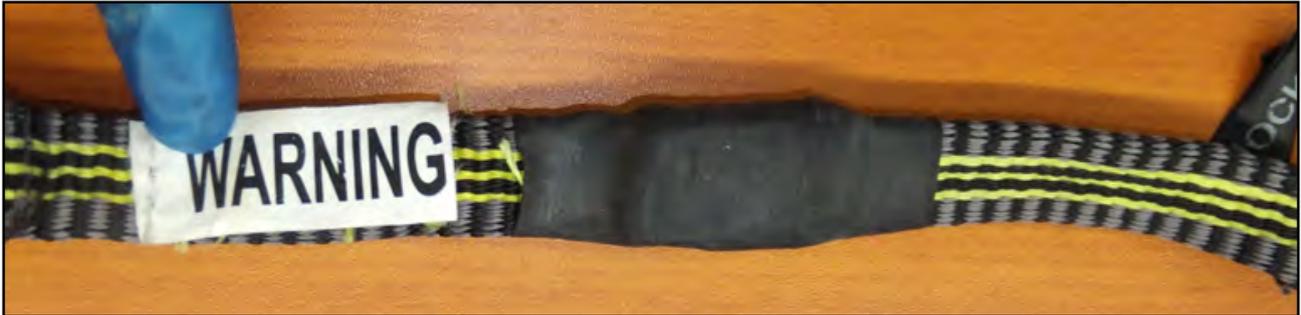
Figure 30: Safety tether overload indicator

- The elastic section of the long tether was frayed with elasticity lost but was still intact (**Figure 29**).
- The overload indicator was exposed (**Figure 30**).

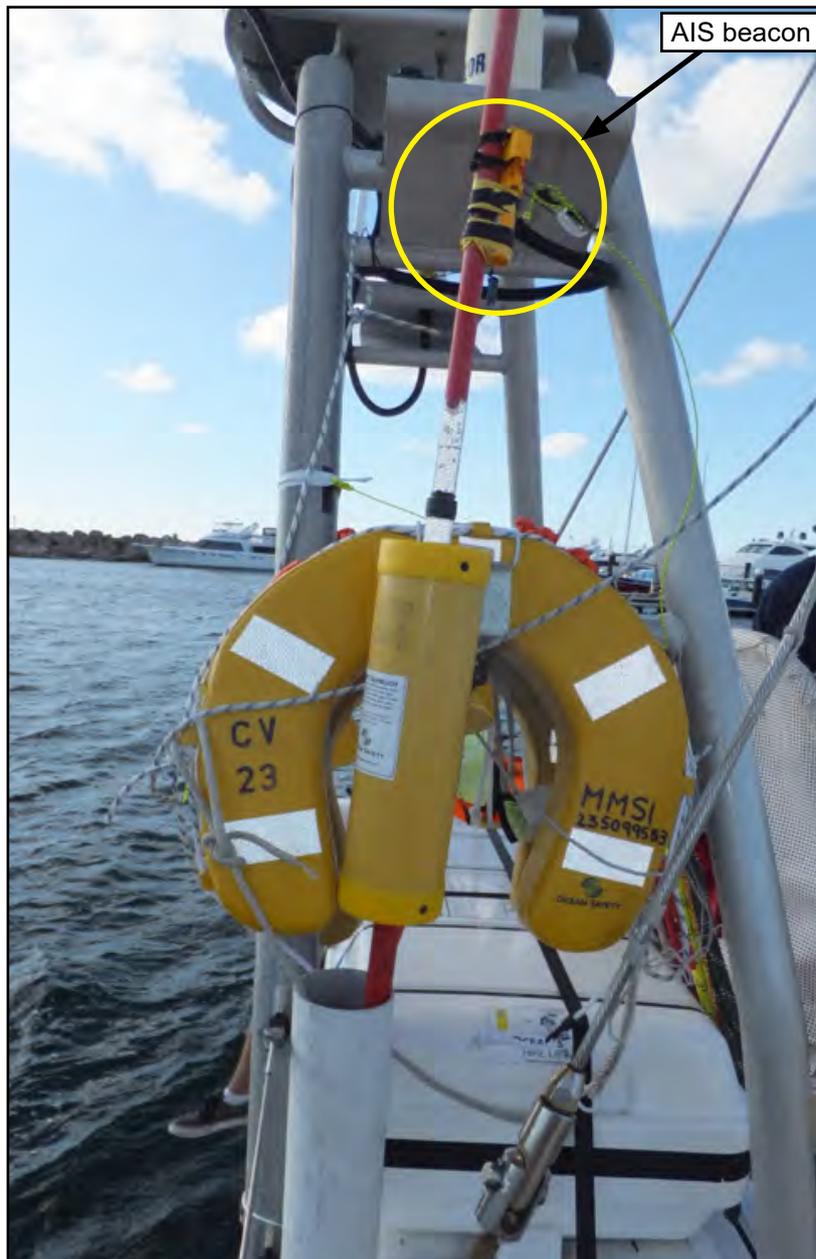
Figure 35: Dan buoy and horseshoe life-ring showing AIS beacon

CV30's dan buoy was secured to the starboard side of the aft gantry (**Figure 35**), to be deployed by the nearest crew member as soon as possible following an MOB. A horseshoe life-ring and buoyant light were attached to the dan buoy. An MOB1 AIS beacon was also secured to the dan buoy and the arming tape was attached with twine to the gantry. When the dan buoy was thrown overboard the AIS beacon was intended to automatically activate as the arming tape was pulled.

During Simon Speirs' MOB recovery, although the dan buoy was thrown overboard there was no reception of the dan buoy's AIS beacon on CV30's plotter.
