# Rail Accident Report

**Collision between a train and utility vehicle at  
Dollands Moor freight yard, Kent  
4 September 2018**

Report 05/2019  
June 2019

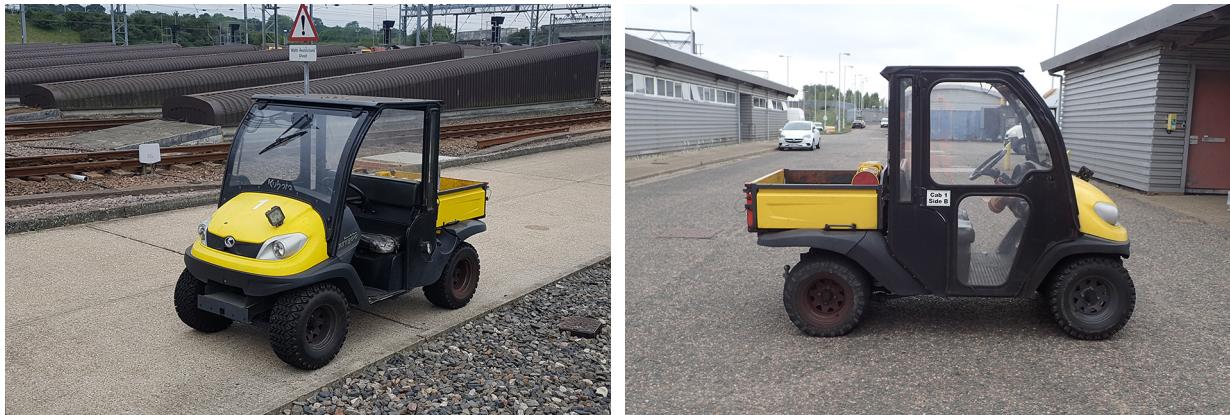
Figures 7a and 7b: views of the undamaged Kubota RTV 500 buggy at Dollands Moor yard

- 19 Buggies to transport staff and equipment around the yard have been provided since the yard became operational. At the time of the accident, the yard was equipped with two Kubota RTV 500 petrol powered utility vehicles, each weighing 620 kg and with a top speed of 40 km/h. Each buggy can carry two members of staff. A rear cargo box allowed train tail lamps and coupling equipment to be transported (figures 7a and 7b).
- 20 Both buggies had been equipped with inspection lights on the left-hand side (figure 7a) to assist with train checking duties, controlled by a switch in the cab. The buggies are left-hand drive and the shunters had removed the left-hand doors to make it easier to get in and out of the vehicles.
- 21 The buggies were leased from a company which serviced the vehicles. DB Cargo was responsible for providing consumables such as fuel, tyres and batteries.

- 52 The inspection of trains was assisted by the additional lights fitted to the left-hand side of each buggy (paragraph 20 and figure 7a). This meant that the right-hand side of a train travelling towards France, such as the train involved in the accident, could only be inspected by a buggy travelling from the west end level crossing towards the east end level crossing, and required a buggy travelling from the access road to cross the track used by the train before the inspection started.

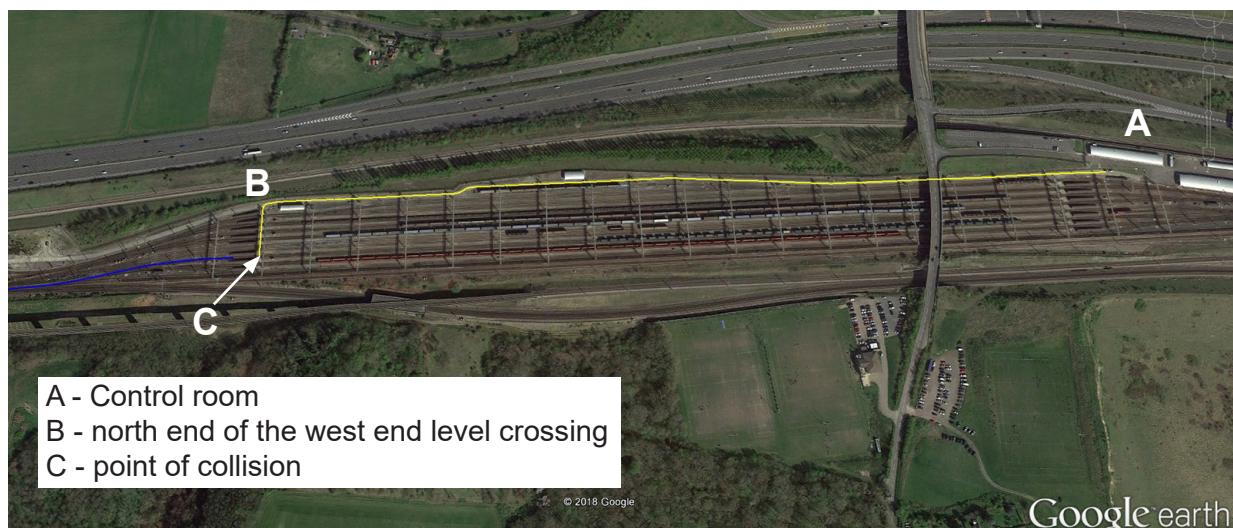
Figure 8: Google Earth image looking north, showing route of buggy from control room to siding 2.

- 37 At 03:36 hrs, the shunter drove up the main access road in a buggy to the west end level crossing, a distance of about 830 metres (figure 8 and figure 9). The other shunter, as was normal practice, made his way to the opposite end of the yard and stopped on the concrete walkway on the north side of siding 2.
