Report detailing the testing  
of an HPL rainscreen  
cladding system tested in  
accordance with the  
requirement as described  
in British Standard 8414-1

# CUSTOMER CLASSIFICATION REPORT

BR 135 (Third Edition) Classification Report

Report Reference: 101856.002

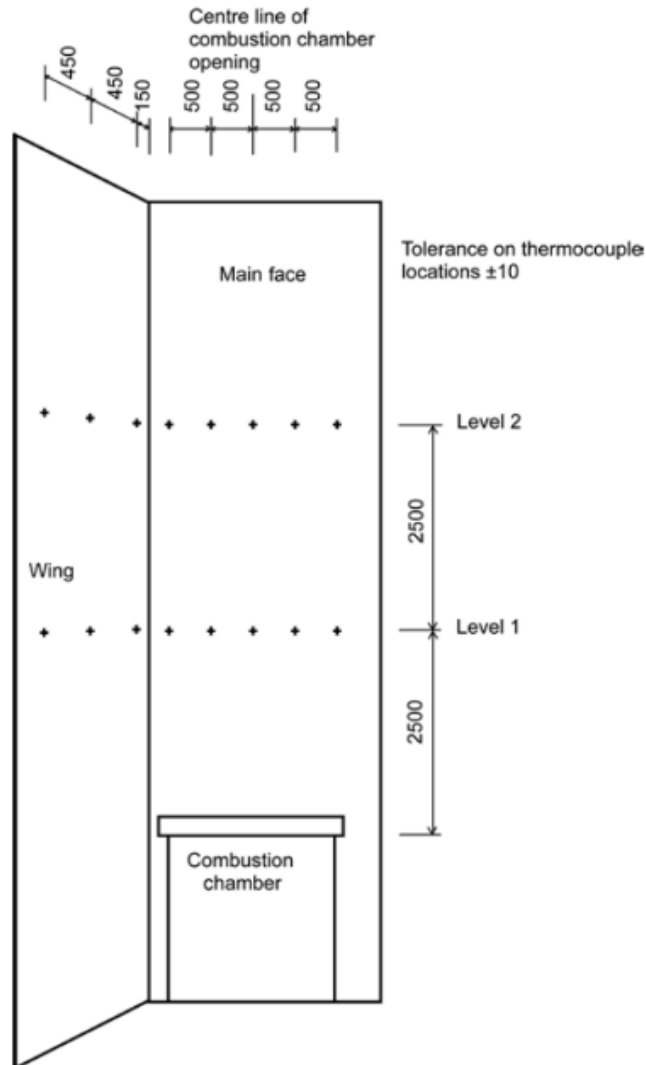
Figure 1 - Location of thermocouples – dimensions in mm

Fire spread is measured by type K thermocouples set at levels 1 and 2 (Figure 1). The start time for fire spread is initiated when the temperature first recorded by any external thermocouple at level 1 equals or exceeds a 200 °C temperature rise above the start temperature and remains above this value for at least 30 seconds.
