Playground Inspection and Maintenance

Site Information

Inspection Ref: 798990

Operational Inspection - 25 March 2019 at 09:35 Inspector:

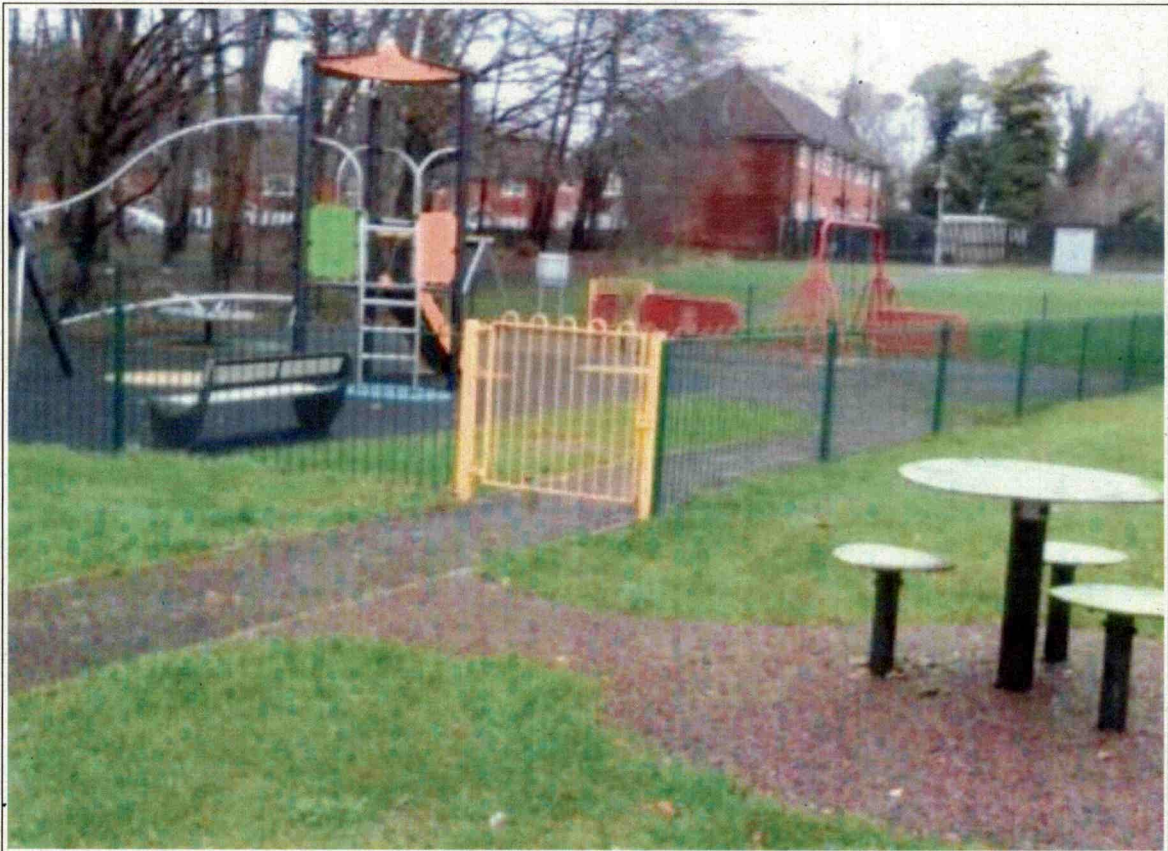
Risk Assessment: **12 - Moderate Risk**

Location: The site is located in an area of public open space and is overlooked by a number of properties in the local community.

Disabled Access: Generally accessible; an area accessible to most.
