## Safety Investigation Report

Watchkeeper WK050 ACCIDENT - NSI

13 June 2018

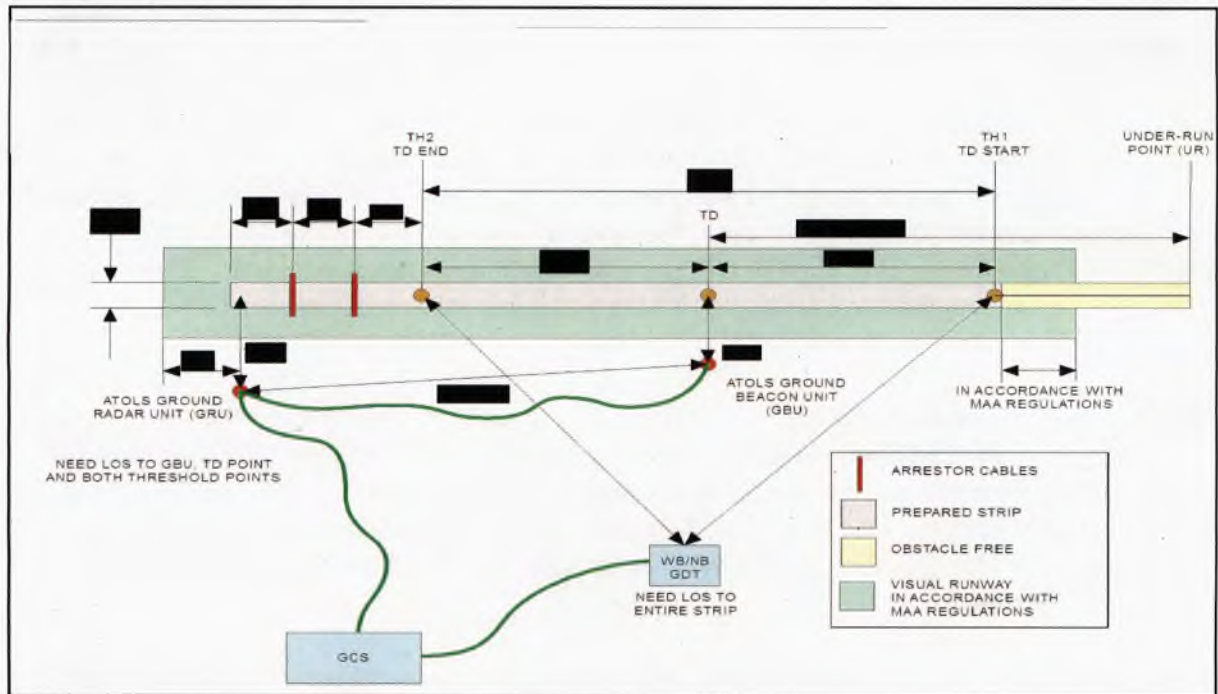
Figure 4: Airstrip parameters.

The NSI team considered other influences on P1's decision to press engine cut. There was evidence from crew interviews of a misconception of the severity of Risk to Life (RtL) and Risk to Equipment (RtE) associated with the AV departing the RW. The layout of the ATOLS has limited equipment close to the RW (Figure 4). Level with the TD point is the GBU, and beyond the arrestor system is the GRU. No personnel are routinely near the ATOLS during a landing and access to the area is controlled by ATC.

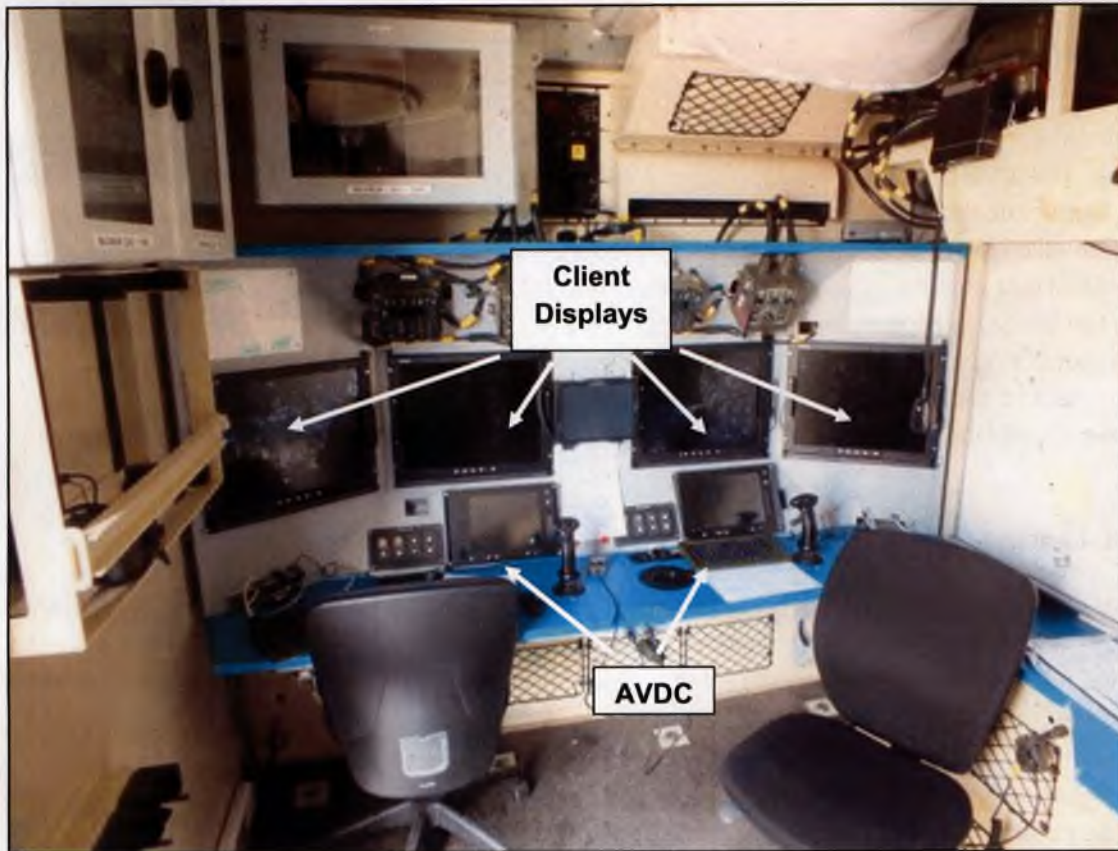
Figure 8: Interior of the GCS.

displayed throughout the incident on the AVDC and Client Displays within the GCS (Figure 8). The ATOLS abort caption on the AVDC (Figure 14) was illuminated red from LSTO and would have remained on until 50ft AGL during the go-around. However, there was no audio alert associated with this caption and it provided minimal visible indication. The NSI team considered the AVDC to be a poor user interface. A pilot's SA can be heavily affected by poor user interfaces so careful design is key<sup>54</sup>. The NSI team concluded that this minimal visible indication could have easily been missed in a situation of high workload and stress.
