Rail Accident Investigation Branch

# Rail Accident Report

**Fatal accident involving a train passenger at  
Twerton  
1 December 2018**

Report 14/2019  
October 2019

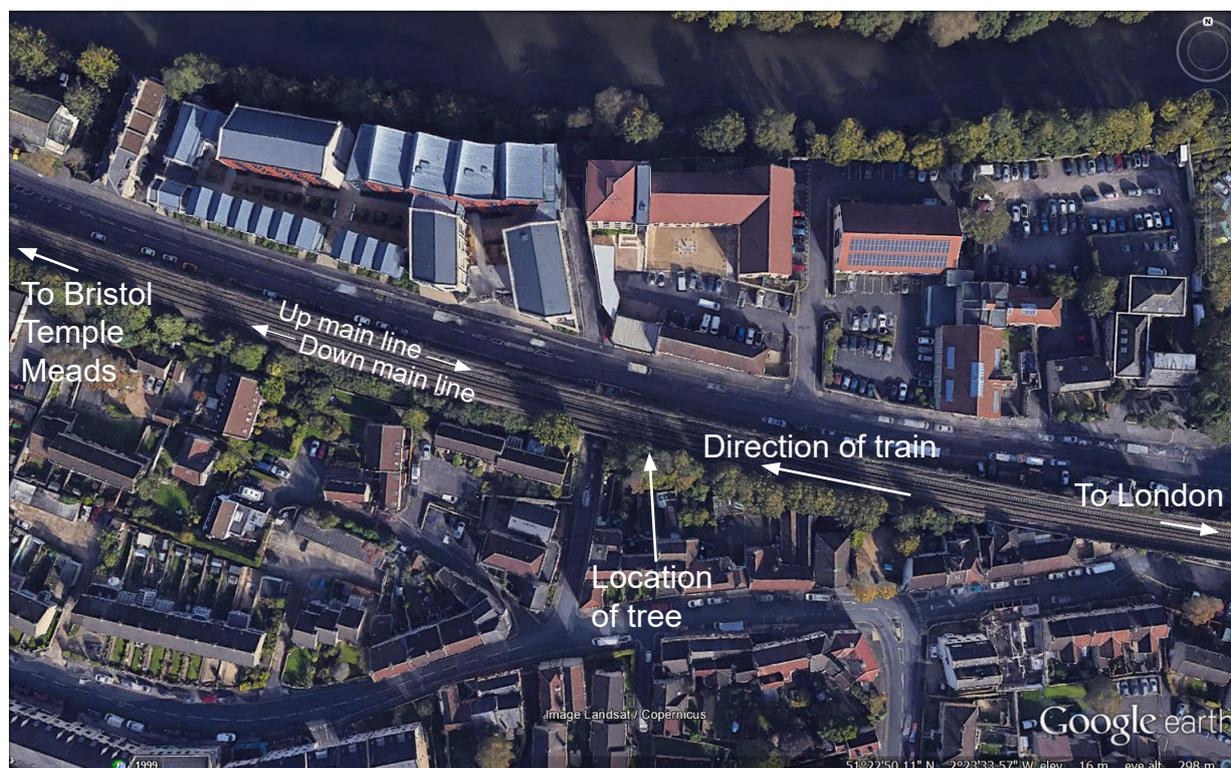
Figure 3: Satellite view of the accident location

- 16 After the accident, Network Rail commissioned an arboricultural consultant to investigate the history of the tree. The consultant's report identified that the tree involved was an ash tree which had been growing on the embankment approximately 5.5 m from the nearest running rail of the 'down' main line.

- 17 The report describes how the tree was either felled or coppiced<sup>2</sup> around 1998 and after that seven stems grew out from the stump. Eventually the stump became colonised by two or three types of wood decay fungi which ultimately led to the failure of the stems. The stem involved then fell towards the railway, coming to rest on a chain link fence at the top of the embankment.

- 18 From a review of historical aerial photographs and video footage, the RAIB has concluded that the stem involved did not fail before 18 April 2015. However, by 4 February 2017, it had fallen and was resting on the fence with some branches extending out towards the railway line. The photographs and video footage also show that the tree remained largely unmoved in this position until at least late on the afternoon of the day of the accident. Given that the tree had been in this position for at least 22 months without moving significantly, it was not a particularly windy day and the RAIB is not aware of any other events that could have affected its position, the RAIB believes it is likely that it was still in that position at the time of the accident.
