Title: GUN 105MM FIELD, L118 TOWED.

AIR RESERVOIR CATASTROPHIC EXPLOSION

Report Reference No: SI/07/0232/SEFIT (A)

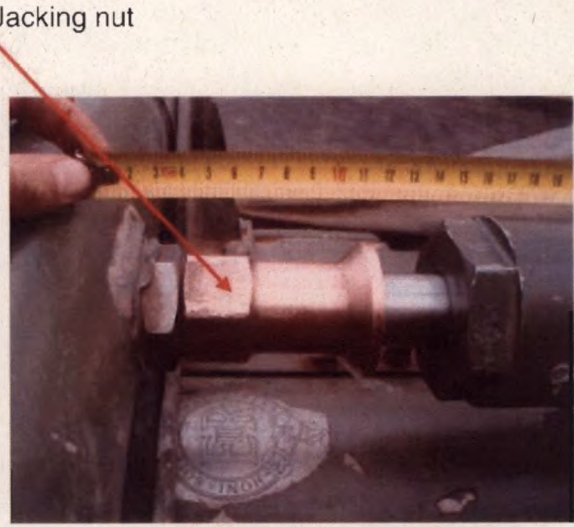
Figure 7a – Serviceable comparison

10. **Recuperator.** The recuperator piston rod (Figure 7) had been subjected to considerable forward force fracturing the spigot, compressing/disfiguring the brass jacking nut, and damaging the rear face of the reservoir (Figure 4). The piston rod anti-rotation washer was not recovered. There was impact damage at the rear of the recuperator where it had struck the breech ring assembly (Figure 8).
